Evidence of an emerging levee failure mechanism causing disastrous floods in Italy

Stefano Orlandini¹, Giovanni Moretti¹, and John D. Albertson²

Orlandini, S., G. Moretti, and J. D. Albertson (2015), Evidence of an emerging levee failure mechanism causing disastrous floods in Italy, *Water Resour. Res.*, 51, 7995–8011, doi:10.1002/2015WR017426.

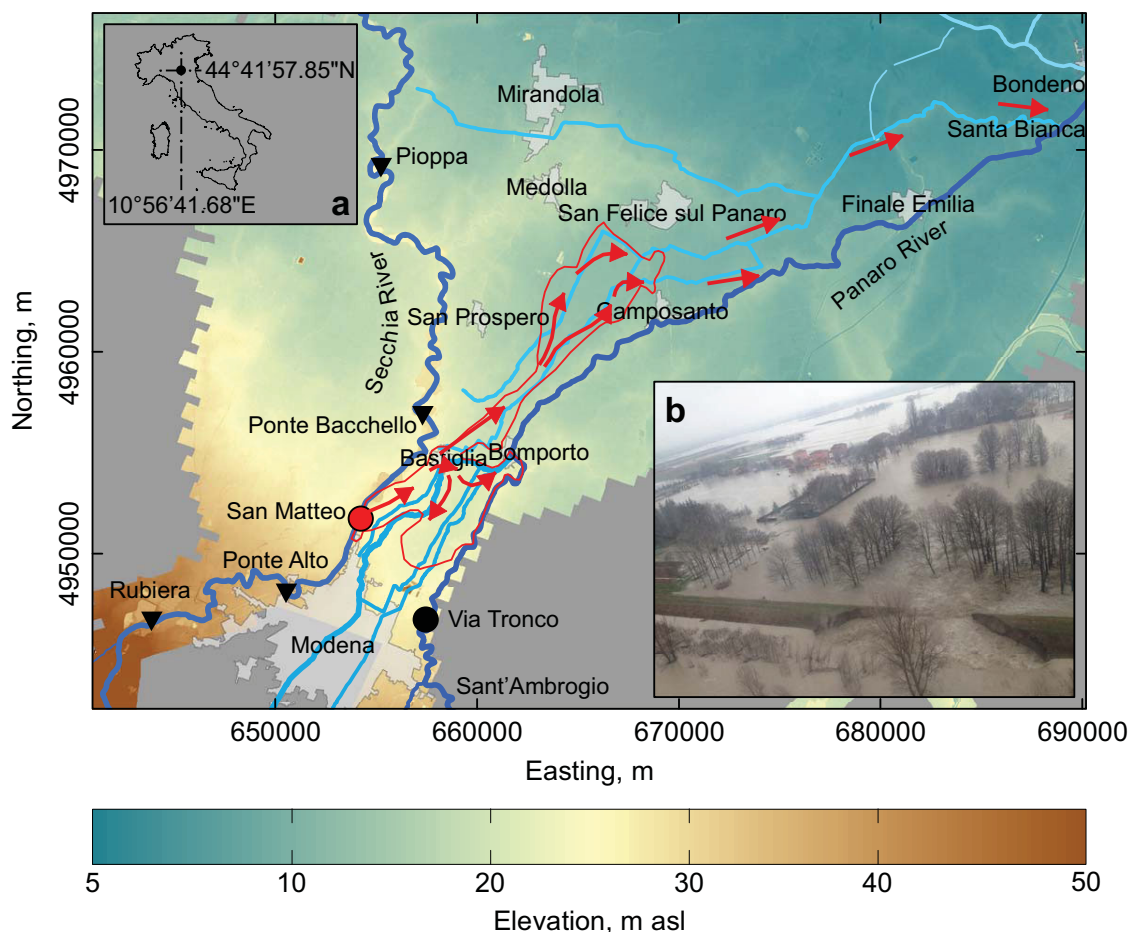
On 19 January 2014, a levee failure occurred along the Secchia River at San Matteo, Northern Italy ($44^{\circ}41'57.85''\text{N}$, $10^{\circ}56'41.68''\text{E}$, Figure 1a). The breach formed on the right side of the river system (from the perspective of looking downstream) was first observed in the morning around 6:30. Since a rapid repair was impracticable at that time, the breach developed by releasing to the surrounding plain a water volume of about $36 \times 10^6 \text{ m}^3$ with a peak flow discharge of about $434 \text{ m}^3 \text{ s}^{-1}$ (section A1). The ultimate extent of the flooded area was about 52 km^2 and the estimated flooding damage was in excess of \$500 million (Figure 1). The levees of the Secchia River are, at least in the perspective of the present investigation, representative of the levee systems developed in the Po Valley from the sixteenth century and now extending for about 2300 km (levees on both sides of the river) along the Po River and its tributaries. The Po Valley is the most densely populated and economically developed area in Italy.

Figure 1. (a) Map of the land flooded after the levee failure occurred along the Secchia River at San Matteo (Northern Italy) on 19 January 2014. (b) The delineation of the flooded areas is based on aerial surveys carried out by the Civil Protection as part of the emergency response plan for the occurred disaster. A volume of water of about $36 \times 10^6 \text{ m}^3$ (Figure 3a, area under the breach loss hydrograph) left the Secchia River by flooding (red arrows) an area of about 52 km^2 . Topographic gradients and barriers are shown by the 1 m resolution digital elevation model reported in the background.

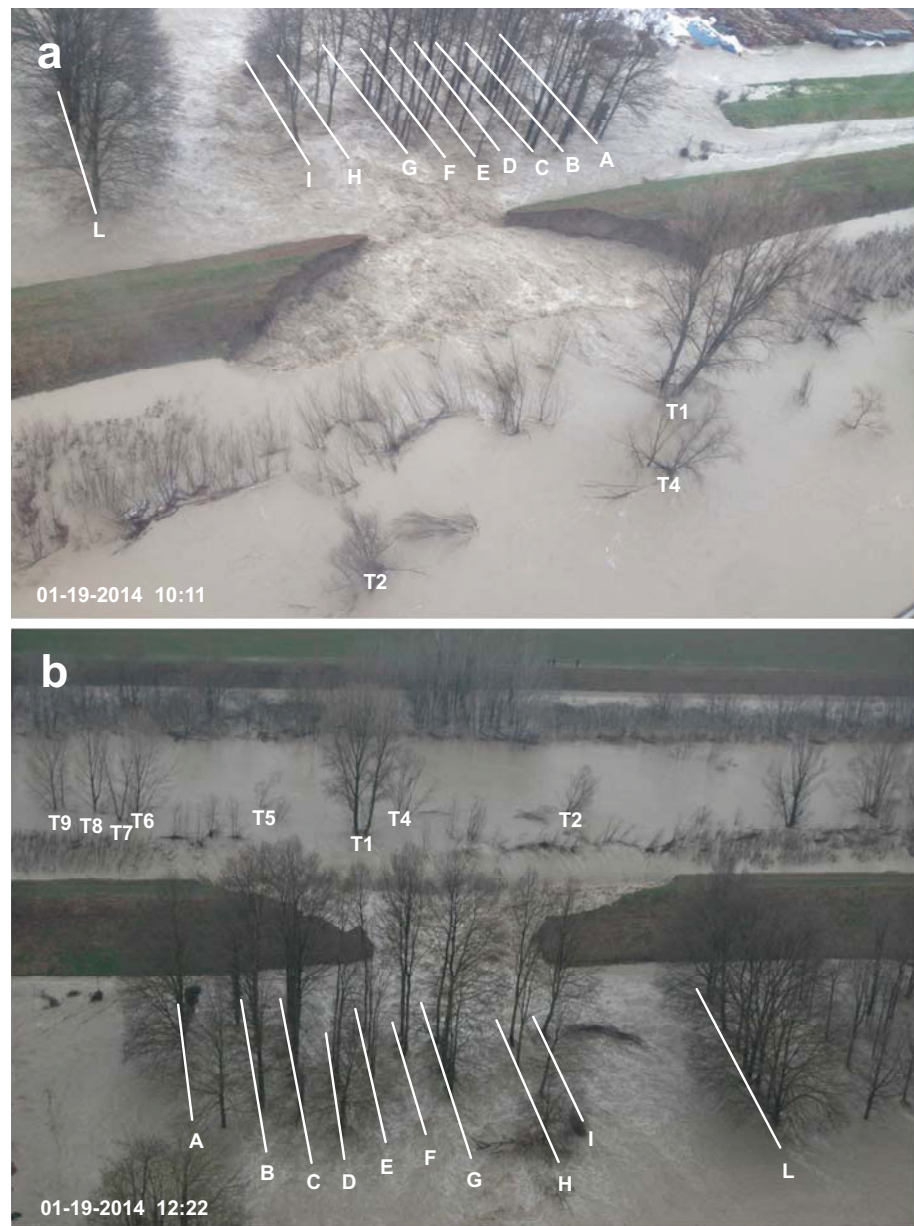
The breach that occurred along the Secchia River on 19 January 2014 (Figures 1 and 4) was first detected at 6:30. It has been reported by several observers that the breach developed from above and that a large erosive flow was spilling out from the river to the landside bank of the levee at the time of the detection. Given

the advanced state of development of the breach at the time of the detection, no attempt to repair the altered levee was readily possible. While the observed clues are helpful, nonetheless, the failure mechanism causing the breach along the Secchia River was not entirely observed. Therefore, plausible hypotheses about the actual failure mechanism and the related triggering processes are explored here.

Figure 4. Photographs of the breach formed along the Secchia River at San Matteo taken from helicopters at 10:11 (Figure 4a) and 12:22 (Figure 4b) of 19 January 2014. Relevant geometrical features of the land surface close to the breach (trees T1–T9 in the riverbed and tree rows A–L in the landside plain) are identified on the photographs to allow the breach configuration to be georeferenced and transferred to relevant aerial photographs (Figures 5b and 5c).

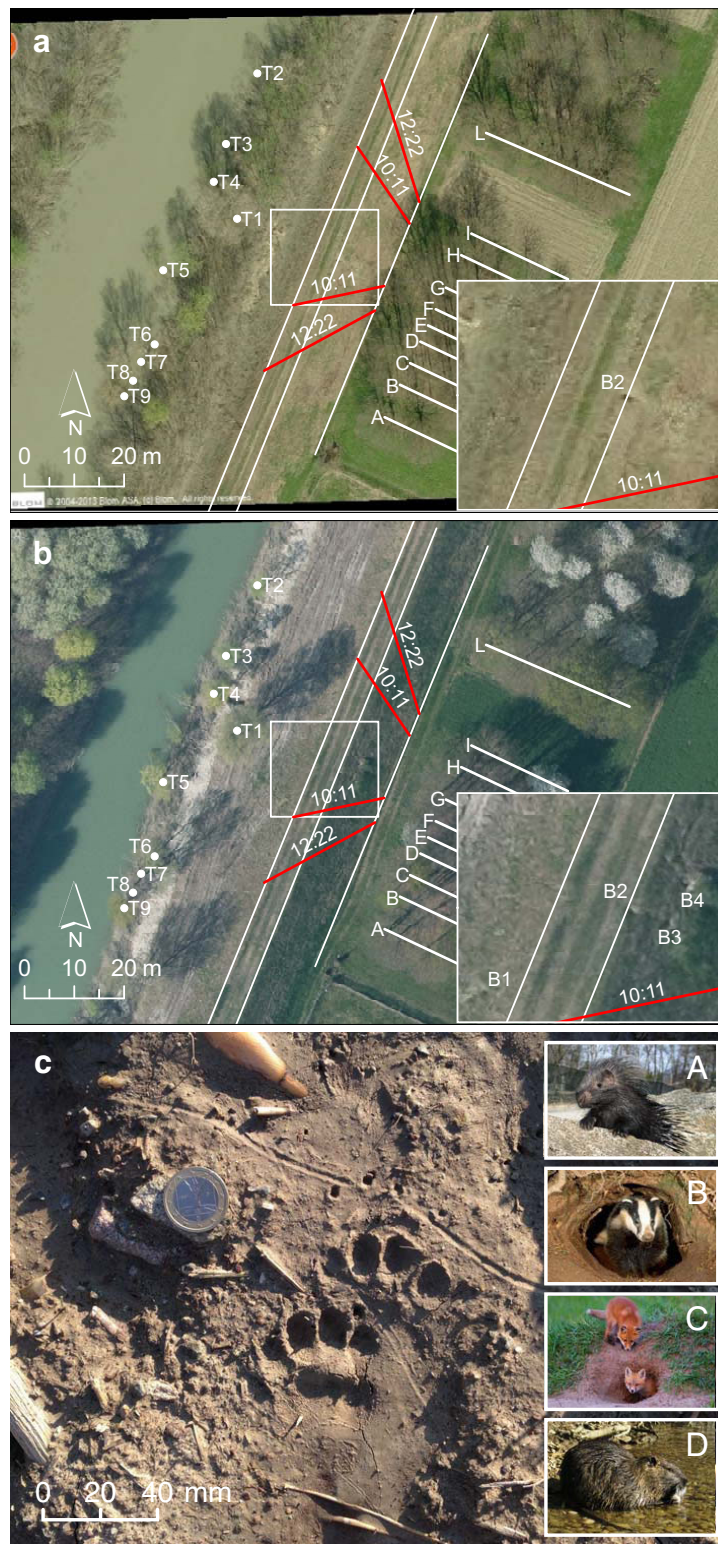
Evidence of wildlife impact on the failed levee was derived from the analysis of 10 cm resolution aerial photographs taken in 2010 and 2012 (Figures 5a and 5b, respectively). This evidence was confirmed by field inspection of the Secchia River after the disaster (Figure 5c). More generally, extensive field inspection conducted along the Secchia and Panaro Rivers revealed an emergent risk connected to the activity of crested porcupines *Hystrix cristata* (Linnaeus, 1758), European badgers *Meles meles* (Linnaeus, 1758), red foxes *Vulpes vulpes* (Linnaeus, 1758), and nutria *Myocastor coypus* (Molina, 1758) (insets A, B, C, and D, respectively, in Figure 5c). The information of the photographs taken from helicopters in the early stage of breach development, at 10:11 and 12:22 (Figure 4), and of previously taken aerial photographs (Figures 5a and 5b) were combined to determine the precise location of the levee where the failure mechanism originated (section A2). Animal burrows (B1, B2, B3, and B4) were found to exist in the levee location where the breach originated (Figures 5a and 5b). In addition, terrain analysis based on a 1 m resolution digital elevation model (DEM) generated from a lidar survey revealed the positions of the animal burrows observed in Figure 5b along the cross section of the failed levee (section A2). Results are reported in Figure 6.

Figure 5. Evidence of burrowing animals in the location of the Secchia River levee that failed on 19 January 2014. Long parallel lines mark the top and landside bottom boundaries of the levee. Figure 5a shows animal burrows appearing in the 10 cm resolution aerial photography taken on 27 March 2010. Figure 5b indicates that on 29 March 2012, animal burrows were further developed. Figure 5c shows the footprint of a wild animal (probably a badger or a crested porcupine) observed on 24 February 2014, along the repaired levee. The burrowing animals that have impacted the levees of the Secchia River include those shown in the insets of Figure 5c: (a) crested porcupine *Hystrix cristata* (Linnaeus, 1758), (b) European badger *Meles meles* (Linnaeus, 1758), (c) red fox *Vulpes vulpes* (Linnaeus, 1758), and (d) nutria *Myocastor coypus* (Molina, 1758).

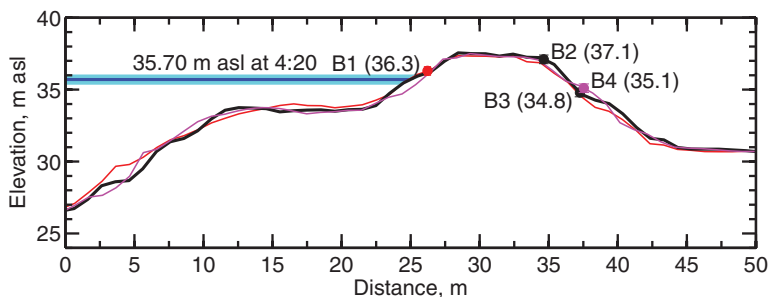
Figure 6. Geometrical relationship between the elevations of burrows B1, B2, B3, and B4 observed (in 2010 and 2012) in aerial photographs (Figures 5a and 5b) of the Secchia River at San Matteo and the river stage reconstructed from hydraulic modeling for the same levee location on 19 January 2014 at 4:20 (Figure 3). Direct river inflow into the den system can be considered possible if an uncertainty of 0.3 m in the determination of both burrow elevations (uncertainty bars) and river stages (light blue band) is acknowledged (hypothesis 1 and section 4.1).

row located on the riverside of the levee (36.3 ± 0.3 m asl) at 4:20, when the river stage was estimated to be 35.70 ± 0.30 m asl (Figures 3b and 6). Since it can be clearly observed that the system of dens developed significantly from 2010 (Figure 5a) to 2012 (Figure 5b), and burrowing animals like badgers or crested porcupines were still living along the repaired levee in 2014 (Figure 5c), it is likely that the den system was more developed at the time of the levee failure than shown in the photograph taken in 2012 (Figure 5b). This would further support the triggering of internal flow and erosion processes by direct river inflow into the riverside entrance of the den system.

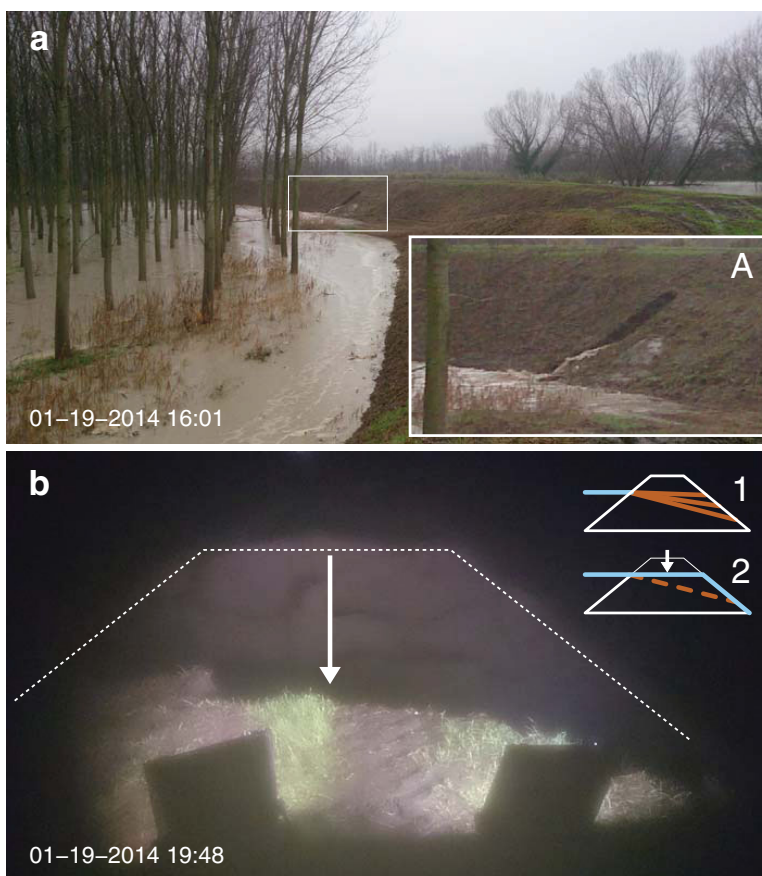
Having observed the disastrous levee failure along the Secchia River, the technical staff of the responsible agency, the “Agenzia Interregionale per il Fiume Po,” and of the Civil Protection executed an emergency response plan by closely watching the levee systems of the Secchia and Panaro Rivers. On 19 January 2014, a developing internal erosion process was observed on a levee along the Panaro River at Via Tronco (Figure 1), at a site where a crested porcupine den was known to exist (Figure 7). The internal erosion process shown in Figure 7a (inset A) was observed at 16:01 on 19 January 2014, but it most likely started at least 1 h before, as indicated by the ponding depth of turbid water lying on the soil surface at the landside of the levee in Figure 7a. The internal flow and erosion processes depicted in Figure 7a are focused at the den of a crested porcupine (inset A of Figure 5c) that was observed and had been filled with earth in the past. The internal erosion process was observed to continuing developing during the period of time from about 16:01 to 19:50 as sketched in the inset 1 of Figure 7b. At about 19:50, the top of the levee was observed to collapse on the gallery caused by internal erosion as sketched in the inset 2 of Figure 7b. The levee top then, lowered by about 3 m, would have been further eroded and overtopped by a river flow loss if a rapid repair operation were not carried out by filling the breach with earth and compacting this earth with an excavator. The collapsed levee was thus repaired, preventing a second disaster.

Figure 7. Observational evidence of the levee failure mechanism occurred along the Panaro River at Via Tronco (Figure 1) on 19 January 2014, under hydroclimatic conditions similar to those occurred along the Secchia River at San Matteo (Figure 2). An internal erosion process was observed at 16:01 as documented in Figure 7a. This internal flow process developed around a crested porcupine den that was observed and filled with earth in the past. The collapse of the levee top over the gallery formed by internal erosion was documented at 19:48 as reported in Figure 7b. The picture reported in Figure 7b was taken from the top of the levee close to the collapsed portion highlighted by the arrow directed downward. The failure mechanism consisted therefore of two stages. In stage 1 (Figure 7a and sketch labeled “1” in Figure 7b), the internal erosion develops around the animal den. In stage 2 (Figure 7b and sketch labeled “2” in Figure 7b), the levee top collapses by filling the gallery in the eroded levee and by exposing the collapsed material to further erosion and overtopping. The collapsed levee was rapidly repaired, preventing a second disaster.

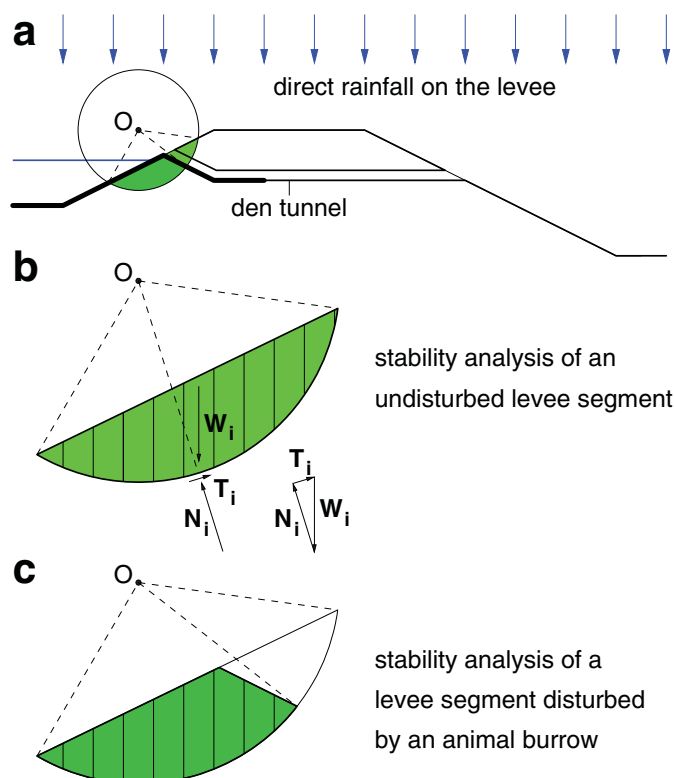
Figure 8. Sketch of the slope stability analysis performed to assess the impact of animal burrows on equilibrium conditions (hypothesis 2 and section 4.2). The bold line in Figure 8a indicates the levee portion on which the analysis focuses. The equilibrium of green segments shown in Figures 8b and 8c is evaluated: O is the center of the circular sliding surface, W_i is the weight of the i th element composing the sliding segment, T_i and N_i are the shear and normal components of W_i to the sliding surface. The blue vertical arrows indicate the direct rainfall on the levee. The blue horizontal line indicates the river stage. The two cases in which the animal burrow is not present (Figure 8b) or is present (Figure 8c) are considered.

A Fellenius slope stability analysis was then performed by varying the center of the circular sliding surface and considering all the forces acting on the variably saturated sliding soil segment (section A4). It is important to note that this was a simplified 2-D stability analysis, and as such the results should be both meaningful for evaluating hypothesis 2 and on the conservative side. The results are reported in Figure 9. A first set of numerical experiments reveals that no instabilities occur by considering a realistic configuration of the tunnel extending from the riverside den entrance into the levee (Figures 9a–9c). No red lines indicating critical sliding surfaces are shown in Figures 9d–9f. The (unknown) internal tunnel geometry is varied in the second set of numerical experiments until red lines indicating critical sliding surfaces came out (Figures 9g–9i). These critical geometrical settings are, however, found to be unrealistic because they produce levee failures also in times when no failures were observed to occur (Figures 9j–9l).

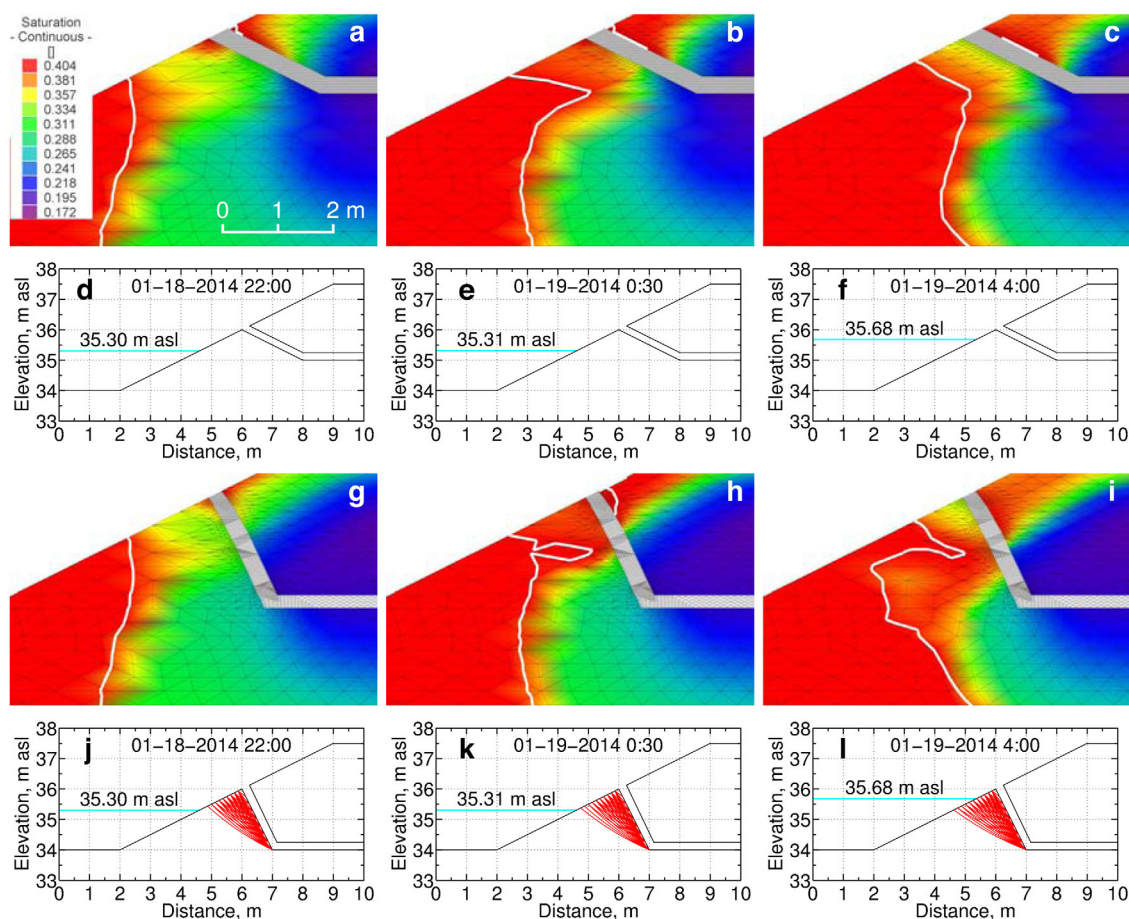
Figure 9. Simulated response of the levee of the Secchia River at San Matteo to direct rainfall on the levee (Figure 2b) and river stage (Figure 3b) in the case sketched in Figure 8 (hypothesis 2). Two possible hypothetical configurations for the tunnel extending from the riverside animal burrow into the levee are reported in Figures 9a–9f and 9g–9l, respectively. The simulation period started at time 22 December 2013 at 0:00 to mitigate the memory effects on the reconstructed levee status. The reconstructed fields of volumetric soil water content are reported at times 18 January 2014 at 22:00 (Figures 9a, 9d, 9g, and 9j), 19 January 2014 at 0:30 (Figures 9b, 9e, 9h, and 9k), and 19 January 2014 at 4:00 (Figures 9c, 9f, 9i, and 9l). The term “saturation” reported in the legend of Figure 9a is used in the FEFLOW program to denote the volumetric soil water content. The white line in Figures 9a–9c and 11g–11i denotes the phreatic (zero pressure) surface.

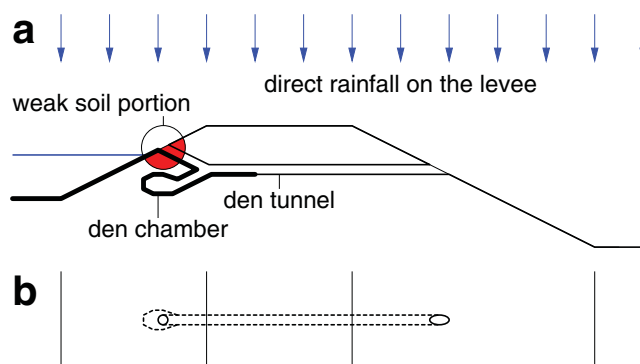
Figure 10. Sketch of the den system hypothesized to explore the possible triggers of internal flow and erosion processes occurred on 19 January 2014, along the Secchia River at San Matteo (hypothesis 3 and section 4.3). Plan and profile views are reported in Figures 10a and 10b, respectively. The bold line in Figure 10a indicates the levee portion on which the analysis focuses. The red circular segment indicates the portion of weak soil centered around the den entrance. The blue vertical arrows indicate the direct rainfall on the levee. The blue horizontal line indicates the river stage.

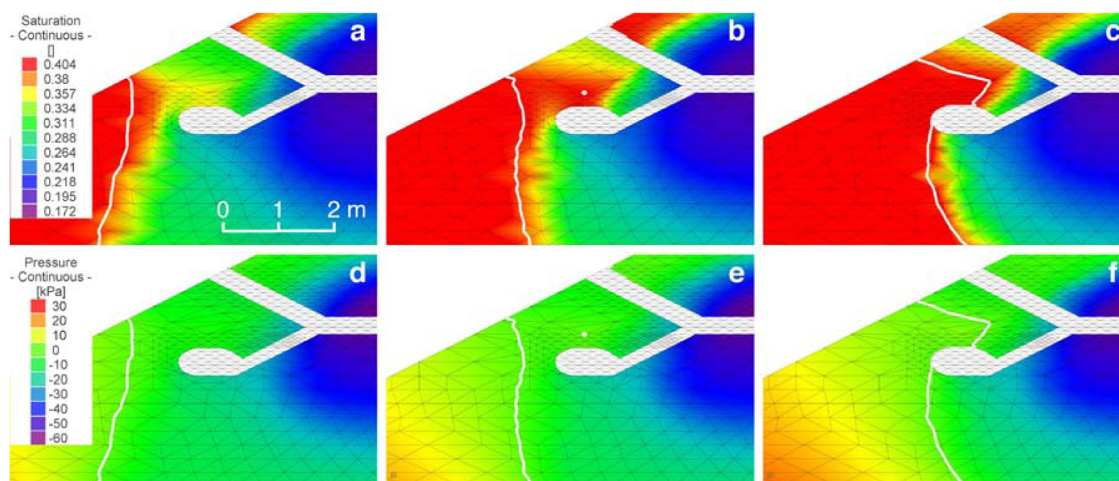
pressure (Figures 11d–11f) become critical at 4:00 of the day 19 January 2014 (Figures 11c and 11f), and that these critical conditions do not occur in other times of the simulation period (December 2013 and January 2014) as should be expected (e.g., Figures 11a–11c and 11f). At 4:00 of 19 January 2014, the ceiling of the chamber became saturated and the soil water pressure became positive. This occurrence would have likely implied the collapse of the den system and the triggering of internal flow and erosion, even with the elevations of animal burrows observed in 2012 (section A5).

Figure 11. Simulated response of the levee of the Secchia River at San Matteo to direct rainfall on the levee (Figure 2b) and river stage (Figure 3b) in the case sketched in Figure 10 (hypothesis 3). The simulation period started at time 22 December 2013 at 0:00 to mitigate memory effects on the reconstructed levee status. The reconstructed fields of volumetric soil water content and pressure are reported at times 18 January 2014 at 22:00 (Figures 11a and 11d), 19 January 2014 at 0:30 (Figures 11b and 11e), and 19 January 2014 at 4:00 (Figures 11c and 11f). The term “saturation” reported in the legend of Figure 11a is used in the FEFLOW program to denote the volumetric soil water content. The white line denotes the phreatic (zero pressure) surface.
