**Axial Pull Tests on Insituform IMain Liner**

**Prepared by  
Cornell University NEESR Group**

**September 7, 2011**

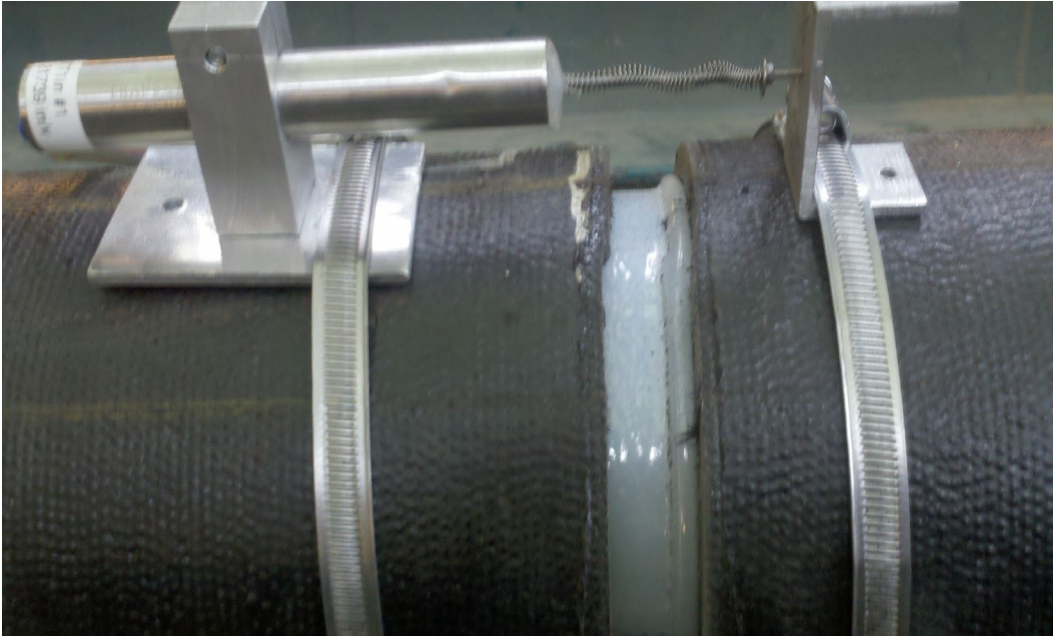
Photo 2. Specimen No. 5, Unbonded Liner, Gap Pull Test

Specimen 5 was an unbonded specimen and loaded in a Gap Pull Test (tension only). As shown in Photo 2, the pipe is loaded on either side of a gap in the DI pipe. This test design allows the liner strength to be considered without the contribution of the existing pipe, similar to lining a cracked, in-situ pipe. As shown in Figure 2, at an approximate displacement of 2.62 mm (0.103 in.) and force of 3.51 kN (0.79 kips) an abrupt reduction of applied force was observed. The specimen continued to accept load reaching a peak of 3.87 kN (0.87 kips) at approximately 63.5 mm (2.5 in.) of displacement. As expected in an unbonded specimen, failure occurred between the liner and mortar interface. It should be noted that the gap was located 724 mm (28.5 in.) from one end of the 2160-mm(85-in.) -long specimen instead of at its center which suggests that this length was adequate to develop a full bond between mortar and ductile iron.

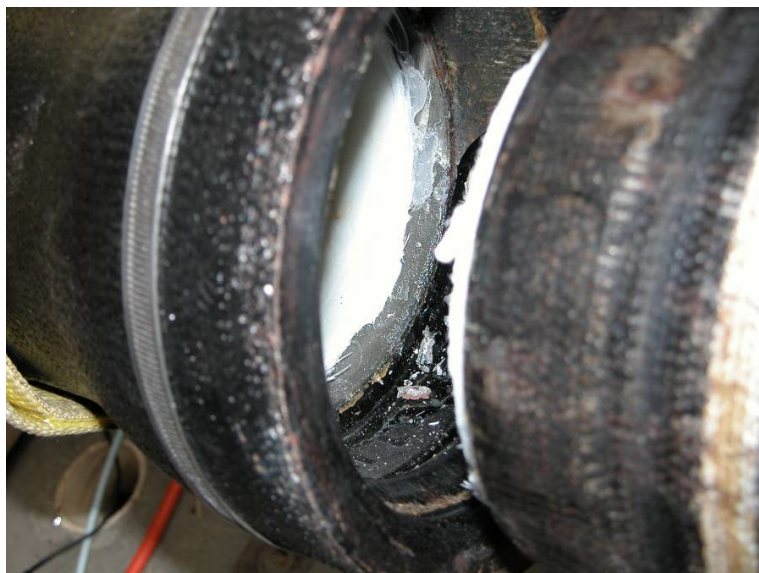
Photo 3. Specimen No. 4, Unbonded Liner, Joint Pull Test

Specimen 4 had an unbonded liner, a pipe joint at its approximate center, and was tested by means of the Joint Pull procedure. As shown in Figure 3, at a maximum displacement of 6.25 mm (0.246 in.) and force of 119 kN (26.7 kips) the specimen liner fractured. This failure mode does not comply with the other unbonded tests. As shown in Photo 3, the liner fracture occurred at the base of the bell. Unexpected mechanical behavior was likely present to produce a failure of the liner in an unbonded specimen.

One explanation is that the polyethylene liner used to preserve the unbonded interface between liner and mortar may have been damaged during installation allowing the epoxy to develop an unwanted bond.

Another possible explanation is that an increase in radial stress occurred because the outer diameter of the liner was larger than the interior diameter of the DI pipe resulting in greater frictional resistance along this interface. According to measurements that were performed on ring specimens, the average outside diameter of the liner is  $D = 152$  mm (6.00 in.), with standard deviation of 0.61 mm (0.024 in.) (Ring Compression Tests on Insituform IMain Liner, Cornell University NEESR Group 2011). It should be noted that the liner of Specimen 4 had consistently greater thickness when both undeformed and deformed than any other specimens tested. Specifically, Specimen 4 is about 5-10% thicker when undeformed and 6 - 38% thicker when deformed than bonded

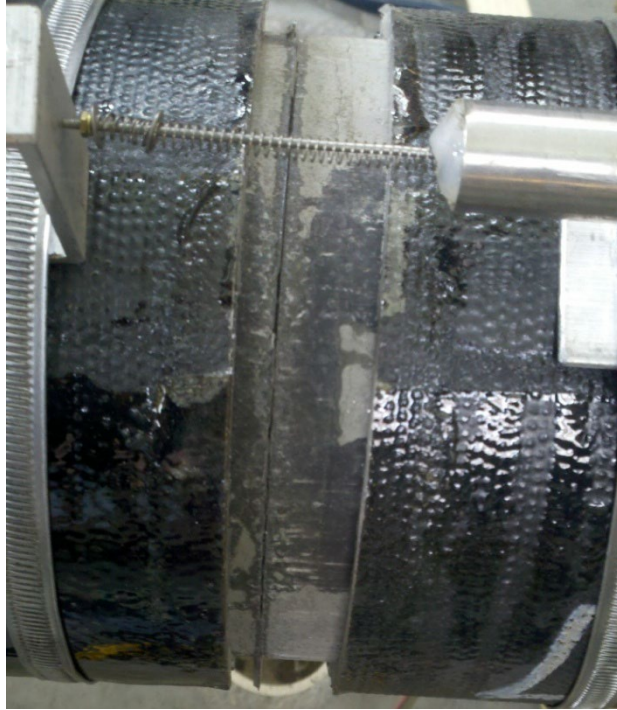
Photo 4. Specimen No. 7, Bonded Liner, Gap Pull Test

Specimen 7 had a bonded liner with full circumferential gap and was tested by means of an Axial Pull Test (Photo 4). As shown in Figure 5, the maximum load achieved before slippage along the DI-mortar interface was 117.9 kN (26.5 kips) at a displacement of 5.74 mm (0.226 in.). Upon continued loading the displacement increased with little change in load until a displacement of 16.5 mm (0.65 in.) when an abrupt decrease in load suggests further slippage along the DI-mortar interface. It should be noted that the gap was not located in the center of the 2160-mm (85-in.)-long specimen but rather 762 mm (30 in.) from one end. Further, slippage occurred in the shorter section which inherently had less available surface area to develop the bond between iron and mortar.

The failure between these surfaces suggests that the bond between liner and mortar is stronger than the manufactured bond between mortar and DI. It also provides evidence that to rupture the liner, the longitudinal development length between DI and mortar should be greater than 762 mm (30 in.).

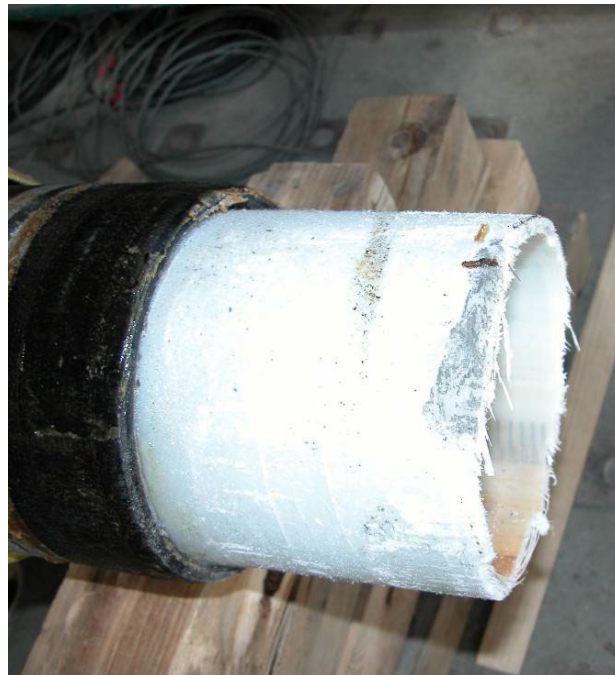
Photo 5. Specimen No. 9, Bonded Liner, Joint Pull Test

Specimen 9 was bonded and subject to a Joint Pull Test in which the joint was located at the approximate center of the specimen. As shown Figure 6, at a displacement of 5.82 mm (0.229 in.) the peak load of 139.2 kN (31.3 kips) was achieved. At this point the liner fractured approximately 180 mm (7 in.) into the bell end of the pipe from the base of the bell as shown in Photo 5. Once fractured, the specimen was no longer able to resist force and the test was discontinued.

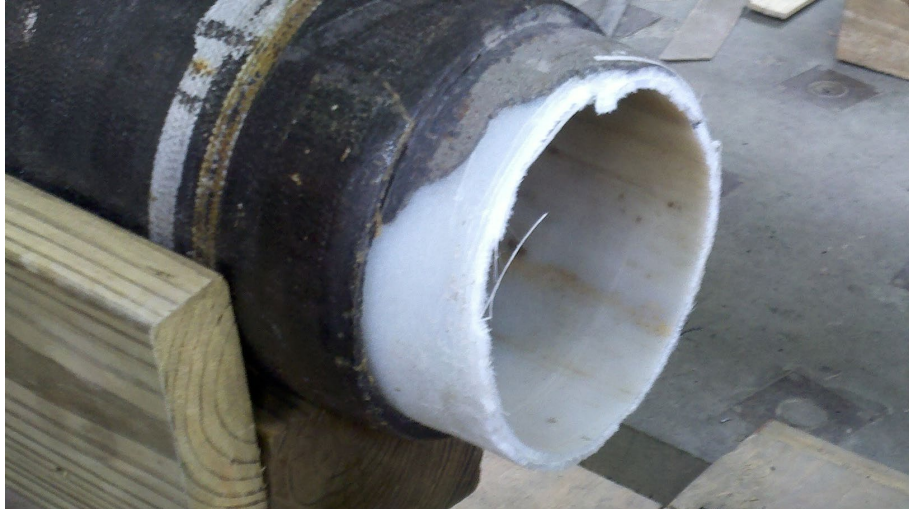
Photo 6. Specimen No. 8, Bonded Liner, Joint Pull Test

Similar to Specimen 9, Specimen 8 was bonded and subject to a Joint Pull Test. As shown in Figure 7, at a displacement of 2.64 mm (0.104 in.) the peak load of 119.2 kN (26.8 kips) was achieved. At this point the liner fractured several inches into the bell of the pipe as shown in Photo 6. After the specimen fractured it was no longer able to return to the peak force and testing was ended. Also noticeable in Photo 6, a portion of the mortar remained bonded to the liner. This further suggests that the mortar-liner bond has the potential to be stronger than the manufactured DI to mortar interface.

Despite Specimens 8, 9 and 11 being similarly bonded and joint centered, the liner of Specimen 8 failed at a displacement approximately 55% less than its counterparts. Assuming that the thickness of the mortar and DI pipe remain constant along the specimen, the thickness of the liner from the south to north end ranged between 8.23 mm (0.324 in.) and 10.4 mm (0.408 in.). Such variance in thickness was much more prominent in Specimen 8 than other pull test specimens. As a result, the thickness ratio between the deformed and undeformed liner ranged between 0.68 and 0.86 for the north or south ends respectively. The range in liner thickness ratio for Specimen 8 was greater than the range of any other tested specimen.

Another observation is the inconsistent debondment of the liner to mortar and mortar to DI interfaces. Referring to Photo 6 it can be seen that the exposed debonded section of Specimen 8 liner has some mortar bonded to it. Mortar bonded to the unbonded liner also can be observed in Specimen 11 (Photo 9). This observation provides further evidence of the inconsistent bonding between both the liner to mortar and mortar to DI interfaces. It also can be inferred that the debondment and eventual failure of these lined specimens is complex and based on inconsistent factors that cannot be characterized easily.

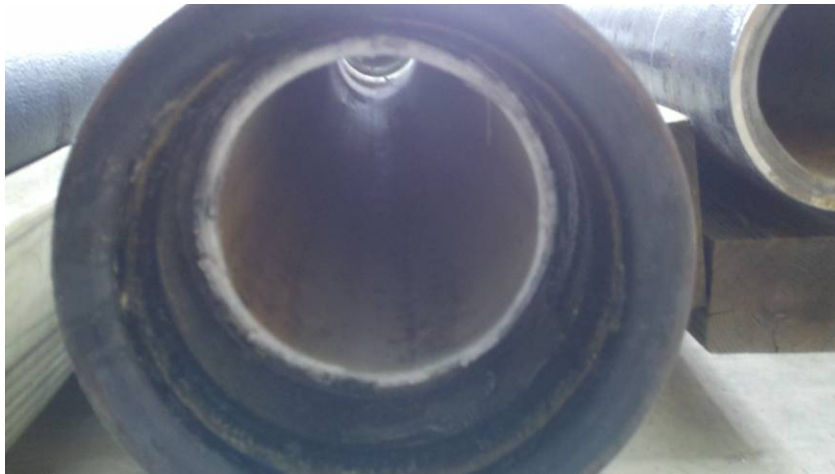
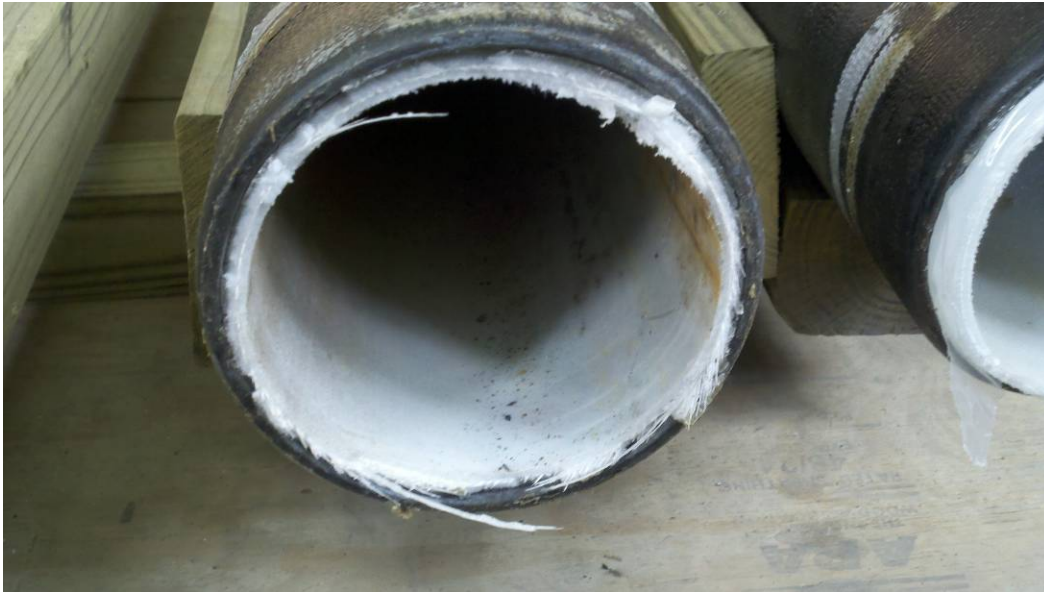
Similar to Specimens 8 and 9, Specimen 11 was also bonded and subject to a Joint Pull Test. At a displacement of 6.02 mm (0.237 in.) a peak load of 143.2 mm (32.2 kips) was achieved (Figure 8). As shown in Photo 7 and Photo 8, the liner fractured cleanly at the base of the bell. After the specimen fractured it was no longer able to accept load and testing was discontinued.

Photo 7. Specimen No. 11, Bonded Liner, Joint Pull Test, Bell End

Photo 8. Specimen No. 11, Bonded Liner, Joint Pull Test, Spigot End

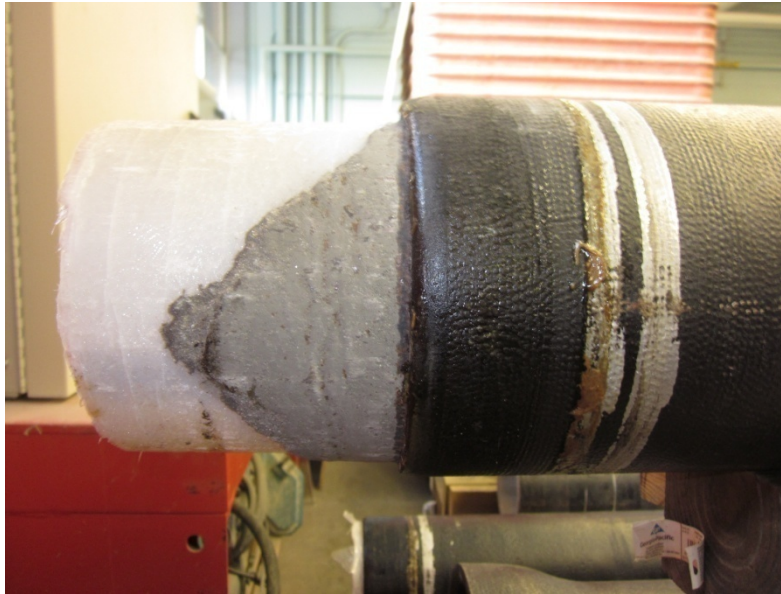
Photo 9. Specimen 11, Debonding of Mortar and Ductile Iron
