Gilpin's Falls Covered Bridge

Cecil County, Maryland

2009 Rehabilitation

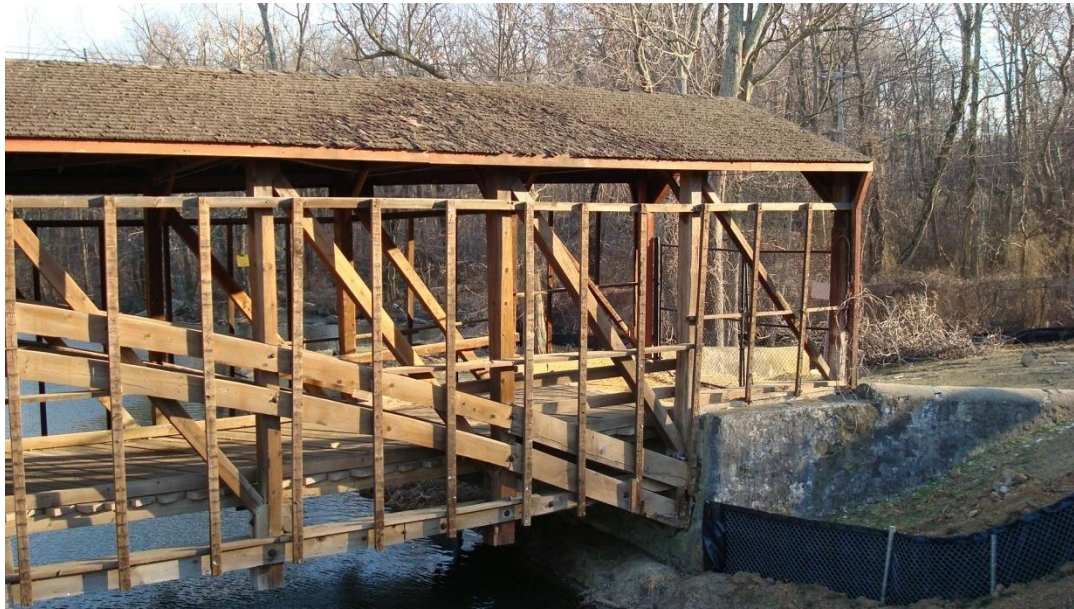
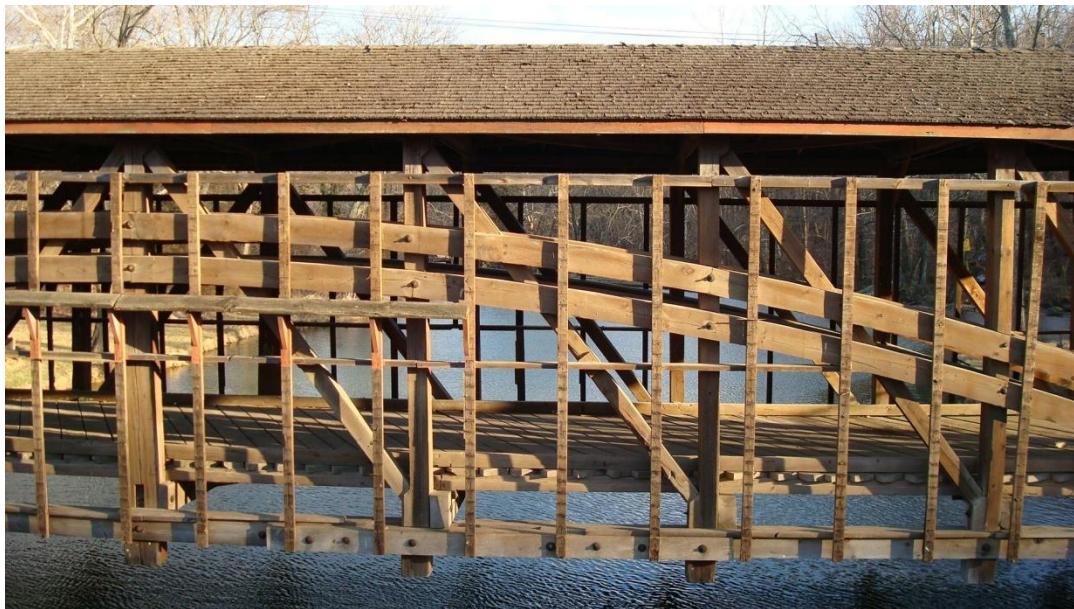
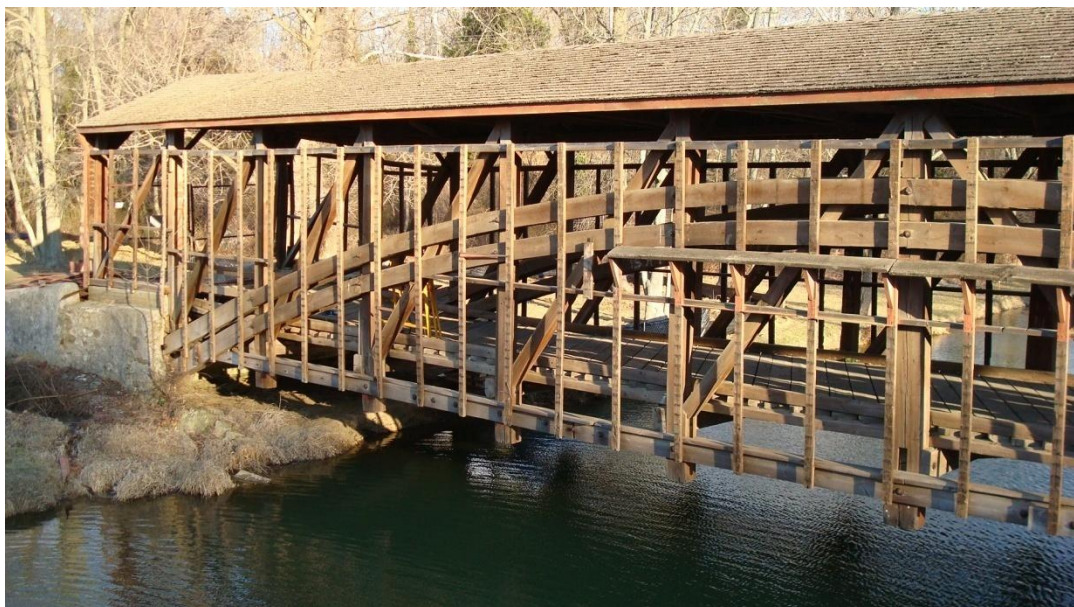
The preceding two pages show bridge details from 2001. The degraded condition of the siding, the internal structure of the Burr arch, and the 1959 addition of steel stabilizer rods can be seen. Notice the embedded timbers within the masonry abutment and how the arch has lost proper bearing (the arch should bear on the embedded timbers).

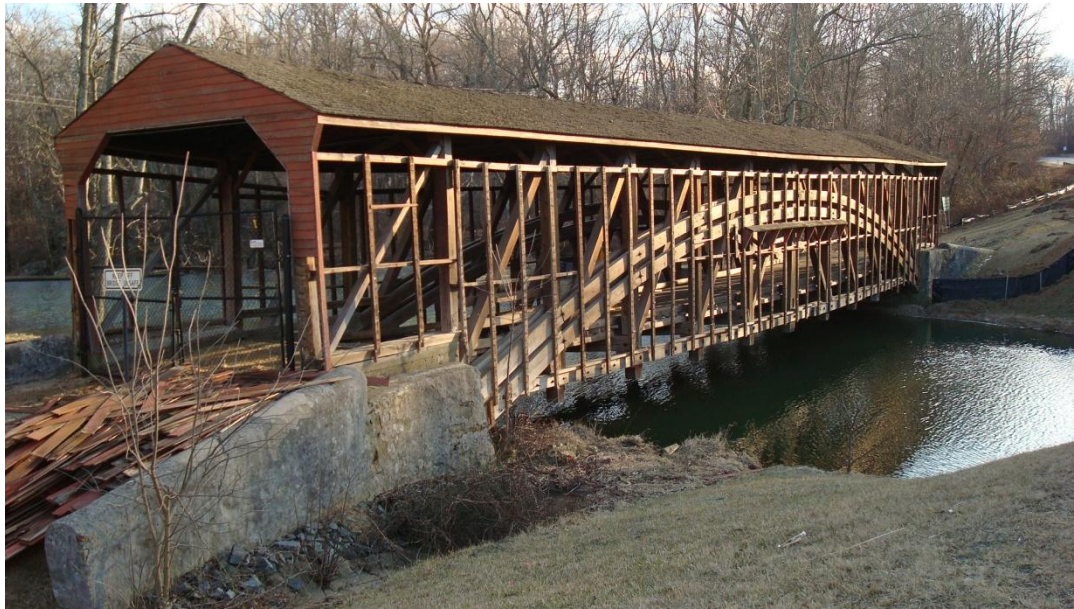
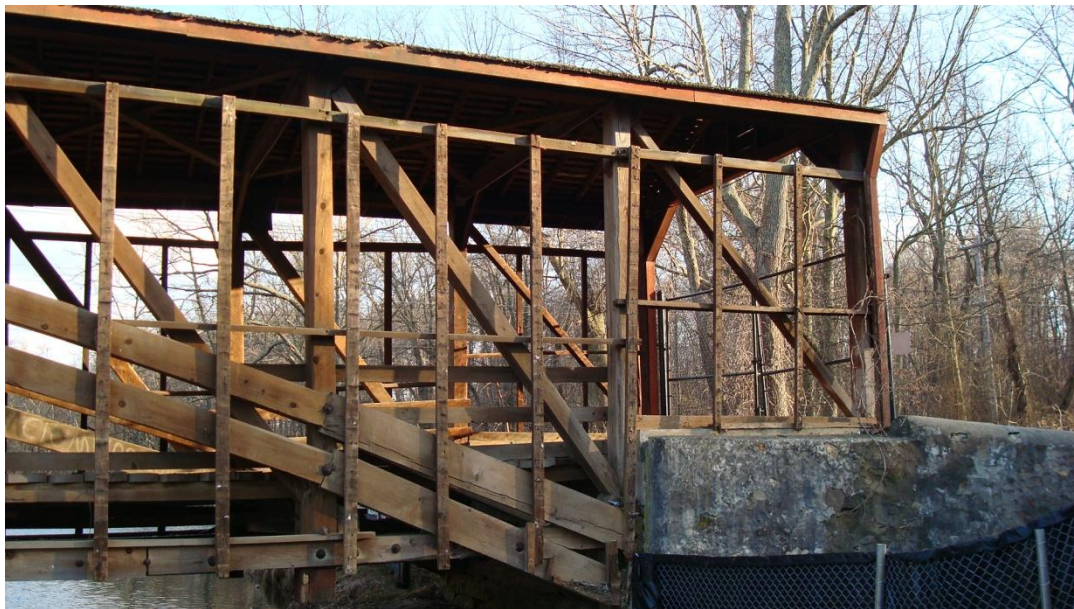
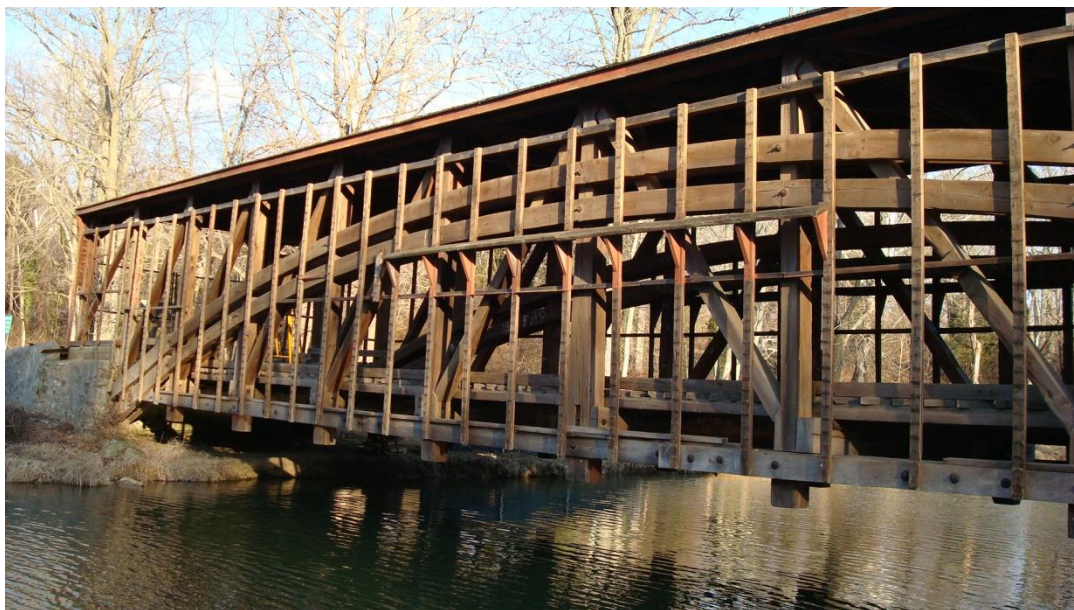
Then the bridge is seen here in February 2009 with the siding removed. The stabilization and restoration project are expected to continue through 2009.

It is difficult to reflect in photographs, but the bridge has lost its vertical camber as its bearing has degraded and it has meanwhile developed a horizontal camber or skew that points it in the upstream direction. Ironically, this may be a contributing factor in its resistance to abusively high flow conditions from a number of severe storms, the most recent of which was 1999's Hurricane Floyd.

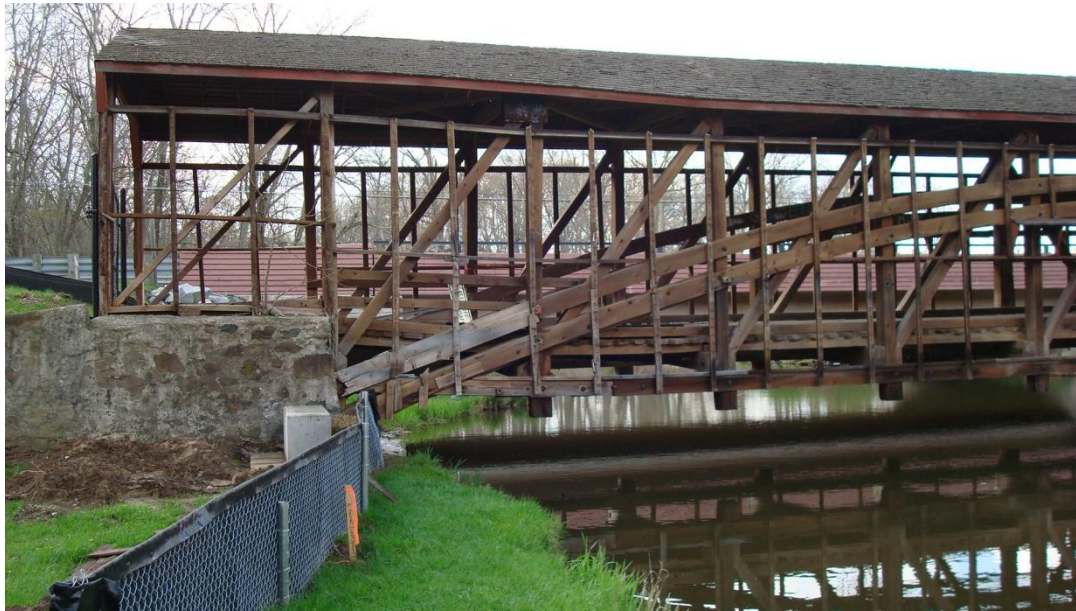
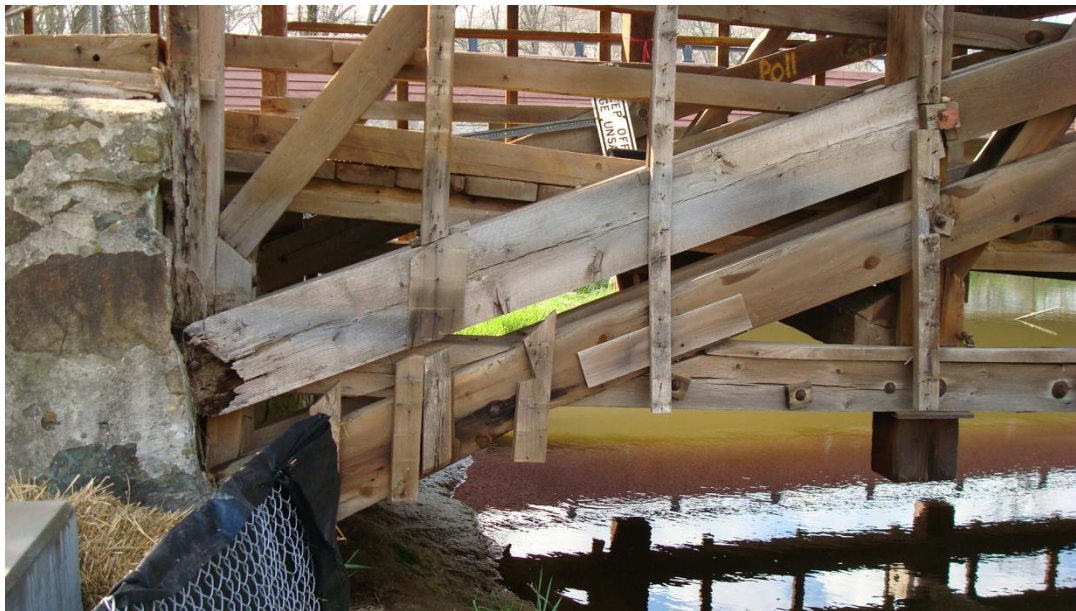
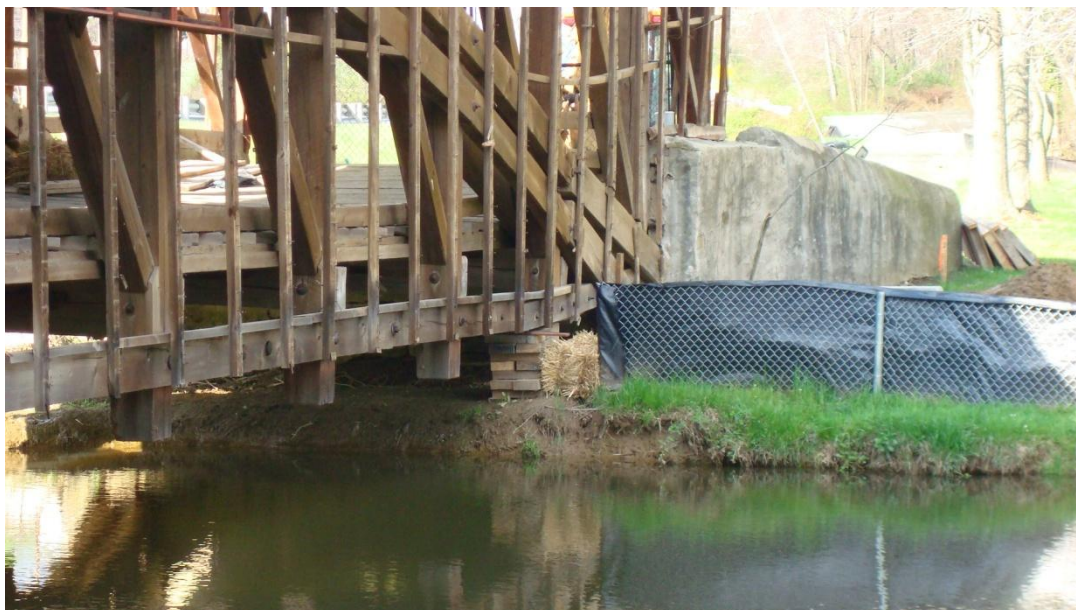
In these photos you can see the considerable deterioration at the south abutment, the resulting settlement of the bridge deck, and the temporary supports at the north abutment (installed circa April 2009). Notice also the super silt fence installed in the high risk areas where active work could threaten the Northeast Creek.

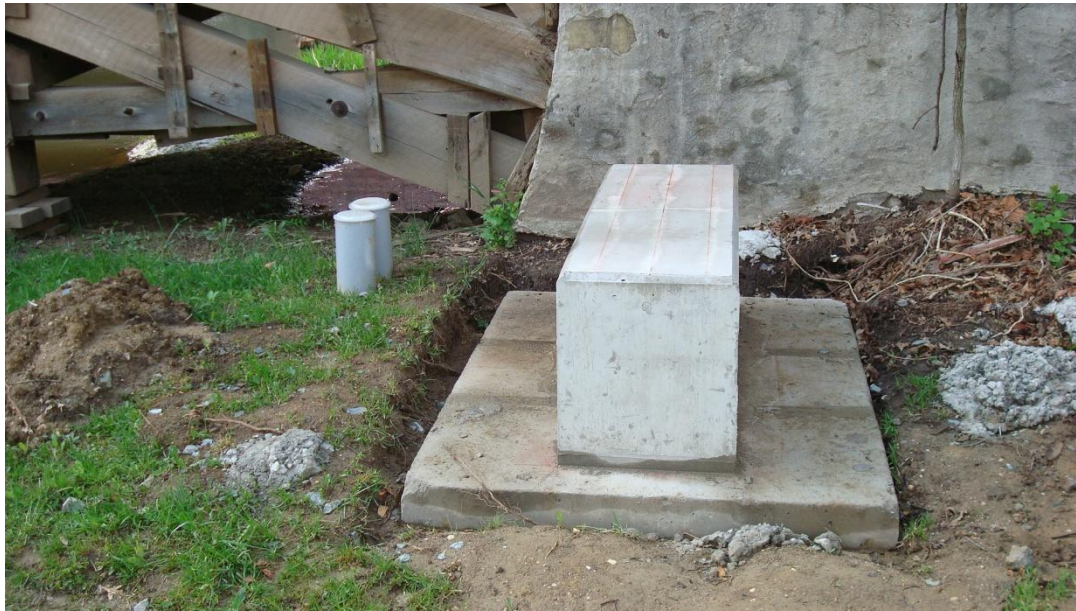
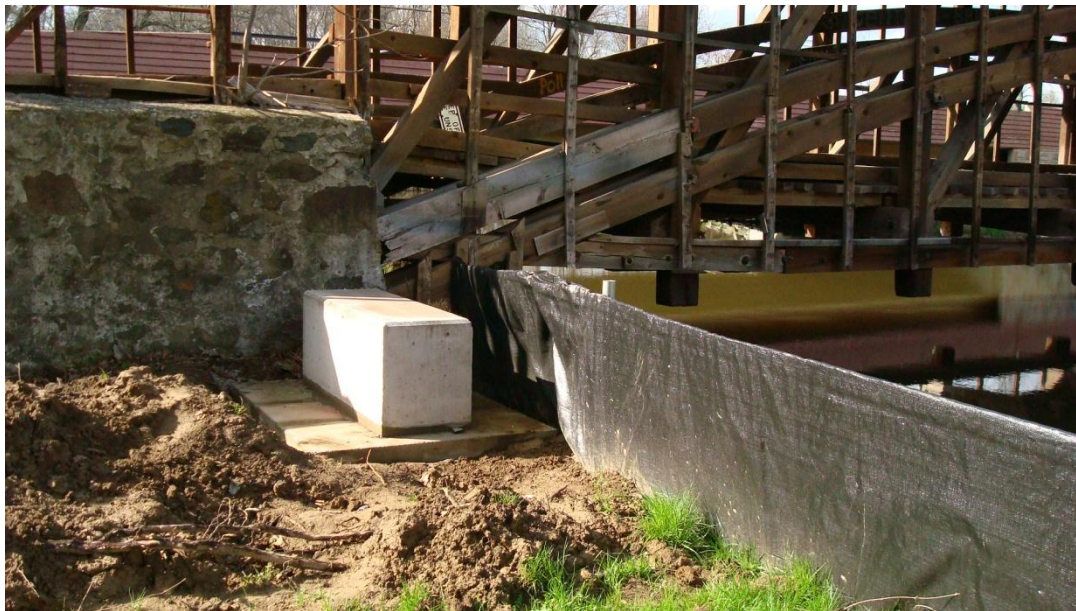
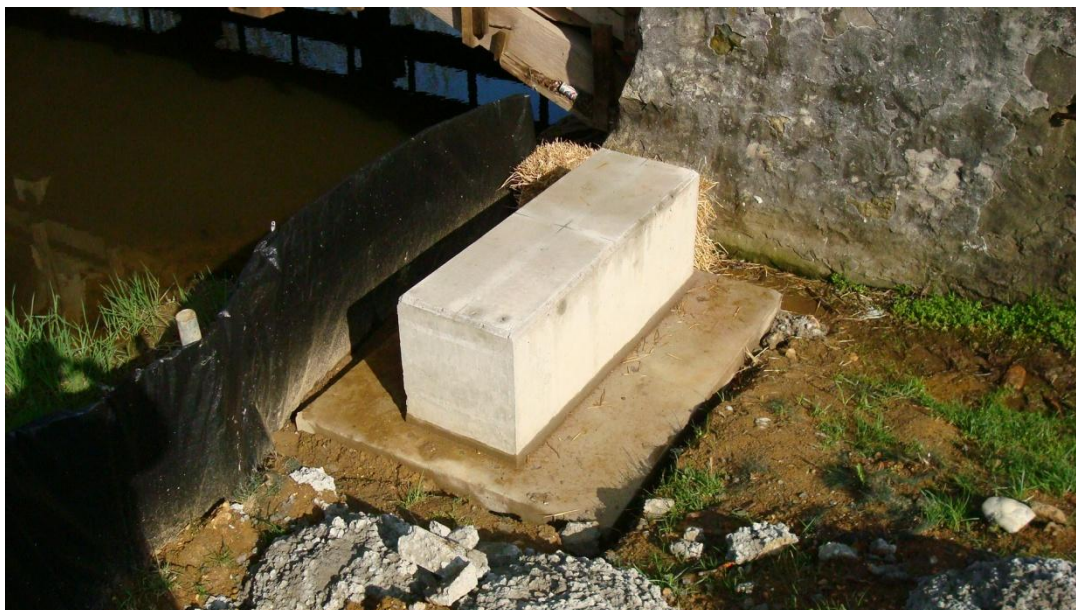
In April 2009, bearing pads were poured at four offset locations. These will support the temporary bridge support beams that will span the North East Creek and be used take up bridge forces as various compression members are removed, one at a time, for repair or replacement. A truss structure distributes forces among a collection of compression and tensile members and the removal of even one member can cause a catastrophic failure; hence, the temporary supports require a great deal of care and the details matter when a nearly 150 year old bridge depends on them.

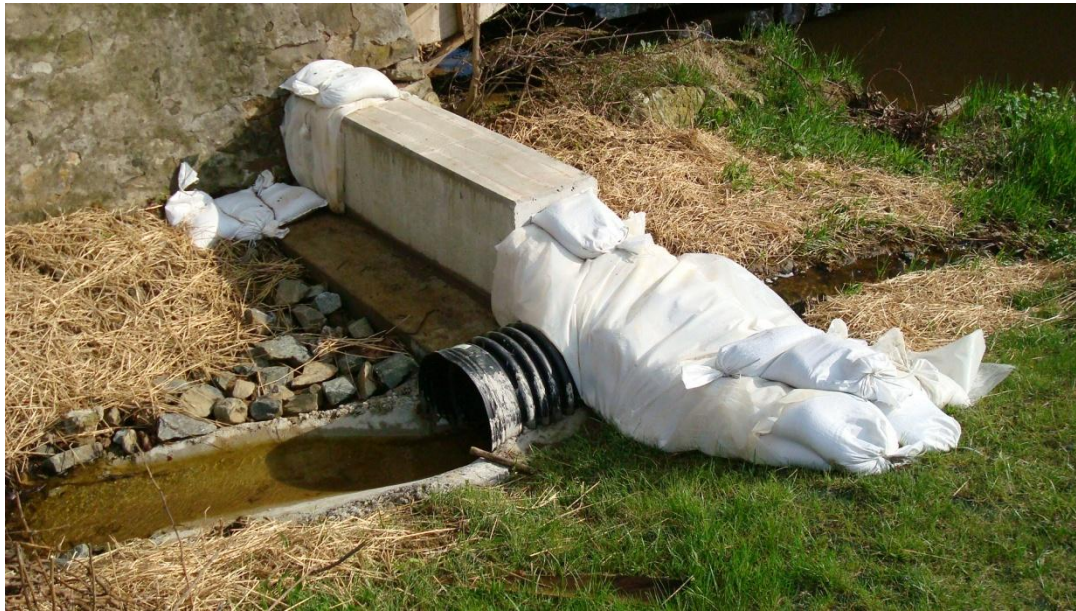
Special care for drainage was necessary at the northwest abutment to ensure that a storm drainage channel did not undermine the critical footing for the temporary supports.

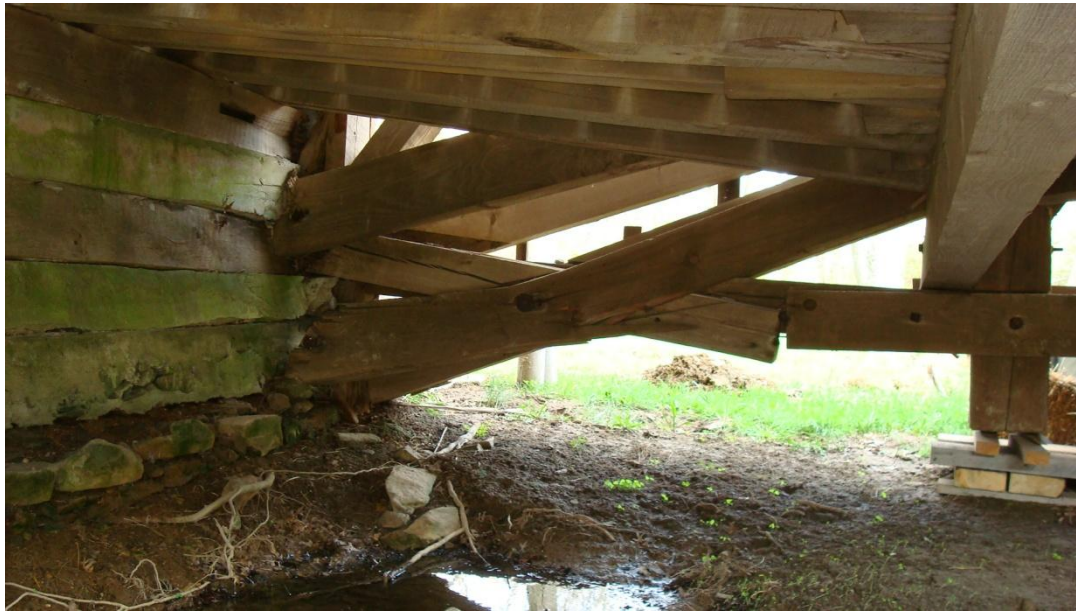
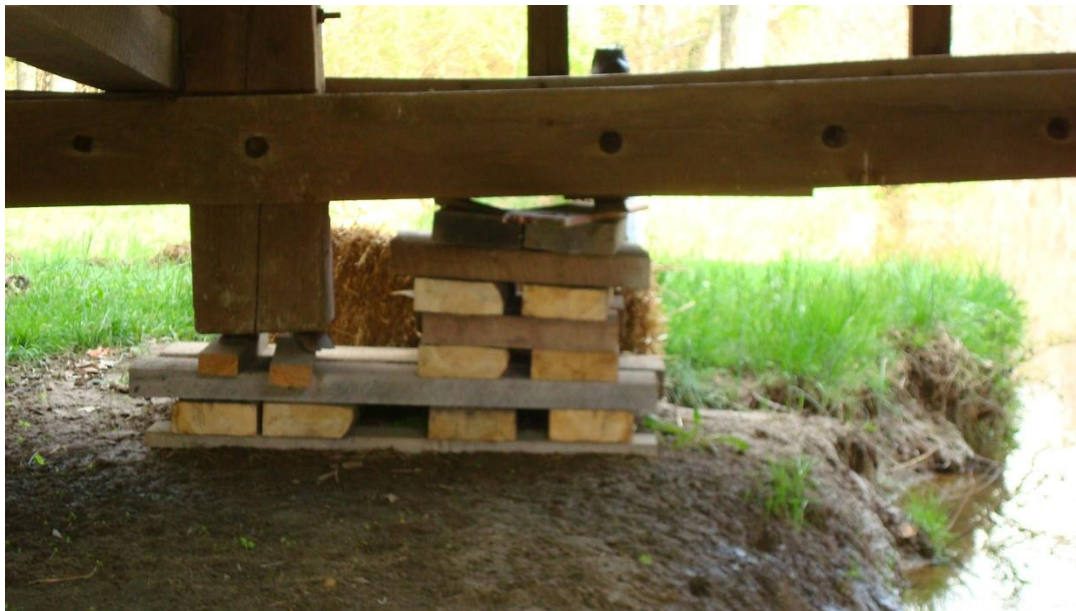
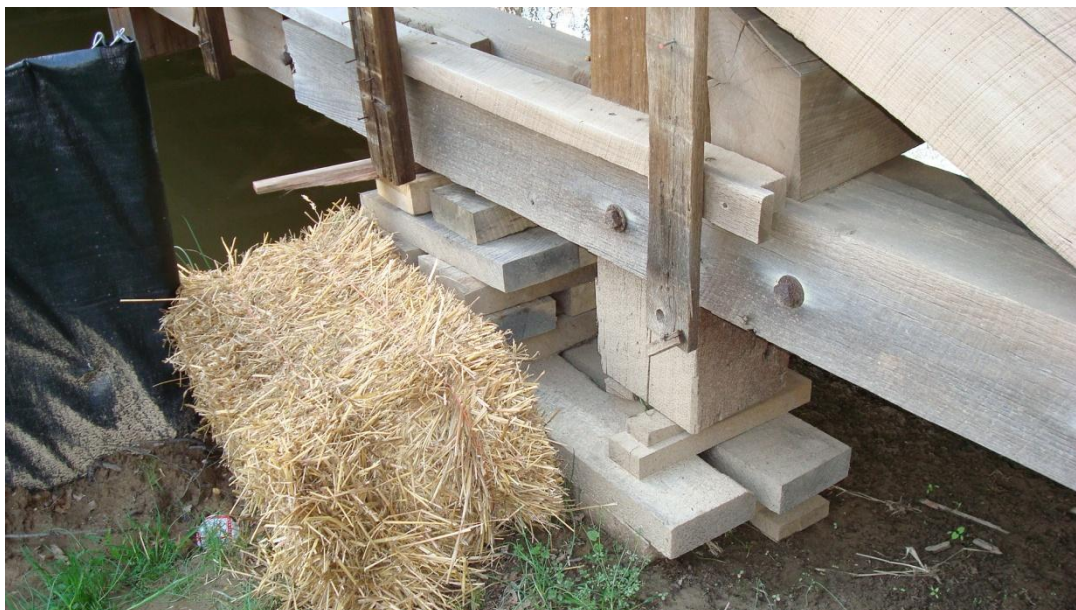
More examples of deterioration at the north abutment. Members typically suffer from water and insect damage at their interface with or near the abutments and as the more critical elements lose bearing and shift, other members begin to fail under increased loads for which they were not designed. As part of the initial work leading up to restoration, the contractors have constructed makeshift supports to impede further migration of the timbers and better ensure the safety of workers on and under the structure. [April 2009]

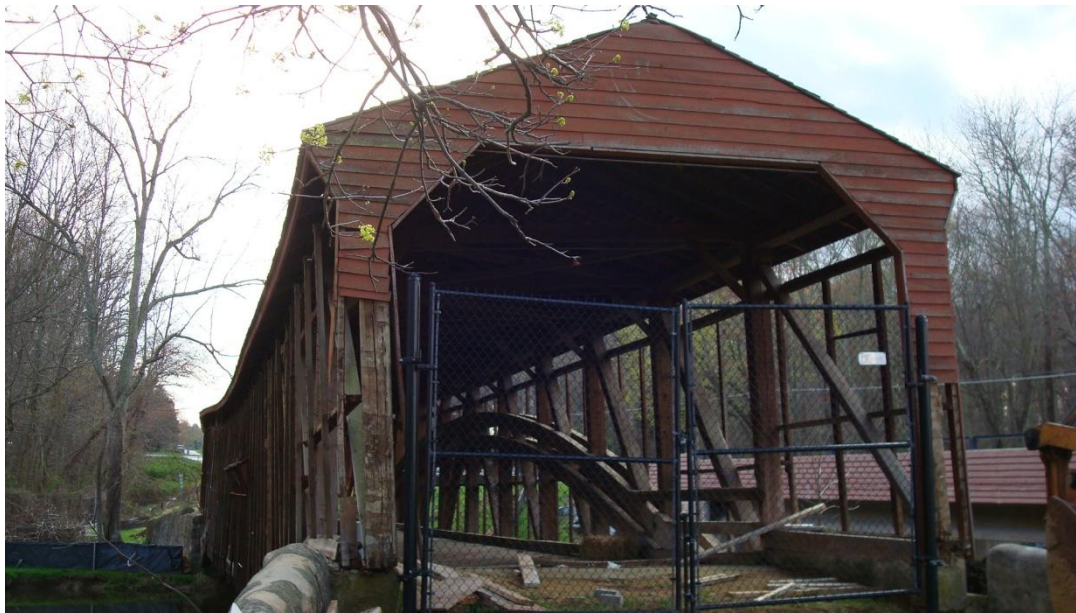
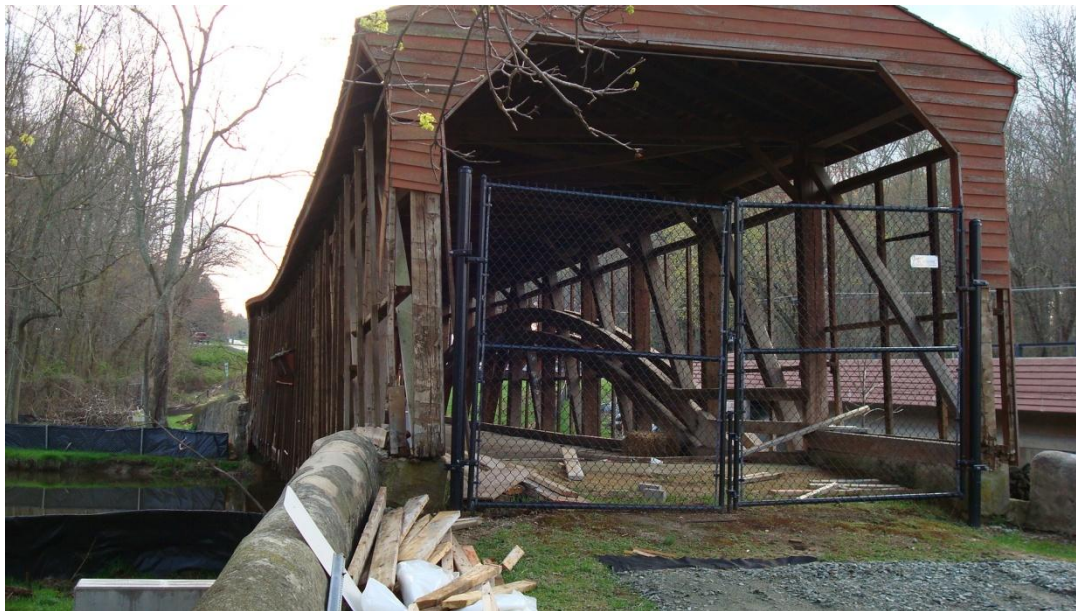
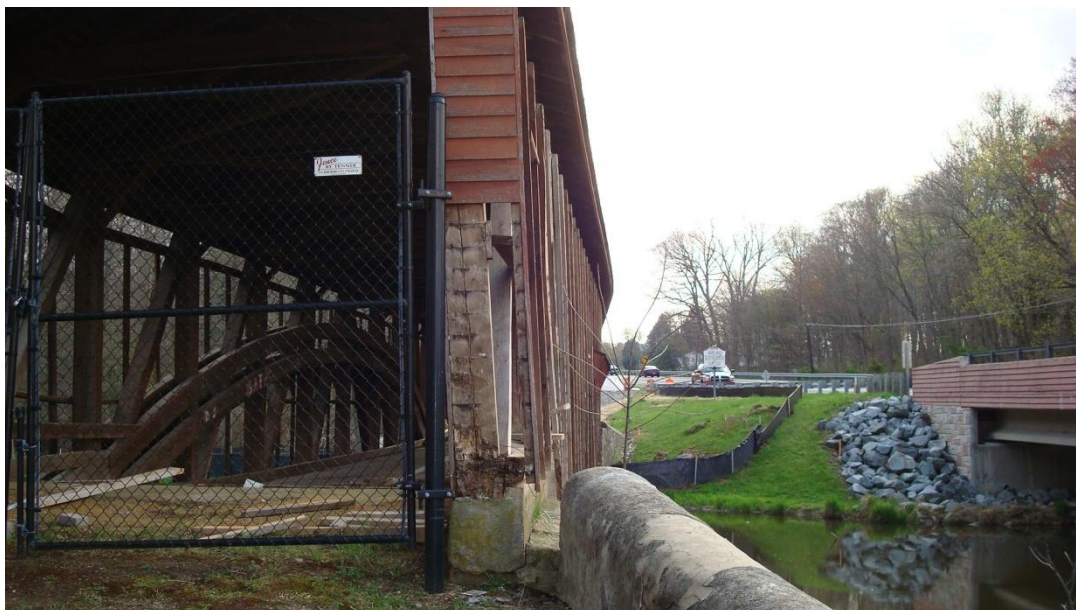
The skew and deflection of the bridge can be seen to some degree in these photographs of the bridge prior to the initiation of the 2009 restoration work.

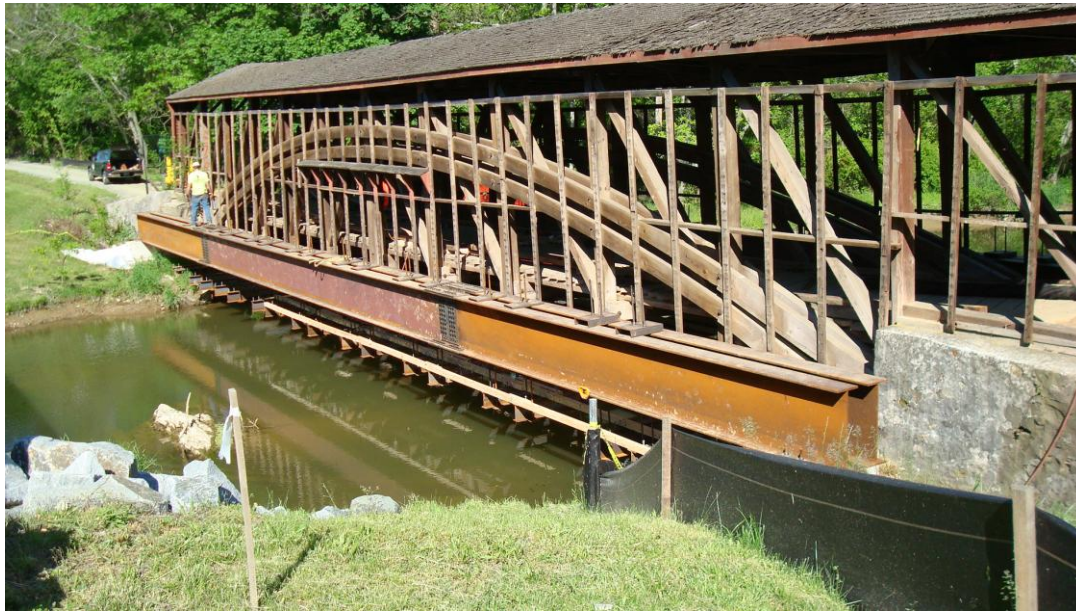
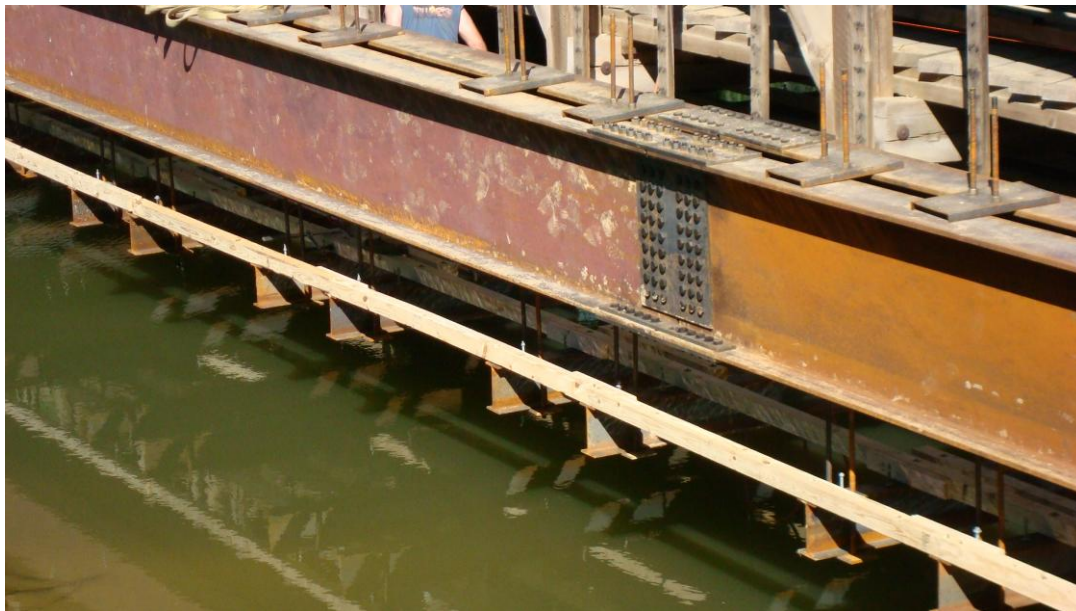
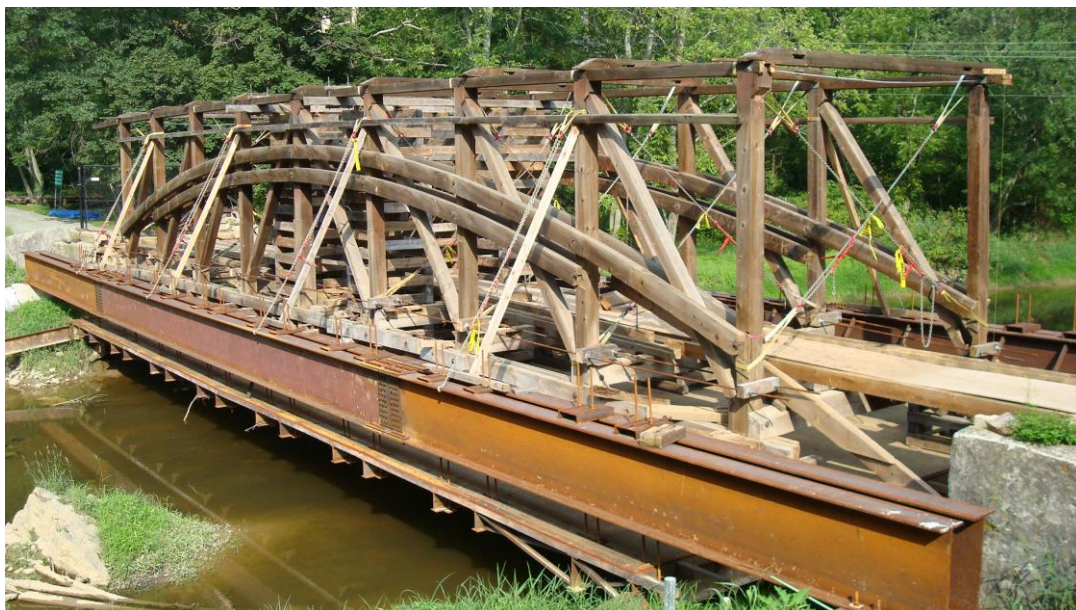
The temporary supporting steel have been placed. Twin I-beams on each side of the bridge rest on temporary concrete supports. The twin beams then support all thread connections with are used to incrementally adjust the elevation of each node in the bridge truss, as well as support the structure while individual members are removed for repair or replacement. The all thread will also enable correction of the skew and camber of the bridge. In this last photograph, the bridge has been stripped to its bare skeleton. (May 2009)

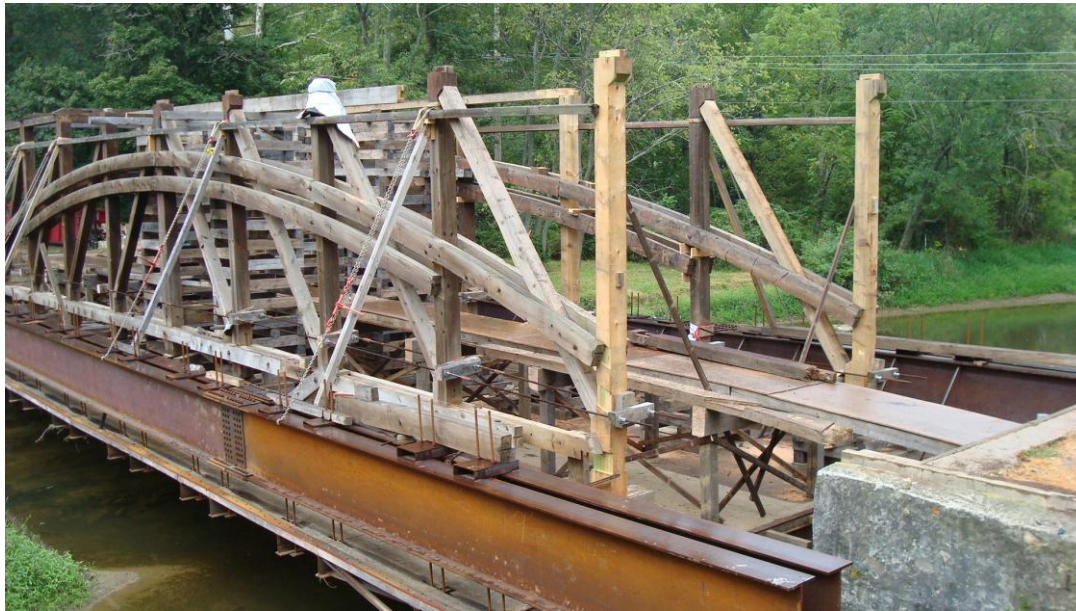
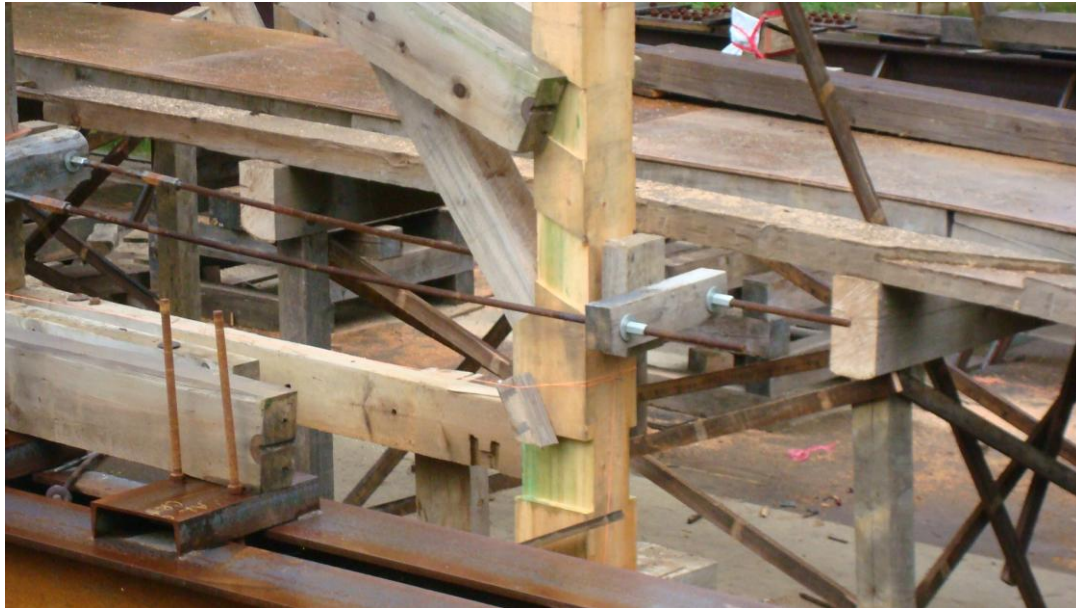
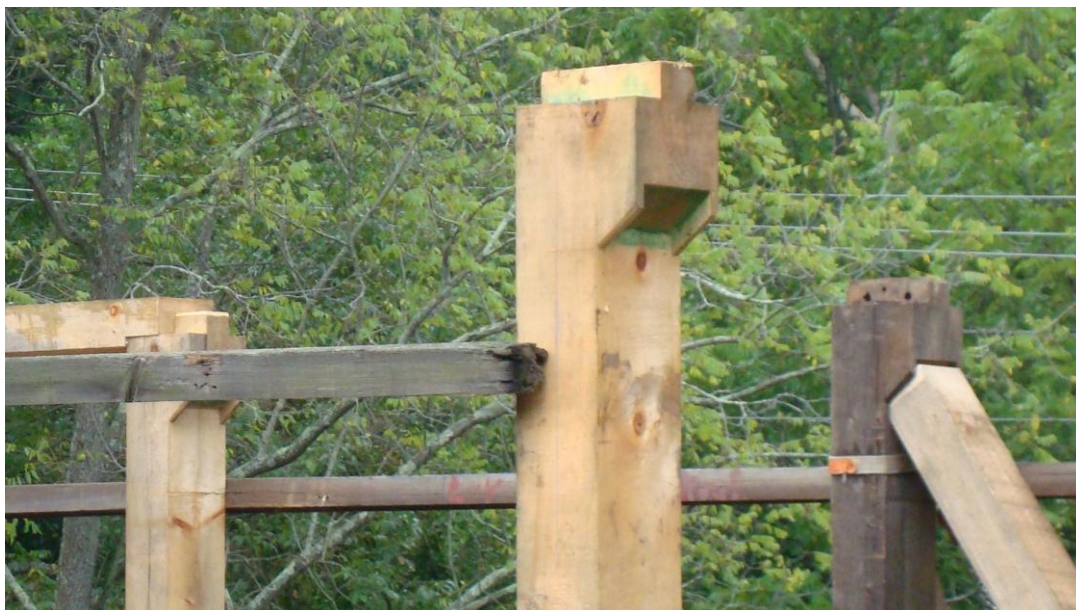
The beginning of replacement and repair of members can be seen in these photographs.

Each replacement member is meticulously hand-crafted by the Barns and Bridges master craftsmen.

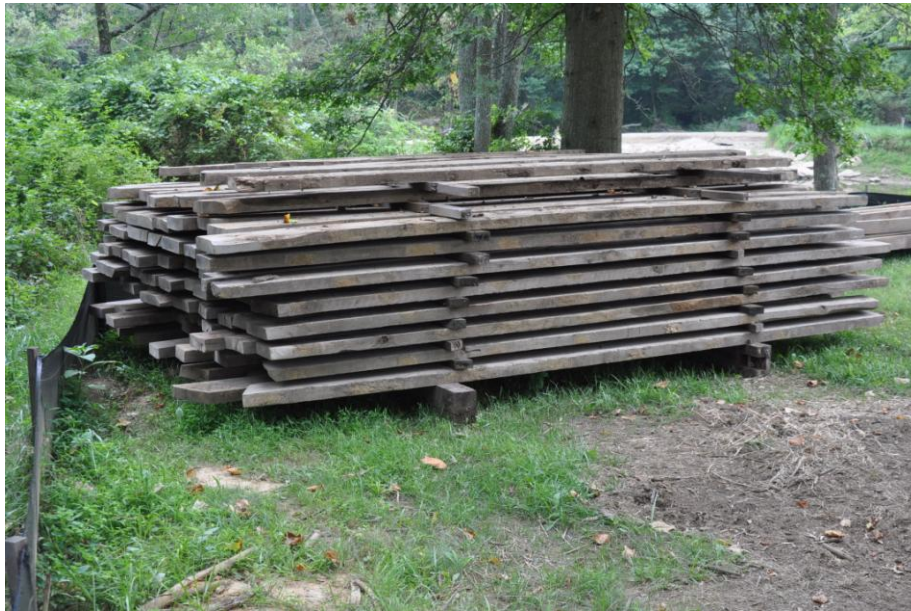
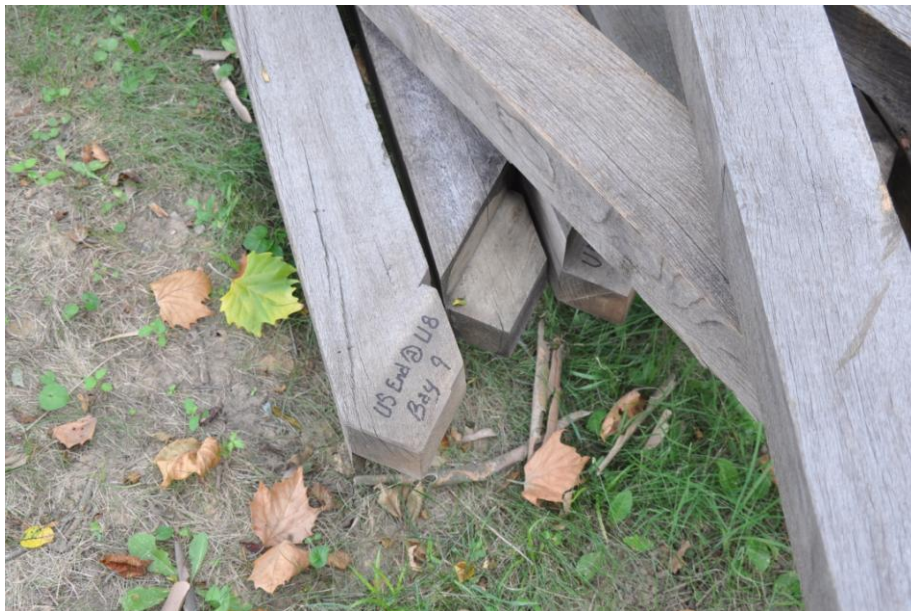
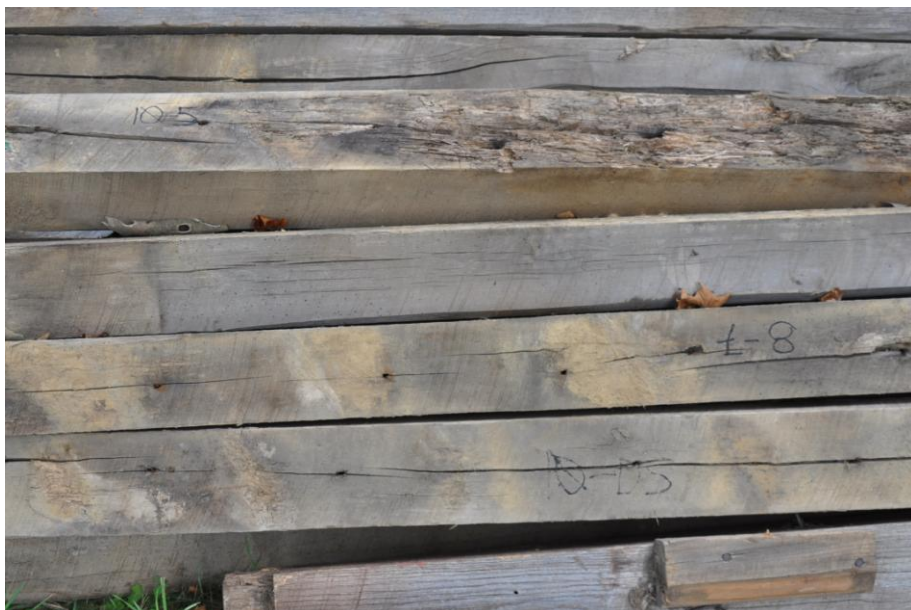
Each member is categorized for condition and cataloged for replacement, if possible. Some members must be replaced, in whole or in part, but the Secretary's (Department of the Interior) Guidelines require that as many members be saved as is practically achievable and where portions of members can be saved, they are usually joined with new material. [Late June 2009]
