Durability Assessment of Externally Bonded Fiber-Reinforced Polymer (FRP) Composite Repairs in Bridges

AJAY BANIYA SANDRA MILEV RACHEL HENRY JOVAN TATAR

Department of Civil and Environmental Engineering University of Delaware

November 30, 2022

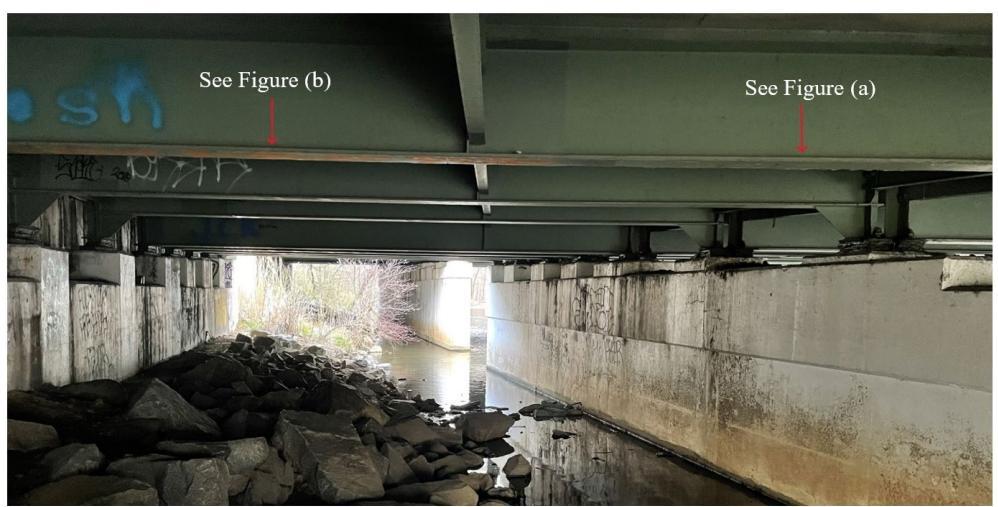
(c) Figure 75. Condition of CFRP composite girder repaired in 2000.

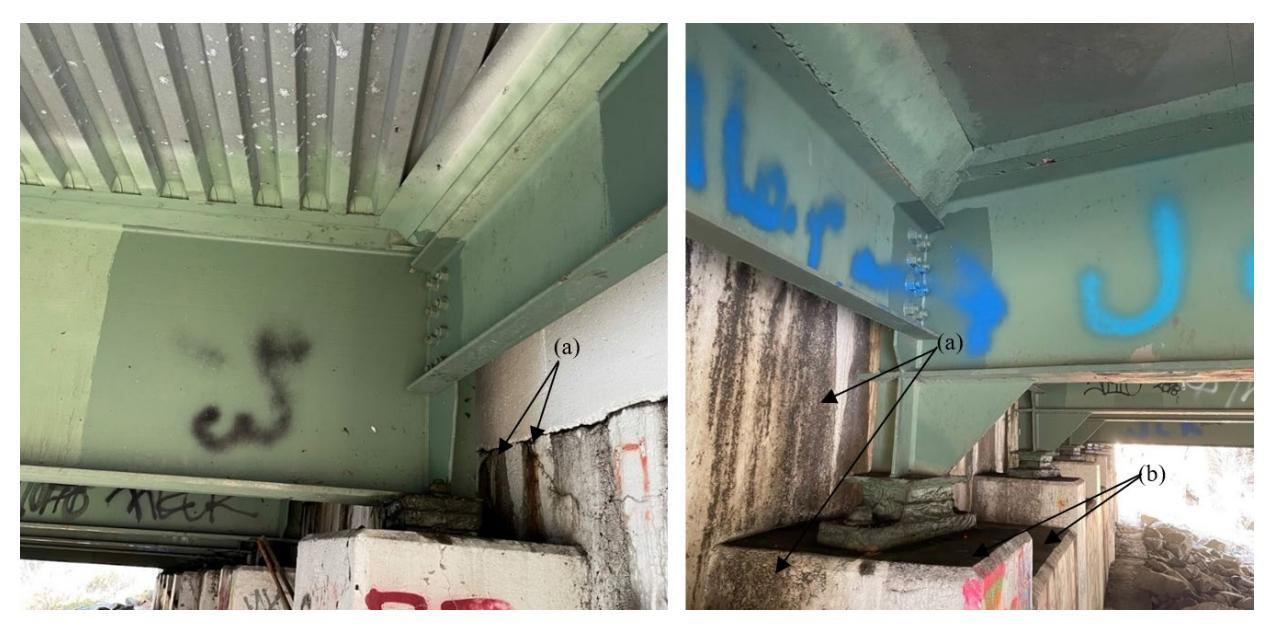
Notes: (a) Stains visible on the concrete retaining wall and abutment. (b) Fine sediment aggregates visible on top of concrete abutment. *Figure 77. Infiltration of moisture at the abutment of the bridge.*

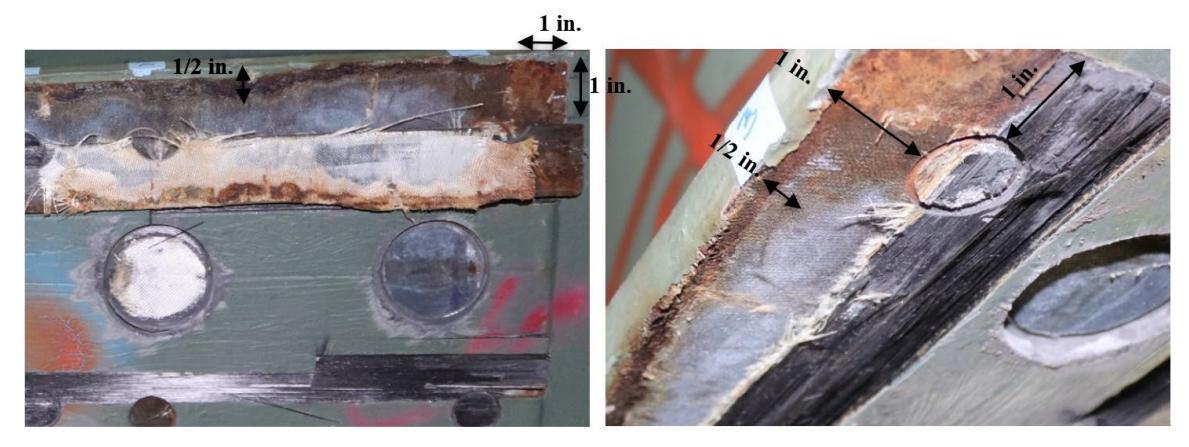
Figure 88. Presence of rust on the Northern end of the girder, located 4 ft. to 10 ft. away from the centerline of abutment 2 (shown in Figure 55).

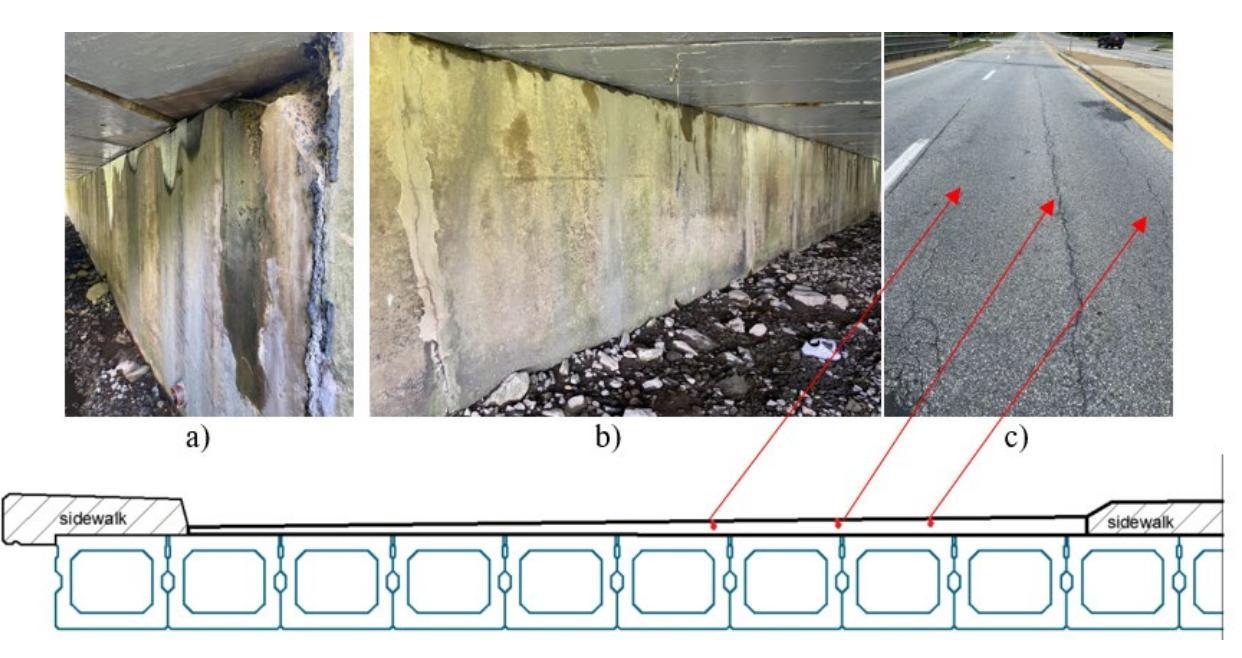
Figure 95. (a) Spalling of the south abutment wall, (b) vertical cracks in the abutment wall, and (c) reflective cracking of the asphalt pavement.

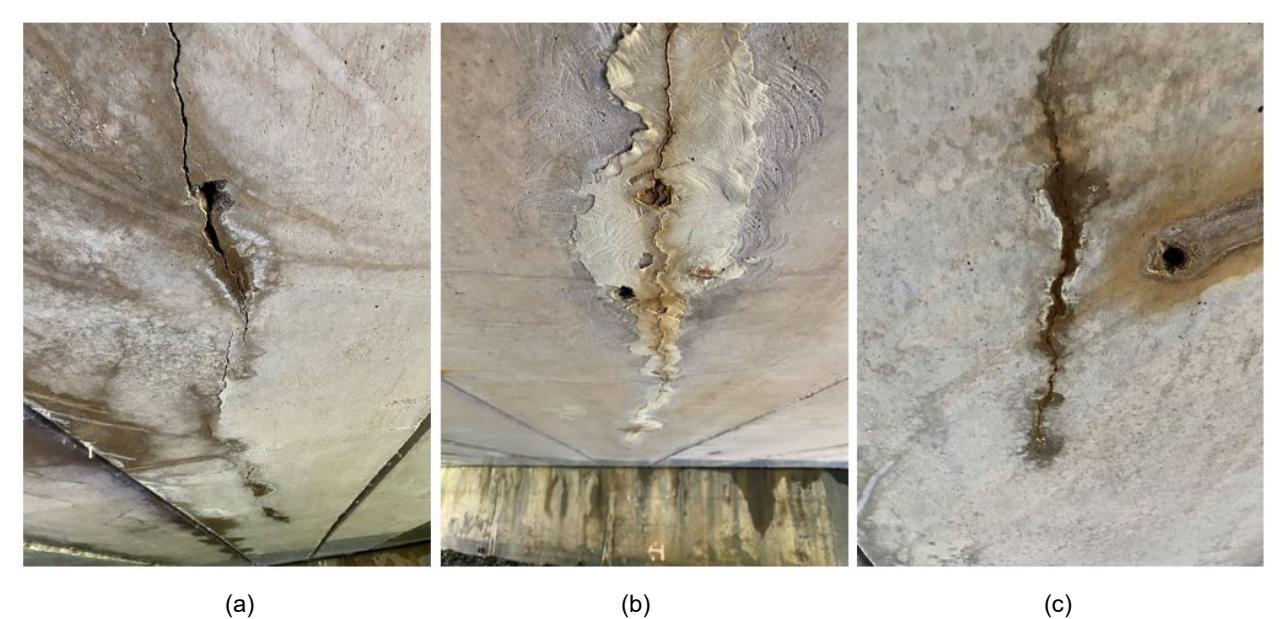
(b) Figure 96. Longitudinal cracks in G7, G15, and G17.

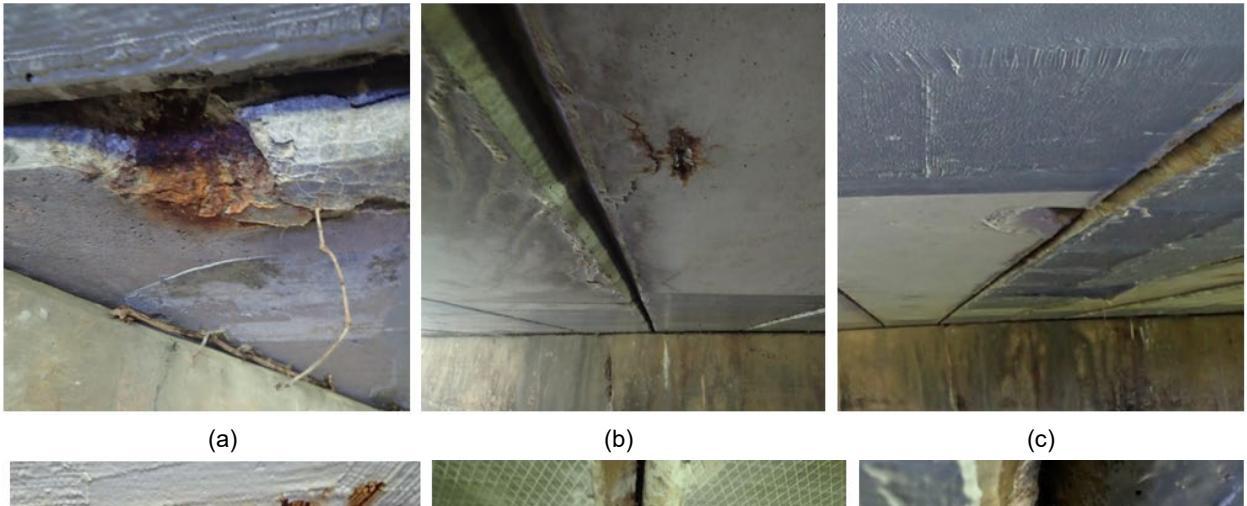
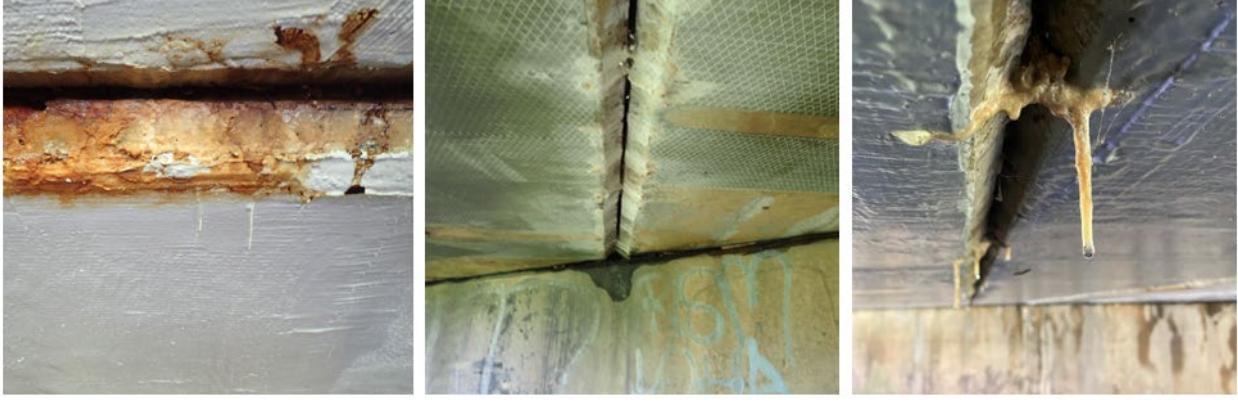
(d) (e) (f) Figure 97. Examples of damaged girders and condition of joints: (a,b,c) concrete spalling, (d) motor oil in the joint, and (e,f) efflorescence.

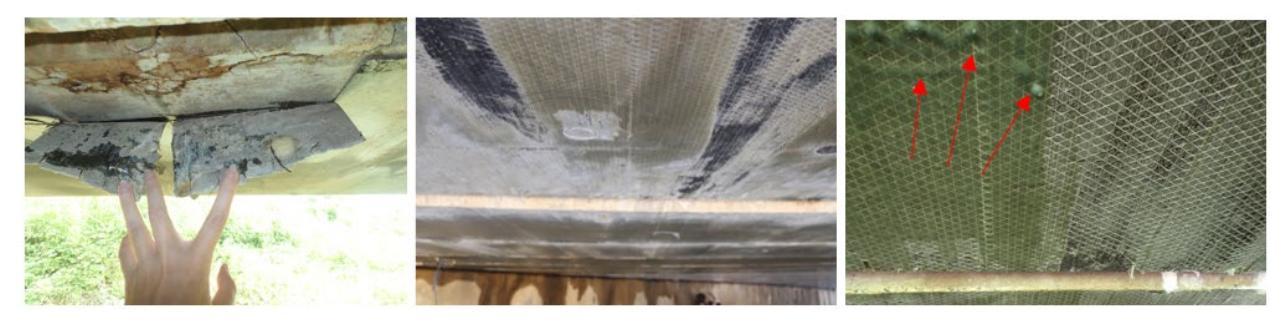
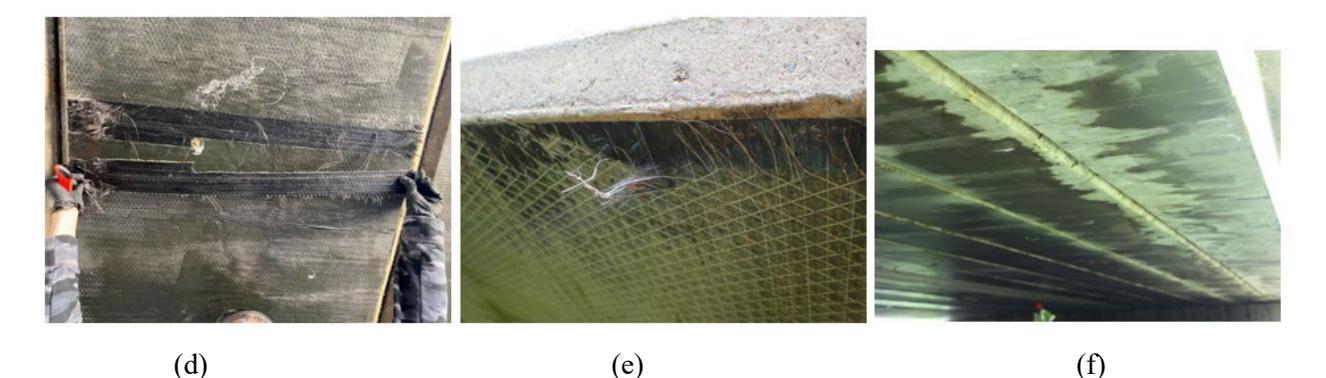
Figure 98. Examples of damage of unidirectional CFRP: (a) end peeling, (b) insufficient saturation, (c) blistering, (d) delamination, (e) frayed fiber, and (f) water stains.

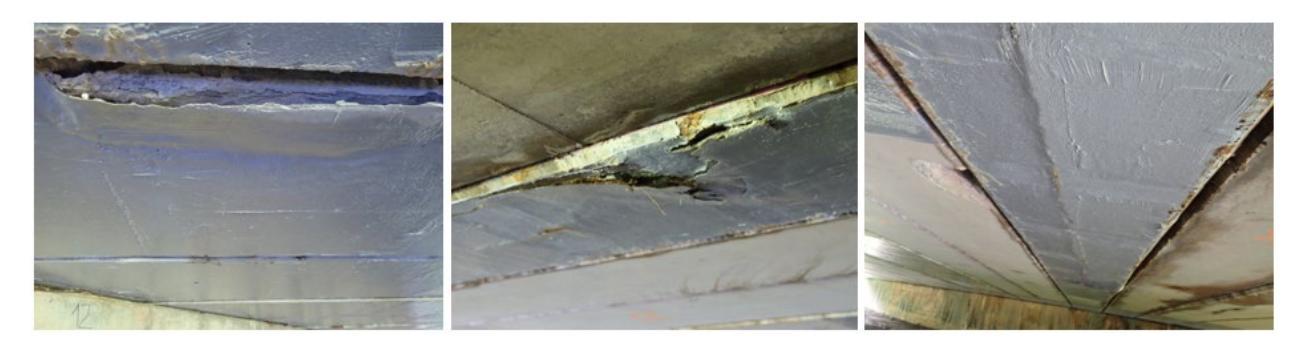
(a) (b) (c) Figure 99. Examples of damage of bidirectional CFRP: (a,b) spalling/CFRP tearing, and (c) bulging below the CFRP indicates the presence of a longitudinal crack.

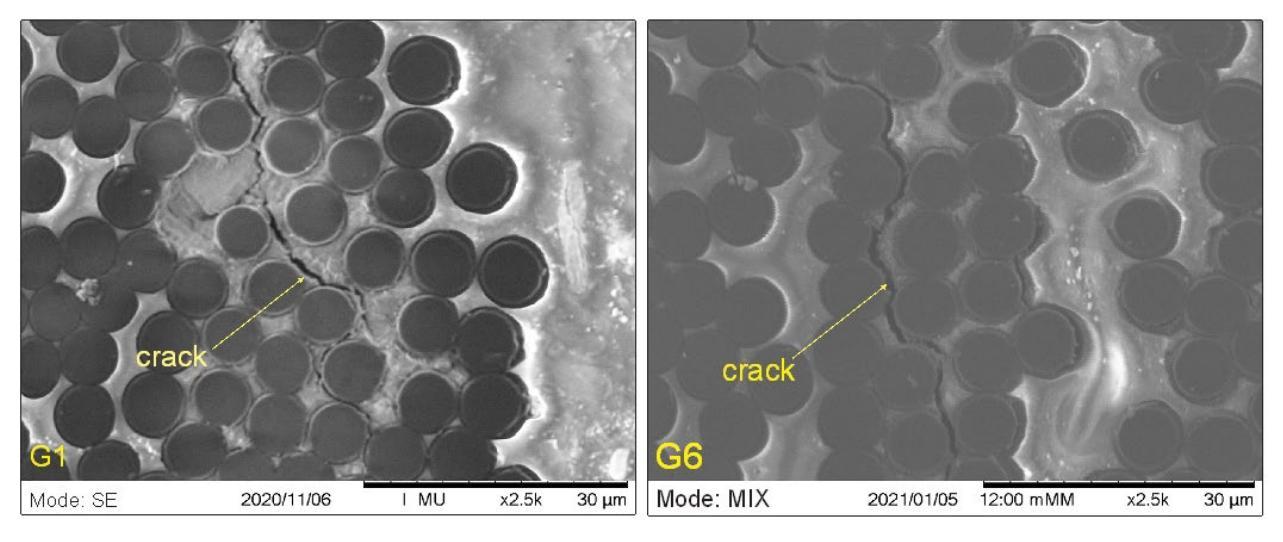
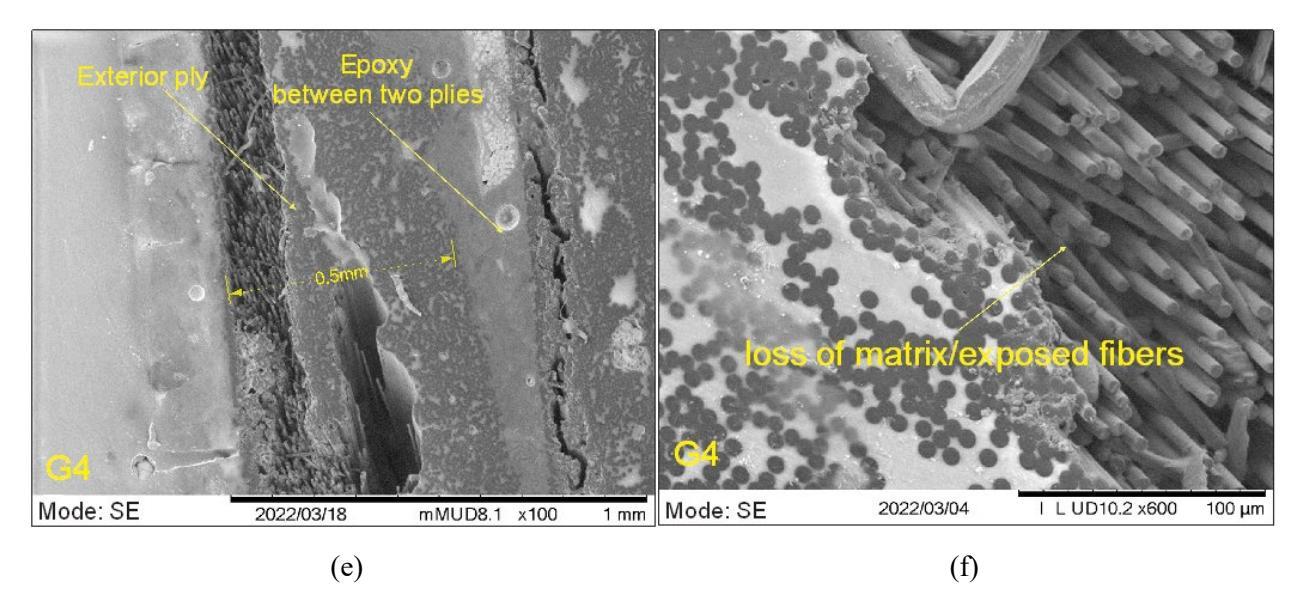
Figure 104. SEM images of CFRP: (a) cracking at the fiber/matrix interface in G1, (b) cracking in the region of closely spaced fibers in G6, (c) bidirectional CFRP, (d,e) cracking and loss of matrix two-ply CFRP on G4, and (f) high magnification image showing exposed fibers in G4.

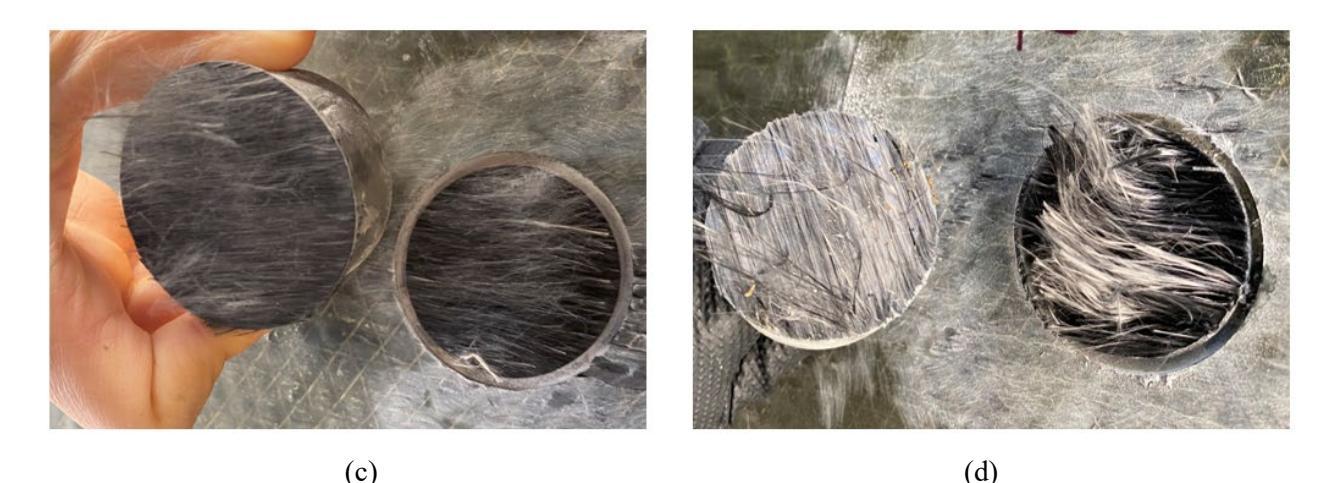
Figure 107. Two failure modes observed: (a) Mode B on G1-U1, (b) Mode E on G23-B1, (c) Mode B on G4-UD2.
