## Personal comments on the Picotrace system

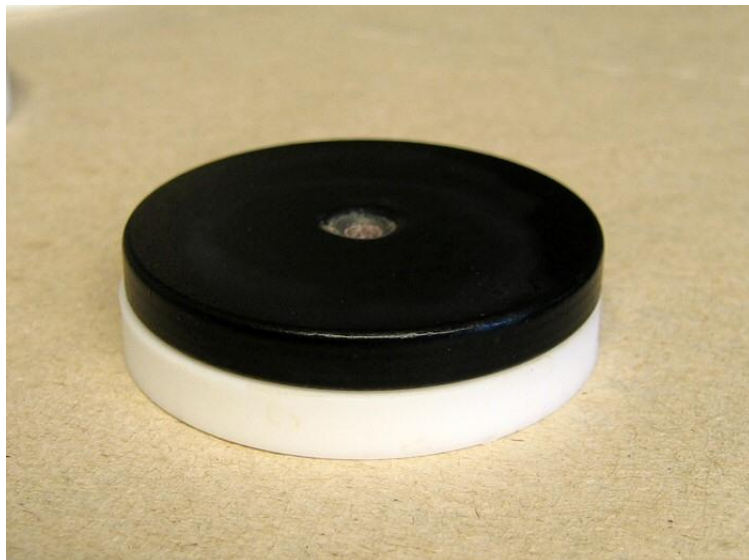
Teflon-coated aluminum pressure disk (black) shown with the 6 mm Teflon spacer we always use to reduce corrosion. The hole in the pressure disk has to be cleaned out periodically to remove dust-producing corrosion products. The corrosion products come from both the aluminum disk (white powder) and from the tip of the pressure bolt (dark-brown powder). This is an old photo. We've switched to graphite-filled Teflon disks, which have reduced corrosion even more than the white Teflon did.

3. The Teflon-coated aluminum pressure disks each have a hole in the middle that is not coated. The purpose of the holes is unclear. Corrosion in the holes, and at the tip of the pressure bolt that presses down on the hole, started immediately from acid vapors diffusing through the Teflon lids. When the pressure plates are removed after a run, white aluminum and brown stainless steel corrosion products fall out onto the sample vessel lids. After a few runs the, Teflon coating on the disks on the side against the vessel started to bubble up as corrosion products formed under the coating. The Teflon coating is very thin. Teflon spray (dry film lubricant) does not seem to help reduce corrosion in the holes. We made a set of 6 mm thick Teflon disks, and put them between the pressure plates and vessel lids. This extra thickness of Teflon dramatically reduces corrosion of the pressure disks, though alignment of the pressure plates with the pressure bolts requires some care.

4. One pressure disk stuck to the Teflon lid because I used the wrong Teflon spray, and part of its Teflon coating tore away when it was pried off. This gave me the idea that the wrong Teflon spray could be used to glue the pressure disks and 6 mm Teflon spacers together. It worked, so now we just leave them stuck together all the time.

The sample blocks look like they will last a long time, though slow corrosion will take its toll. The pressure disks aren't so robust, and we are on our third set. What finally wrecks them is not corrosion, but overtightening the pressure bolts. When the vessel expands during heating, the plates bend under the bolt. Don't overtighten. Always use Teflon spray in the sample block holes, and I recommend 6 mm Teflon disk spacers between the aluminum pressure disks and the vessel lids. It may be that the sample blocks can be recoated with Teflon. There are many shops that claim to be able to do this around the U.S., though I have my doubts.

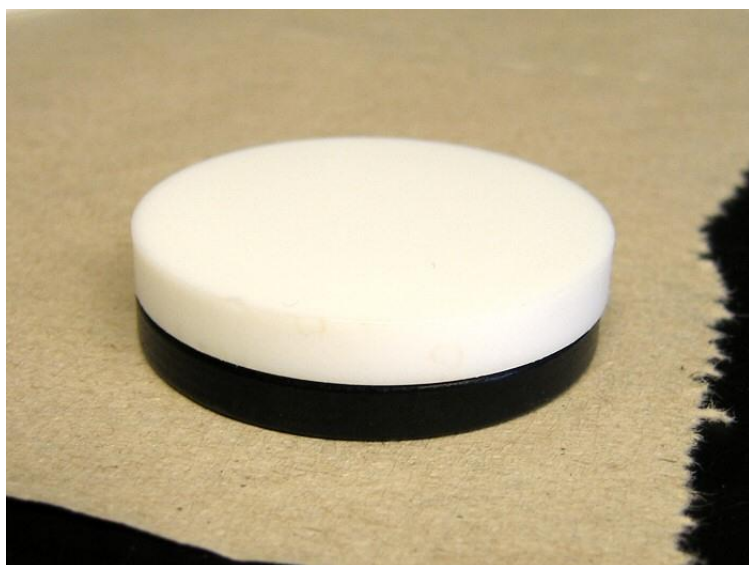
Same as above, upside down, to show that there is no fancy machining. Aligning the two disks between the sample vessels below and the pressure bolts above can be a pain. Fortunately, after a run or two the two disks tend to stick together, especially if you use the [sticky Teflon spray](#). We just leave them stuck together.

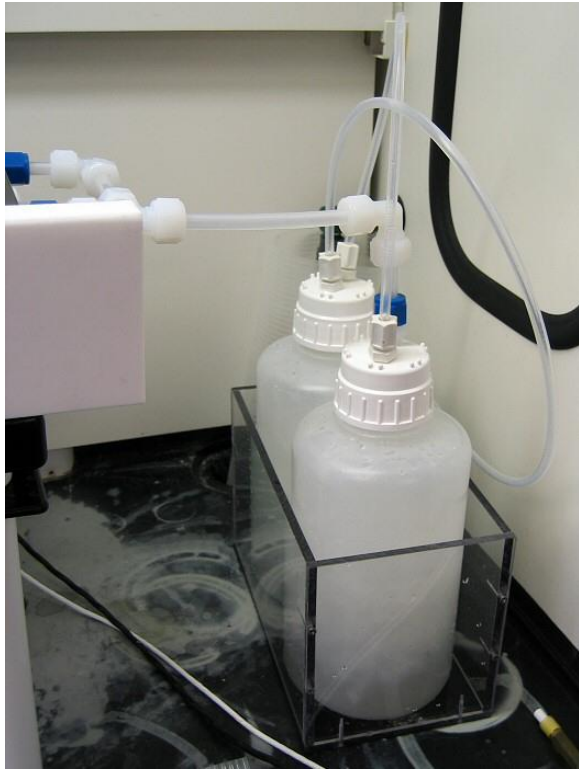
We built a plastic box that holds the two bottles upright despite the tubing pulling in different directions.

Two pairs of 2-liter plastic sparging bottles with tubing are supplied, used to neutralize the acid vapors that come off the samples as they dry. The bottles are supposed to contain NaOH solution to neutralize the acids. The bottles each have a Teflon top plug and supplied tubing. The PVC tubing supplied is large diameter and stiff, making it difficult to handle and difficult to keep the bottles upright.

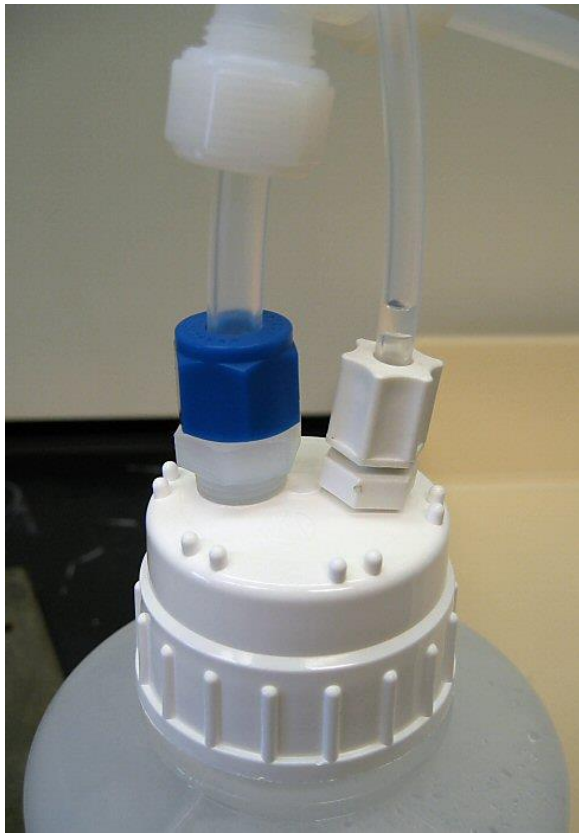
We made our own neutralization system out of non-collapsible bottles (Nalgene 2126-2000 plastic vacuum bottles). The Picotrace plugs won't fit, so we had to drill and tap the caps that come with the Nalgene bottles.

This is an outside view of our drilled and tapped Nalgene bottle top. Note that we used the Picotrace-supplied fitting for the large-diameter Teflon tubing (left) that comes from the sample vessel drying cover, but used our own 6 mm OD tubing and fitting for the tube that goes to the aspirator (right).

The aspiration rate through the bottles supplied with the system was difficult to control. Either vapors were not drawn through the bottles at all, because of leaks around the PVC tubing where it passes through the bottle top plugs, or the bottles collapsed under the vacuum. There was little middle ground.
