Performance Testing of Field-Aged Cured-in-Place Liners (CIPL) for Cast Iron Piping

Final Report

NYSEARCH/Northeast Gas Association

Cornell University

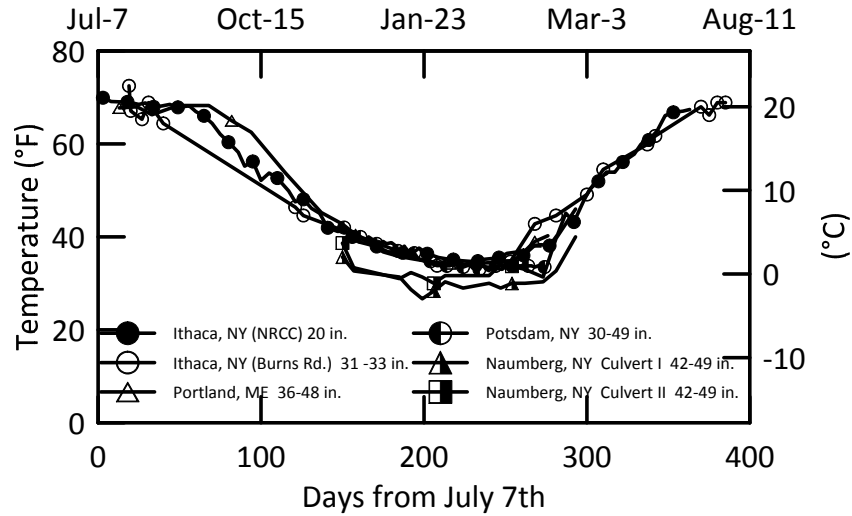
Figure 3.2. Measured Ground Temperatures in Northeastern United States

Figure 3.2 illustrates ground temperature data for these locations. A comparison of data sets reveals a relatively consistent trend in seasonal temperature for the different conditions included in the study. Ground temperatures can fluctuate between 70 and 25 °F (21 and -4 °C) over a period of 6 to 7 months. More typically, the data show that ground temperatures vary between 70 and 30 °F (21 and -1 °C).

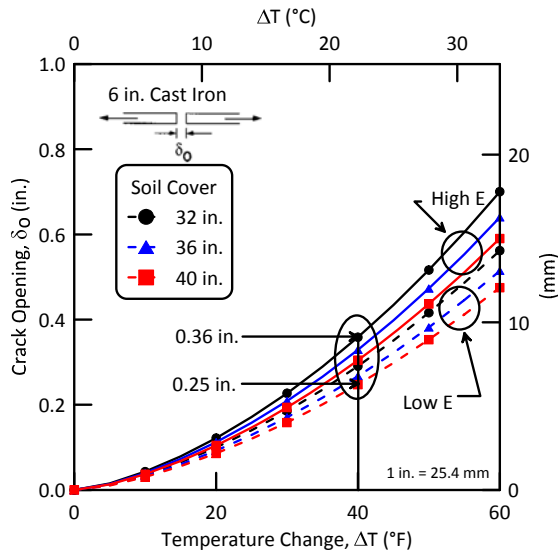
a) 6-in.(150-mm)-Diameter

b) 12-in.(300-mm)-Diameter

Figure 3.4. Crack Opening for CI Piping vs. Temperature Change

The analytical model gives the opening, δ_o , of a round crack for different temperature changes. Using the pipe and soil characteristics described above and the design temperature change of $\Delta T = 40^\circ\text{F}$ (22°C), the crack openings for 6- and 12-in. (150- and 300-mm)-diameter CI piping were determined. Figures 3.4(a) and 3.4(b) show the results for these CI pipelines for the two bounding values of axial stiffness, EA.

For the 6-in. (150-mm)-diameter piping, the crack opening ranges between 0.25 and 0.34 in. (6.4 and 8.6 mm). For the 12-in. (300-mm)-diameter piping, the crack opening ranges between 0.30 and 0.43 in. (7.6 and 10.9 mm). These openings represent upper bound seasonal expansions/contractions of round cracks in CI pipe at typical burial depths.

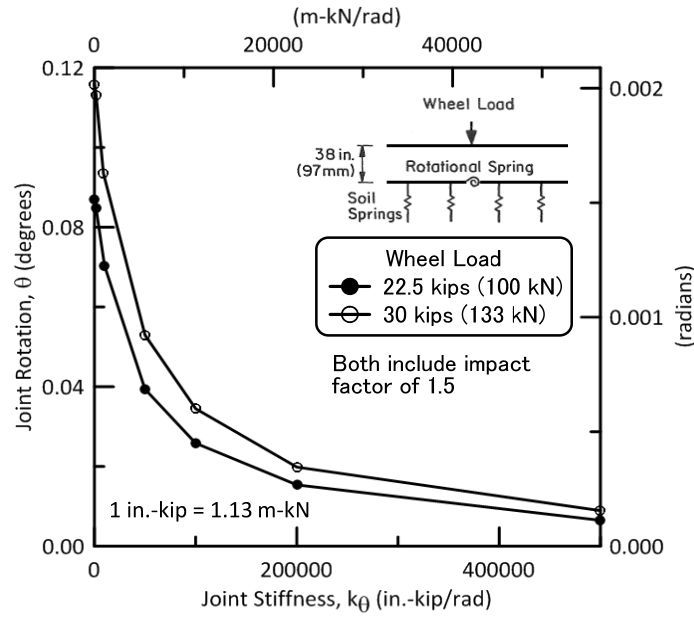
Figure 3.8. Predicted CI Joint Rotations Induced by Traffic Loads (after O'Rourke, et al., 1996)

During Phase B the specimen is subjected to one million (1,000,000) cycles of joint rotations to reflect 50 years of service life. The amount of rotation that the joint experiences in the field, and should be applied during the test, is a function of joint rotational stiffness, k_{θ} , pipe diameter, D , mechanical properties of the cast iron (i.e., Young's modulus, E), subgrade soil reaction, k_{s1} , burial depth, z , and applied surface load, P . Parametric analyses were carried out with respect to the above factors. The pipeline is analyzed as a beam on elastic foundation, following Hetenyi's approach (Hetenyi, 1939).

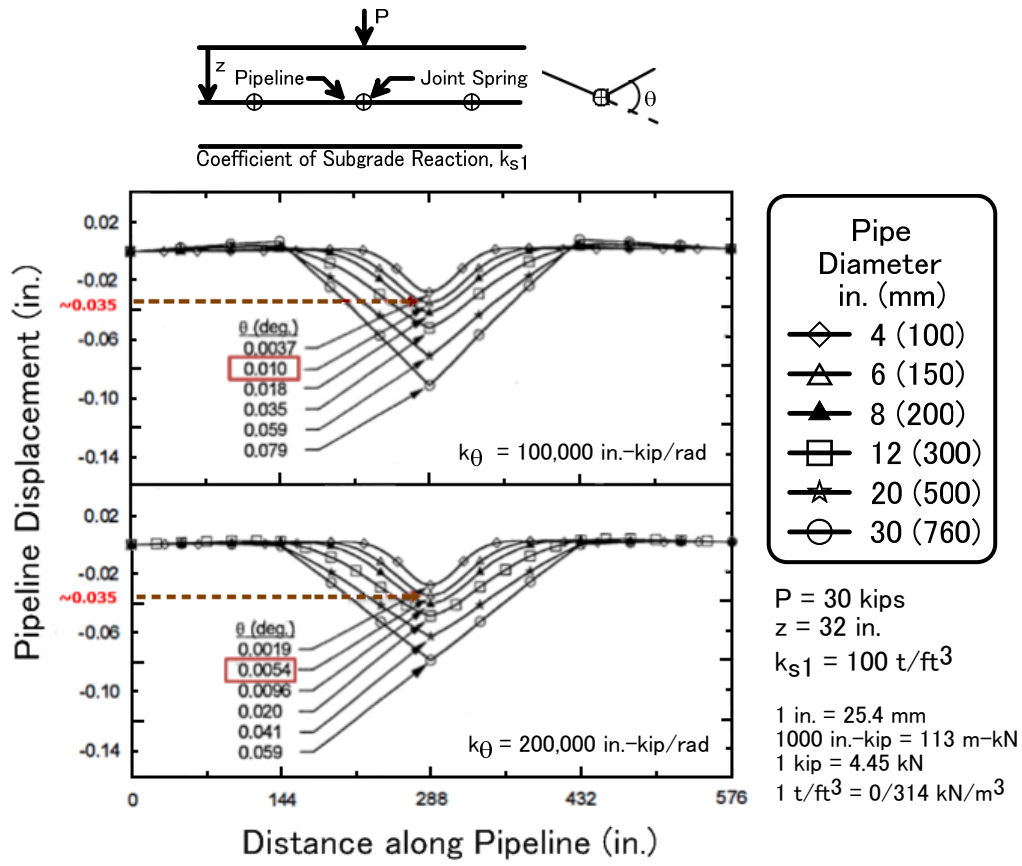
Figure 3.9. Effect of Pipe Size and Joint Stiffness on Pipeline Displacement and Joint Rotation

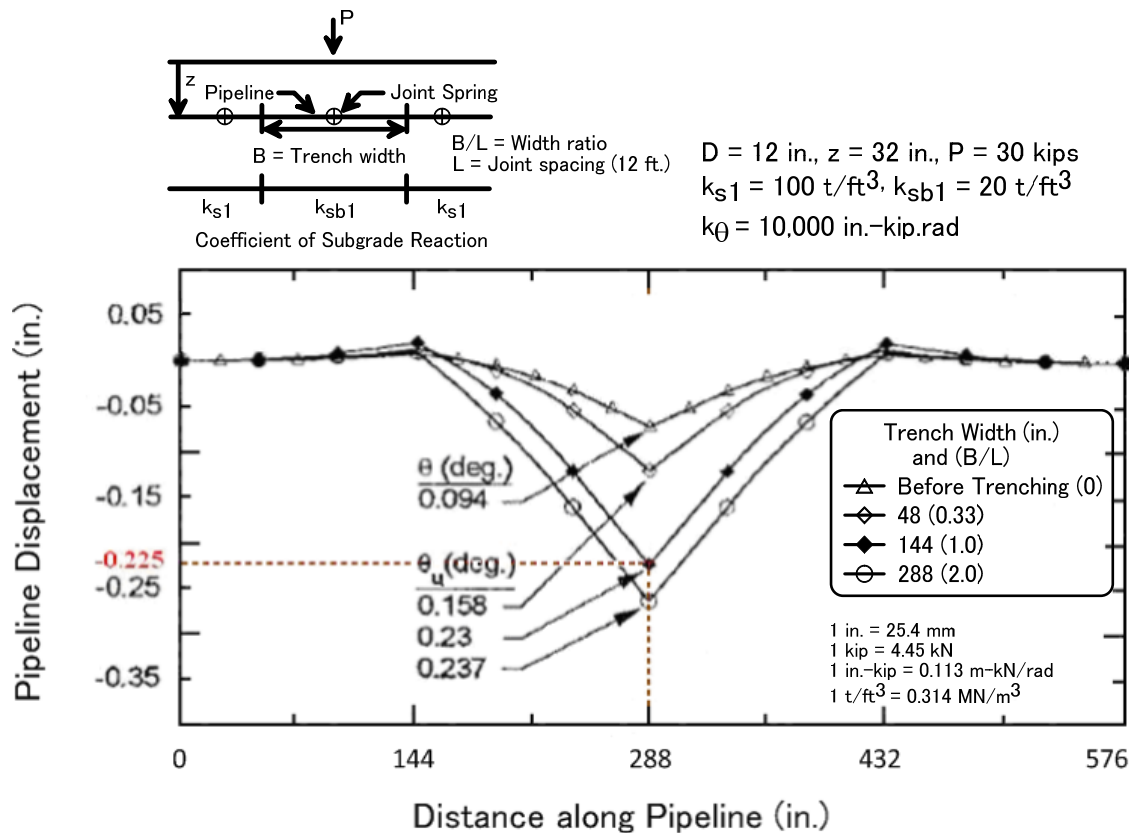
Figure 3.14. Effect of Trench Width on Joint Rotation on a 12-in. (300-mm)-Diameter Pipeline

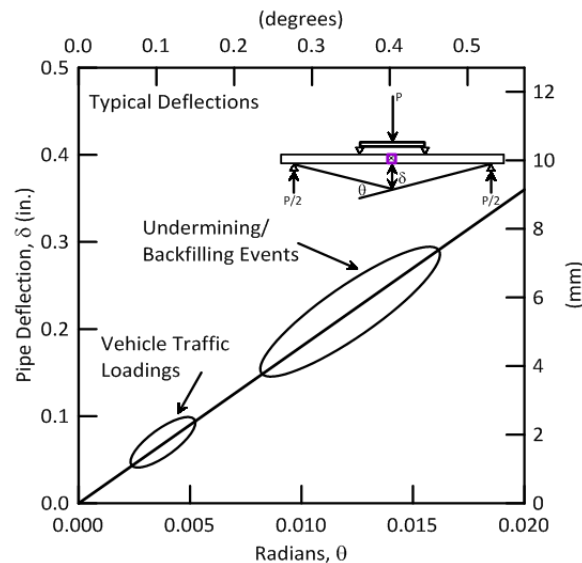
Figure 4.4. Typical Range of Deflections for Vehicular Loading Effects

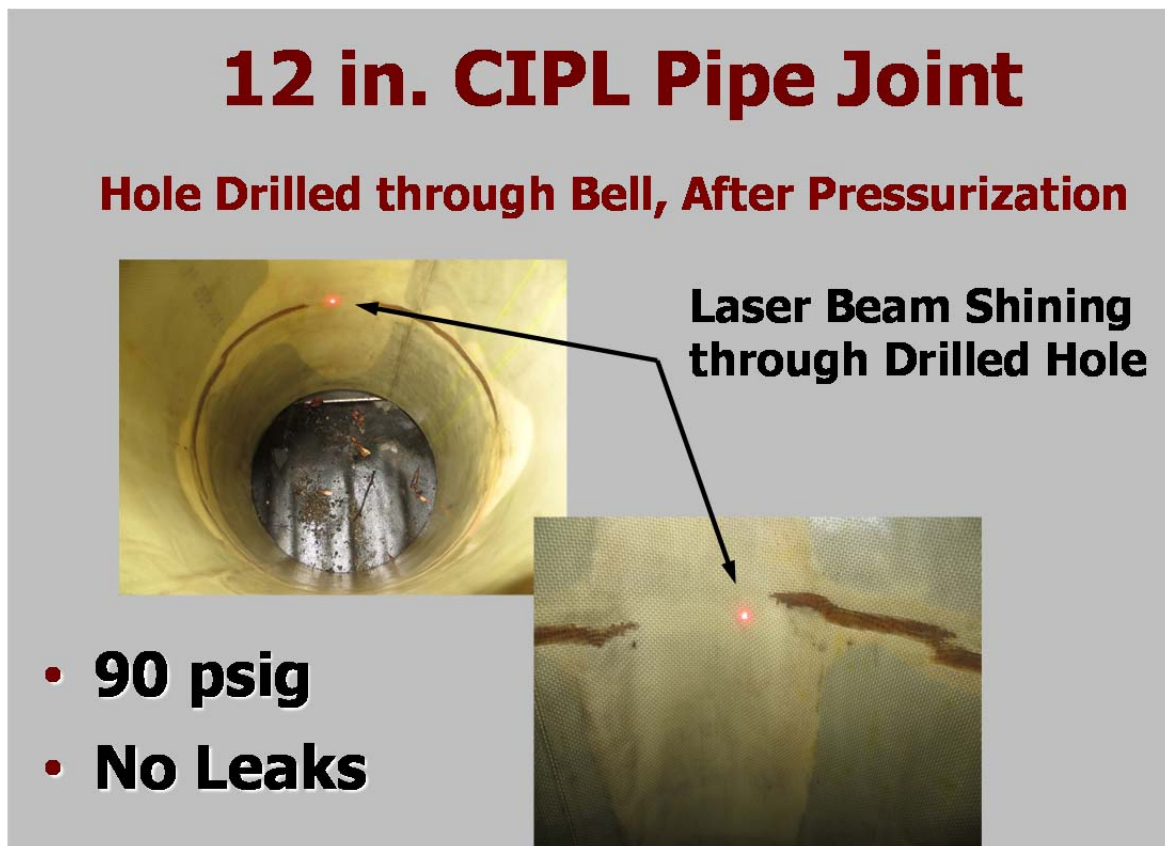
Figure 5.27. Interior of Specimen 12-2 after Pressure Verification Test
