Performance Evaluation of Aqua-Pipe under Earthquake-Induced Ground Deformation

Final Report

Cornell University

May 2021

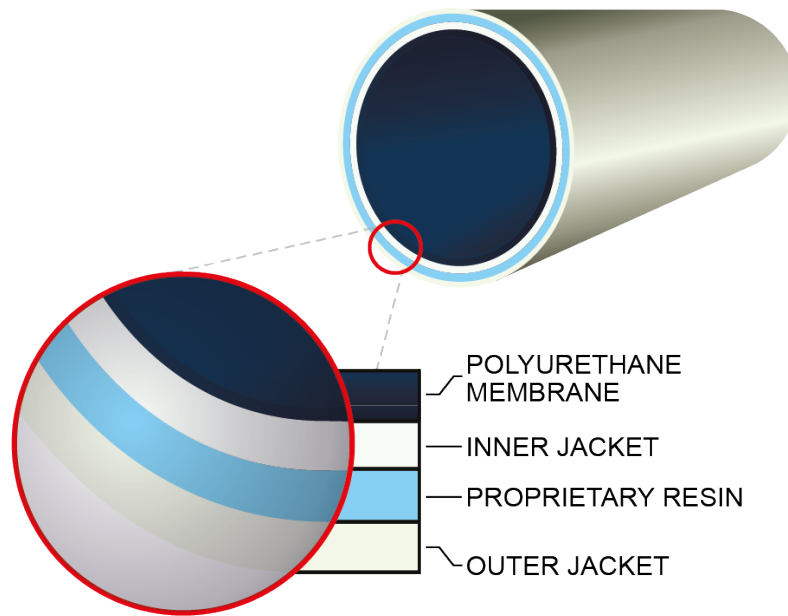
Figure 1.1. Aqua-Pipe™ Lining Components

The installation of AP1 results in a fold perpendicular to the circumference because the jackets are purposely chosen slightly oversized in diameter to ensure proper contact with the inner surface of the host pipeline once inflated onto it. Figure 1.3 shows the two layers of AP1 fabric before being impregnated with epoxy and cured in place. Figure 1.4 shows the AP1 lining after curing inside of an existing pipeline, where a limited-sized fold can be observed. The fold is virtually absent after the installation of AP2.

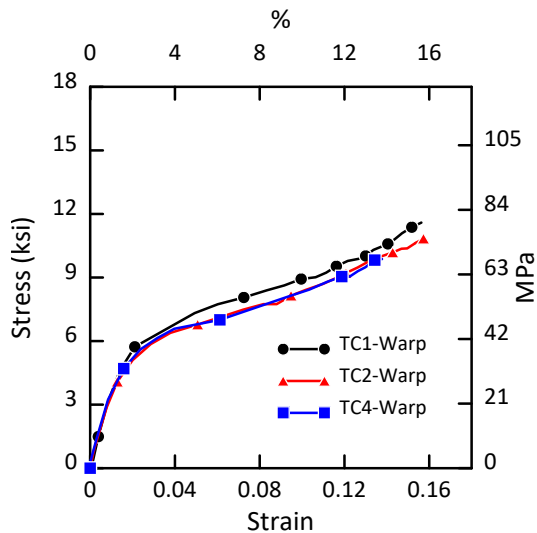
Figure 2.4. Stress versus Strain Plots to Failure for AP1 Specimens in the Warp Direction

The results of the tensile coupon tests in each direction show good agreement. Each test was run until the woven fabric structure of the specimens tore apart, indicating failure. Axial stress versus strain data were used to determine the stress and strain at failure in each direction, as shown in Figure 2.4 and Figure 2.5 by the maximum measured stress. The average failure stress and strain for Specimens 1, 2, and 4 in the warp direction were 10.9 ksi and 15%, respectively, with standard deviations of 0.94 ksi and 1.2%. The average failure stress and strain for Specimens 3, 4, and 5 in the weft direction were 15.3 ksi and 11.1%, respectively, with standard deviations of 1.68 ksi and 1.6%. The ratio of the average stress at failure in the weft versus warp direction is 1.40, which is nearly identical to the ratio of stress at failure reported by the manufacturer.

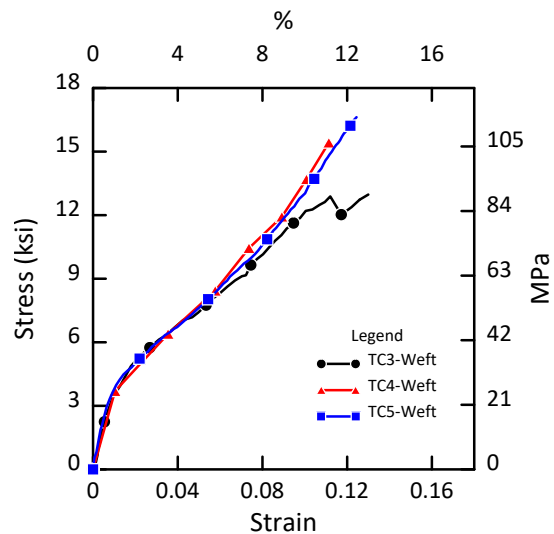
Figure 2.5. Stress versus Strain Plots to Failure for AP1 Specimens in the Weft Direction

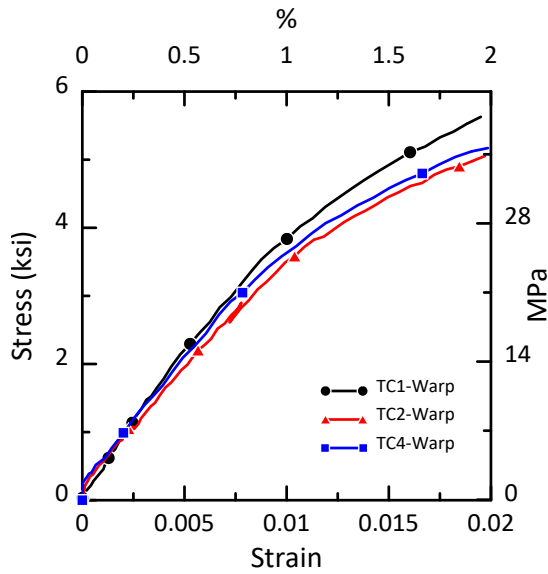
Figure 2.6. Expanded Stress versus Strain Plots for AP1 Specimens in the Warp Direction

Table 2.1 and Table 2.2 provide summaries of the Young's modulus, tensile stress and strain at failure, and Poisson's ratio in the warp and weft directions, respectively. A close examination of the plots in Figure 2.6, Figure 2.7, Figure 2.8 and Figure 2.9 shows a departure from linearity at a strain of between 0.5% and 1.0%. The Young's modulus and Poisson's ratio in both the warp and weft direction decreases at strains between 0.5% and 1.0%.

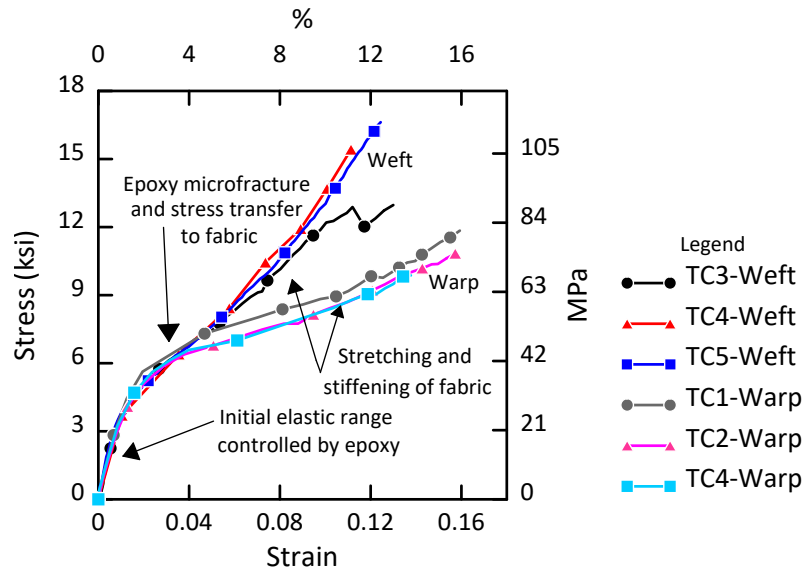
Figure 2.10. Stress versus Strain Plots for AP1 Specimens in the Warp and Weft Directions

In Figure 2.10, the stress versus strain data for the warp and weft directions are plotted at the same scale. From zero to between 0.5% and 1.0% strain, the lining responds as a linear elastic solid. The Poisson's ratio is approximately 0.24 in both directions, and the difference in the Young's modulus is less than 7% lower in the warp than in the weft direction. In this range of tensile strain, the Young's modulus and Poisson's ratio are controlled principally by the epoxy.

As the strain approaches and exceeds 1.0%, micro-fractures develop in the epoxy, and stress is transferred increasingly from the epoxy matrix to the fabric. This stress transfer results in a reduction of modulus. Moreover, the fabric stretches more in the warp direction than in the weft direction, where the failure strain is smaller. As tensile strain exceeds approximately 5%, the fibers stretch and tighten, leading to increased modulus in both the warp and weft directions. The stiffness and strength in the weft direction exceed those in the warp direction due to the higher crimp in the latter direction.

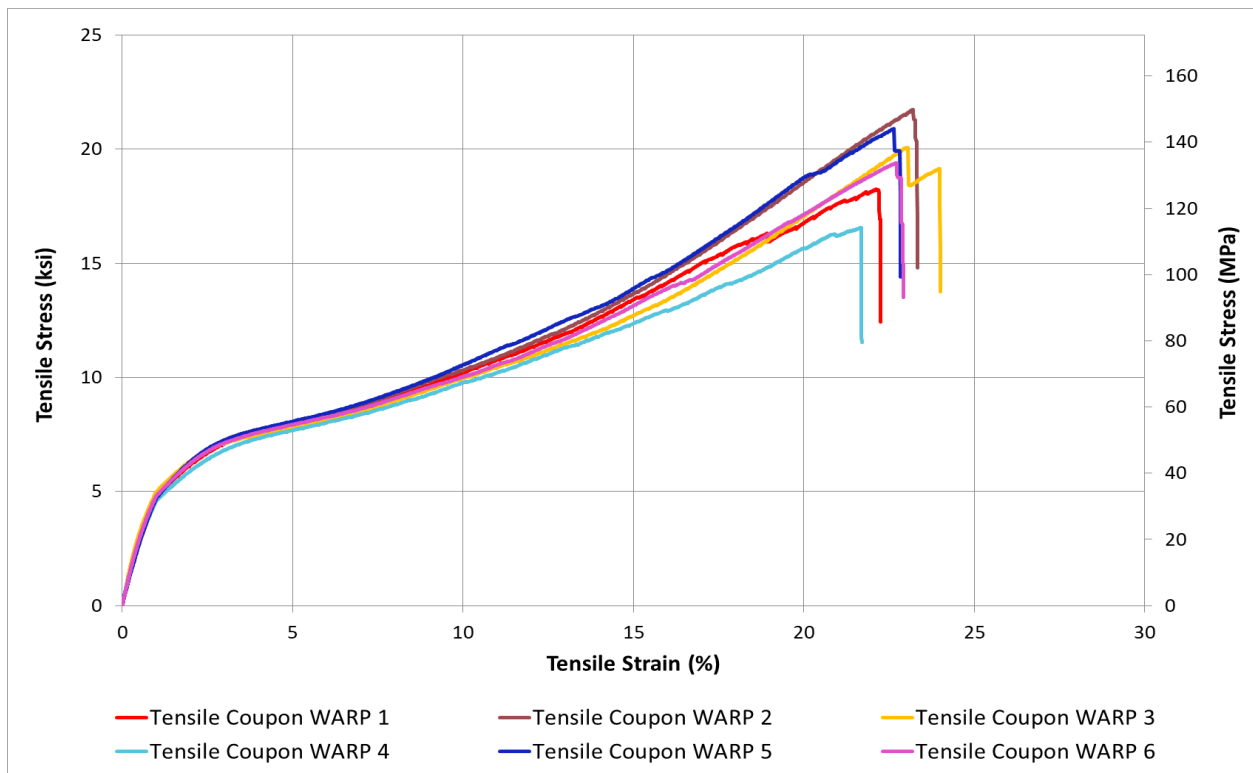
Figure 2.11 Tensile Stress versus Strain from CDCQ for AP2 Warp Tensile Coupon Tests

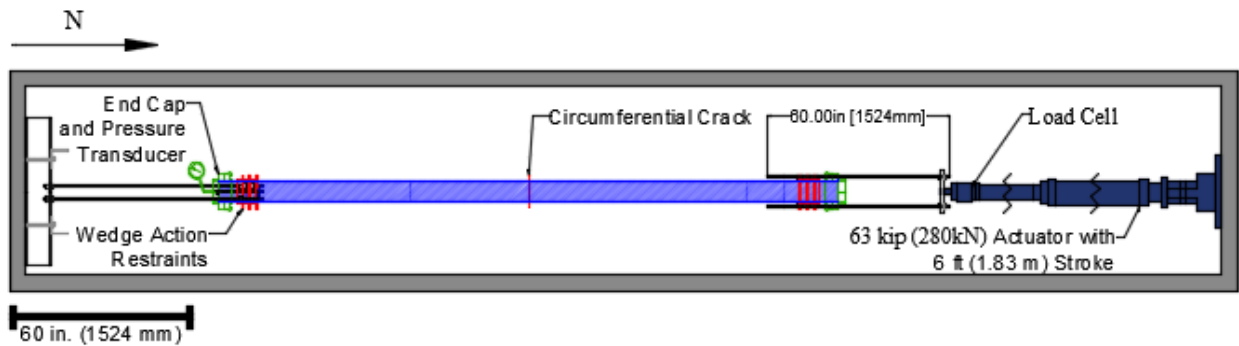
Figure 3.1. Plan View of a Direct Tension Test in the Large Load Frame

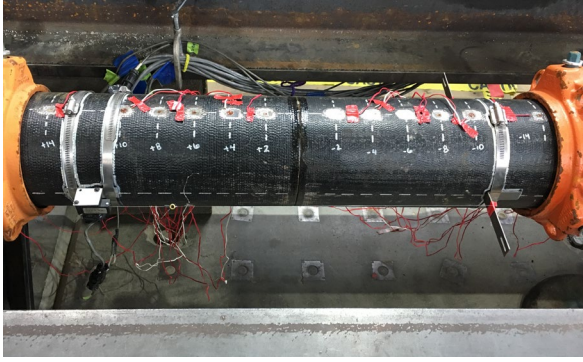
(a) View of DT1 Specimen in Load Frame Before Test Initiation

Figure 3.5 (a) and (d) show photographs of the DT1 test pipe. Figure 3.5 (a) shows the pipe at the beginning of the test. Strain gages on the crown of the pipe and a string pot along the eastern springline of the pipe can be seen in the photo. Figure 3.5 (b) and (c) show the pipe after the first and second 6 in. (152 mm) of actuator displacement, respectively. Figure 3.5 (d) shows the maximum 12 in. (305 mm) opening of the center crack near the end of the test. At 12 in. (305 mm) of crack opening, the loading frame geometric limits were met, and the specimen was unloaded.

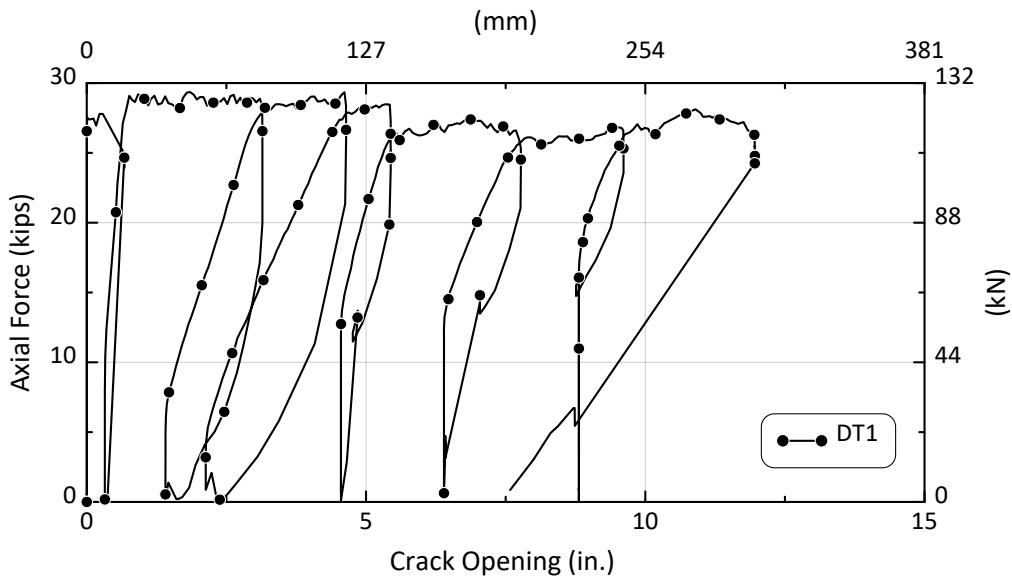
Figure 3.6. Axial Force versus Crack Opening for DT1

Figure 3.6 shows the axial force versus gap, or crack, opening. As displacement was applied, the axial load increased rapidly so that the slope of the plot appears to be a vertical line. After approximately 1 in. (25 mm) of crack opening, the test was paused, causing the first cyclic loading in the figure. After resuming the test, multiple load and reload cycles were applied until a maximum gap opening of 12 in. (305 mm) was achieved. Six unloading and loading cycles are

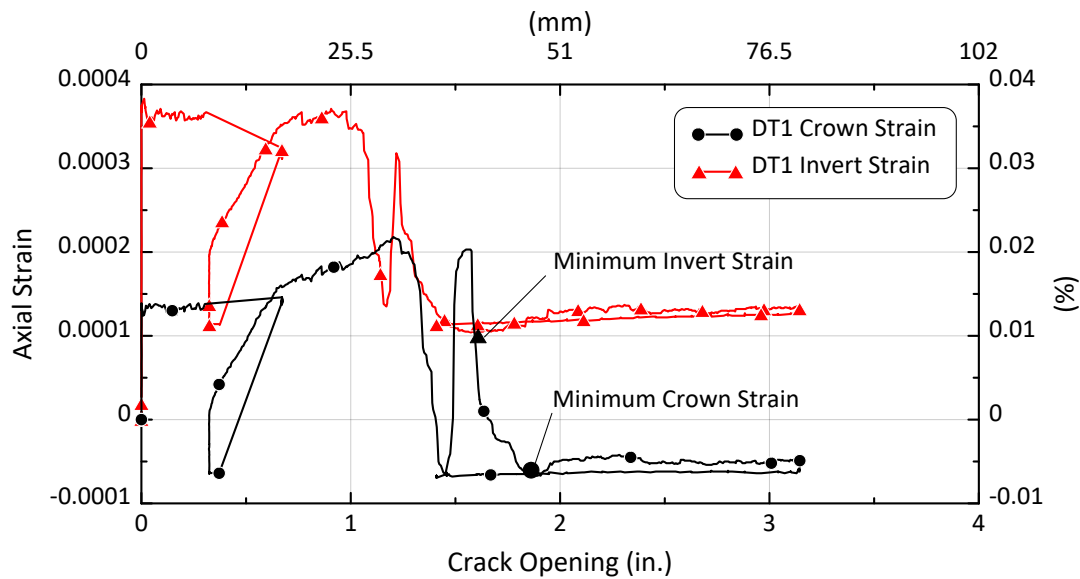
Figure 3.7. Longitudinal Strain at Strain Gage Station 6 versus Crack Opening for DT1 Specimen

Each minimum reading indicates when debonding had fully propagated past the location of the gage. At approximately 1.7 in. (43 mm) of gap opening, the invert strain dropped to its minimum value, followed by the crown strain that dropped to its minimal value at 1.9 in. (48 mm) of gap opening. There is a lag of approximately 0.20 to 0.25 in. (5.1 to 6.4 mm) in crack opening between

the minimum readings. The same applies to the maximum strain readings (after which there is a perceptible decline). The maximum strain coincides with the crack opening at which debonding begins at the gage station.

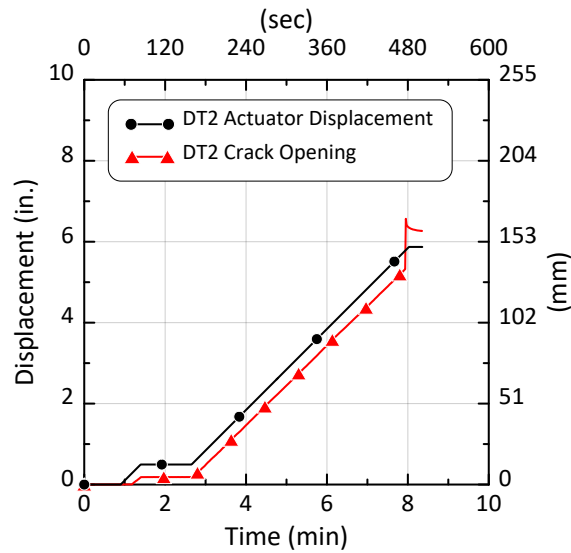
Figure 3.9. Actuator Displacement and Crack Opening versus Time for DT2 Specimen

The actuator displacement and crack opening versus time are shown in Figure 3.9. Actuator displacement is a direct measurement of the hydraulic piston movement. Crack opening represents the relative movement between the north and south pipe lengths. Only the south section of the pipe specimen debonded from the lining so the gap opening is equivalent to pipe movement along the south part of the lining. Crack opening was determined by averaging the displacements of the horizontal string pots, N-Pipe and S-Pipe, across the centerline. At approximately 1 minute, there was a slip of the retaining collars that resulted in an offset between the actuator displacement and gap opening. Further crack opening occurred in unison with the actuator displacement,

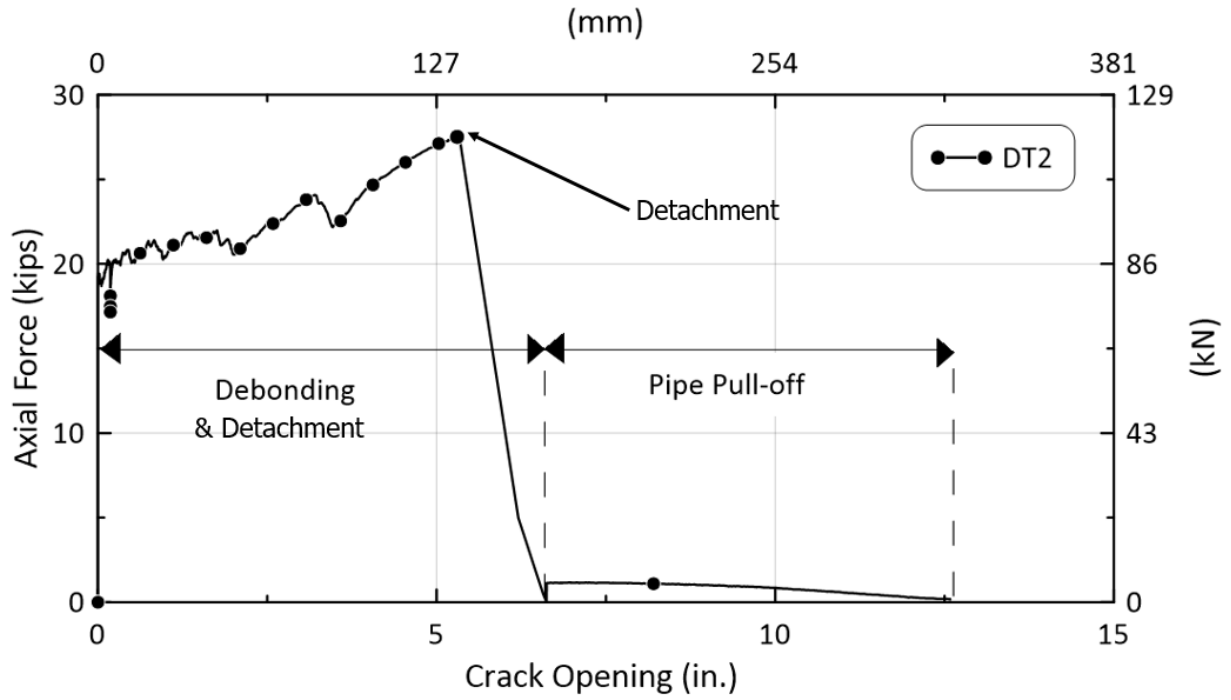
Figure 3.10. Axial Force versus Crack Opening for the DT2 Specimen

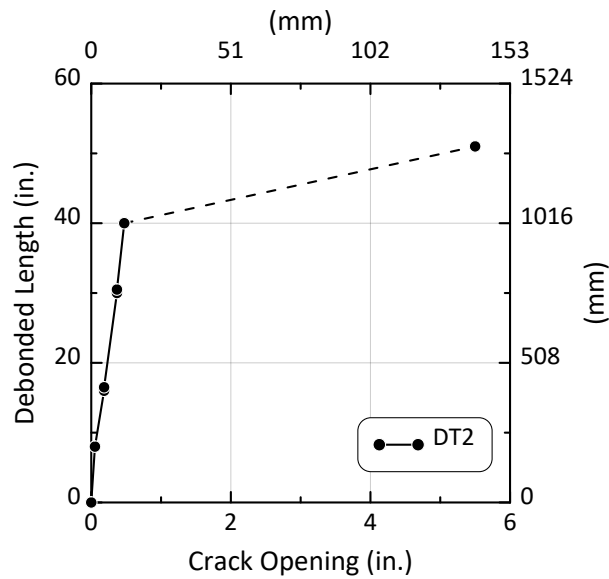
Figure 3.11. Location of Debonding Front versus Crack Opening of the DT2 Specimen

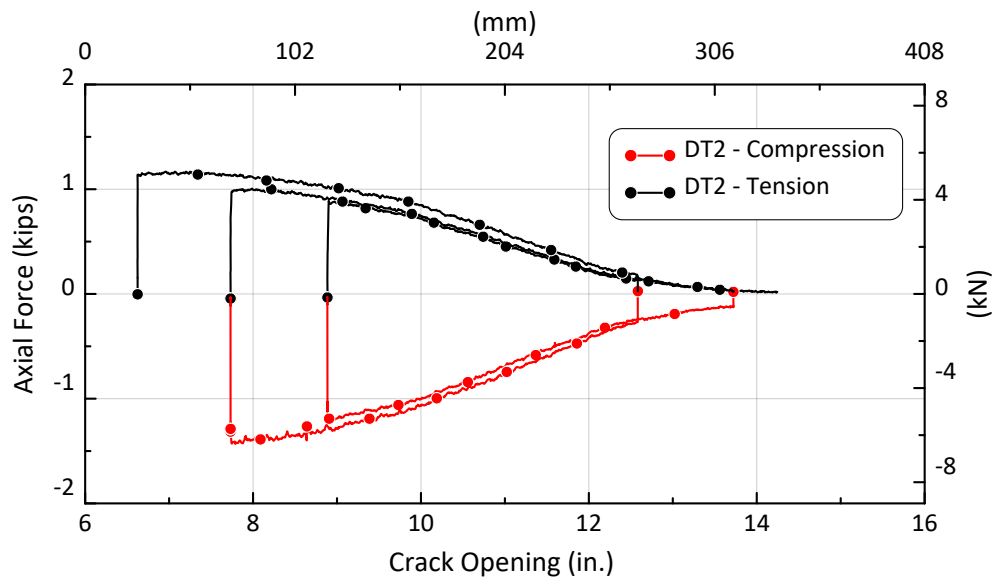
Figure 3.12. Axial Force versus Crack Opening during Pipe Pull-off for DT2

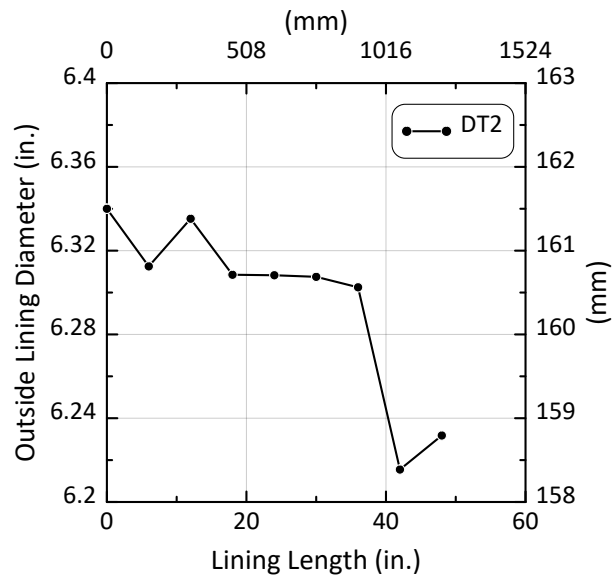
Figure 3.13. Average Outer Diameter of Lining along the South Section of the DT2 Specimen

Because the lining was cast and cured inside the pipe, the outside diameter of the lining is the inside diameter of the pipe. As the pipe was pulled along the lining, the larger end of the pipe was pulled across a lining diameter that decreased until a minimum diameter at about 42 in. (1067 mm) south of the initial center gap. Because the end of the pipe was displaced past a lining diameter lower than that of the pipe, contact between the inside diameter of the pipe and outside diameter of the lining was lost with a corresponding loss of shear resistance between the two surfaces. This geometric condition resulted in the reduction of axial load with increasing pipe lining movement

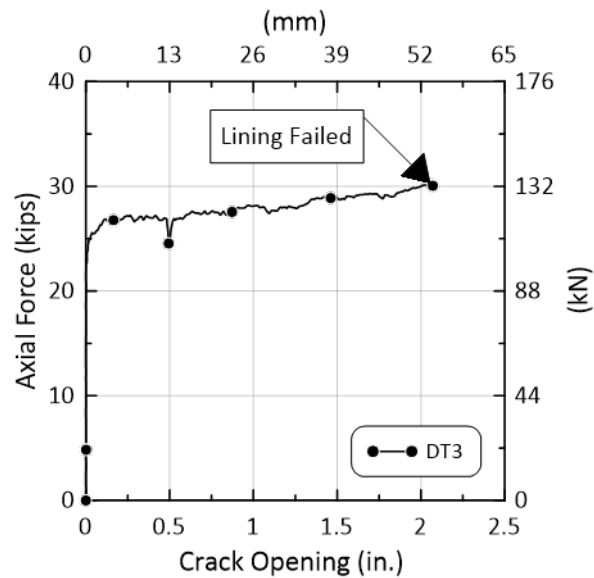
Figure 3.15. Axial Force versus Crack Opening for DT3

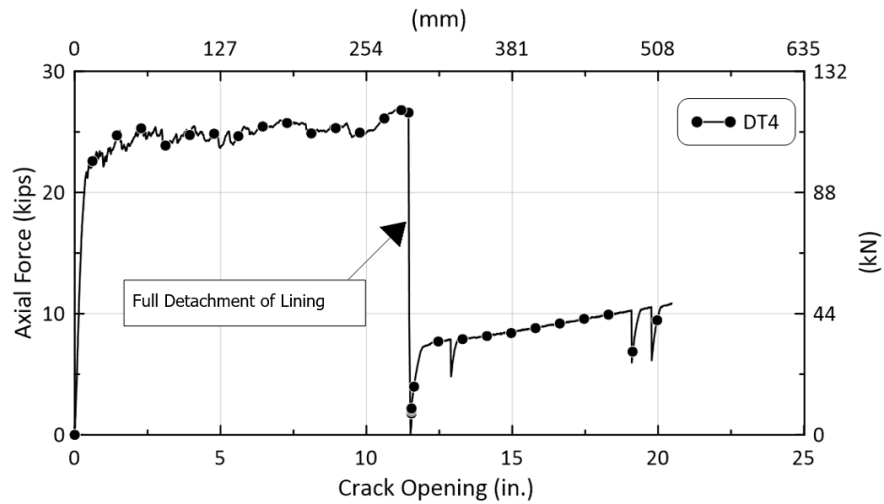
Figure 3.16. Axial Force versus Displacement for DT4 during Debonding

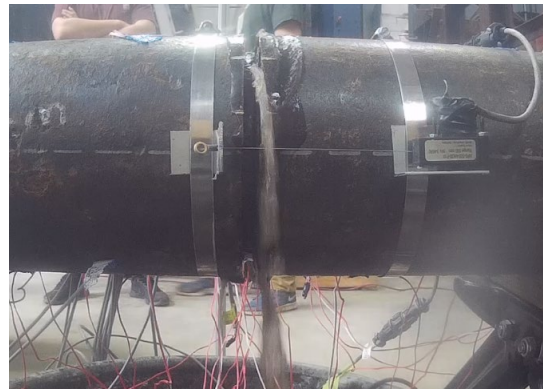
(b) View of Specimen Leaking after 0.3 in. (8 mm) of Crack Opening

Figure 3.19. Photos of the Test Specimen before and during the First Stage of DT5

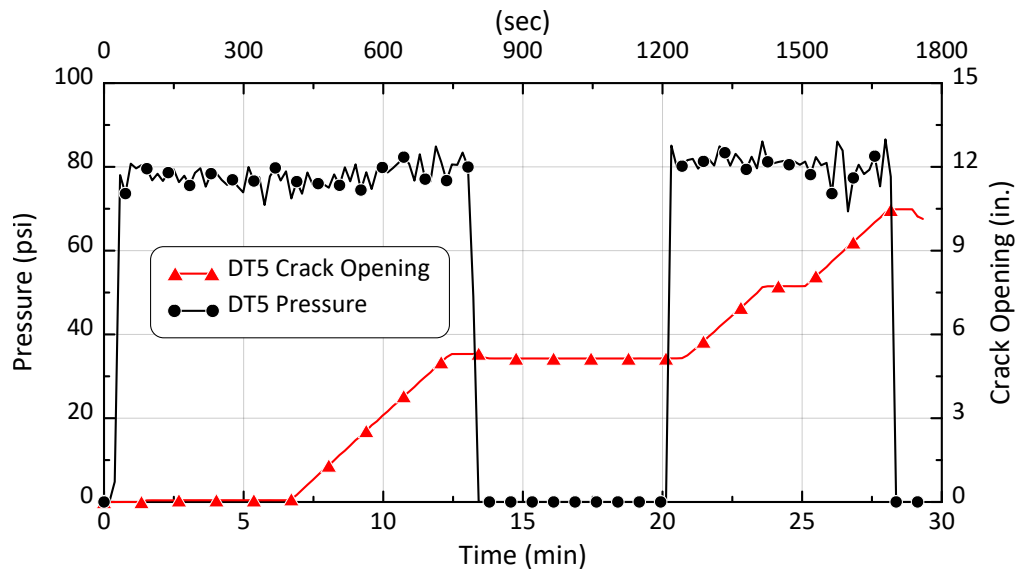
Figure 3.20. Pressure versus Time During the First Stage of DT5

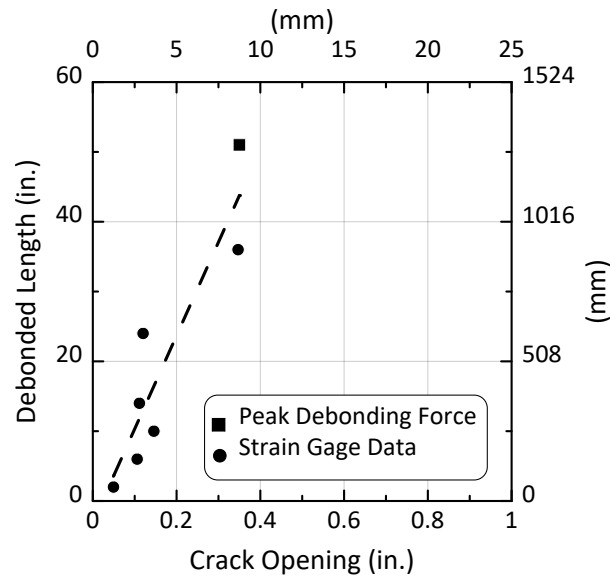
Figure 3.22. Debonding Front versus Crack Opening for DT5 Specimen

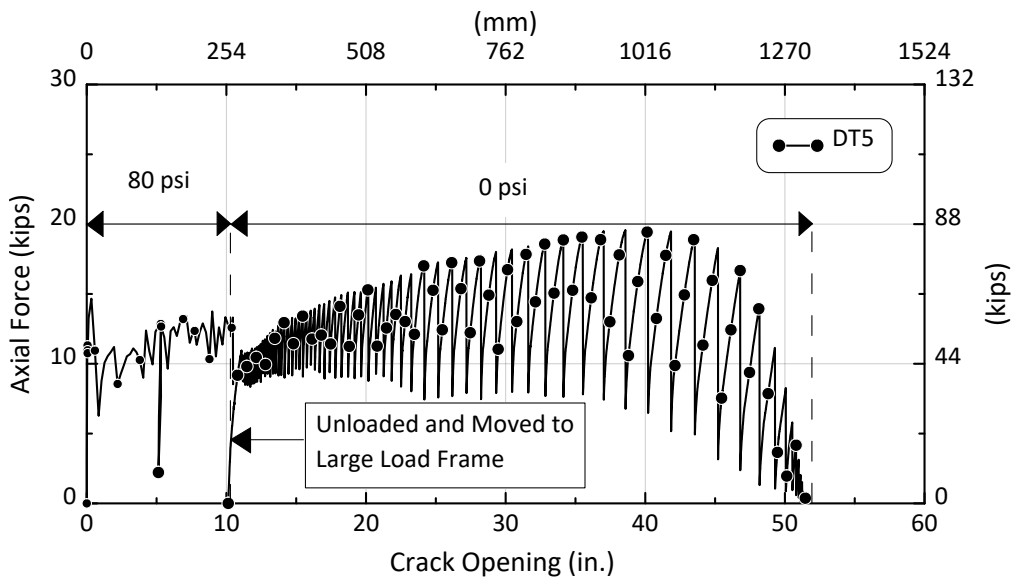
Figure 3.23. Axial Force versus Crack Opening for DT5 Specimen

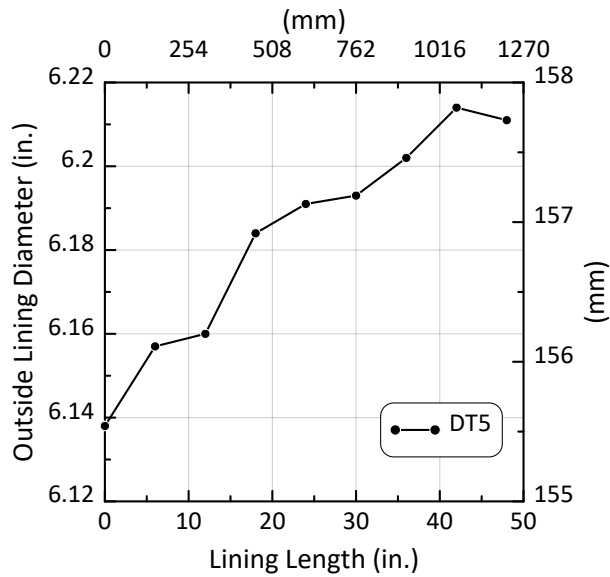
Figure 3.24. Average Outer Lining Diameter along the South Section of the DT5 Specimen

Figure 3.24. shows the average outside lining diameter plotted with respect to distance along the lining. The diameter was measured from the center of the specimen at zero to near the end of the lining at 48 in. (1219 mm). As the pipe was pulled along the lining, the smaller end of the pipe

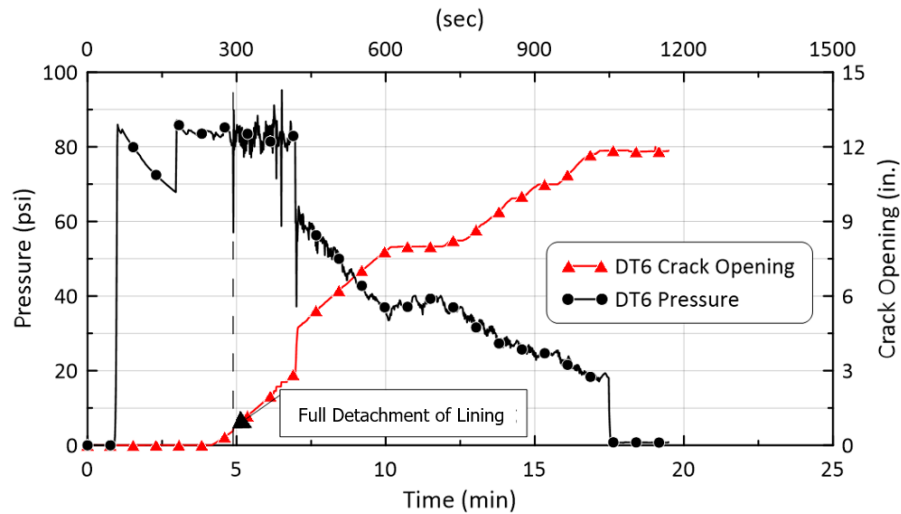
Figure 3.25. Internal Pressure versus Time for DT6 Specimen

Leakage was observed soon after the beginning of the test. The leaking caused internal pressure to drop from 80 psi (551 kPa) to approximately 20 psi (138 kPa) after roughly 17 in. (432 mm)

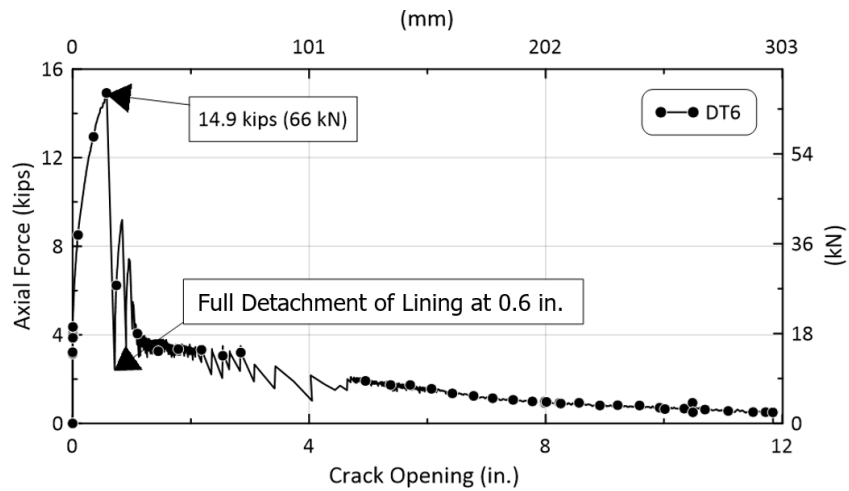
Figure 3.26. Axial Force versus Crack Opening for DT6 Specimen

Figure 3.26. shows that, after detachment, the axial force continued to decrease with increasing crack opening. Following the procedures developed for DT2 and DT4 through DT6, the average

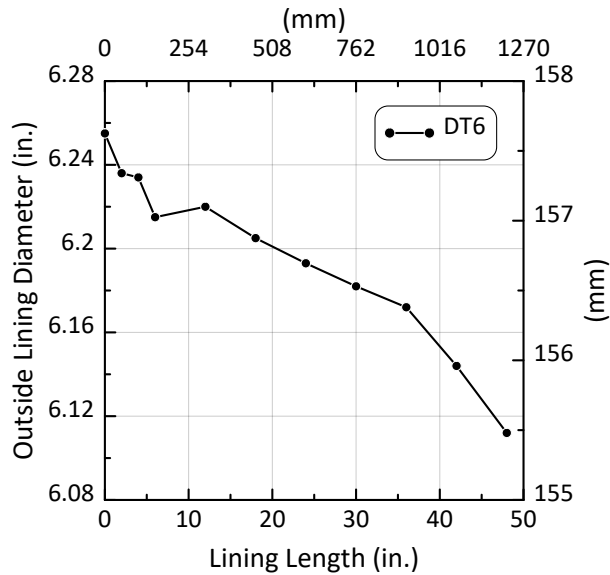
Figure 3.27. Average Outer Lining Diameter along the South Section of DT6

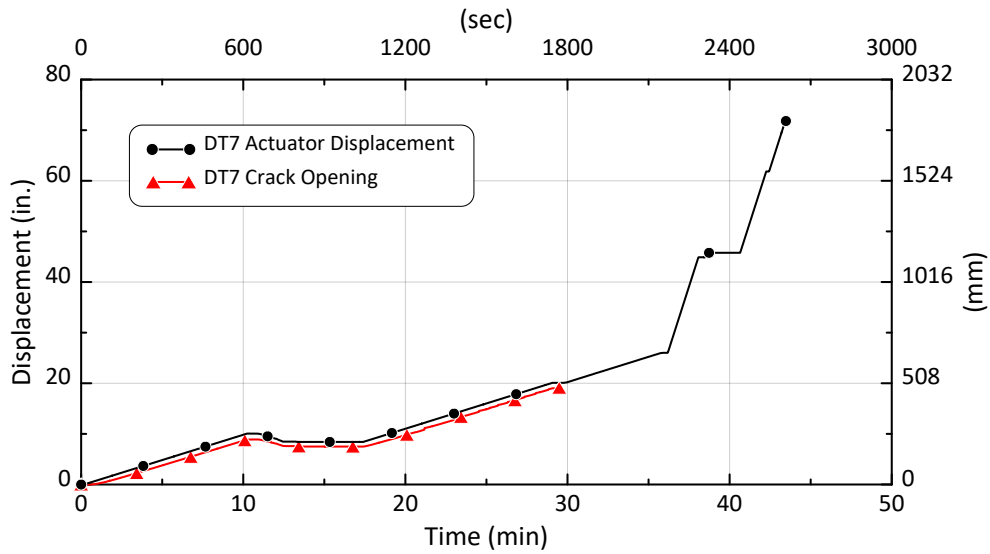
Figure 3.30. Actuator Displacement and Crack Opening versus Time for DT7

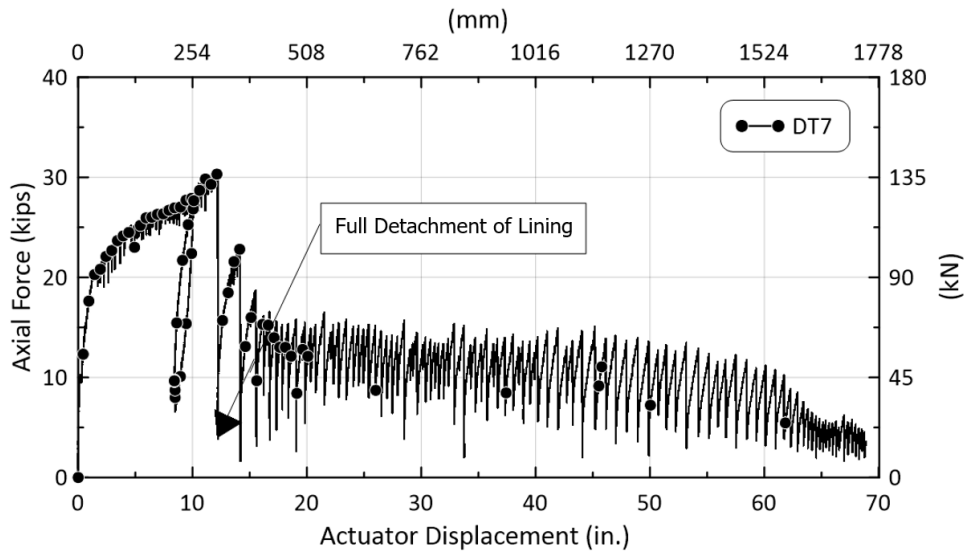
Figure 3.31. Axial Force versus Actuator Displacement for DT7

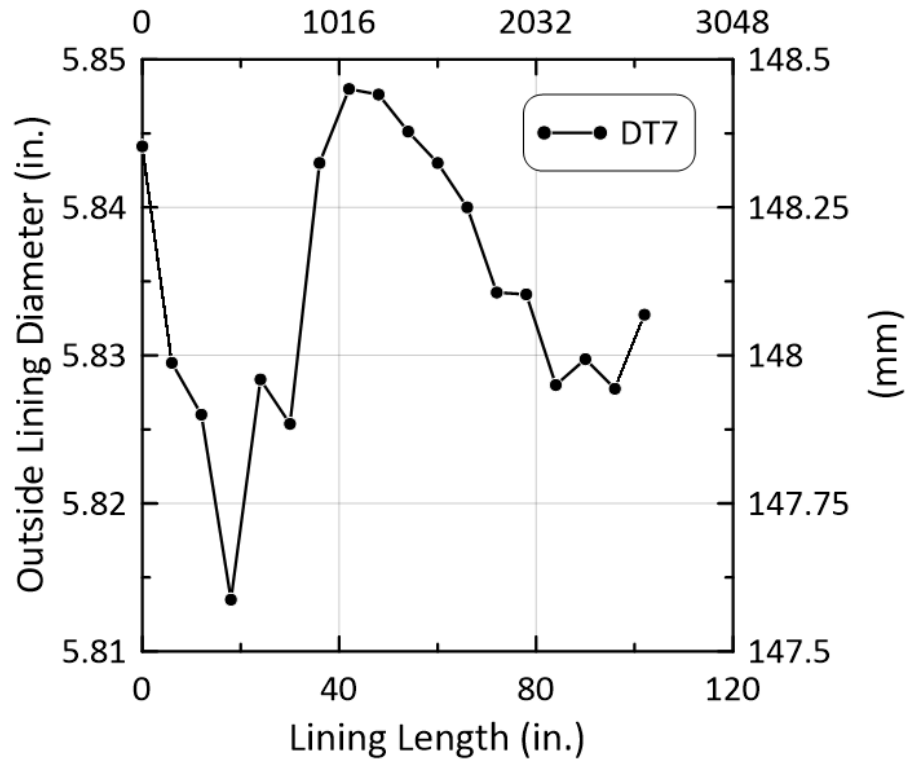
Figure 3.34. Average Diameter versus North Pipe Section Length for the DT7 Specimen

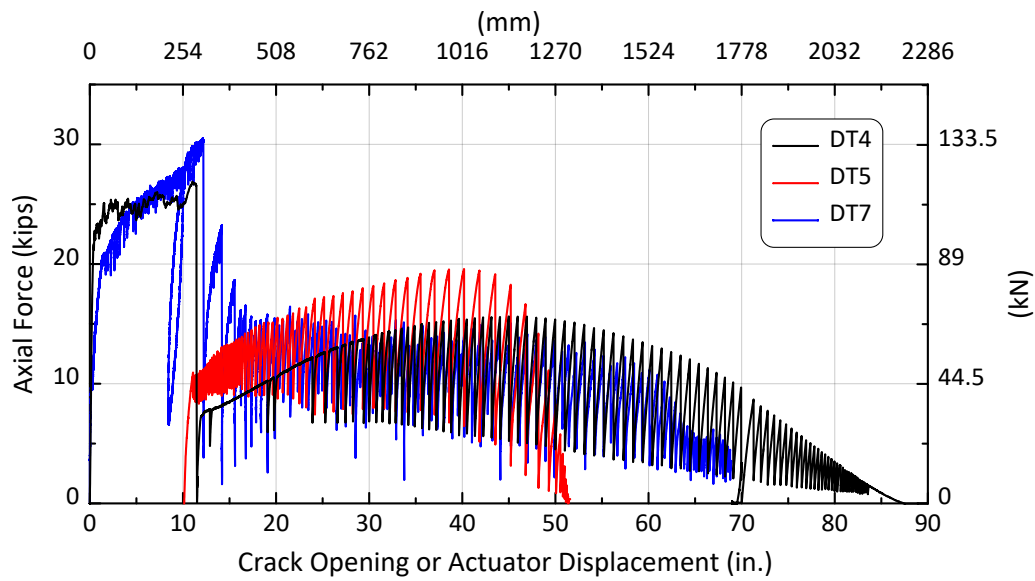
Figure 3.35. Axial Force versus Crack Opening or Actuator Displacement for DT4, DT5, and DT7

The test results show a complex interaction involving the pipe and lining geometry, friction between the lining and pipe, and internal pressure. After debonding, DT4 and DT5 were performed at zero internal pressure. The highest maximum force after debonding was recorded in DT5. A larger change in pipe and lining diameter over distance was measured in DT5 than in DT4. DT7

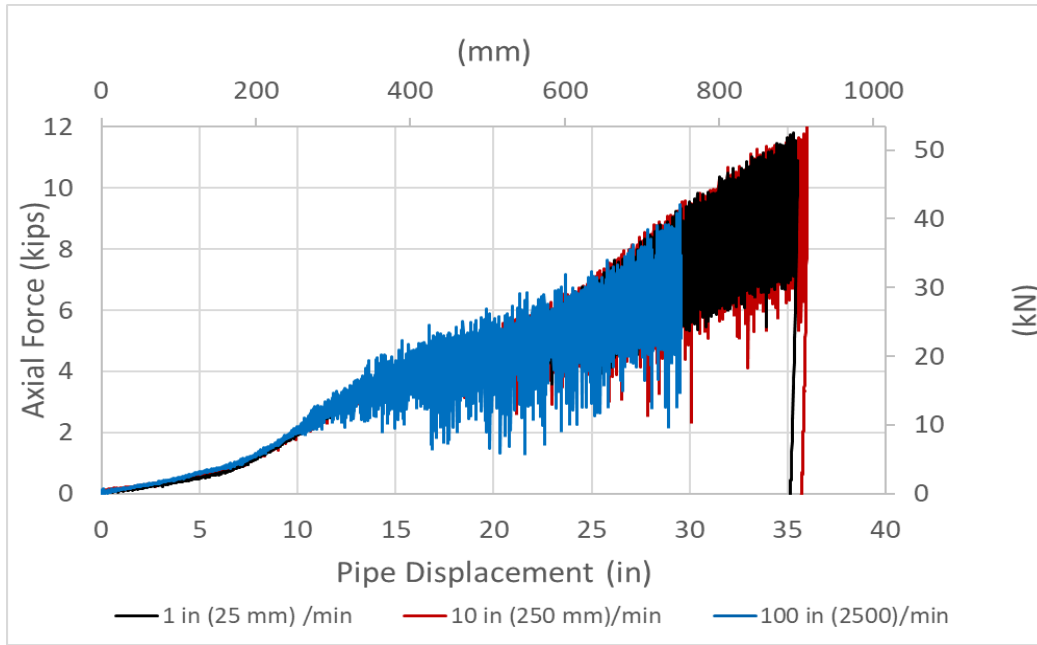
Figure 4.6. Comparison of Axial Force versus Pipe Displacement Response at Zero Pressure for Different Loading Rates

These results show that axial load versus displacement performances is not influenced by the loading rate. The load response remains unchanged over two orders of magnitude in displacement rate. Showing the independence of load response to the rate of loading displacement eliminates an important variable, and simplifies both the experimental conditions for relevant testing as well as the characterization of ground deformation effects on cured in place pipe behavior.

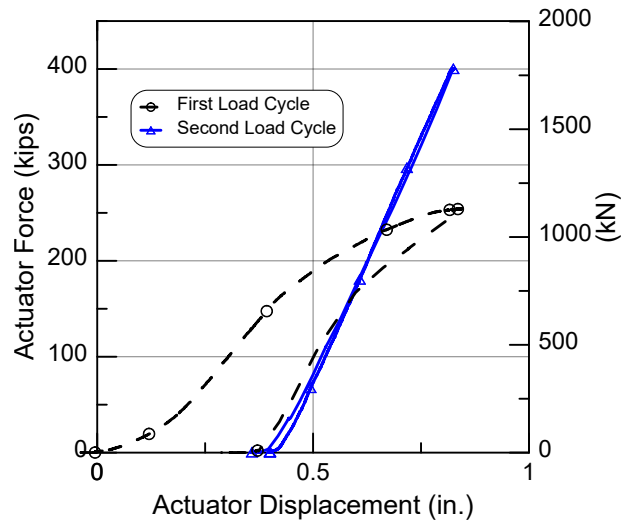
Figure 6.5. DC1 Axial Force versus Displacement

There was an immediate drop in axial load as shown in the figure. The test was paused at 1.5 in. (38 mm) of axial displacement and then continued to a total displacement of 3.8 in. (97 mm). The displacement rate was increased from 0.1 in./min. (0.25 mm/min.) to 1.0 in./min (10 mm/min.) when the test was resumed after failure of the CI bell.

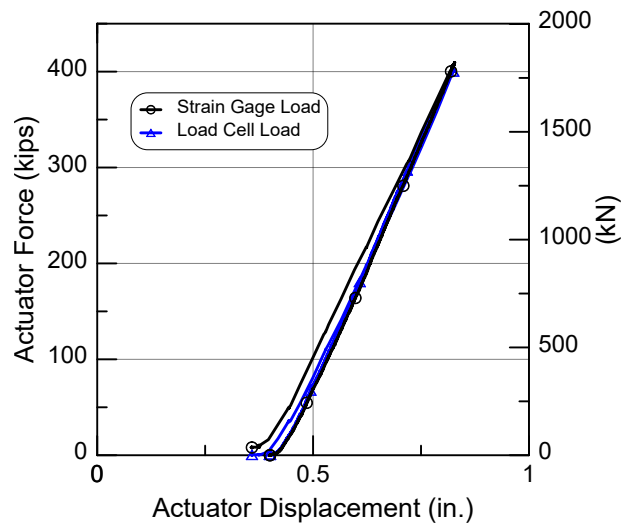
Figure 6.6. Comparison of Axial Force versus Displacement with Load Cell and Strain Gage Measurements

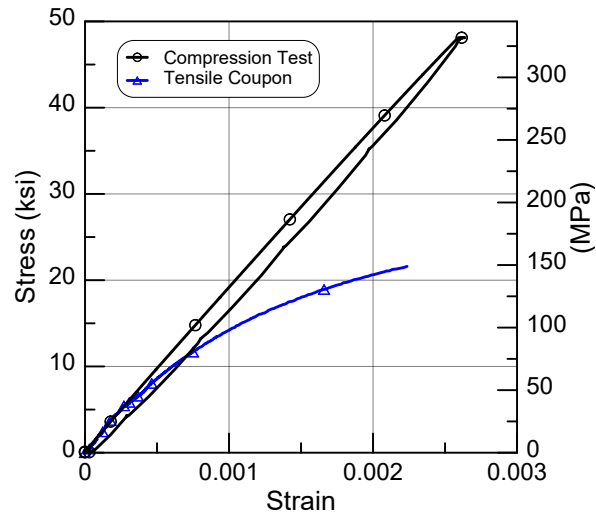
Figure 6.7. Comparison of CI Stress versus Strain Relationship from Tensile Coupon and Direct Compression Tests

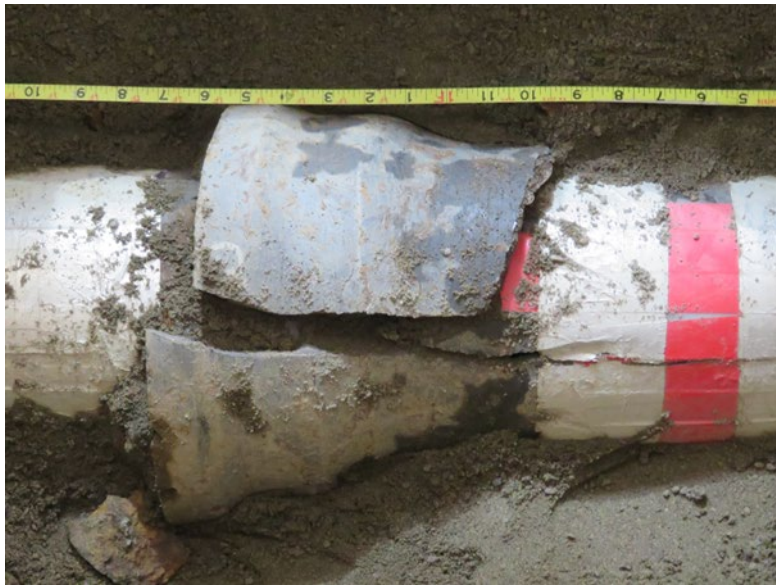
Figure 6.9. DC2 Fractured CI Bell

The test specimen was pressurized in the condition shown in Figure 6.9 and Figure 6.10 at 80 psi (552 kPa). Drips of water were observed at two locations along the wrinkled lining. A very low leakage rate of 95 mL/min. (3.2 fl. oz./min.) was measured.

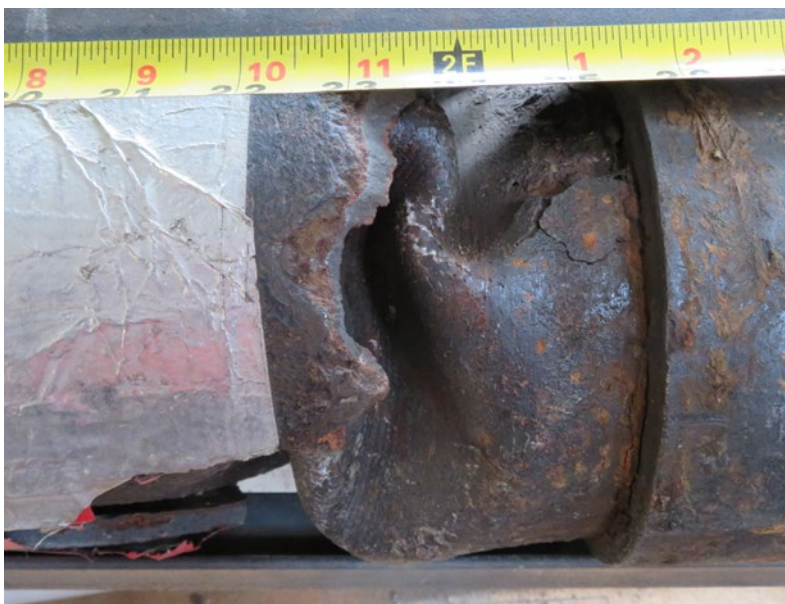
Figure 6.10. DC2 Deformed and Buckled Lining

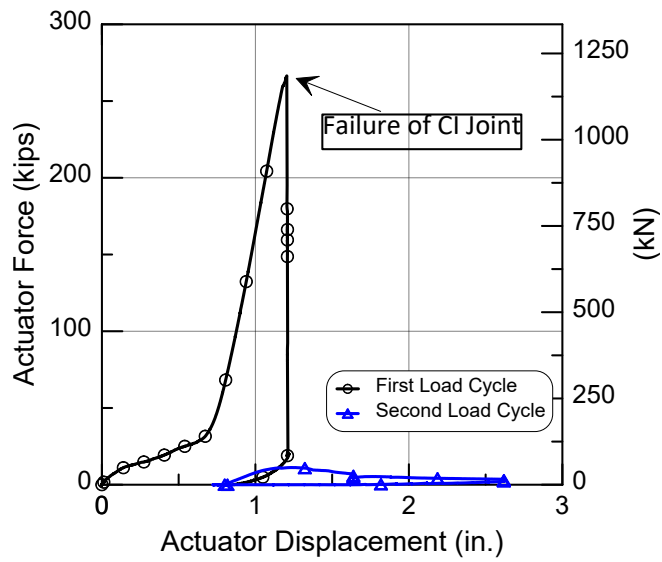
Figure 6.11. DC3 Axial Force versus Displacement Plot

The third compression test was performed on a test specimen provided by LADWP with a cement caulked joint. Figure 6.11 presents a plot of the actuator force versus axial displacement. There is a noticeable change in slope of the force versus displacement plot at about 0.7 in. (18 mm), when the spigot made firm contact with the back of the bell. The pipe barrel north of the joint failed at a

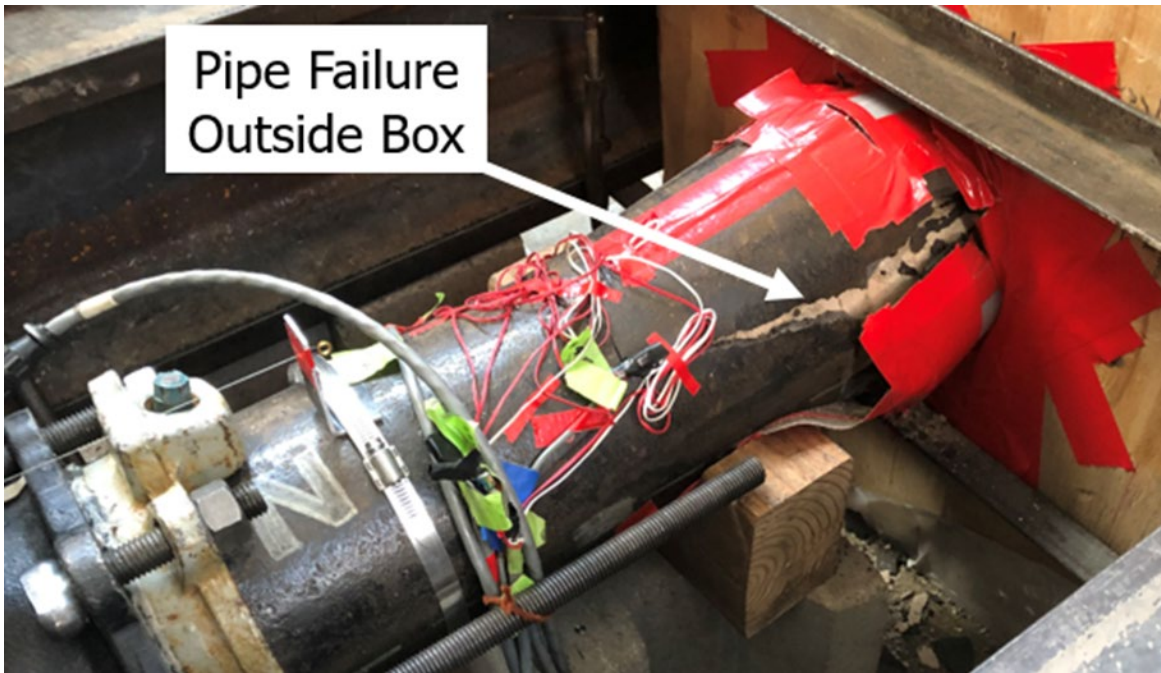
Figure 6.12. DC 3 Fractured Test Pipe Specimen

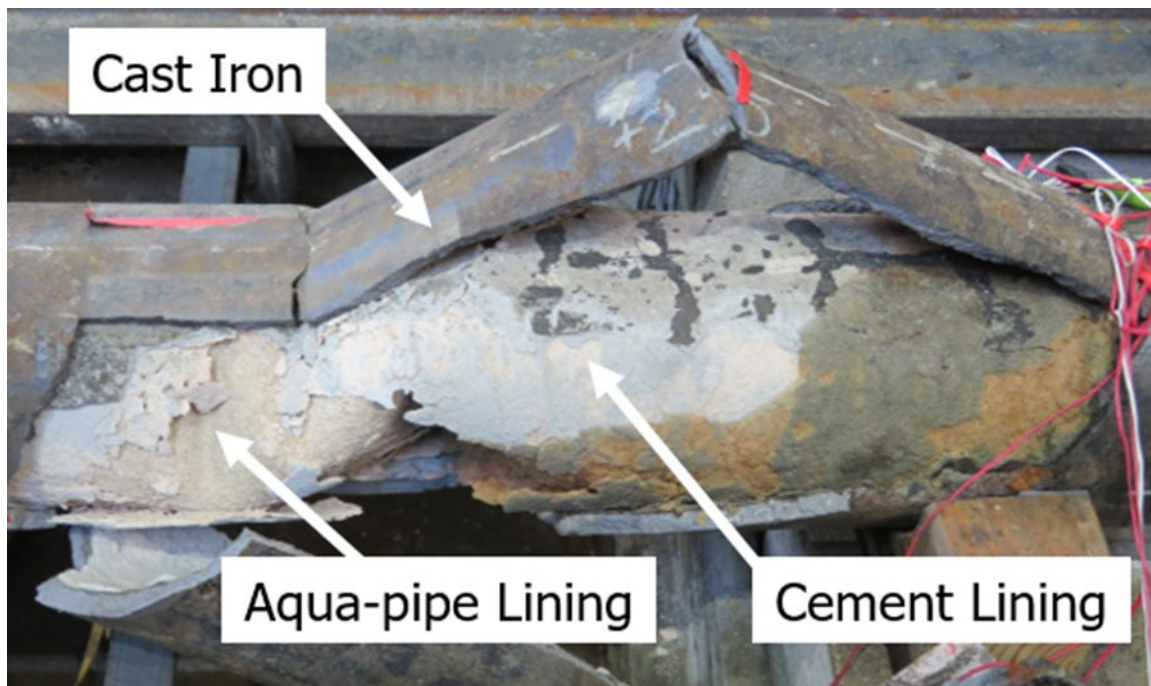
Figure 6.13. DC3 Fractured Test Pipe Specimen View of Deformed Aqua-Pipe Lining and Cement Lining

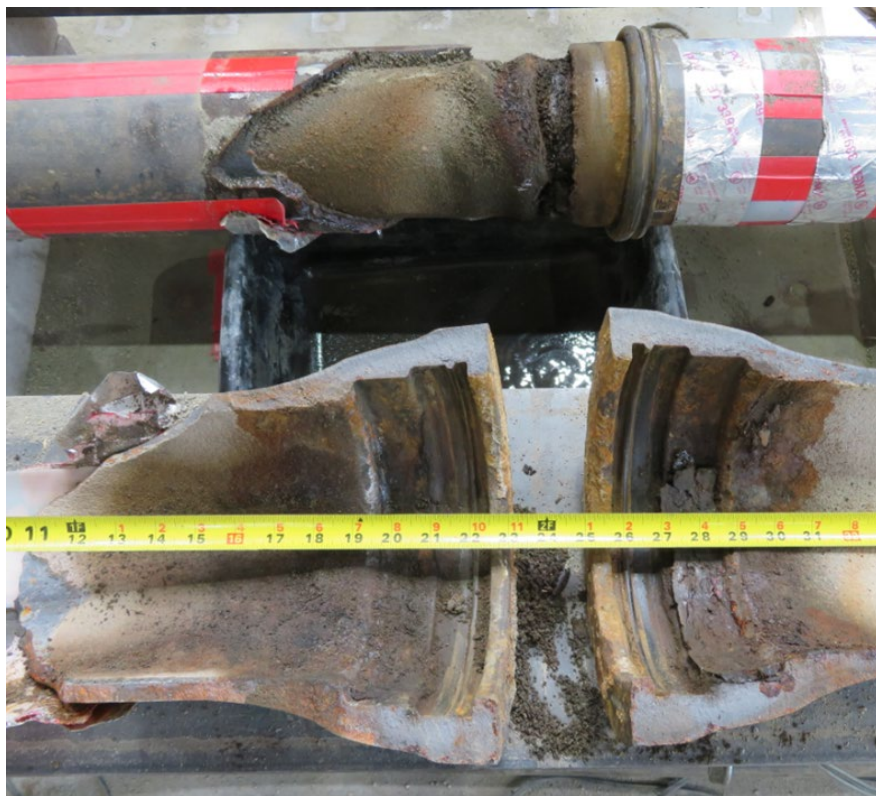
Figure 6.15. DC 4 Fractured CI Bell and Deformed Aqua-Pipe Lining

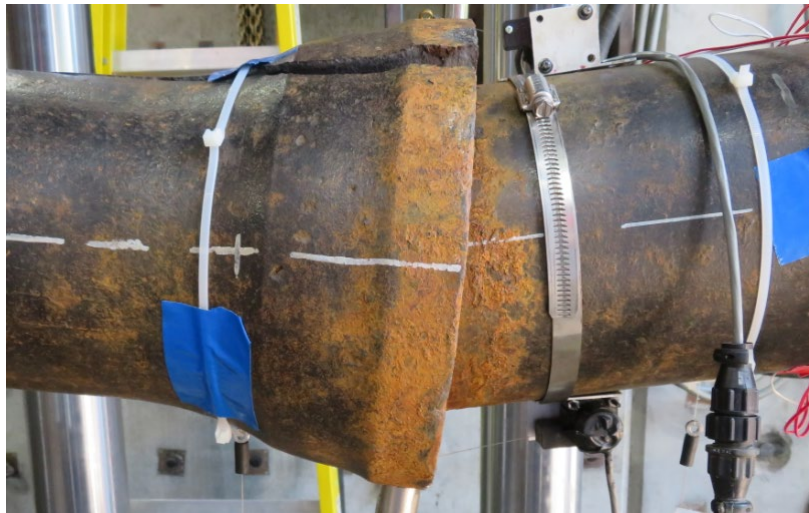
Figure 7.5. Photo of CI Bell Fracture at Crown
