Performance Evaluation of Aqua-Pipe under Earthquake-Induced Ground Deformation

Final Report

Cornell University

May 2021

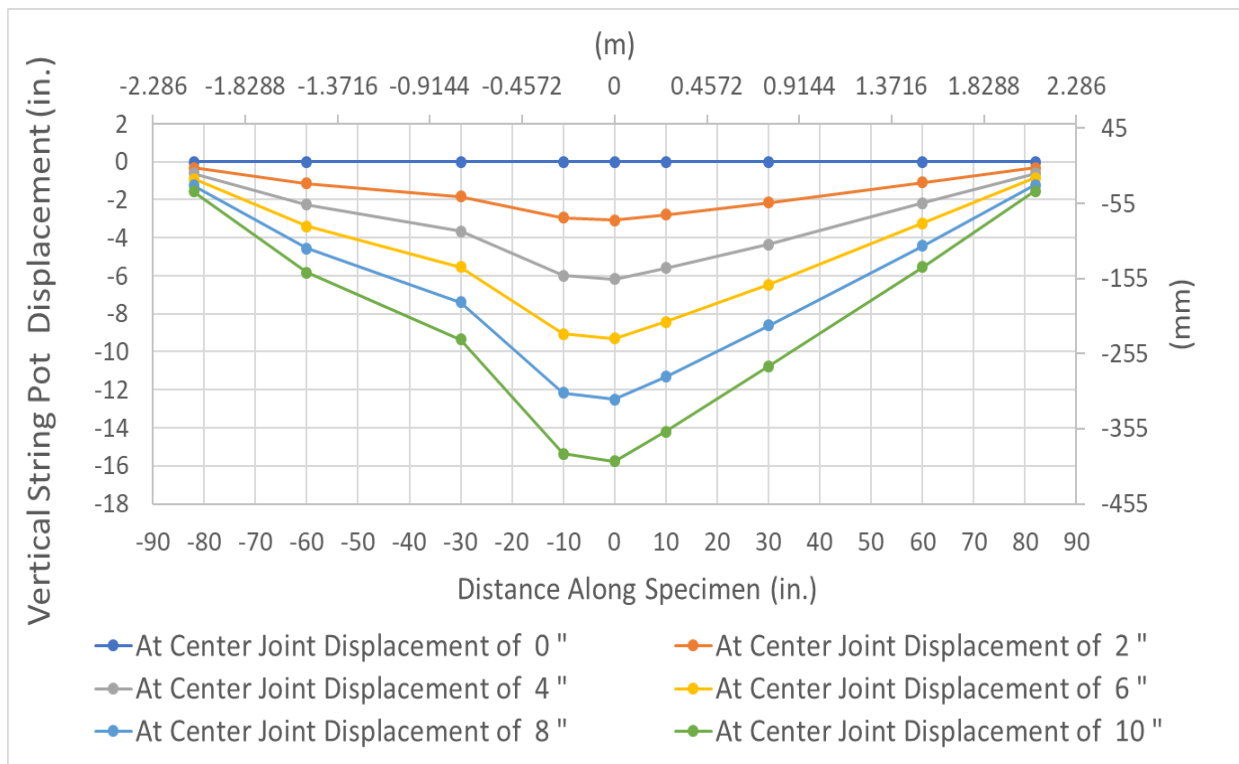
Figure 7.7. Vertical Displacements for AP1 DI Joint with Various Center Joint Movements

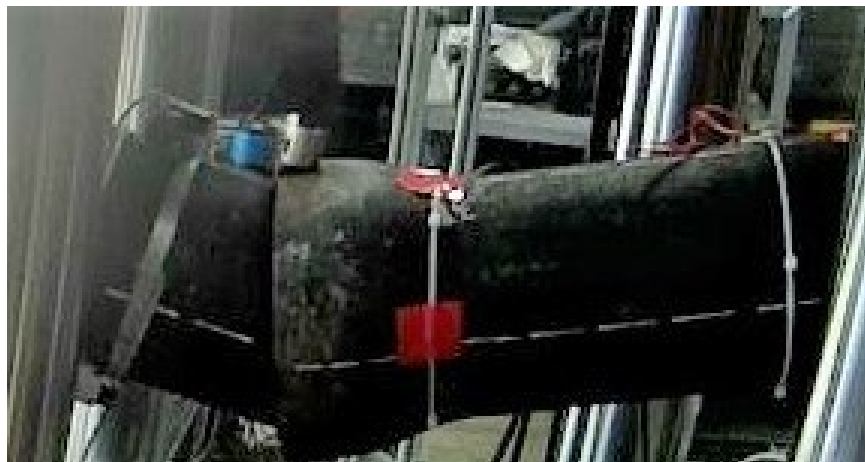
Figure 7.9. Maximum DI Joint Rotation

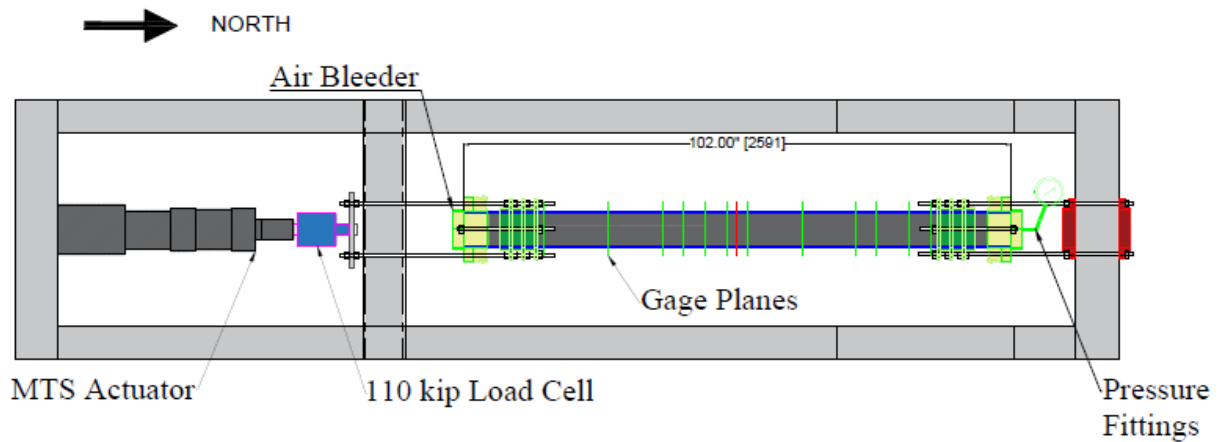
Figure 8.1. Plan View of a Direct Tension Test in the Small Load Frame

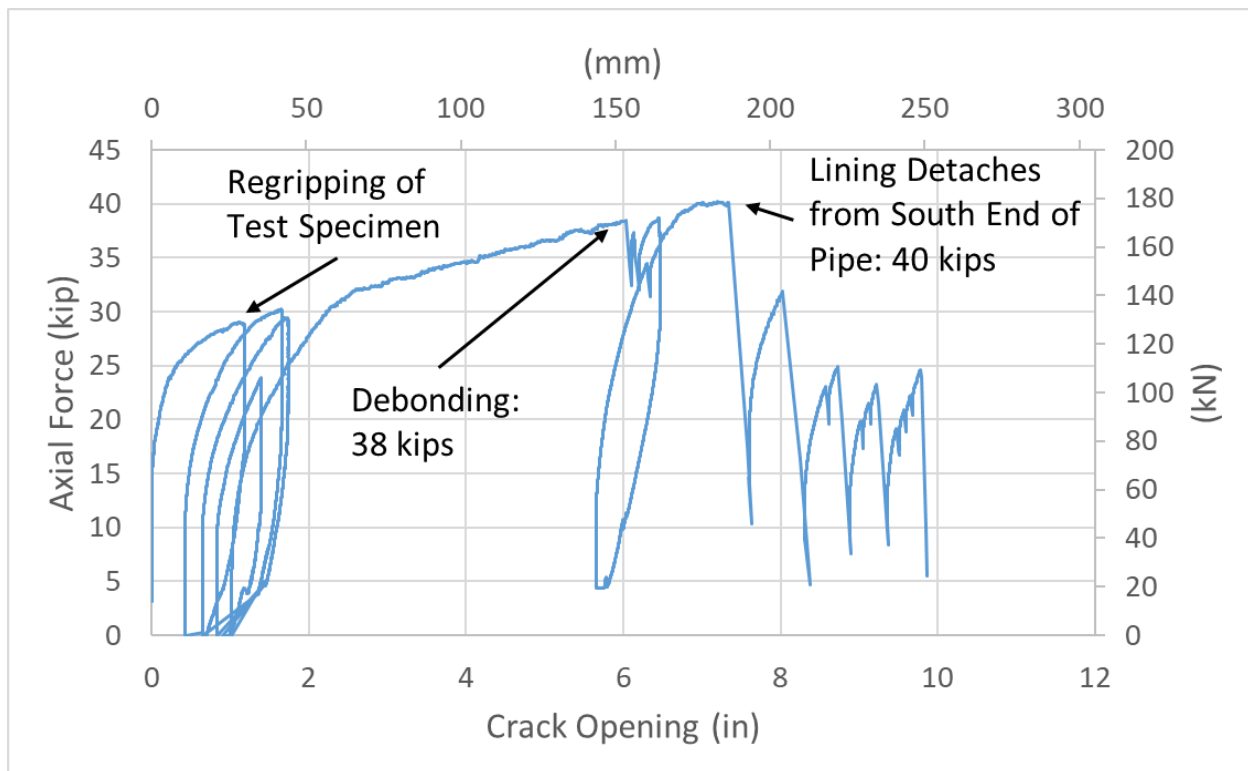
Figure 8.2. Axial Force versus Crack Opening for AP2 DT1

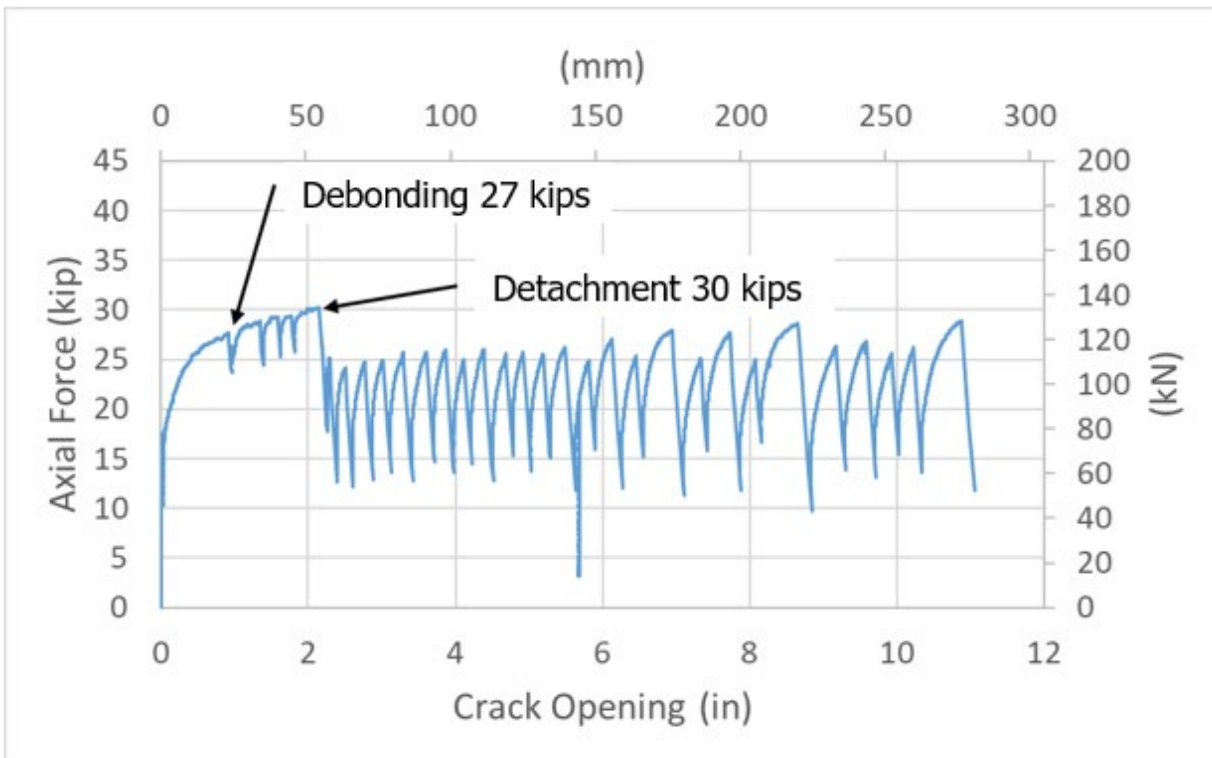
Figure 8.3. Axial Force versus Crack Opening for AP2 DT2

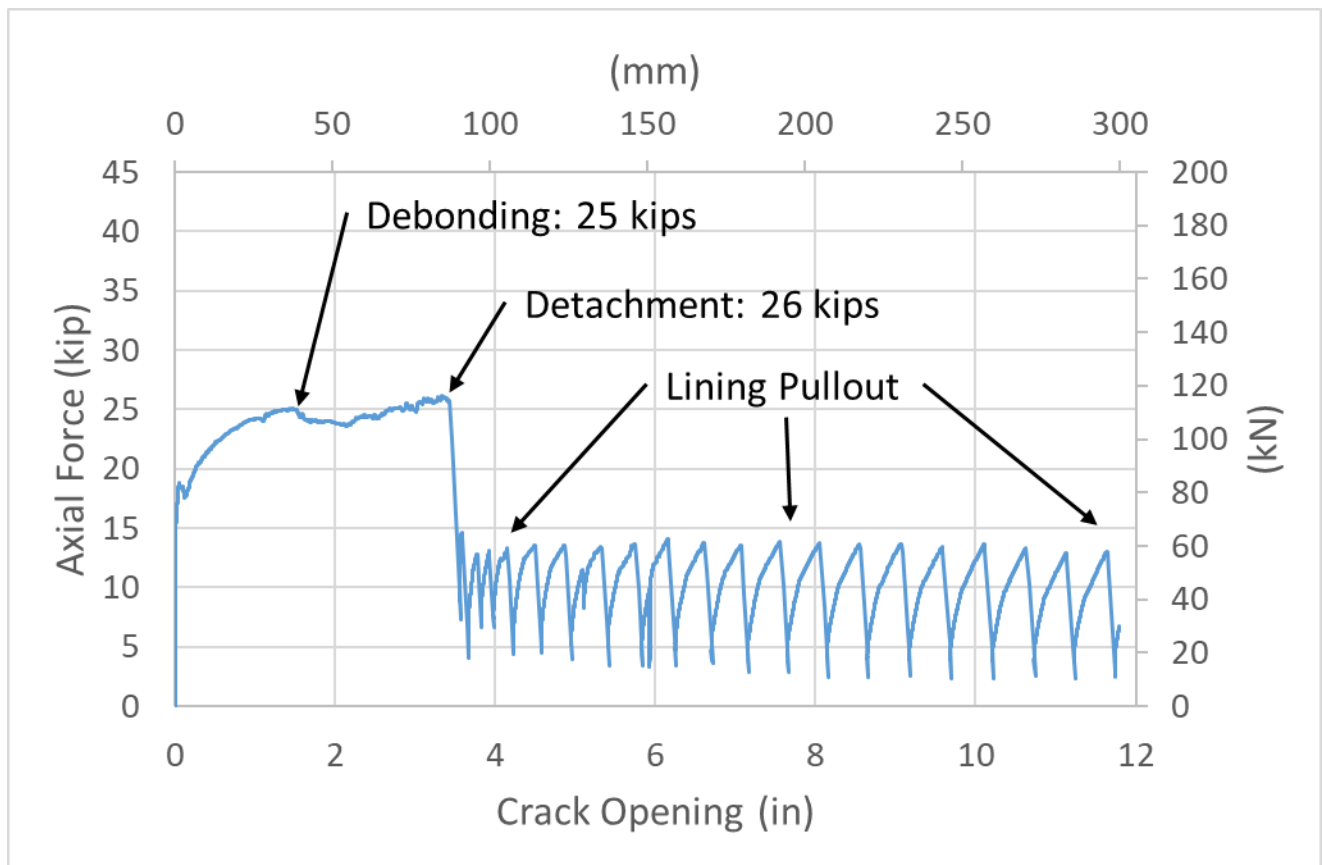
Figure 8.4. Axial Force versus Crack Opening for AP1 JDT1

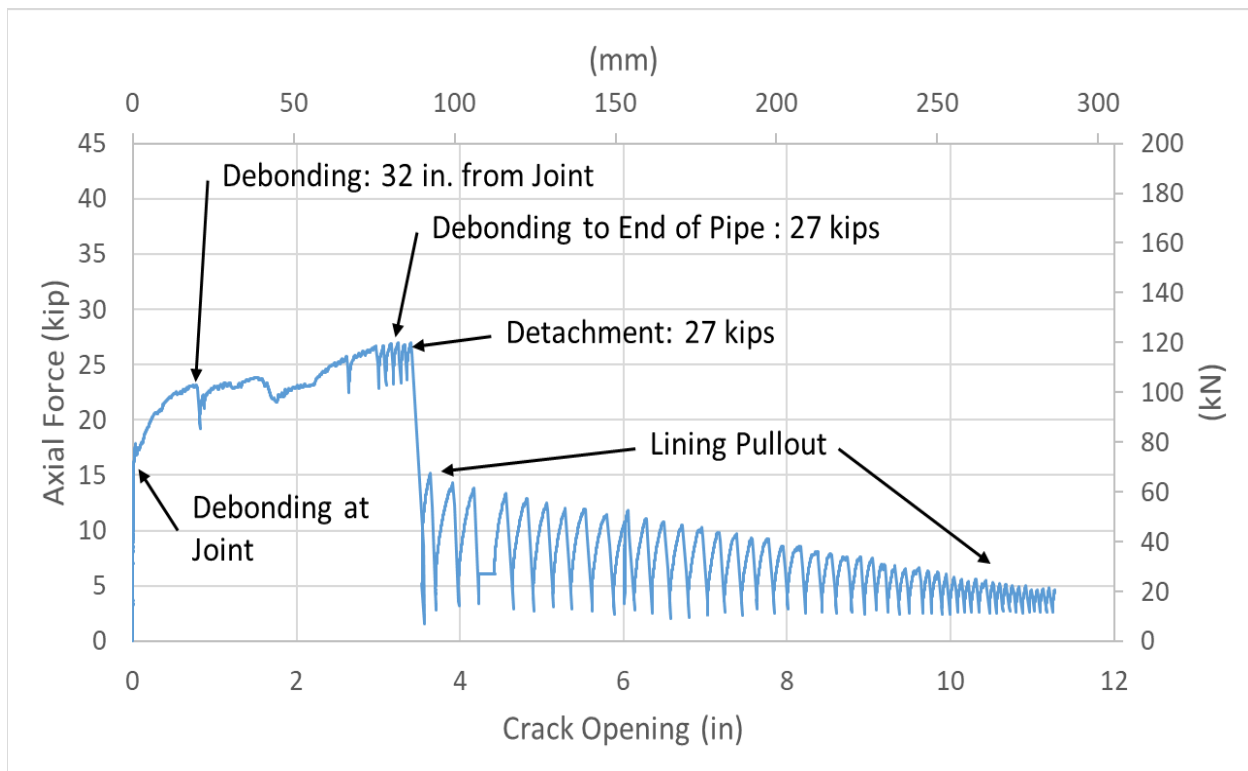
Figure 8.5. Axial Force versus Crack Opening for AP1 JDT2

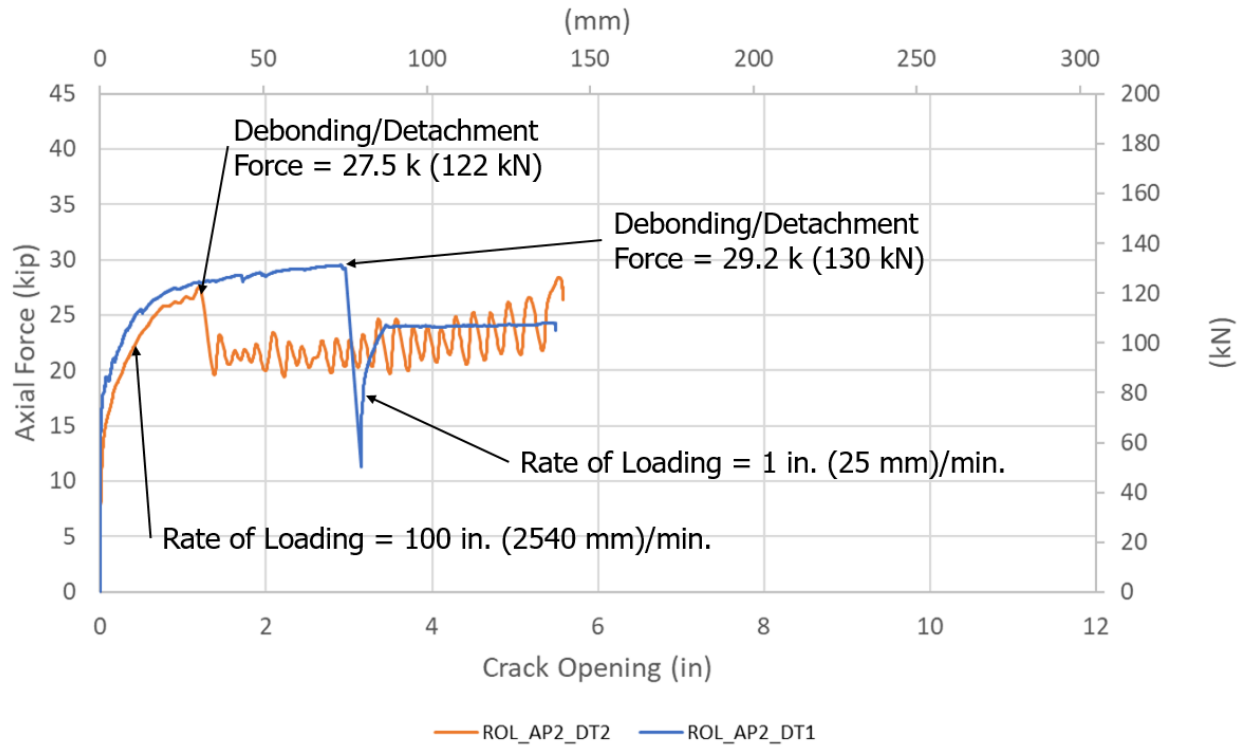
Figure 8.6. Axial Force versus Crack Opening for Rate of Loading Tests

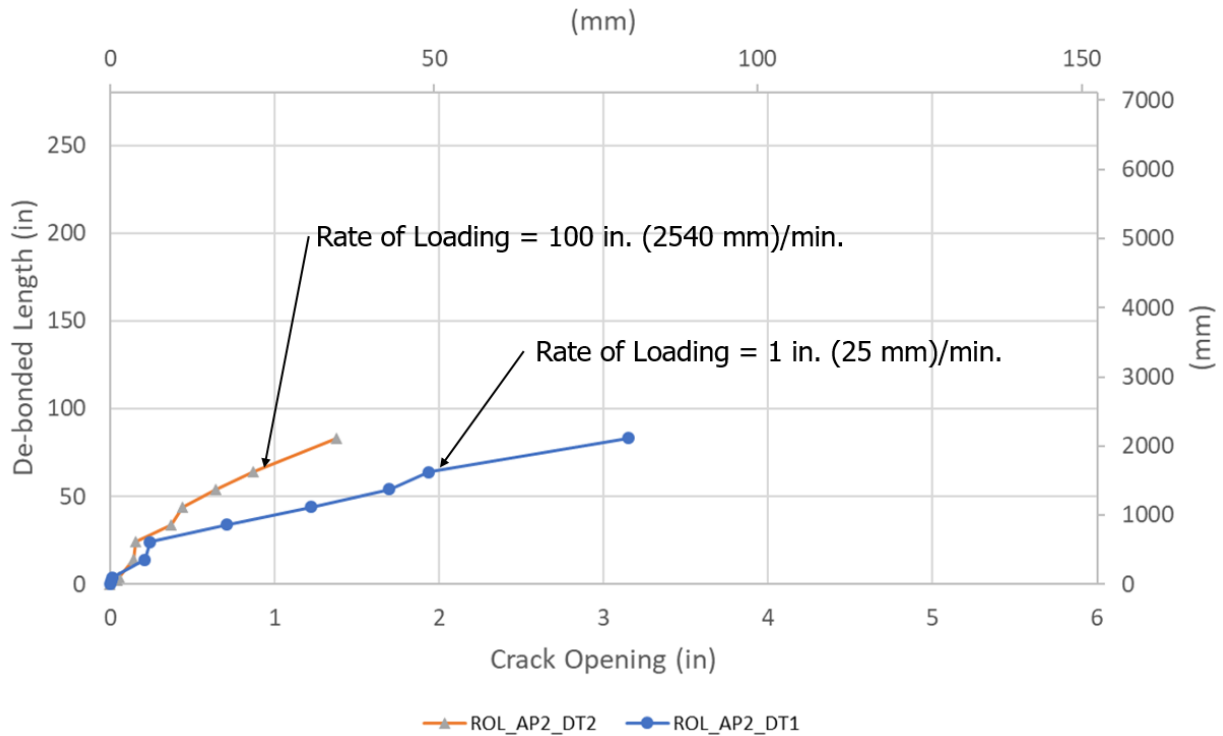
Figure 8.7. Debonding Length versus Crack Opening for Rate of Loading Tests

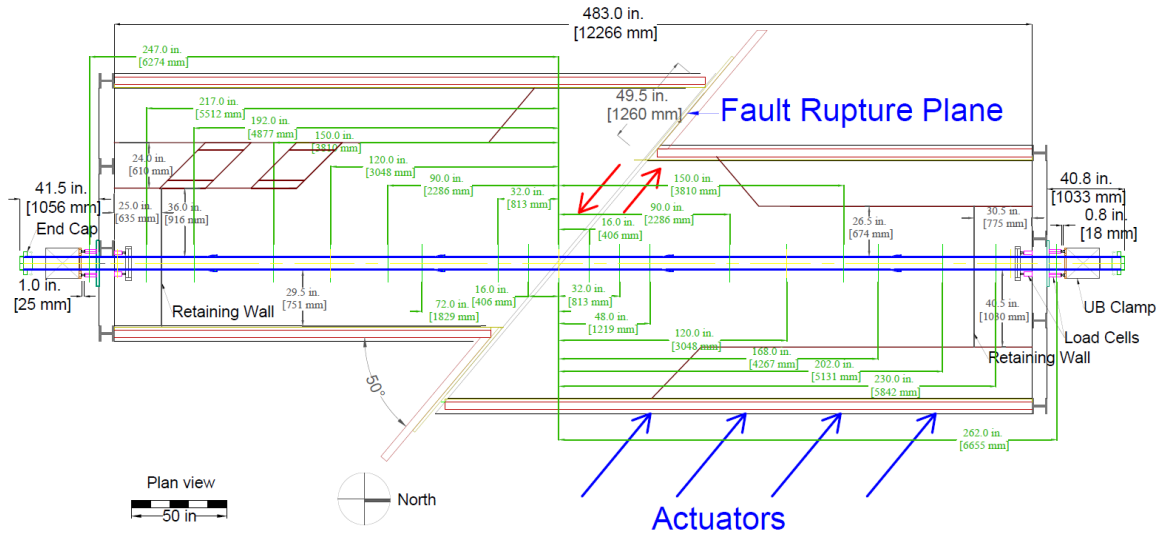
Figure 9.1. Plan View of Pipe Centered DI Pipeline with AP2 Lining in Test Basin

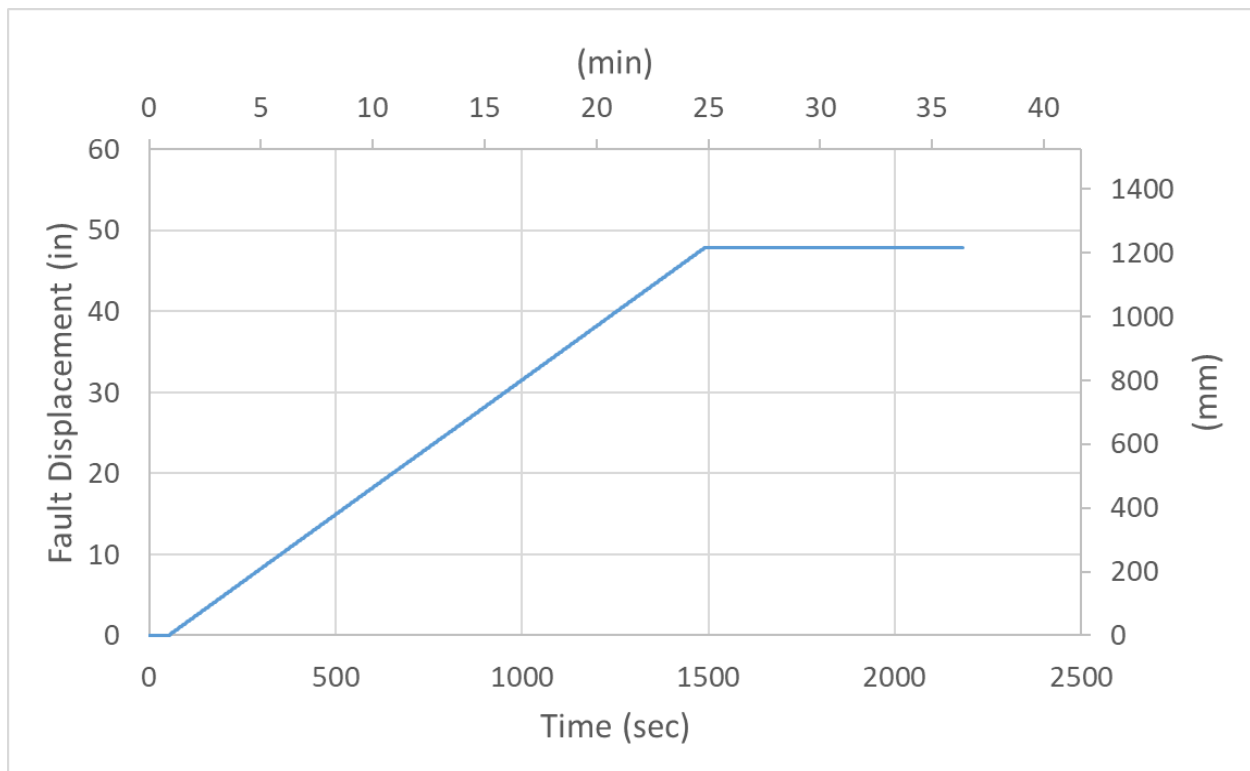
Figure 9.6. Fault Rupture Displacement versus Time

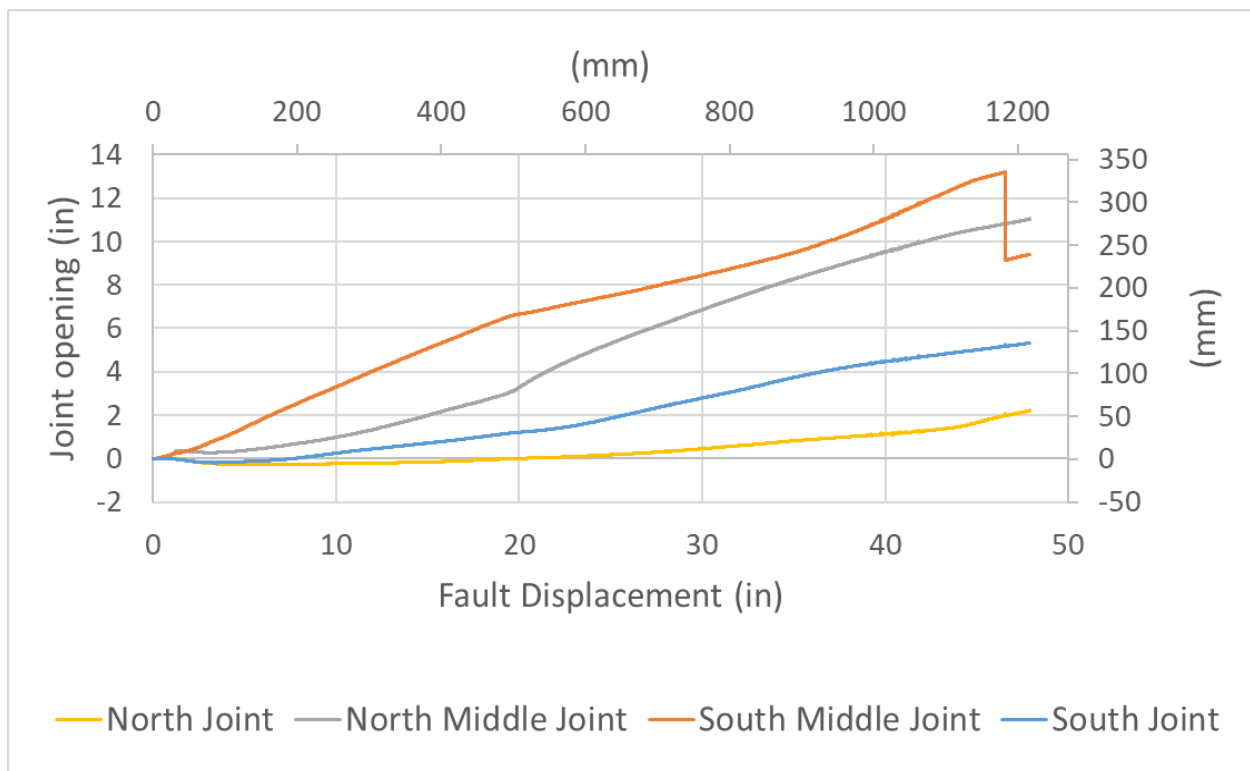
Figure 9.8. Joint Openings versus Fault Displacement

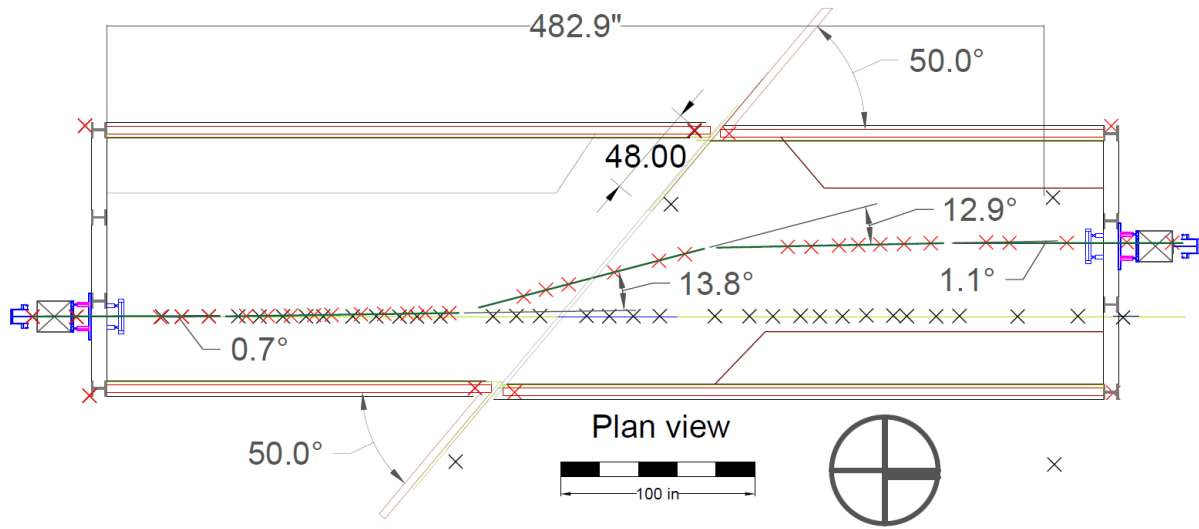
Figure 9.10. Leica Survey Showing Deformed Pipeline with AP2 Lining after Fault Rupture Test

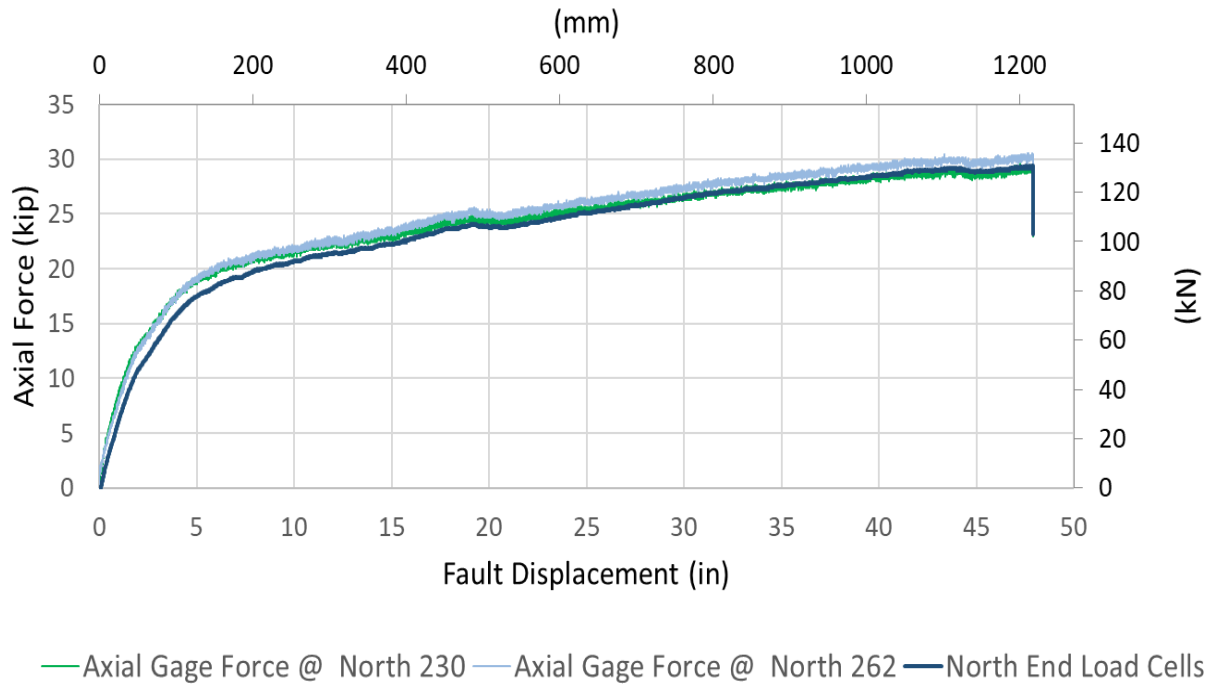
Figure 9.11. Axial Force in Both Pipe and Lining Measured by North End Load Cells and Strain Gage Planes 230 and 262.

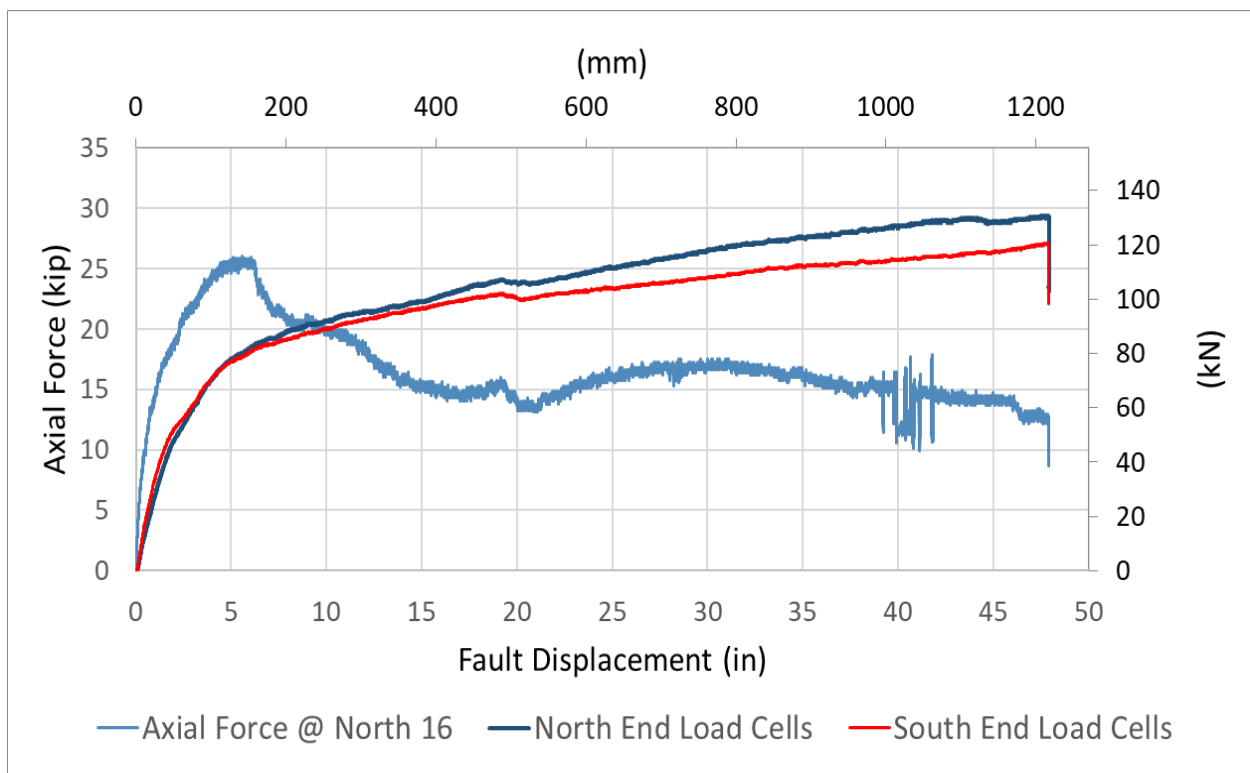
Figure 9.14. Axial Force at Station 16 Relative to the Base Case

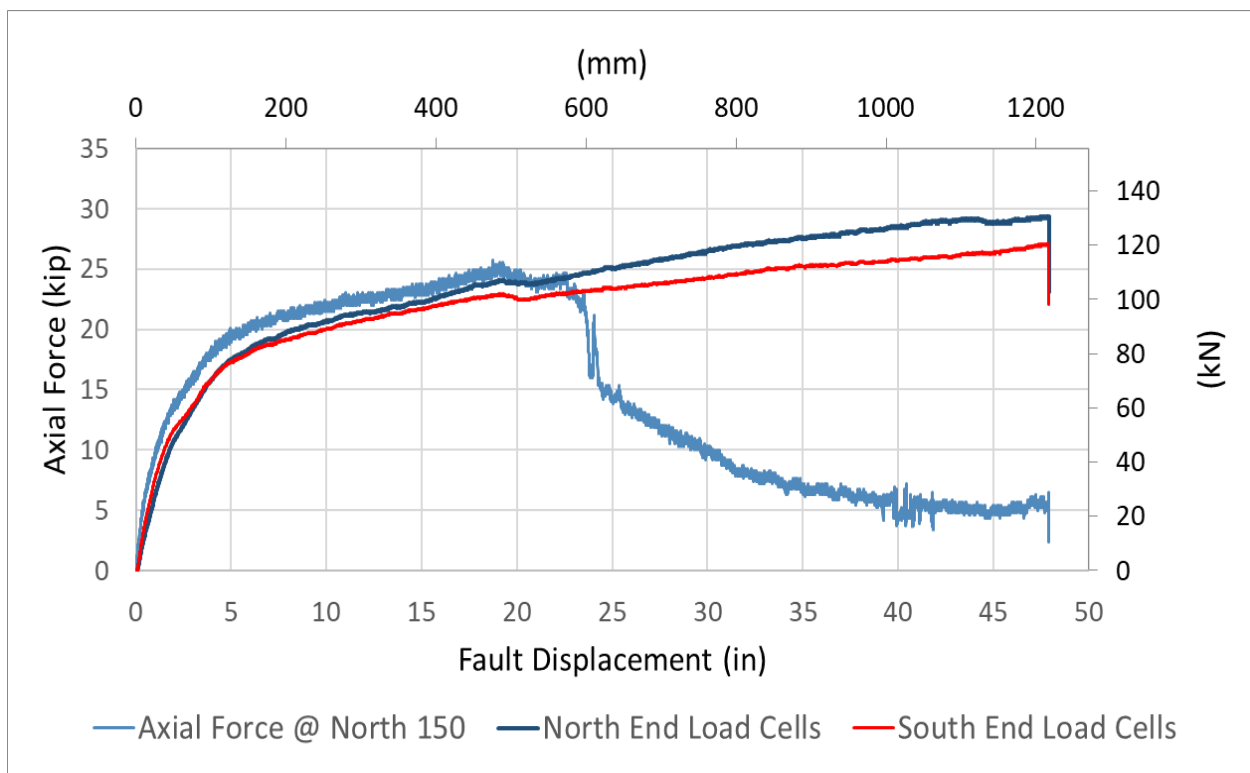
Figure 9.18. Axial Force at Station 150 Relative to the Base Case

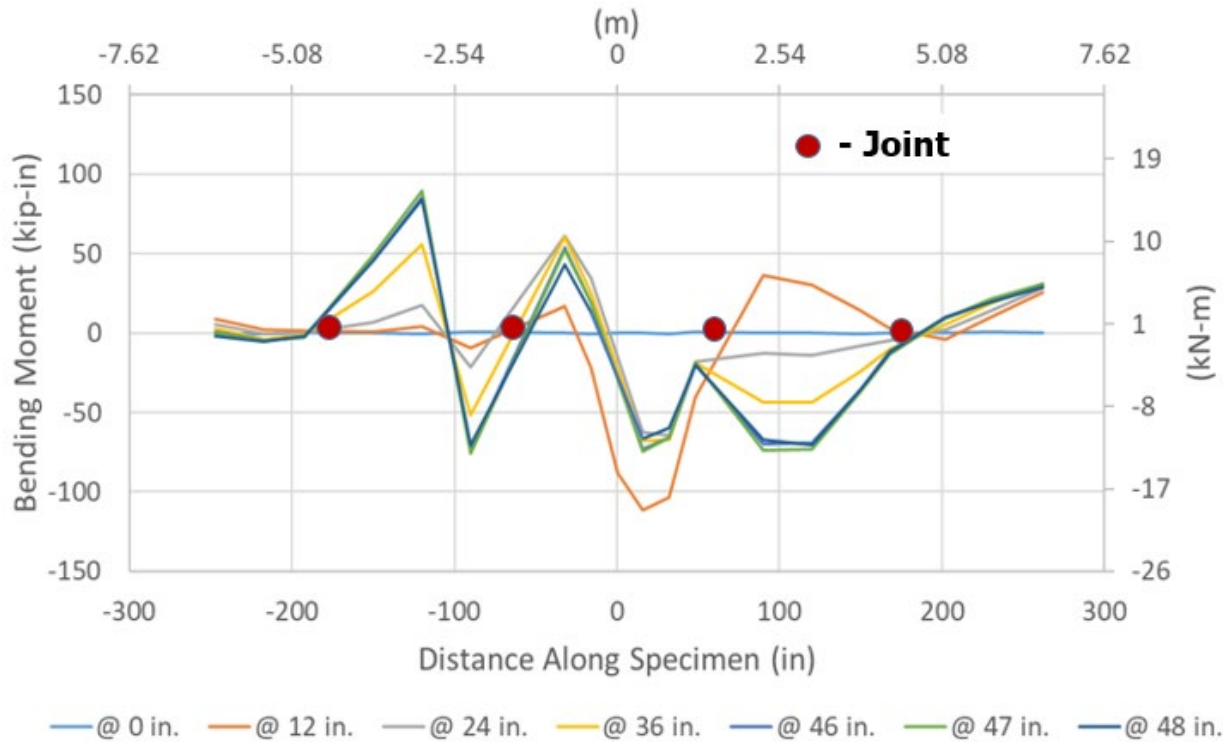
Figure 9.19. Bending Moments in Pipeline versus Distance from Fault

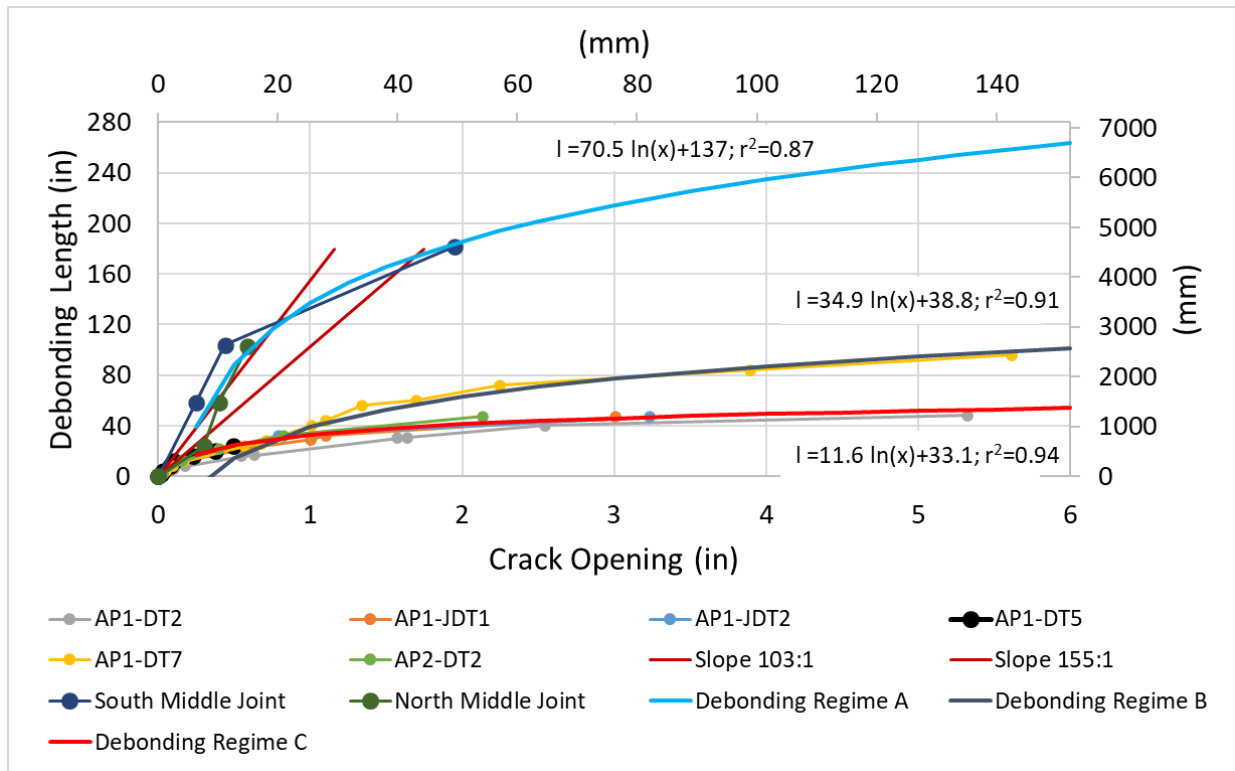
Figure 9.22. Debonded Length vs Crack/Joint Opening: Direct Tension and Fault Rupture

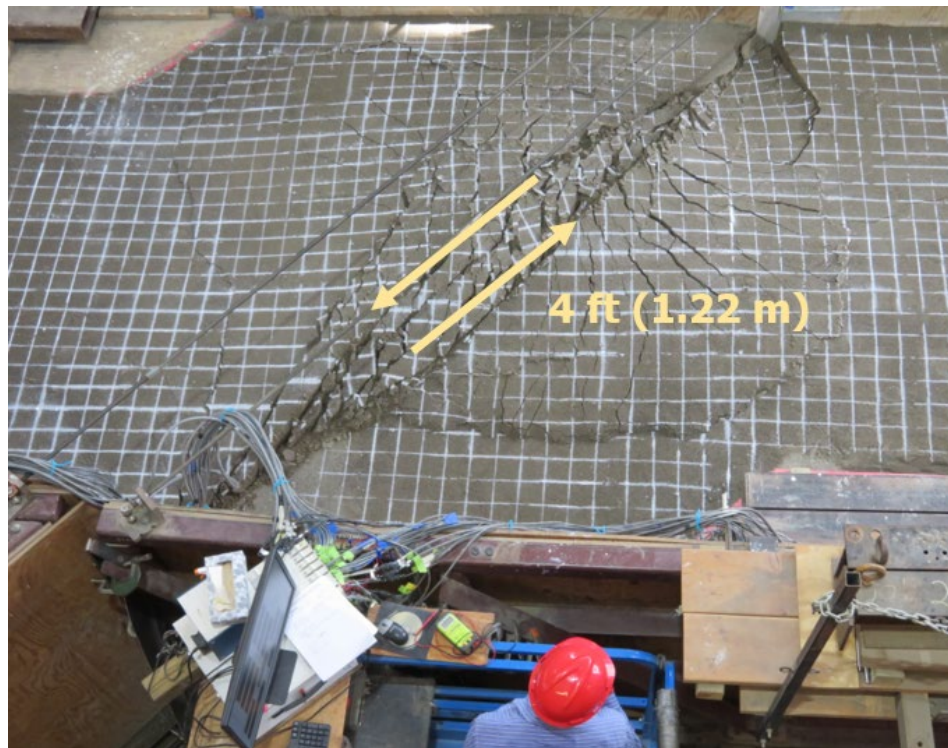
Figure 9.23. Maximum Fault Rupture

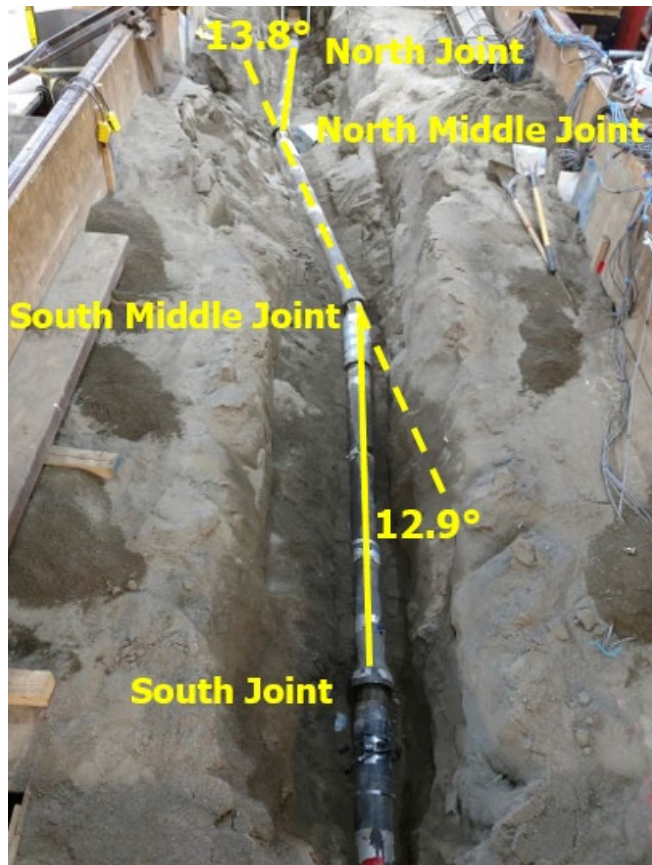
Figure 9.24. Test Pipeline Deformation after Fault Rupture Test

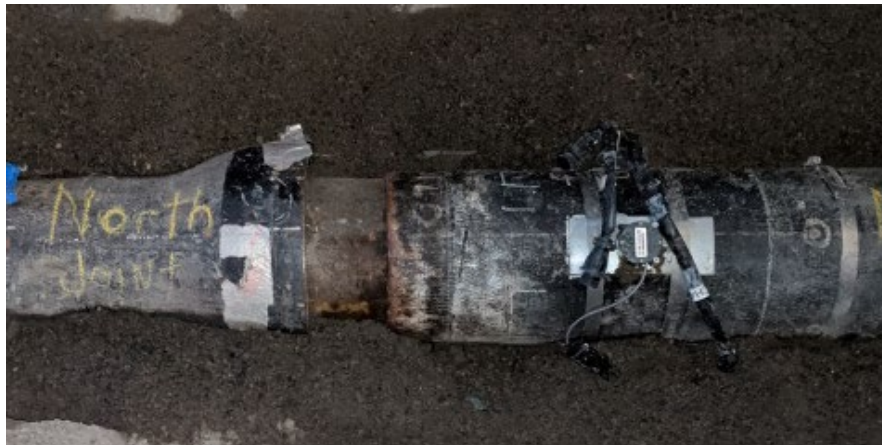
Figure 9.25. Deformation at North Joint

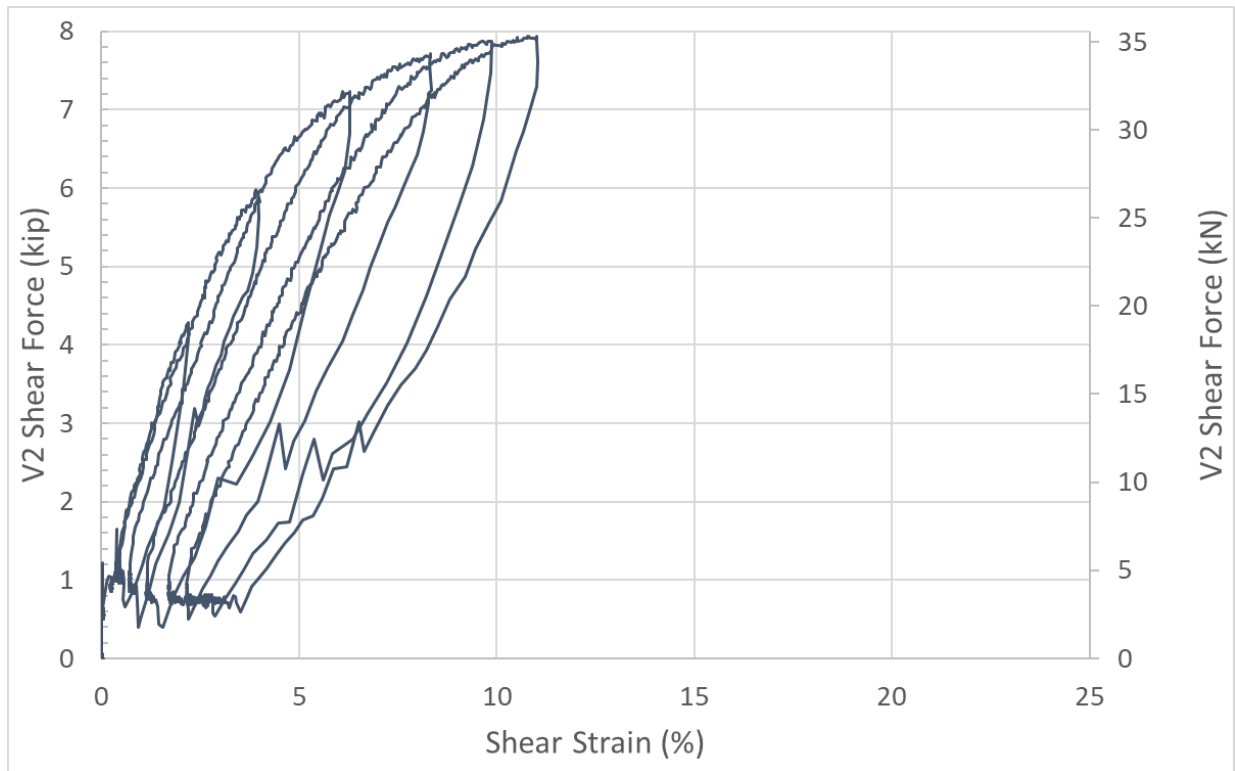
Figure 10.8. Shear Force versus Shear Strain for SE Lining Exposure, SO-1D-80

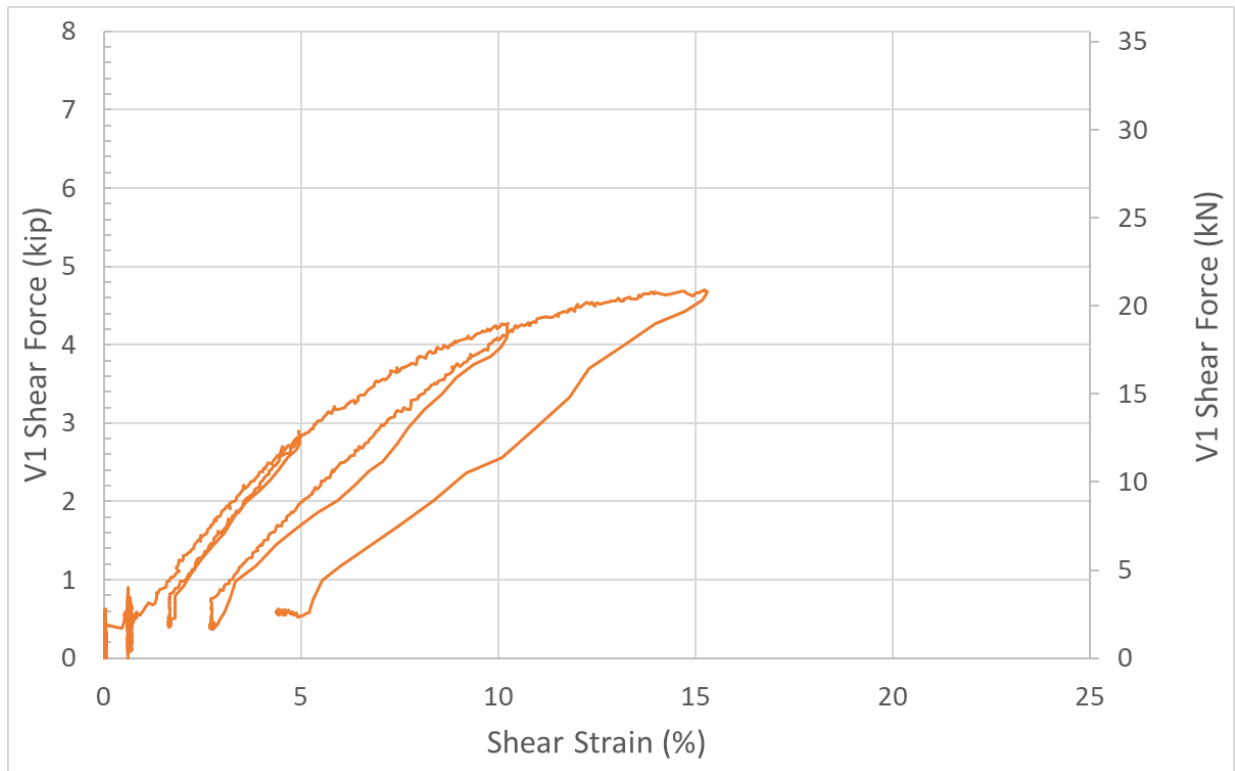
Figure 10.9. Shear Force versus Shear Strain for NW Lining Exposure, SO-2D-80

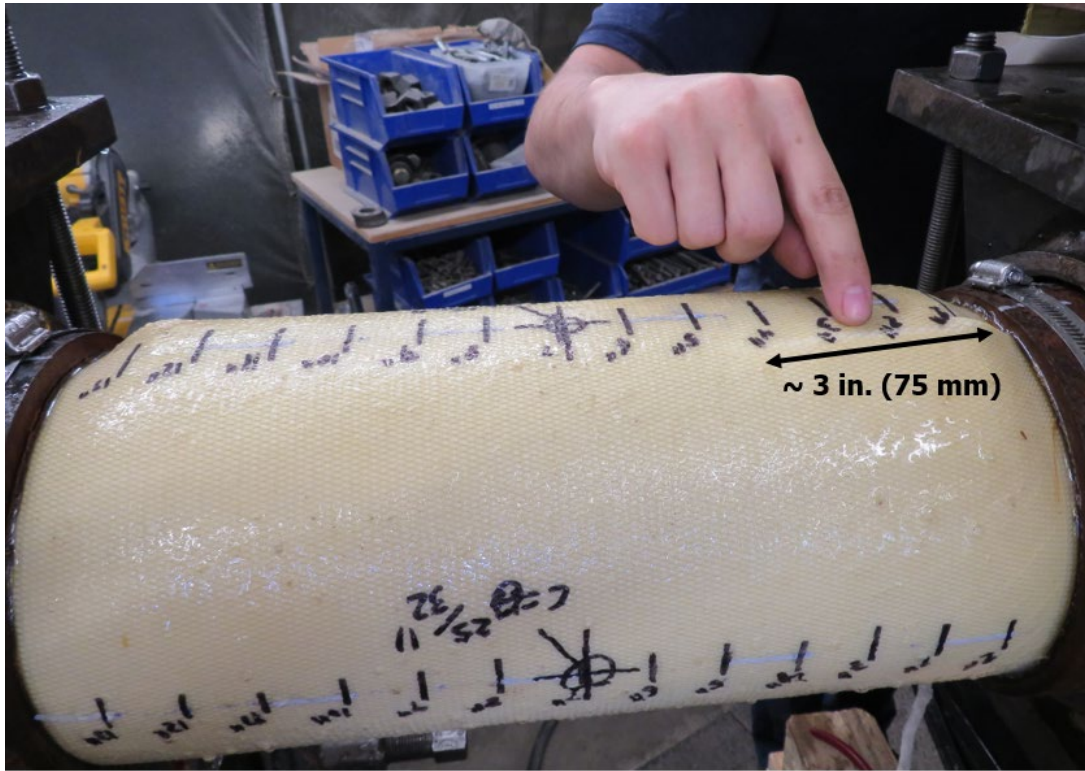
Figure 10.11. Lining Rupture at NW Lining Exposure, SO-2D-80

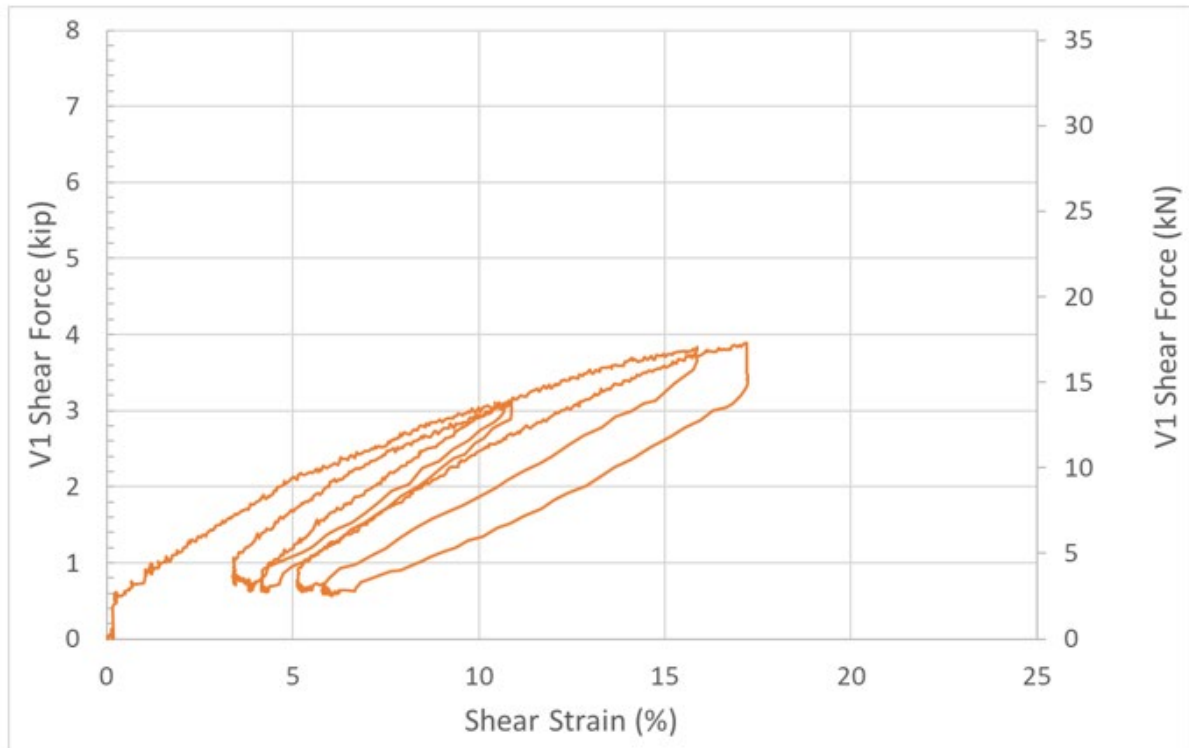
Figure 10.17. Shear Force versus Shear Strain for NW Lining Exposure, SOBB-2D-80

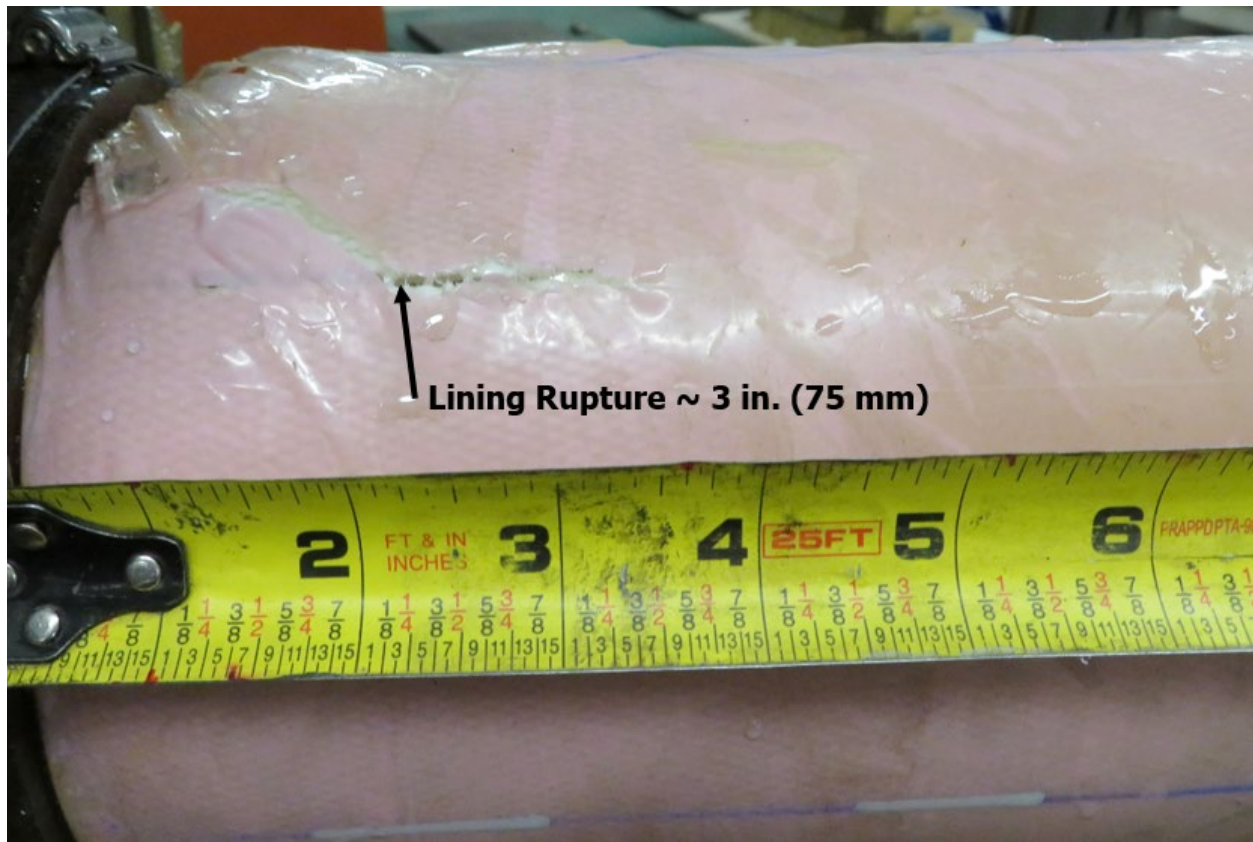
Figure 10.19. Rupture at SE Lining Exposure, SOBB-1D-80

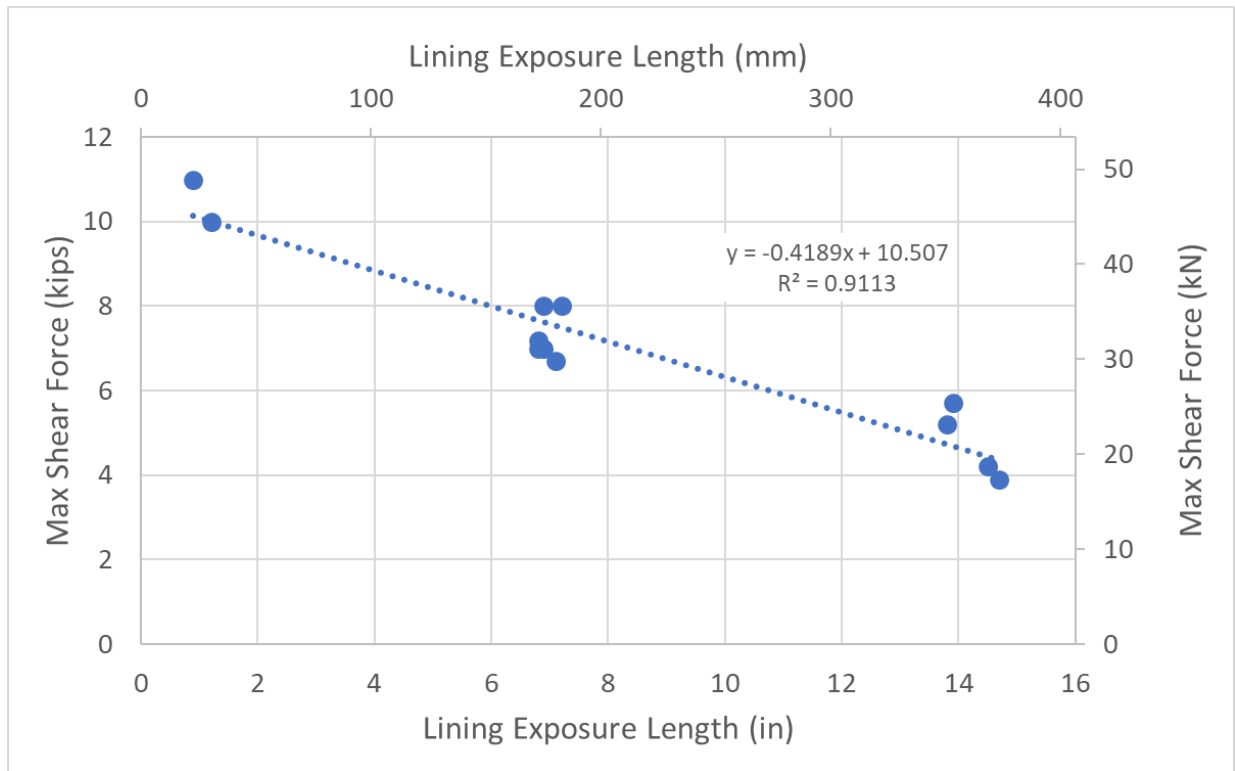
Figure 10.20. Maximum Shear Force vs Lining Exposure Length
