Performance Evaluation of Aqua-Pipe under Earthquake-Induced Ground Deformation

Final Report

Cornell University

May 2021

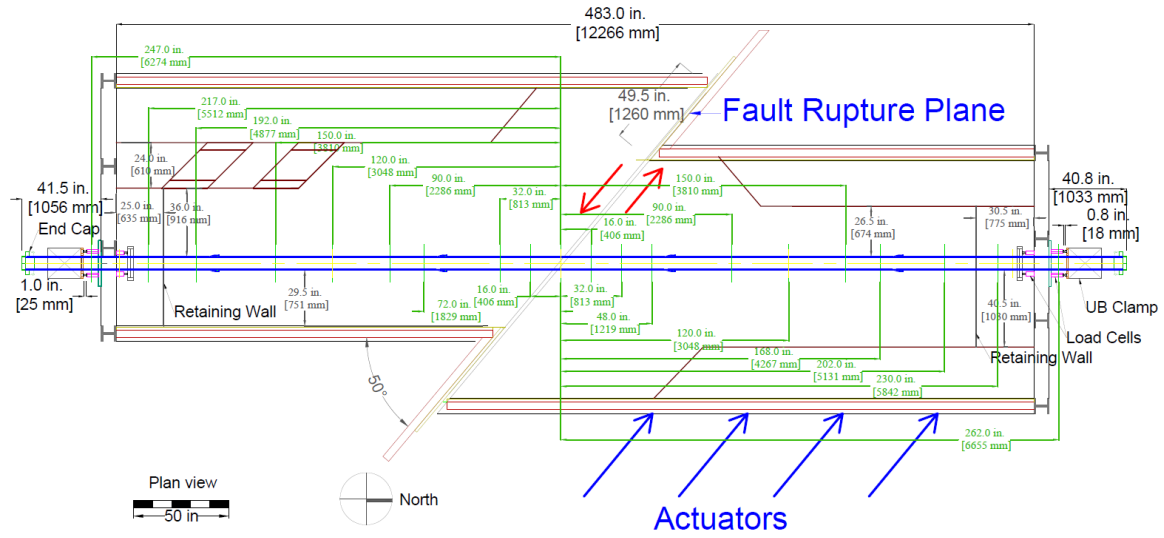
Figure C.1. Plan View of Test Pipeline with AP2 Lining and Gage Station Locations
