# Four-Point Bending Testing of 6-in. (150-mm), 12-in. (300-mm), and 16-in. (400-mm)-Diameter Kubota Earthquake Resistant Ductile Iron Pipes

Mr. Toshio Toshima  
Kubota Corporation

Cornell University  
School of Civil and Environmental Engineering  
Hollister Hall  
Ithaca, NY 14853

April, 2017

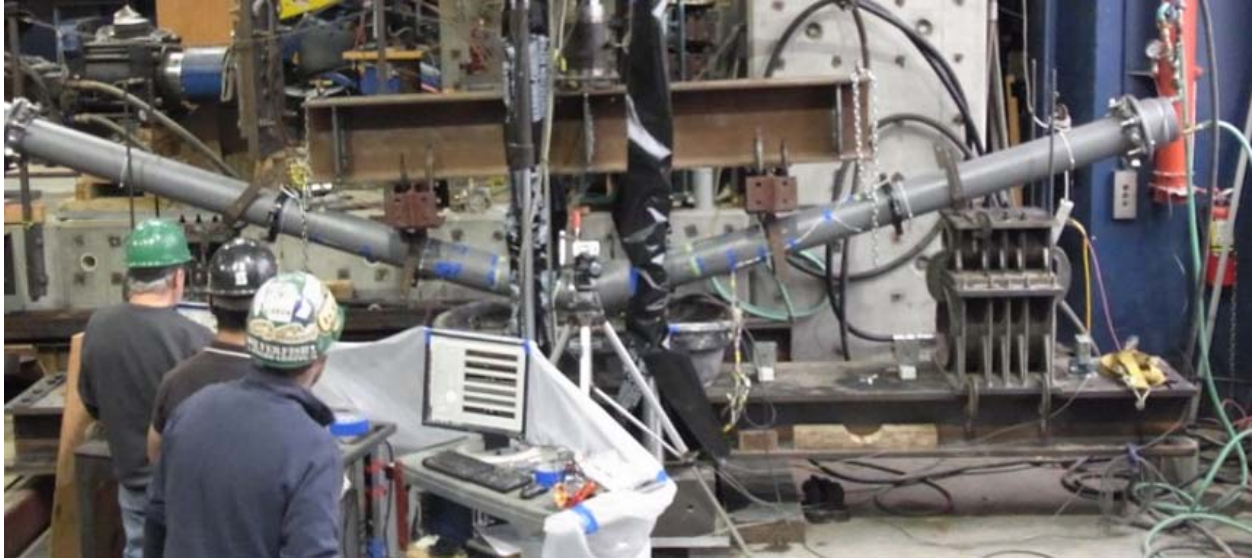
Figure 2.8. Photo of 6-in. (150-mm) ERDIP Bending Specimen T1 after Testing

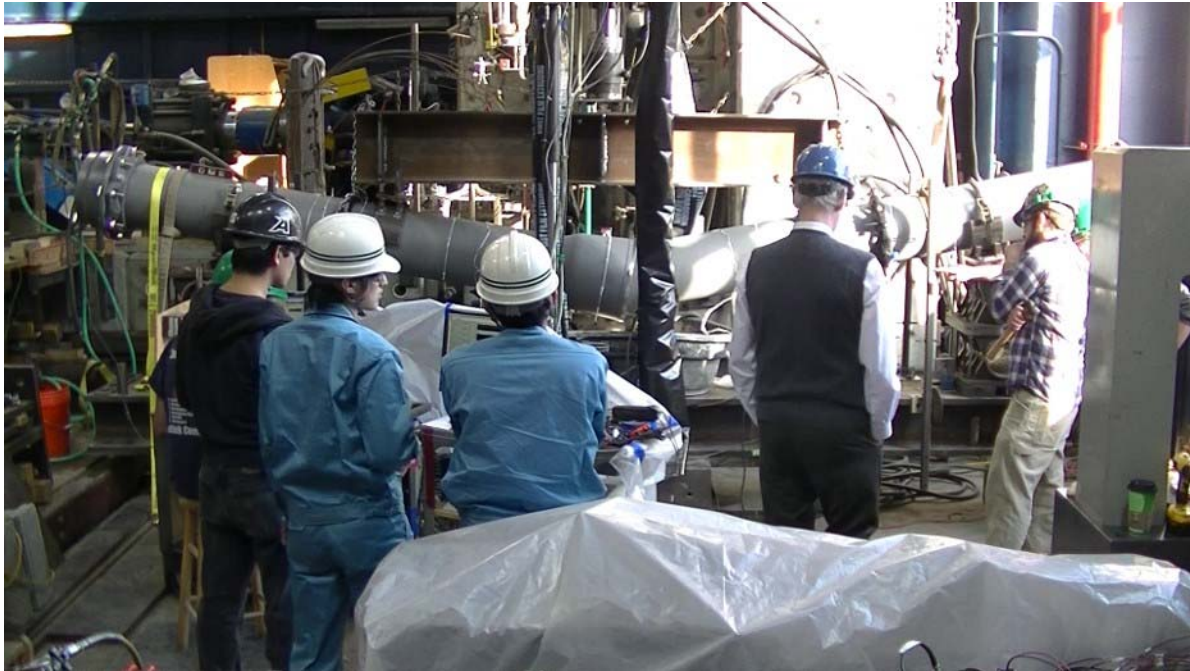
Figure 2.16. Photo of 12-in. (300-mm) ERDIP Bending Specimen T2 after Testing

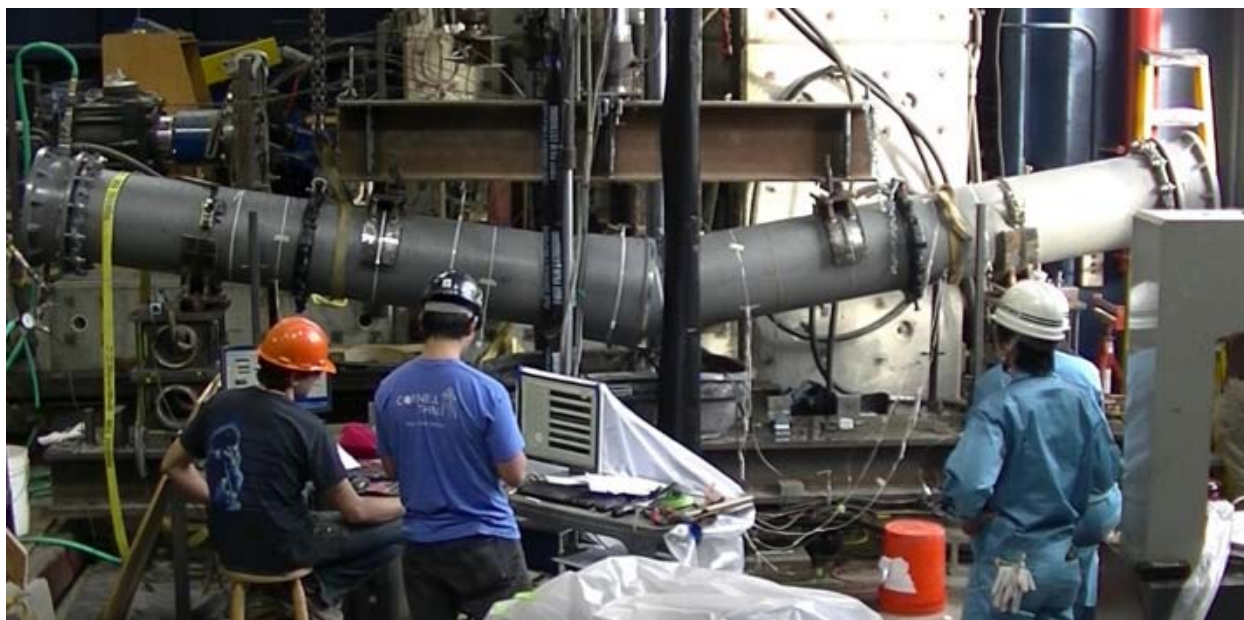
Figure 2.24. Photo of 16-in. (400-mm) ERDIP Bending Specimen T3 after Testing

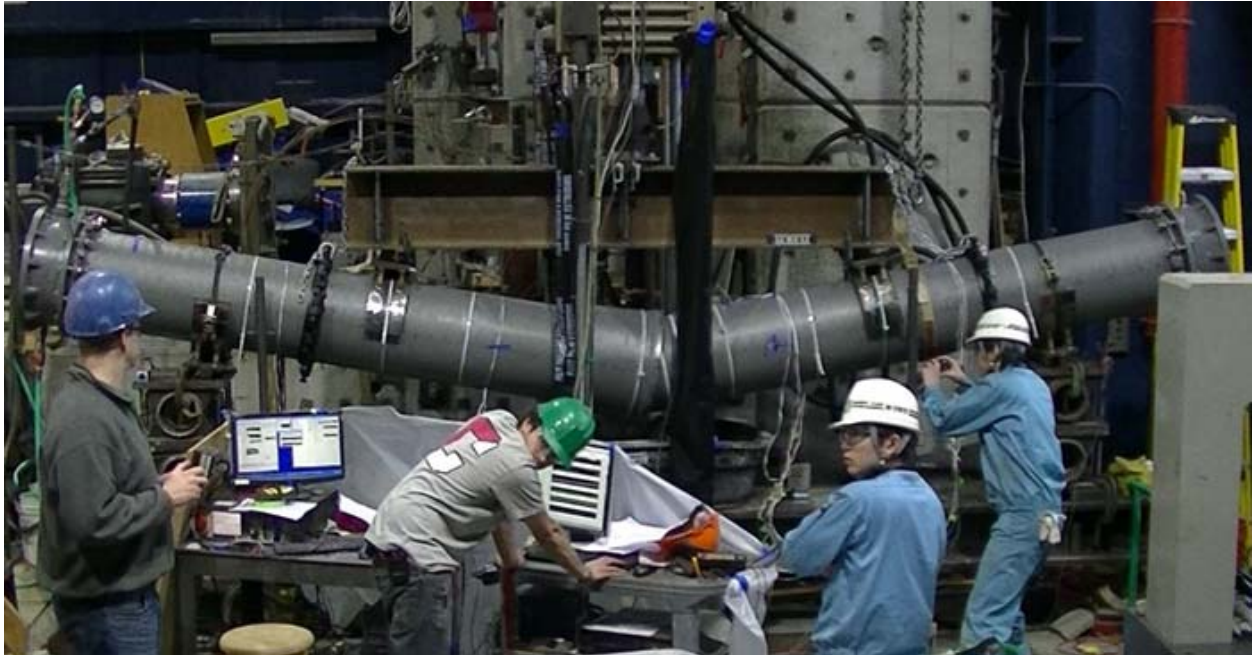
Figure 2.32. Photo of 16-in. (400-mm) ERDIP Bending Specimen T4 after Testing
