Four-Point Bending Tests of Ductile Iron Pipe with Insituform IMain Liner

Prepared by
Cornell University NEESR Group

September 7, 2011

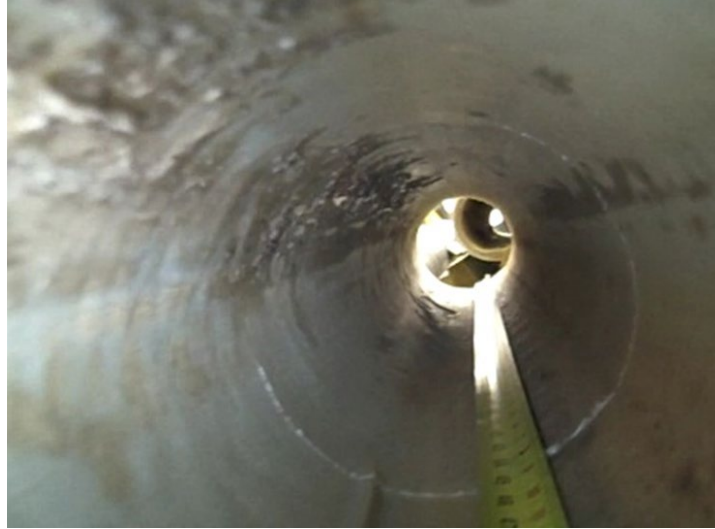
Photo 2. Image of Specimen 1 Liner after First Rotation Testing Showing a Crack at the Center

At a downward displacement of -17.3 mm (-0.68 in.) there was an audible pop and immediate reduction of applied force. This force reduction is clearly shown in Figure 3, and represents the initial cracking of the liner in tension at the bottom of the test specimen. Photo 2 illustrates the crack in the liner. The compressive force exerted by the actuator at the time of the liner break (see Table 1) was $F = 27.6 \text{ kN}$ (6.2 kips). This agrees favorably with the calculated breaking force of 27.7 kN (6.23 kips) found using the geometries and flexural strength given in Section 2.

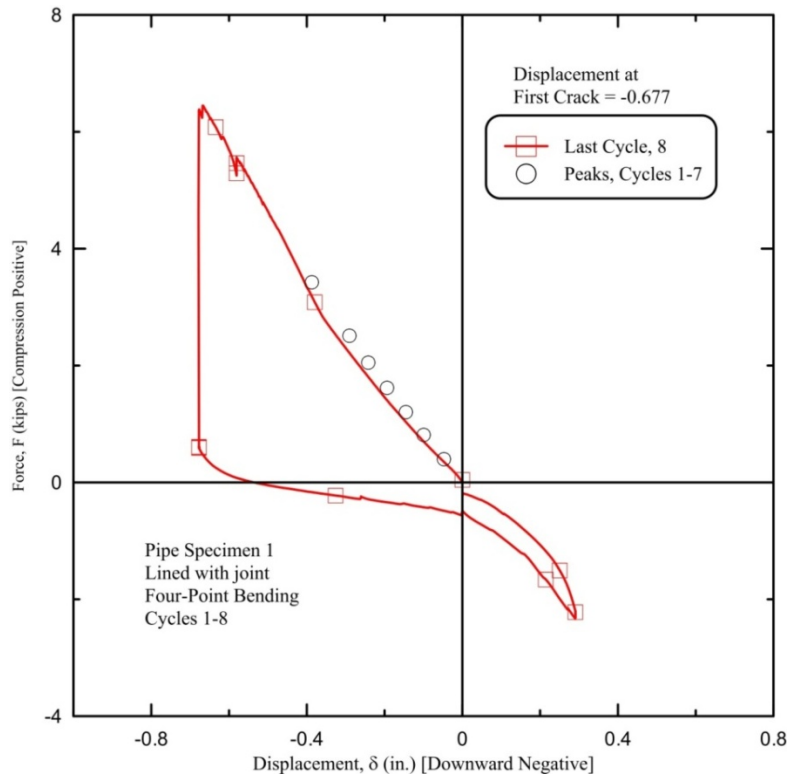
Figure 4. Peak Force vs. Displacement for Specimen 1

Figure 4 shows the peak points from the individual cycles 1 through 7, along with the complete force–displacement results for cycle 8. Cycles 1 through 7 peak data follow the trend line for cycle 8.

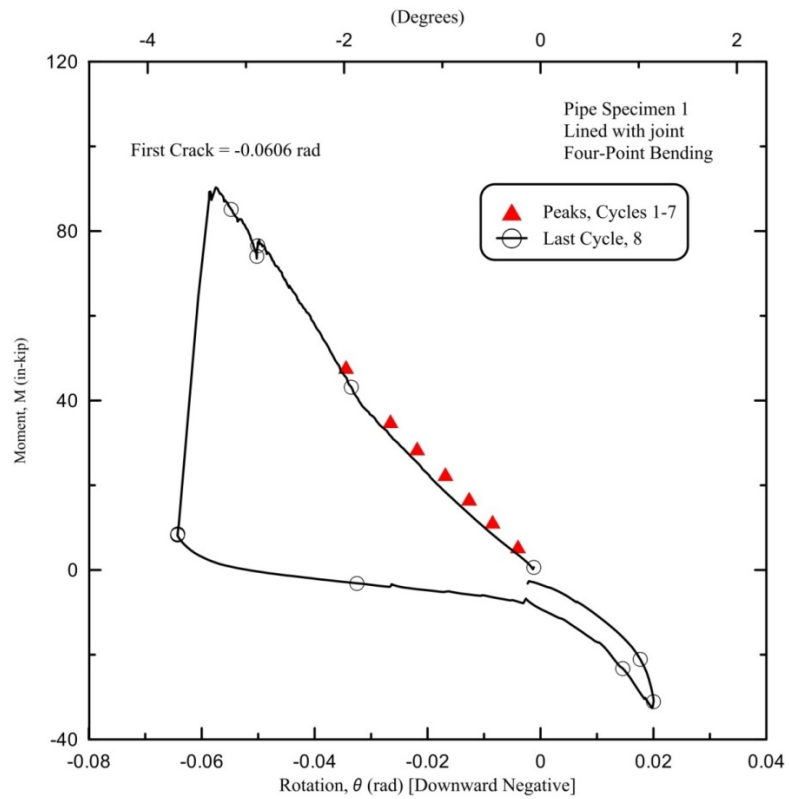
Figure 5. Moment vs. Rotation for Specimen 1

Similarly, Figure 5 shows the moment–rotation results based on the peak points from the individual cycles 1 through 7, along with the complete moment-rotation results of cycle 8 for Specimen 1. Data in Figure 5 follow the same trends as in Figure 4 since both moment and rotation are linear functions of force and displacement, respectively. Rotation data in Figure 5 are based on measurements from the DCDTs, as described in section 3 of this report.

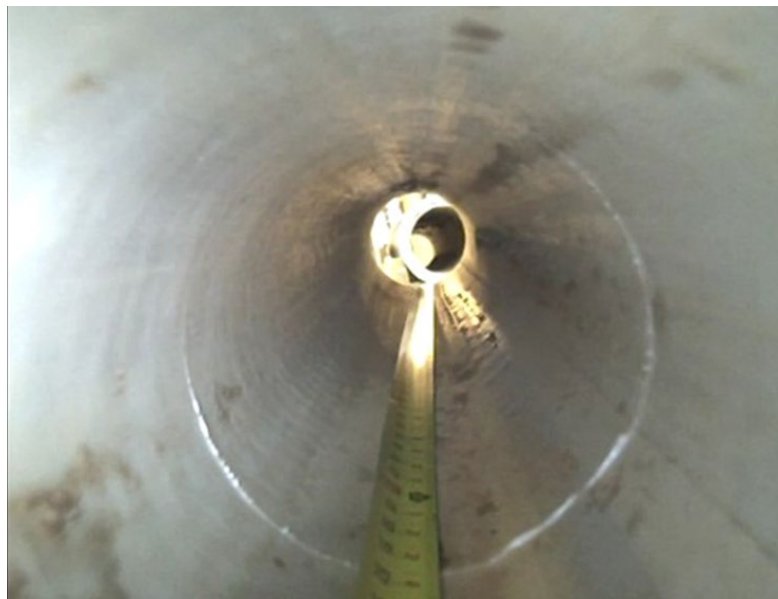
Photo 3. Image of the Specimen 2 Liner after First Rotation Testing Showing a Crack at the Center

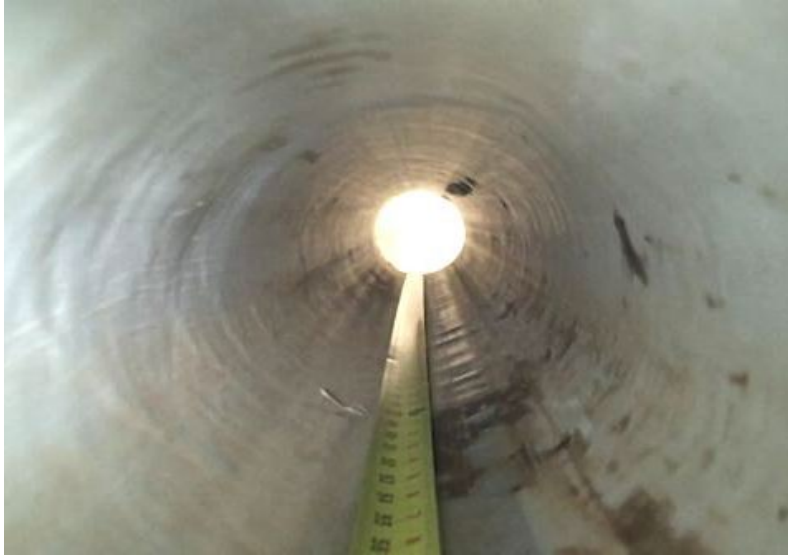
Photo 4. Image of Specimen 3 Liner after First Rotation Testing Showing No Crack

At an upward displacement of 5.21 mm (0.205 in.) the first contact took place across the gap at the bottom of the pipe. This metal to metal contact between the two segments of pipe is referred to as gap closure. Discerning the behavior of the liner beyond this point becomes more complicated because the center of rotation shifts to the location of binding. The tensile force applied at metal binding was -3.78 kN (-0.85 kips). Photo 4 shows the inner part of the liner confirming the absence of a crack. The maximum compressive force exerted by the actuator at the time contact was noticed was $F = 6.67 \text{ kN}$ (1.5 kips) (see Table 1).

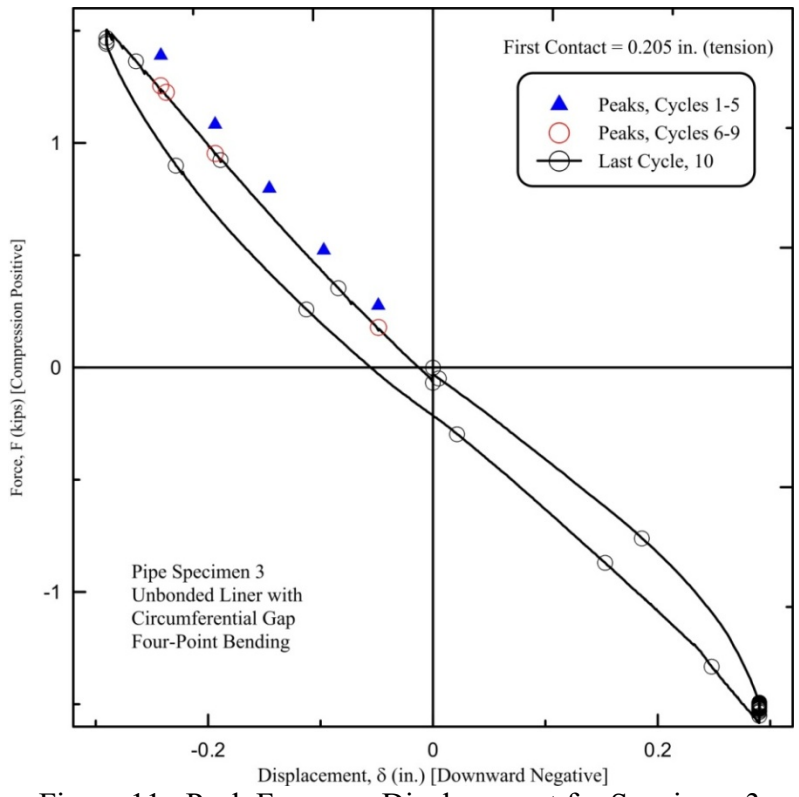
Figure 11. Peak Force vs. Displacement for Specimen 3

Figure 11 shows the peak points from the individual cycles 1 through 9, along with the complete force-displacement results for cycle 10. It is noted that before the first contact, which took place during cycle 5, the peak force required for each targeted downward displacement is slightly greater than the peak force required for the same targeted displacement after cycle 5. The peak points of cycles 6 through 9 are consistent with the complete force-displacement results from cycle 10.

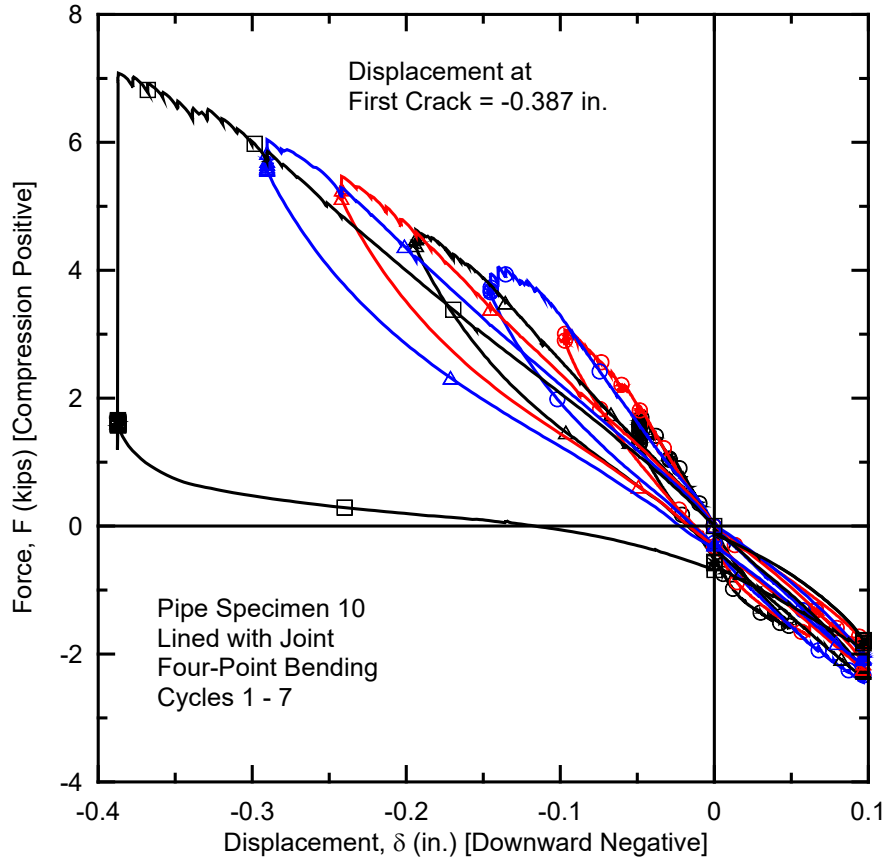
Figure 13. Force vs. Displacement for Cycles 1 – 7, Specimen 10

Specimen 10 had a bonded liner with the joint at the center of the test specimen. The planned test regime for Specimen 10 is given in Table 5. Figure 13 shows the force-displacement results for the first seven cycles of Specimen 10.

At a downward displacement of -9.91 mm (-0.39 in.) there was an audible pop with an immediate reduction of the applied force. This force reduction is clearly shown in Figure 13, and represents an initial cracking of the liner in tension at the bottom of the test specimen. Photo 5 shows the crack in the liner. The compressive force exerted by the actuator at the time of the liner break (see Table 1) was $F = 28.9 \text{ kN}$ (6.5 kips). This agrees favorably with the calculated breaking force presented in Section 2.

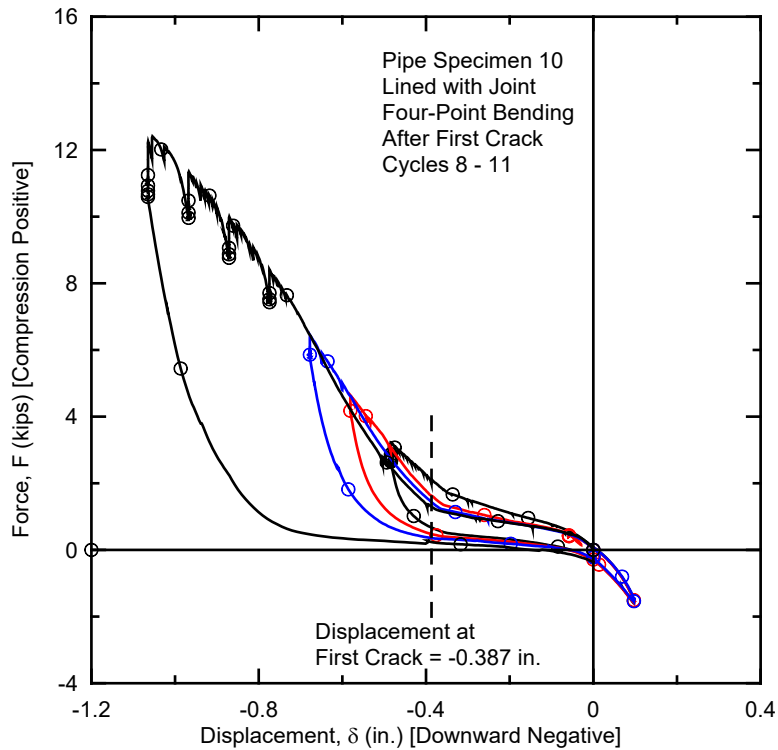
Figure 14. Force vs. Displacement for Cycles 8 - 11, Specimen 10

Figure 14 shows the incremental force–displacement data for cycles 8 through 11 for test Specimen 10. The curves have distinctly steeper slopes after the first crack at a displacements of -9.91 mm (-0.39 in.).

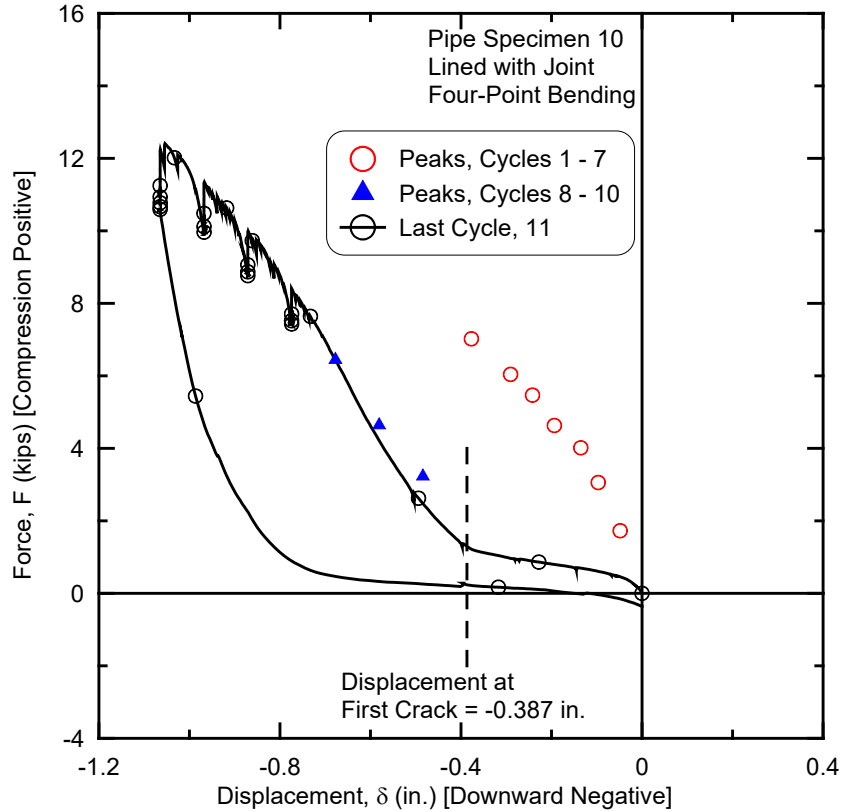
Figure 15. Peak Force vs. Displacement for Specimen 10

Figure 15 shows the peak points from the individual cycles 1 through 10, along with the complete force–displacement results for cycle 11. Cycles 1 through 7 peak data show a clear trend of a “backbone” force–displacement curve. Following the first cracking at $\delta = -9.91$ mm (-0.39 in.), the peak points of cycles 8 through 10 are consistent with the complete force–displacement results from cycle 11.

Figure 16 shows the moment–rotation results based on the peak points in the load cycles for Specimen 10. These data follow the same trends as in Figure 15 since both moment and rotation are linear functions of force and displacement, respectively. The rotations in Figure 16 are based on clinometer data.

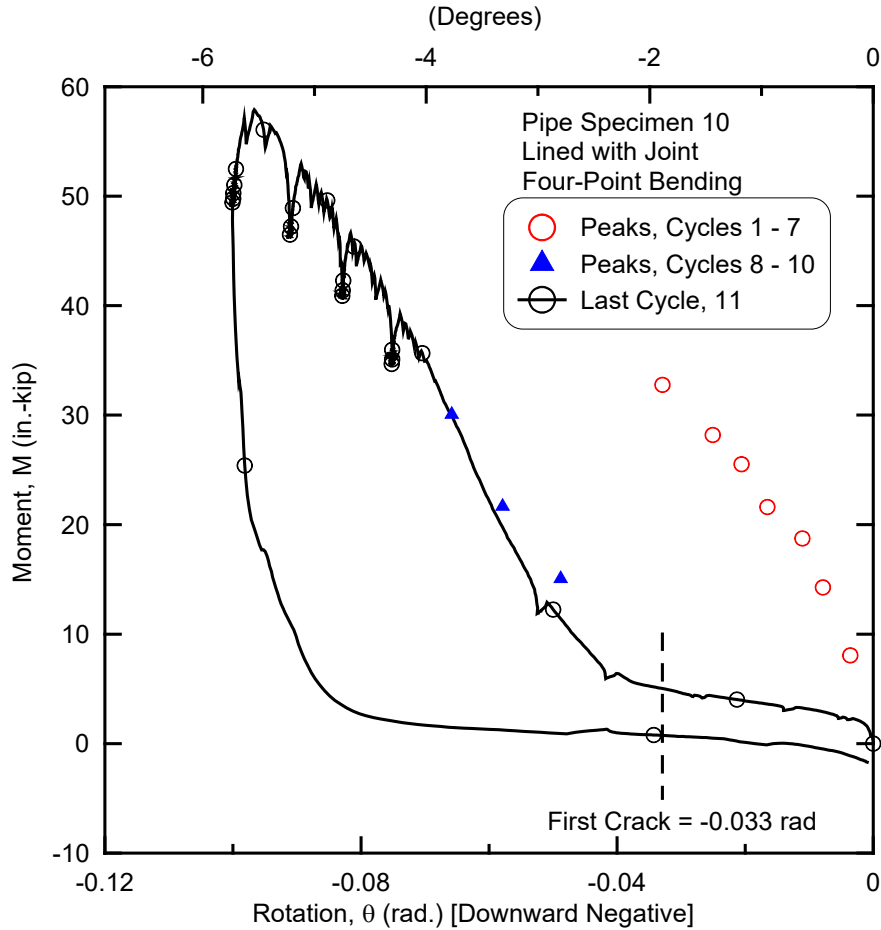
Figure 16. Moment vs. Rotation for Specimen 10

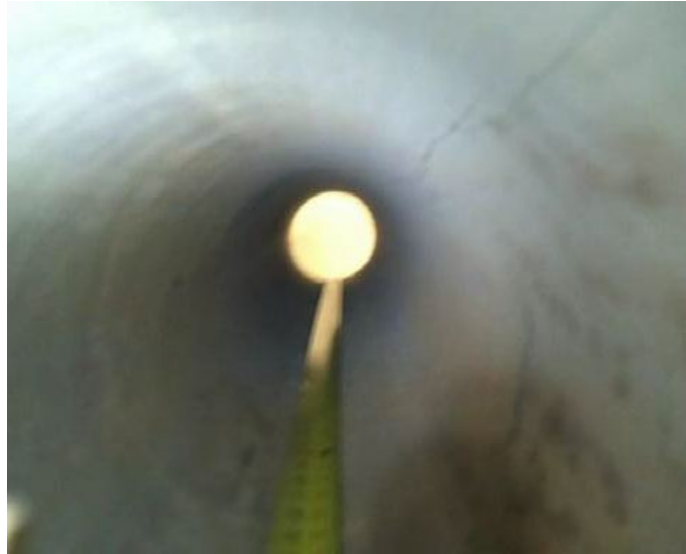
Photo 6. Image of the Specimen 12 Liner after First Rotation Testing

At a downward displacement of -11.94 mm (-0.47 in.) an abrupt reduction of the applied force is observed (Figure 17). The compressive force exerted by the actuator at the time of contact (see Table 1) was $F = 16.0 \text{ kN}$ (3.6 kips). Photo 6 verifies that this reduction in force does not represent complete cracking of the liner because no visual indication of failure is observed inside the pipe. It is not certain whether an unseen portion of the liner failed or that the bond between DI and mortar or mortar and IMain liner ruptured causing slip along their respective interface. Also note, when Specimen 12 was lined by InsituForm it was the last specimen at the end of the bonded sections.

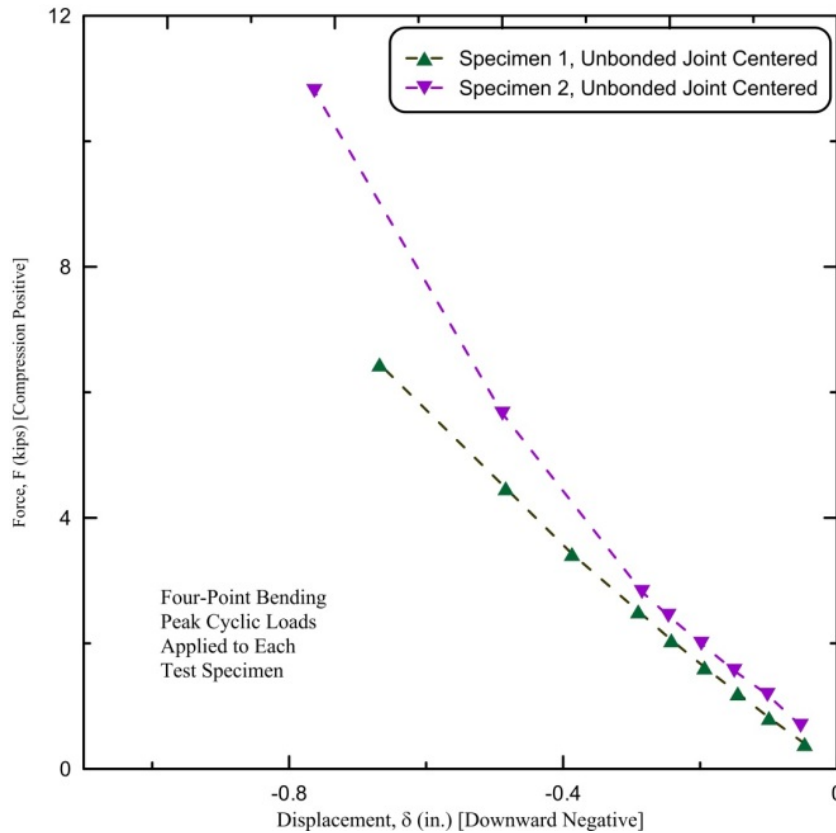
Figure 20. Force-displacement based on peak points for Specimens 1 and 2.

Figure 20 illustrates force-displacement based on peak points in the load cycles for Specimens 1 and 2. To calculate the initial bending stiffness, EI, of the two specimens, Equation 2 is utilized. Applied force and the resulting displacement of the first cycle were used to calculate this parameter. As shown in Table 7, Specimen 1 has an initial bending stiffness $EI = 88,800$ kips-in², whereas Specimen 2 has $EI = 136,000$ kips-in². Despite being identical specimen types and cracking at comparable downward displacements, the applied force at cracking for these specimens varies significantly. This difference in the failure force may be attributed to several factors including inconsistencies in the quality of unbonding between the liner and mortar. If some liner to mortar bonding was generated in Specimen 2 it would account for the difference in bending stiffness and flexural strength between the specimens.

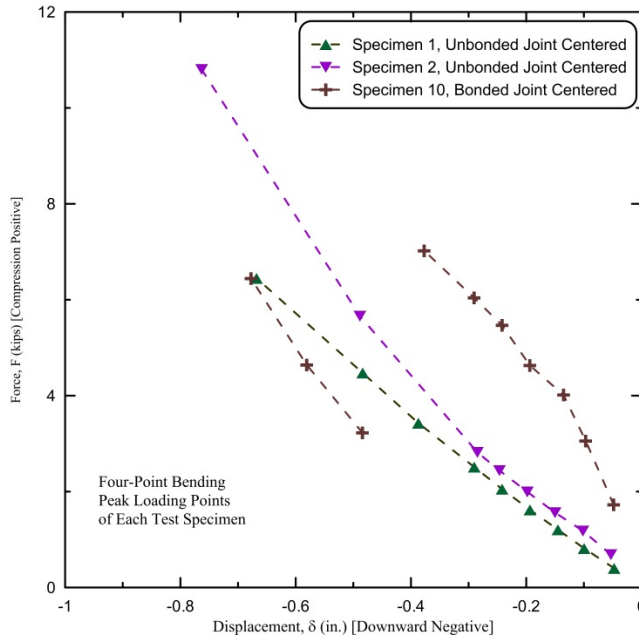
Figure 21. Force-displacement based on peak points for Specimens 1, 2 and 10

Figure 21 illustrates force-displacement results based on peak points of load cycles for Specimens 1, 2 and 10. Specimen 10, which is bonded, has a greater initial bending stiffness than the unbonded specimens. The liner cracks at approximately half the displacement of liners in Specimens 1 and 2. The applied force when the liner cracks is 28.9 kN (6.5 kips), which corresponds well with the force required to crack the liner of Specimen 1 and the value provided by InsituForm.
