Endurance of Medium Voltage Joints under Laboratory Wet Aging Environments

NEETRAC

Thomas Parker, JC Hernandez-Mejia, and Caryn Riley
GT-NEETRAC

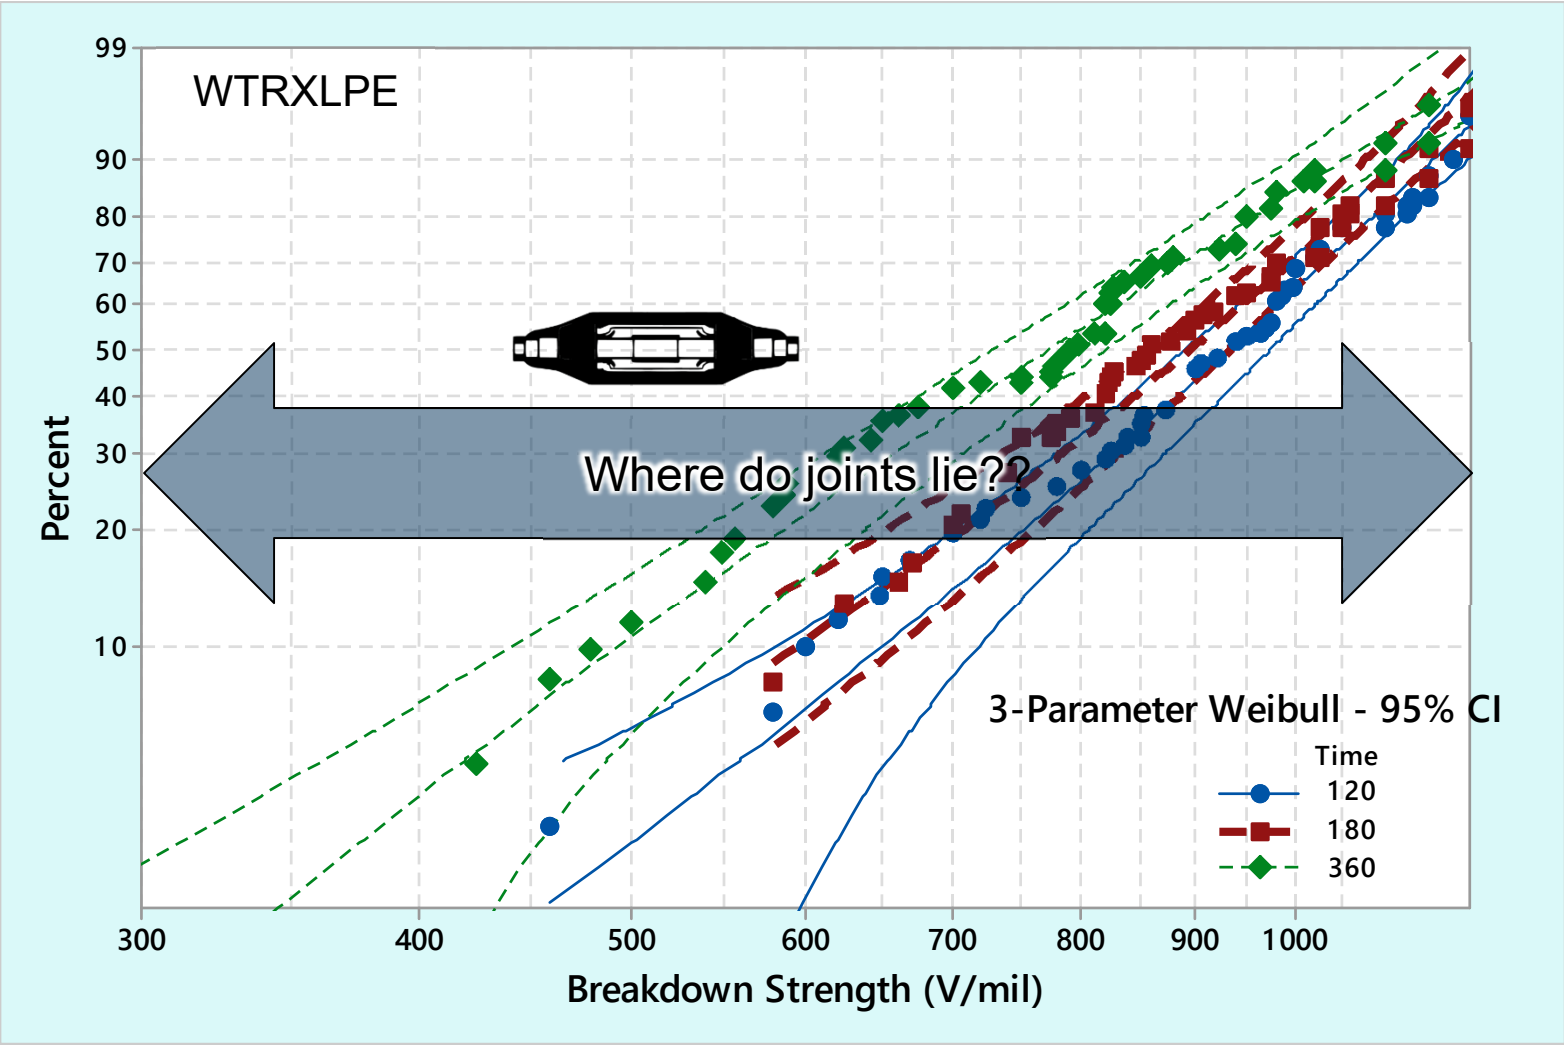
Compiled AWTT Cable Data (2000 - 2016)

Research work has been conducted on the endurance of MV EPR & TRXLPE cable cores using:

- Accelerated Water Tree Test (**AWTT**) – **time limited** test with results based on Break Down Strength (BDS)
- Accelerated Cable Life Test (**ACLT**) – **open-ended** test time with results based upon Failure On Test (FOT)

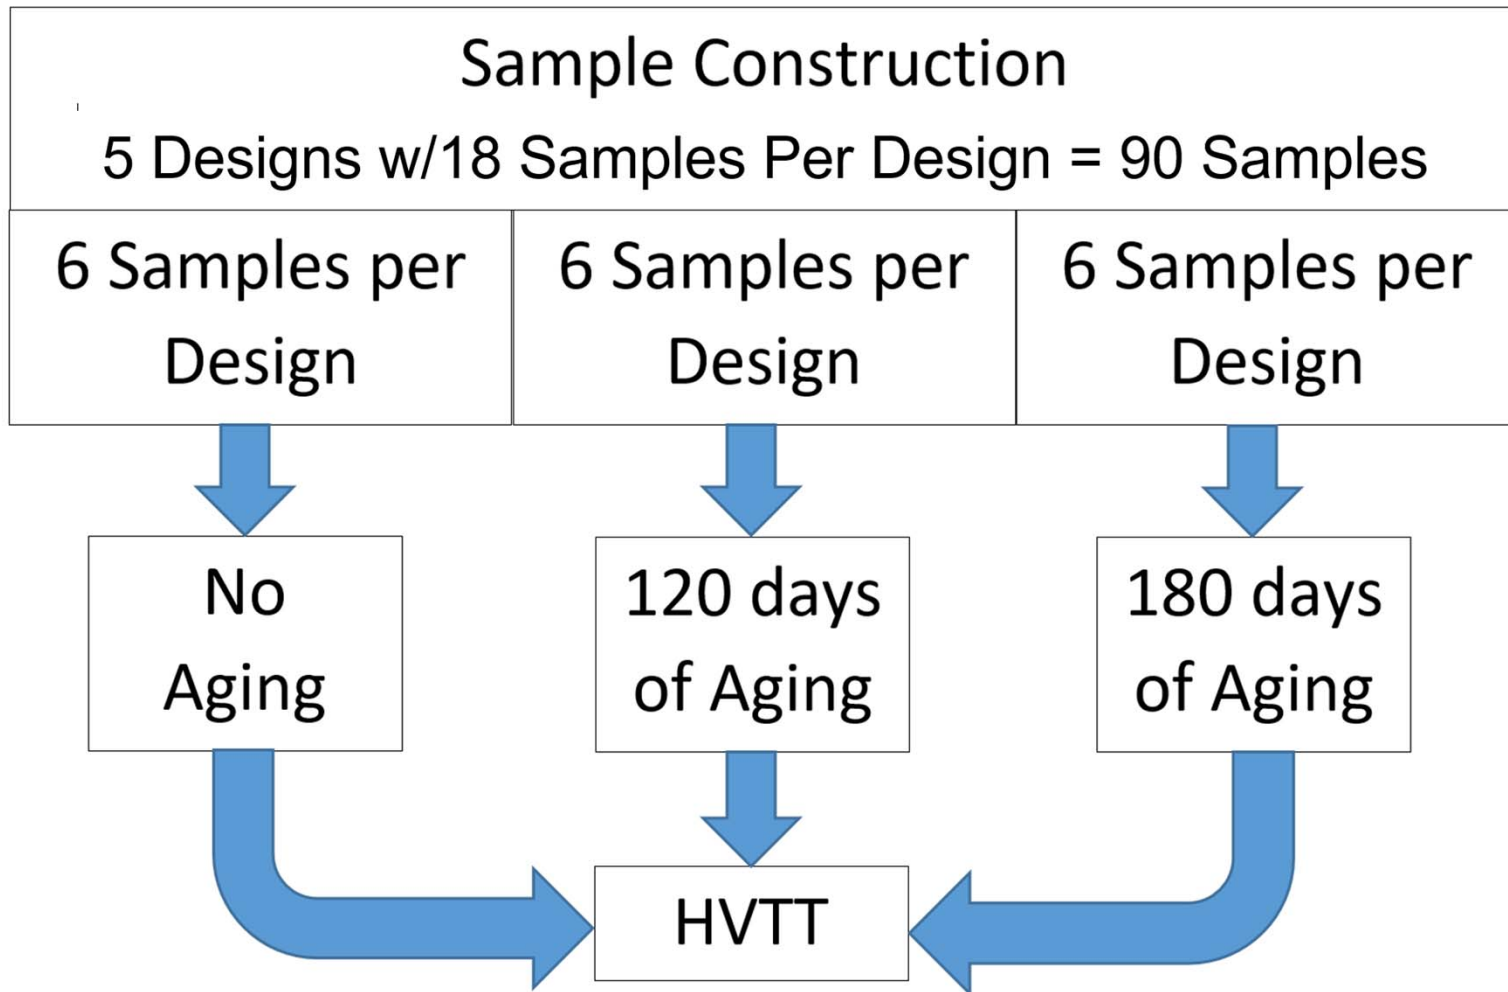
Test Program

- There is not any endurance data available for joints in the same manner as the cable
- Short term survival data is limited – i.e. 3 samples 30 days at $3U_0$ in IEEE 404
- Need to understand the relative endurances (cable and accessories)
