SEDIMENTATION STUDY OF SUMMIT NORTH MARINA

Research Report No. CE-86-53

Ocean Engineering Program
Department of Civil Engineering
University of Delaware
Newark, Delaware 19716
January, 1986

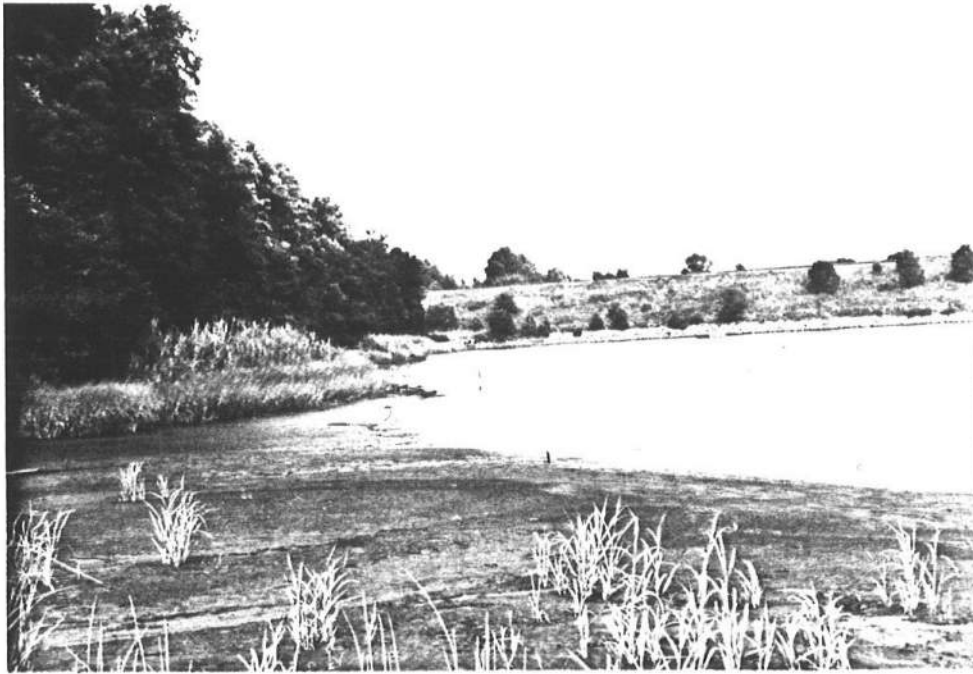
Photo 1. From Station A toward the Pipe at the Eastern End of Marina Area. Note the growth of green alga on the beach indicating little wave action on the beach inside the shoal located at the entrance of the marina site.

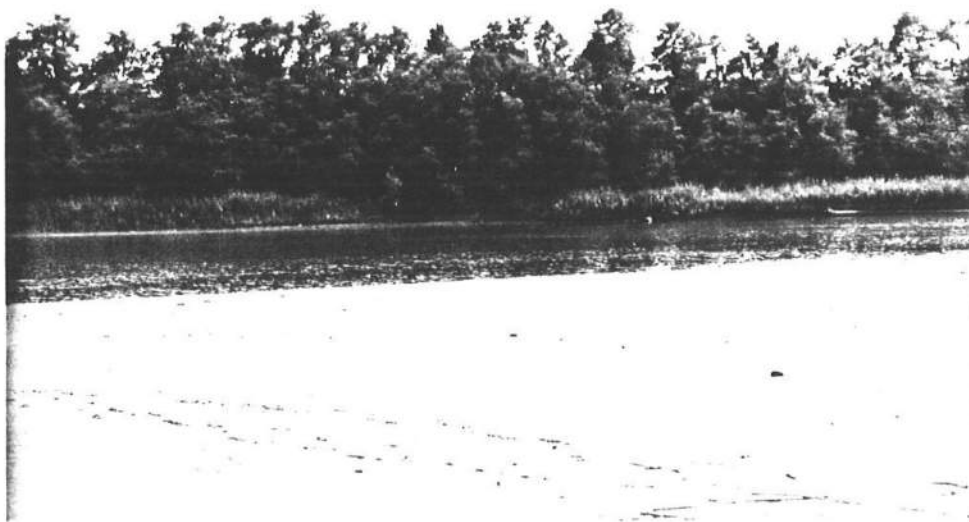
Photo 2. From Station A toward Station B. Note that the area covered with water approximately corresponds to the area dredged to connect the marina site to C & D Canal.

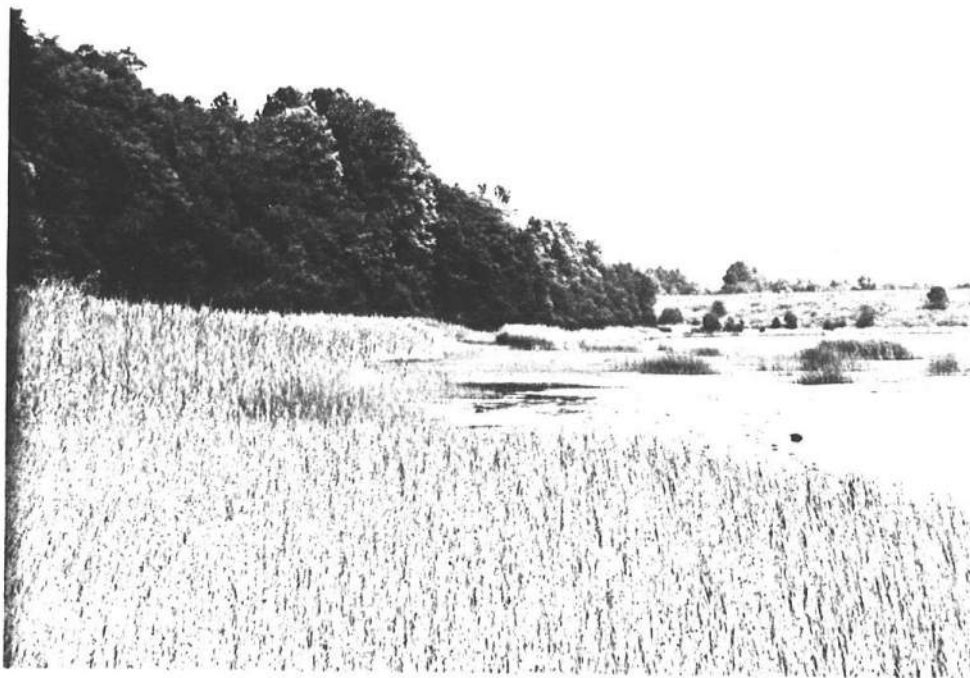
Photo 3. From Station C toward Station A. Note that the area covered with grass tends to promote the sediment deposition and be located at a higher elevation than the area without grass.

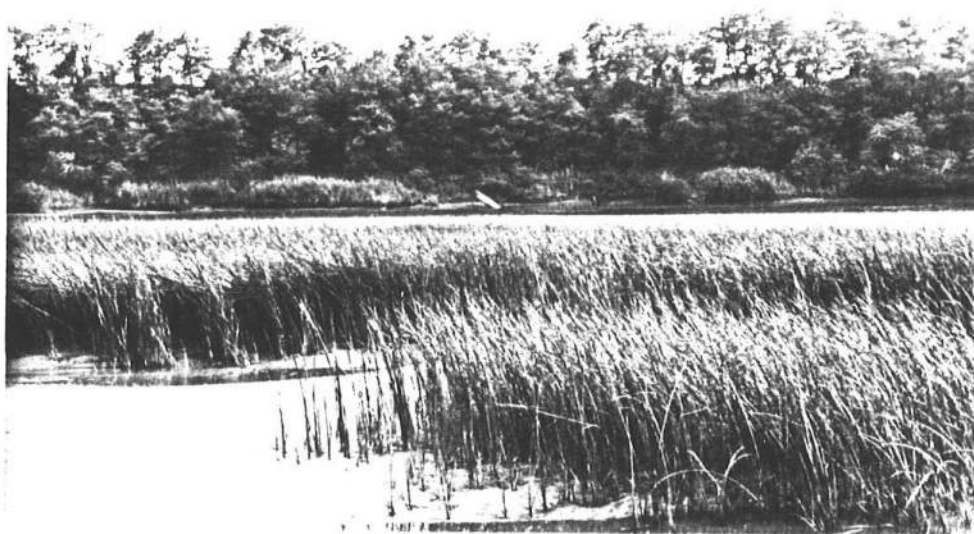
Photo 4. From Station C toward Station D. Note that the grass promotes sediment deposition but creates a drainage channel between the two areas covered with the grass.

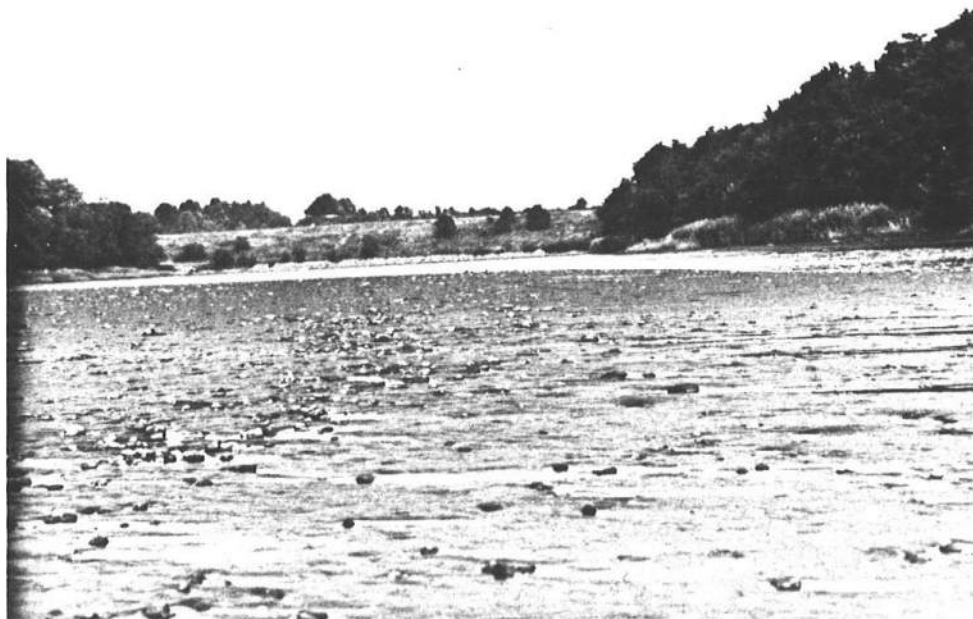
Photo 5. Cobbles near Station D on the Shoal. Note that these cobbles are likely to be originated from the eroding bluff surrounding the marina area. The cobbles may be transported by the action of ship-generated large waves. The role of ice in transporting the cobbles is not investigated.

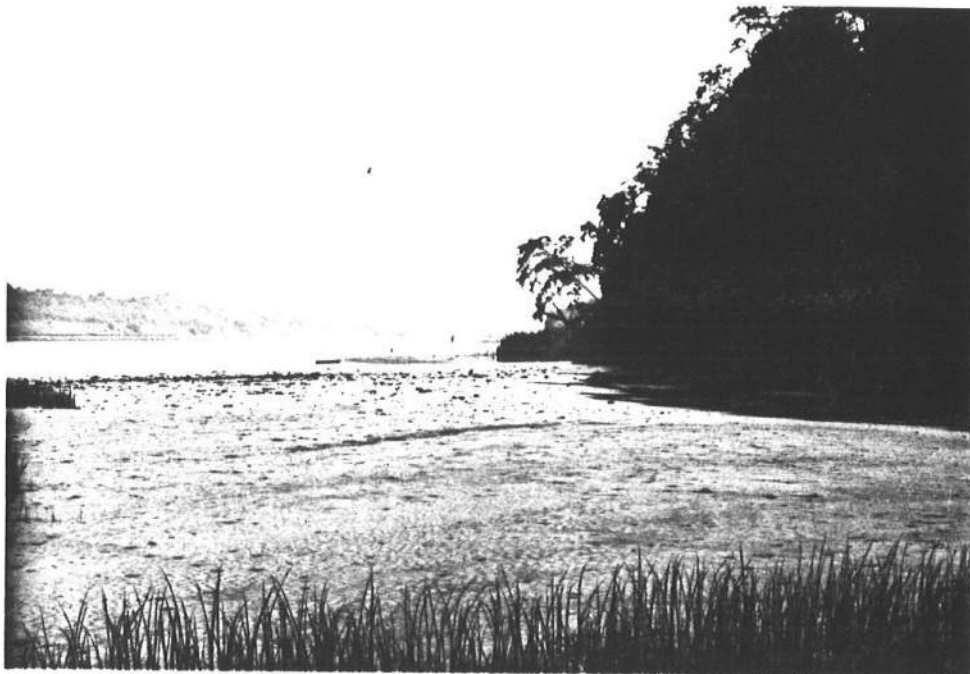
Photo 6. From Station D toward Station E. The length of the bluff which appears to be eroding rapidly between Stations D and E is approximately 110 ft.

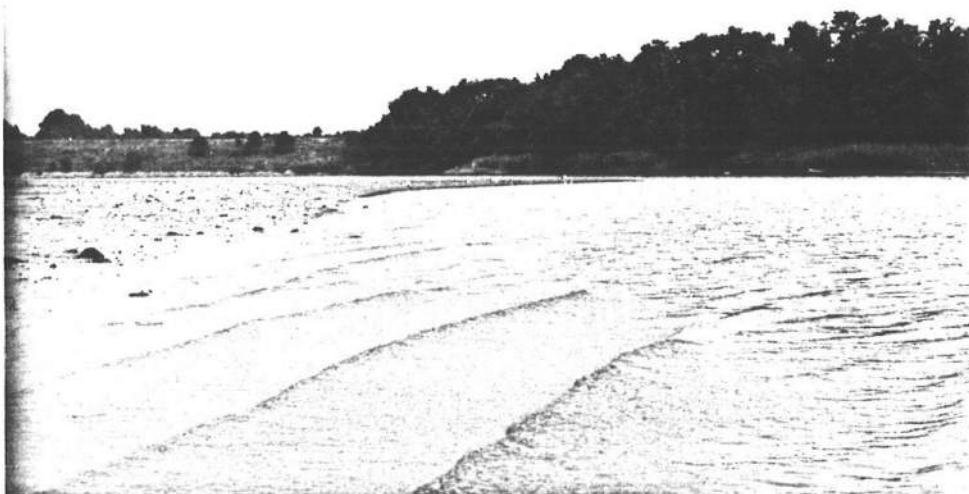
Photo 7. Obliquely Incident Waves Near Station E. These obliquely incident waves are observed to cause longshore sediment transport along the shoreline from Station E toward Station D.

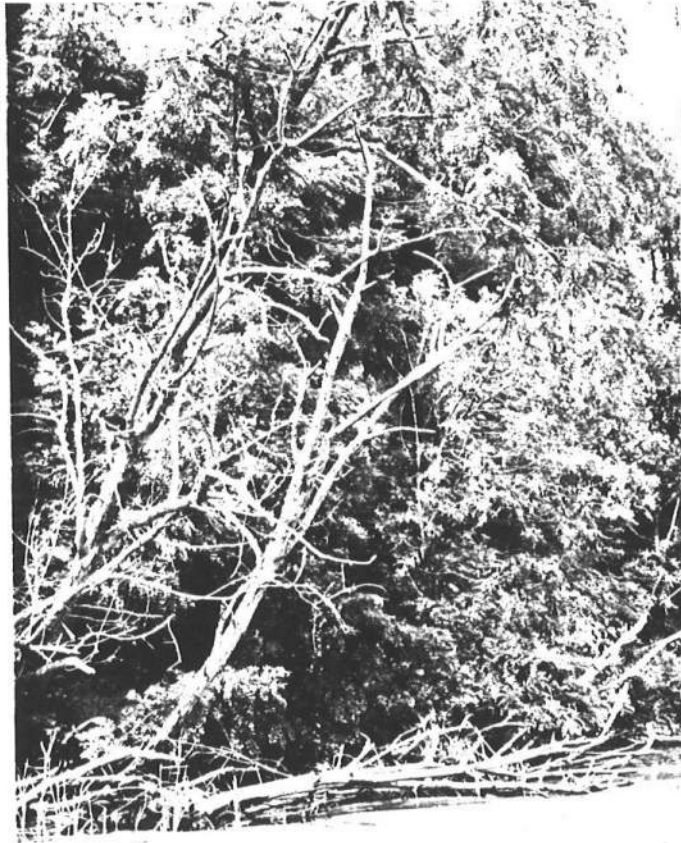
Photo 8. Bluff Erosion near Station E. Note that the trees are falling into water because of the bluff erosion. The tree leaves tend to protect the eroding bluff against precipitation in summer by intercepting rainfall and reducing the impact of raindrops.

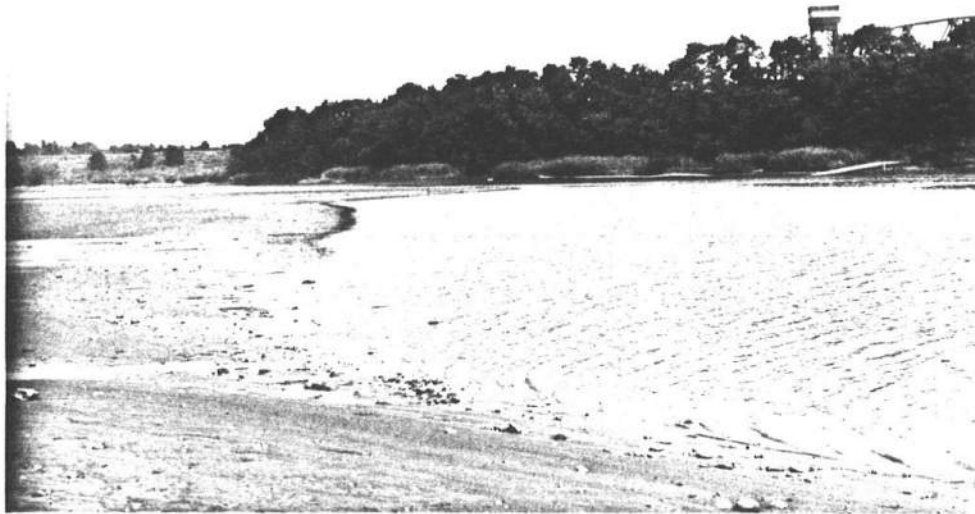
Photo 10. From Station E toward Station D. Note the extent of the shoal at the entrance of the marina site. The southern shore of the marina area is covered with trees and appears to be more stable than the northern shore.

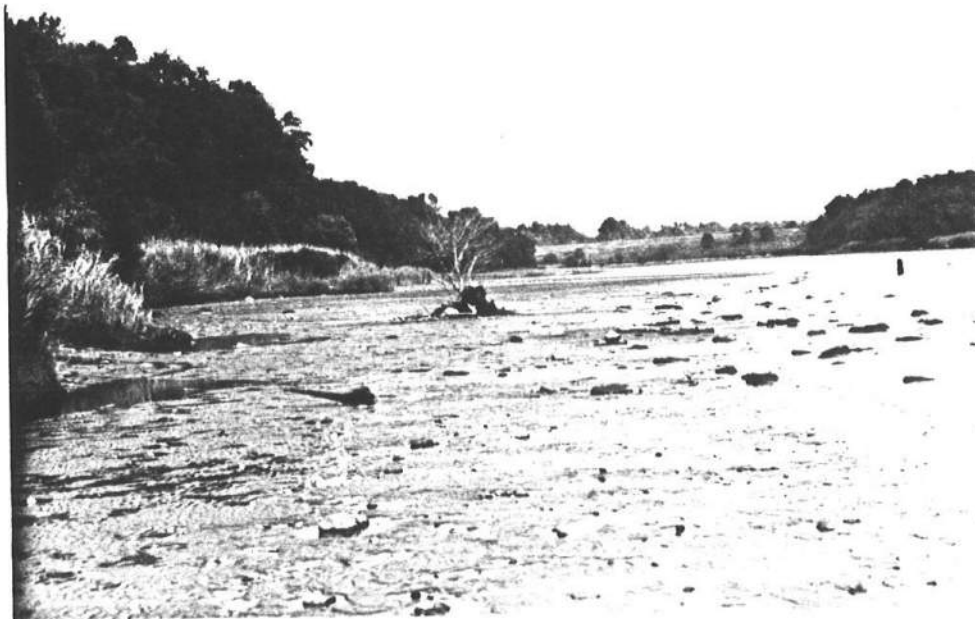
Photo 12. From Second Fallen Tree toward First Fallen Tree. The shore-normal distance from the eroding grass roots, shown in Photo 14, to the first fallen tree in this picture is approximately 40 ft.

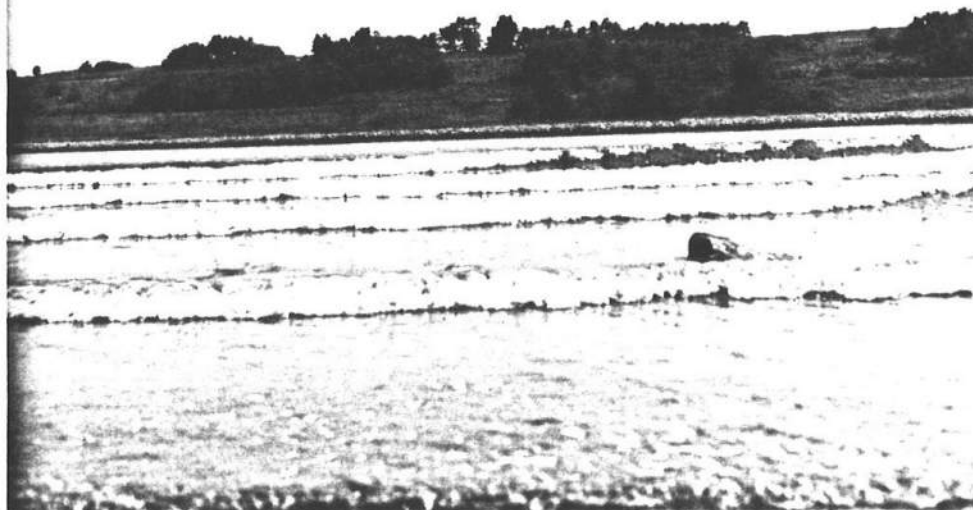
Photo 13. Waves Generated by Two Boats Passing in C & D Canal. The wave height was approximately one foot and the waves lasted for a few minutes.

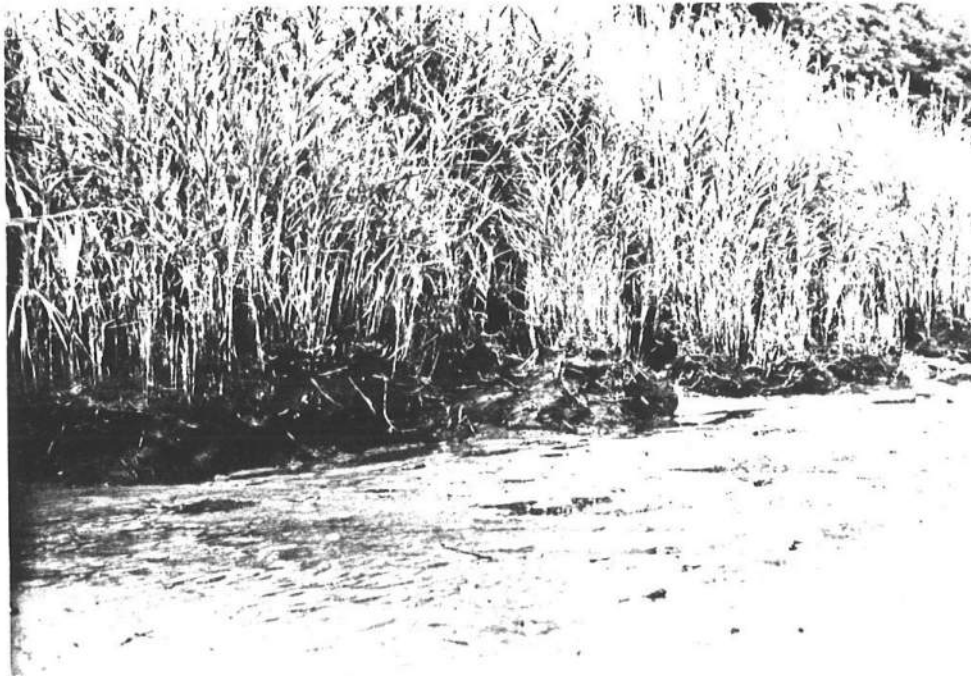
Photo 14. Eroding Grass Roots due to Wave Action. The grass roots are exposed to wave and current action during high tides and eroding although the roots tend to reduce the erosion rate.

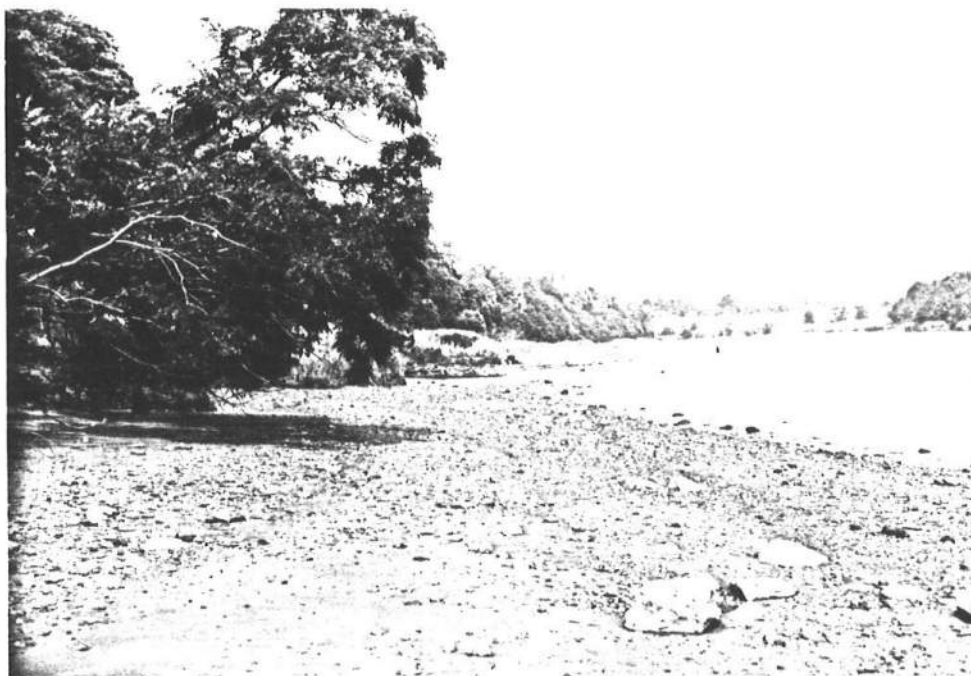
Photo 15. From Third Fallen Tree toward First and Second Fallen Trees. The first fallen tree is shown in Photo 12. The second fallen tree lying on the beach in the distance still has green leaves. The leaning tree on the upper left hand side of this picture is located in the vicinity of the eroding bluff shown in Photos 16 and 17.

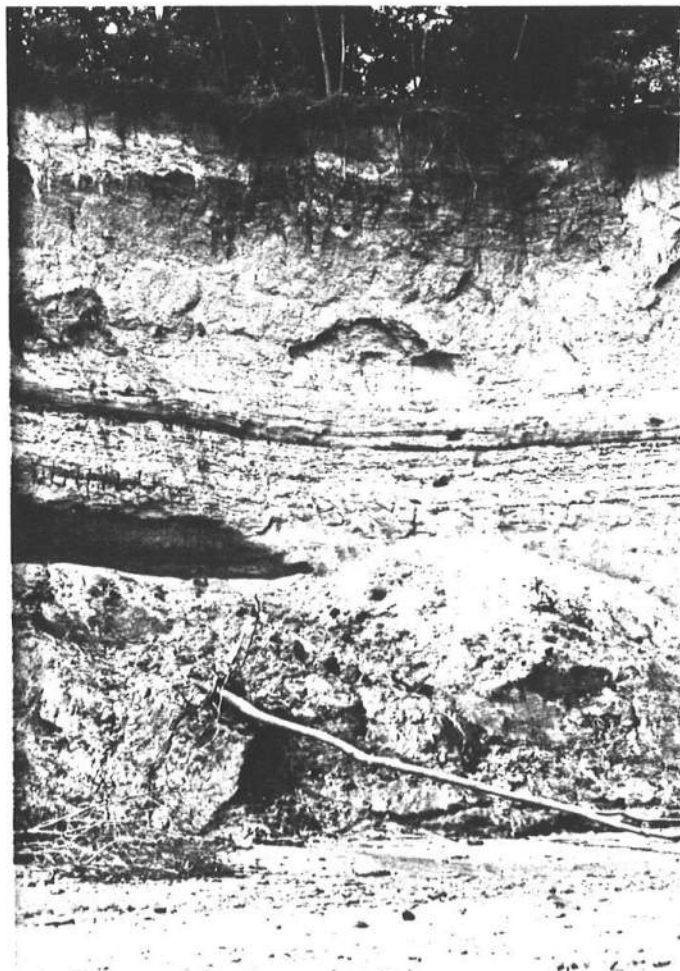
Photo 16. Eroding Bluff without any Vegetation. The height of this eroding bluff is approximately 60 ft. The hanging tree roots and fallen branches indicate active erosion.

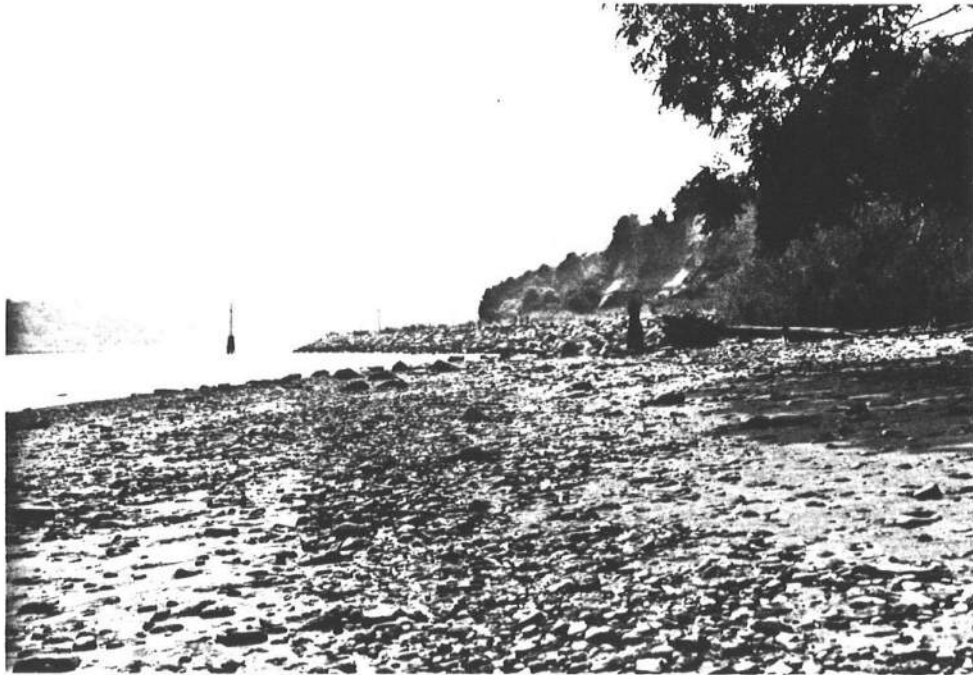
Photo 18. From Eroding Bluff toward Third Fallen Tree. The tree trunk standing vertically next to the root of the fallen tree is located approximately 25 ft from the vegetation growing at the toe of the bluff.

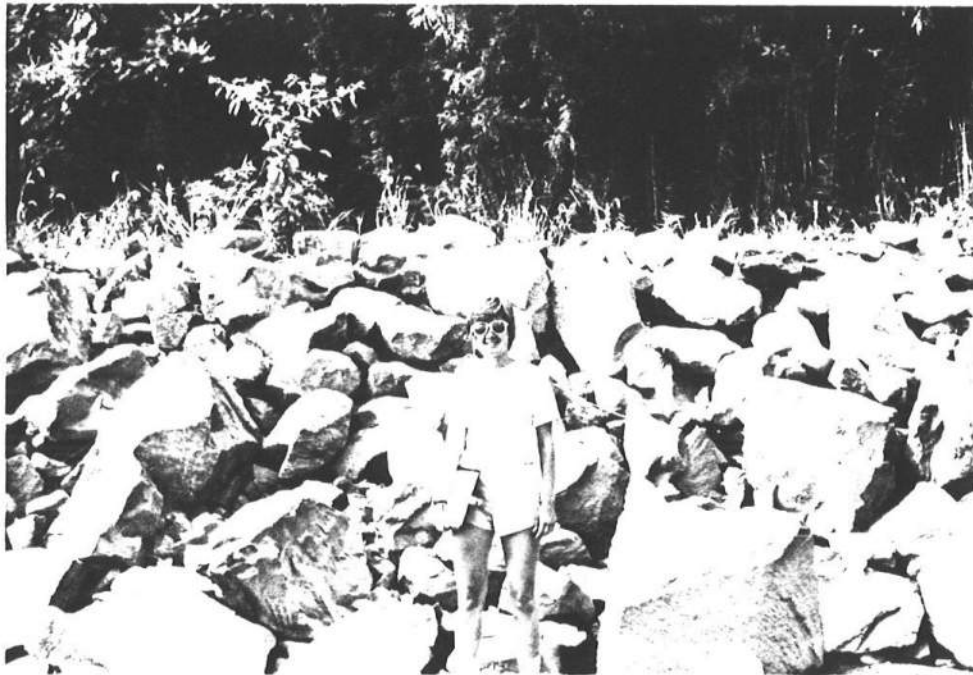
Photo 19. Gwen Charles of Height 5'8" in Front of Riprap Revetment. The height of the riprap revetment is approximately 9 ft. The revetment slope is approximately 1 on 1.5 as shown in Fig. 39. The horizontal line between gray and brown stones indicates the elevation of the high water level.

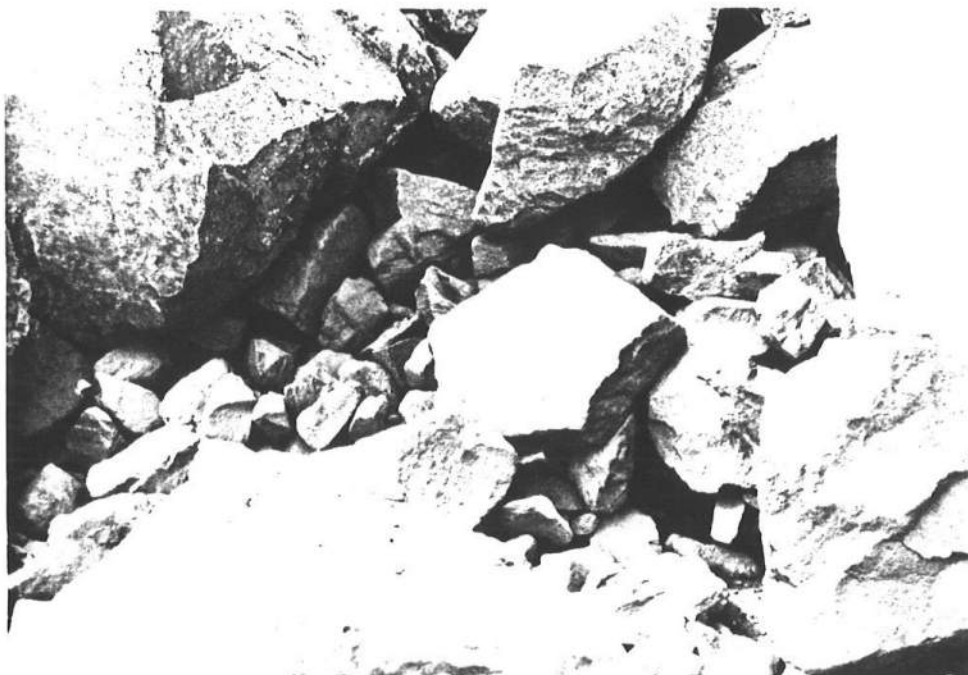
Photo 20. Exposed Underlayer Quarry Stone. The smaller underlayer quarry stone placed underneath the primary quarry stone is exposed and may eventually be dislodged by large waves generated by vessels passing in C & D Canal during high tides.

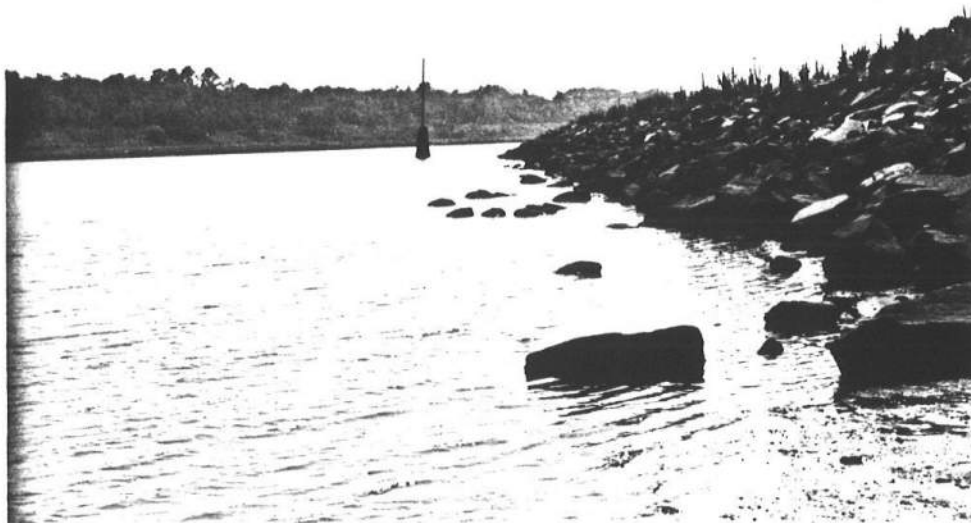
Photo 21. Primary Quarry Stone Fallen into Water. The displacement of the primary quarry stone was probably caused by large waves generated by vessels. However, the displacement could also be caused by ice or during the construction of the revetment.

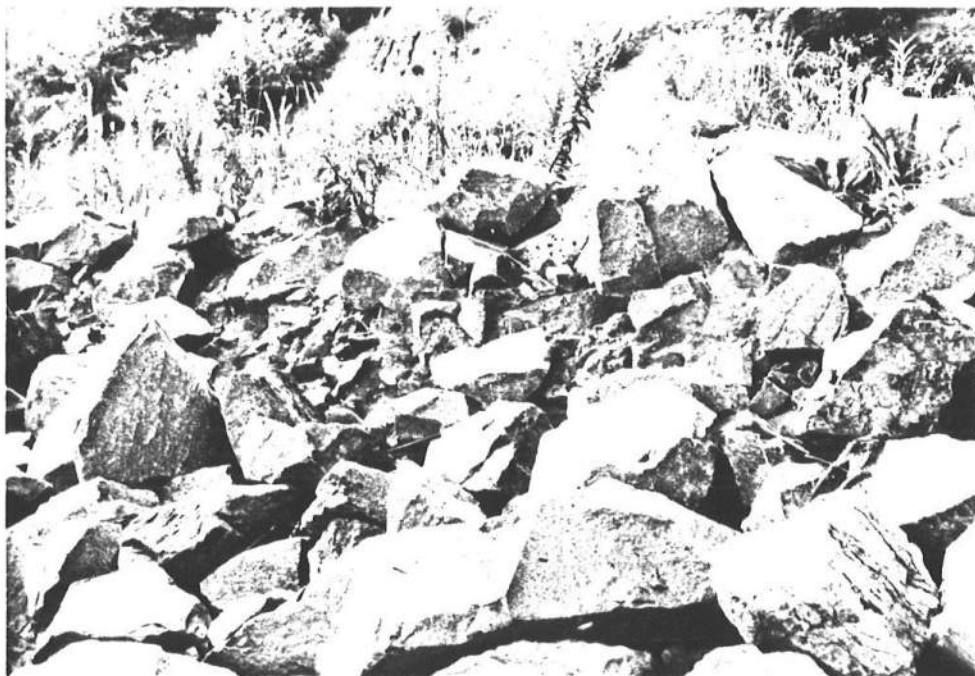
Photo 22. Exposure of Soil Underneath Quarry Stone. The quarry stone appear to have slid down and the soil underneath the quarry stone was exposed. The access road built above the riprap revetment for the revetment construction is 25 ft wide.

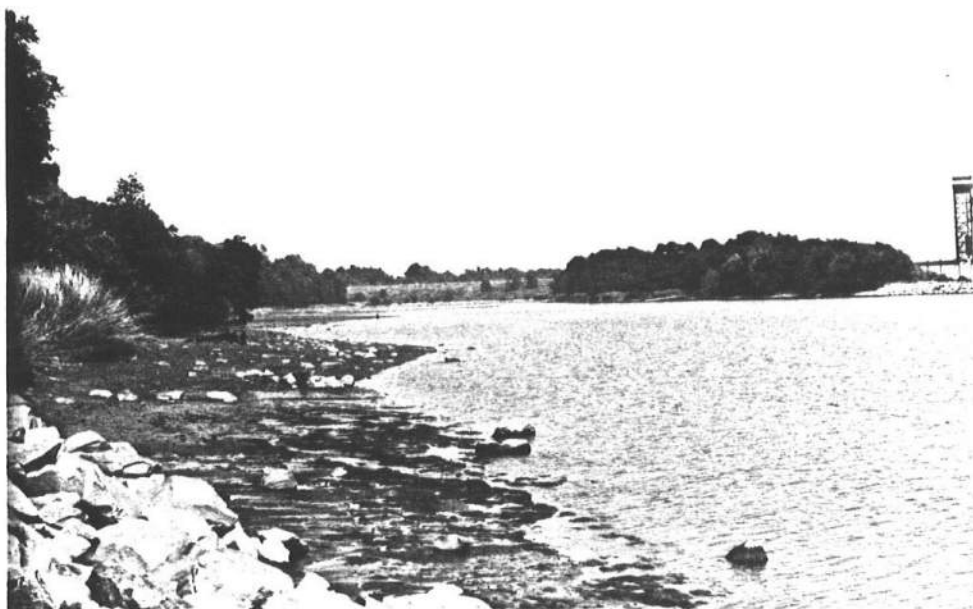
Photo 23. From Riprap Revetment toward Marina Site. Note the consolidated clay in front of the riprap revetment which looks darker than the beach materials along the eroding bluff. This indicates that the sediment originated from the eroding bluff is transported toward the marina site, resulting in lack of cohesionless sediment in front of the riprap revetment.
