A COASTAL ENGINEERING STUDY OF  
INDIAN RIVER INLET, DELAWARE

DEL-SG-5-77

Ocean Engineering Technical Report 14

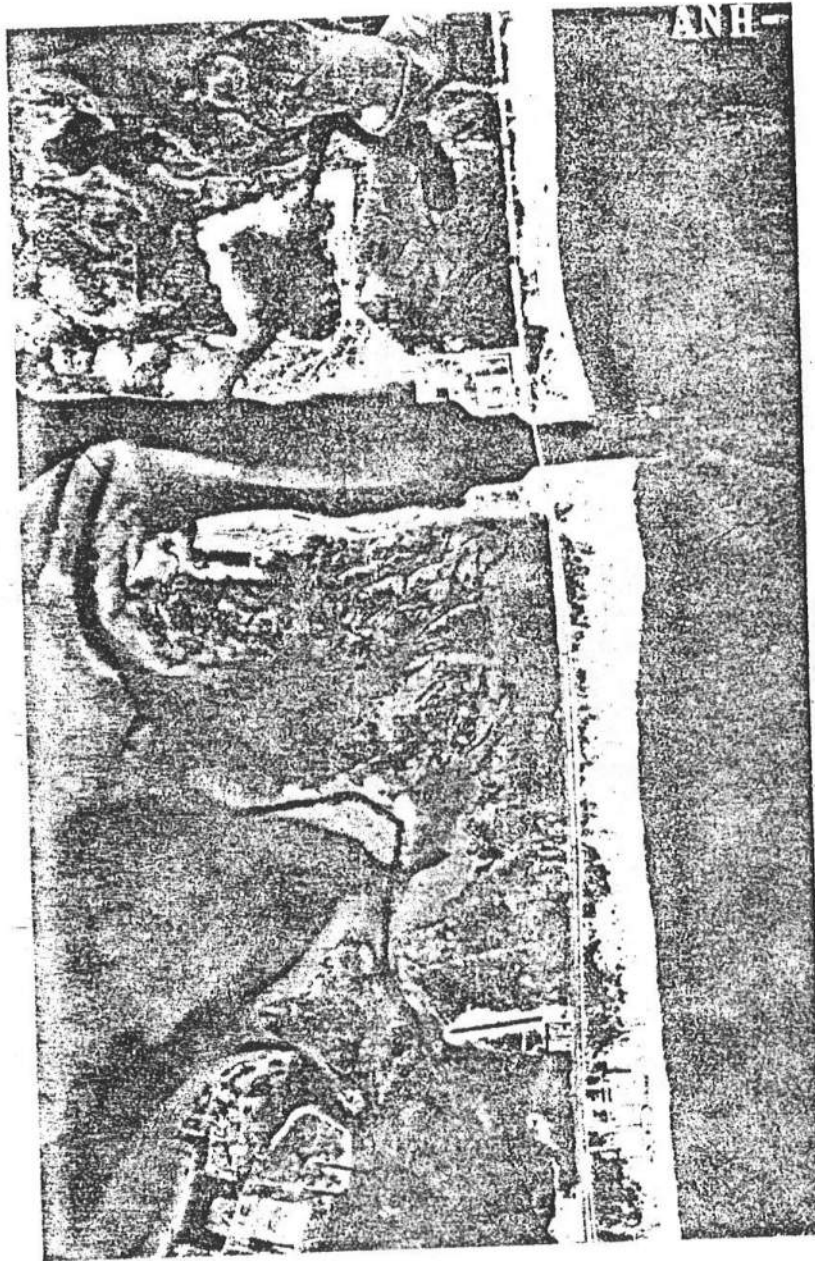
Figure 14 Indian River Inlet, 1960 (U.S. Department of Agriculture, 1975)

Figure 14 shows the inlet and its changing shoals in 1960. Figure 15 was taken March 15, 1962 several days after a devastating northeasterly storm hit the Delaware coast. Large volumes of sand were carried west across the road and deposited in the marsh in overwash fans. Figure 16 and Figure 17 show the inlet on May 2, 1968 and June 8, 1971, respectively. The erosion of the beach north of the inlet can be seen threatening the approach to the new inlet bridge. A complex flood tidal shoal is also developing in Indian River Bay.

In 1957, and again in 1963, the state dredged from an area behind the dunes and north of the inlet to obtain sand for nourishing the north beach. The borrow site from the 1957 dredging can be seen in Figure 14. The 1963 dredging was conducted in the same area.

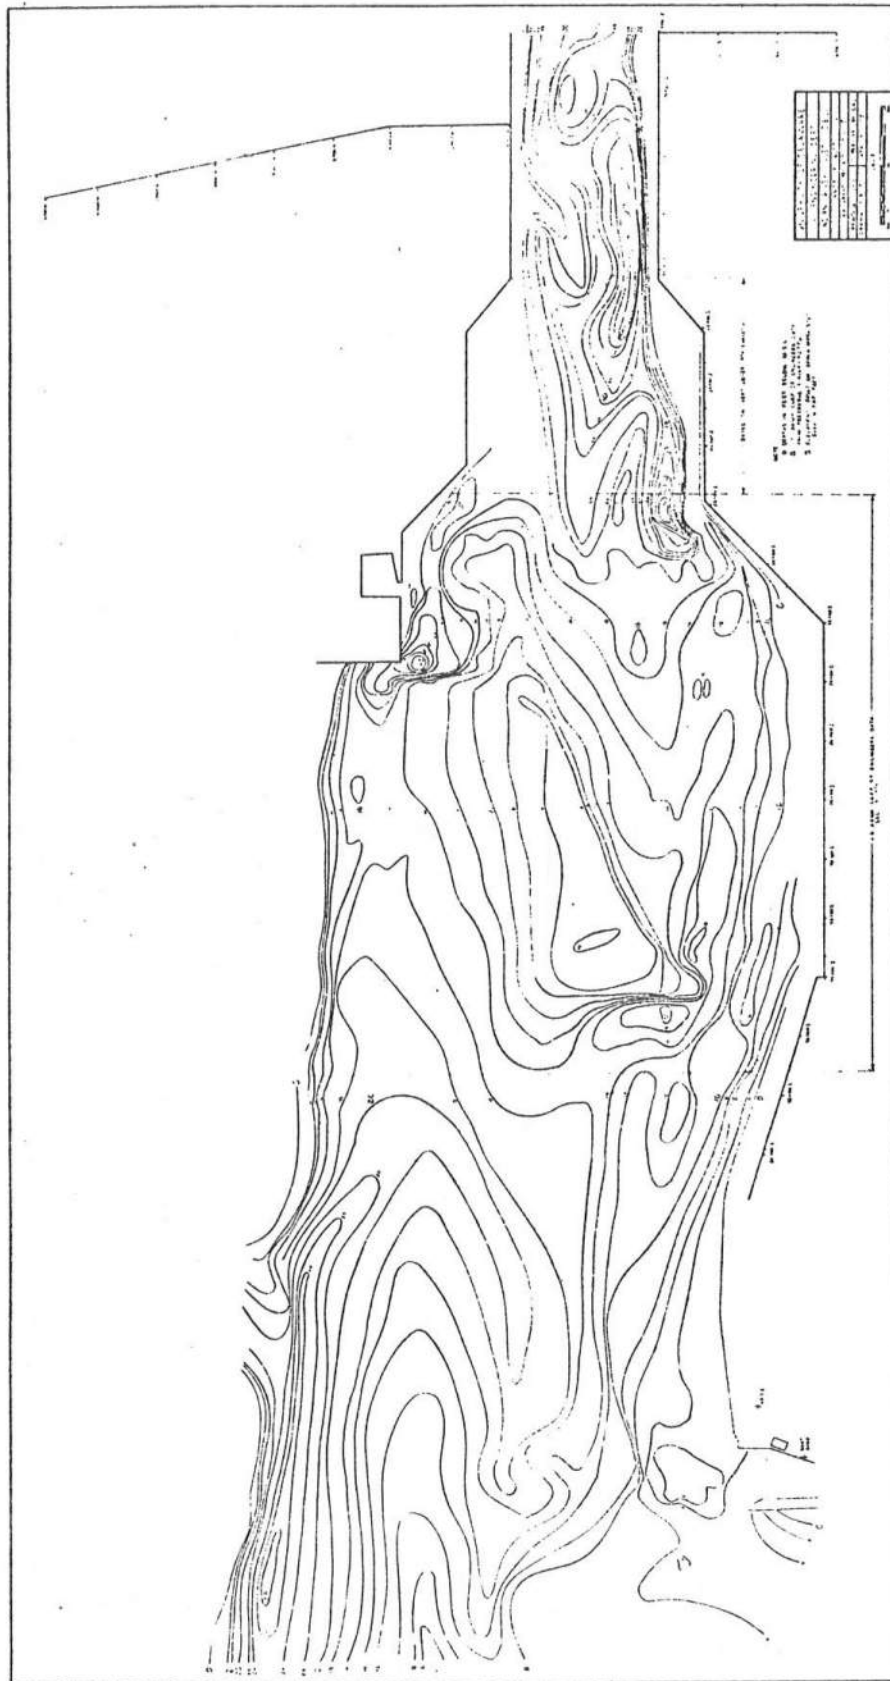
Figure 21 Hydrographic Survey of Indian River Inlet Channel, April, 1975

The inner and outer charts from the three surveys are shown in Figures 19 through 24. Many features of the inlet and shoals maintained

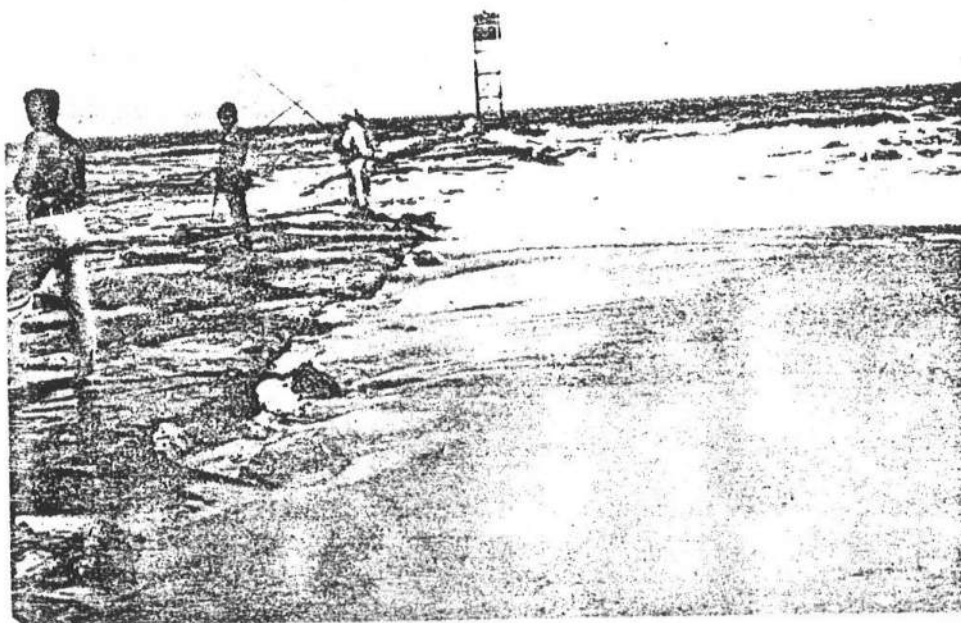
Figure 29 Sand Being Carried Over the South Jetty by Ocean Waves

The beach berm crest at Indian River Inlet is generally 7 to 7.5 feet above NGVD, while the crest of the south jetty is about one foot lower than that of the beach berm crest. During periods of high tides, waves sweep up the beach, across and through the south jetty, and into the channel, carrying large volumes of sand, which is deposited in the channel. A photograph of this process is shown in Figure 29.

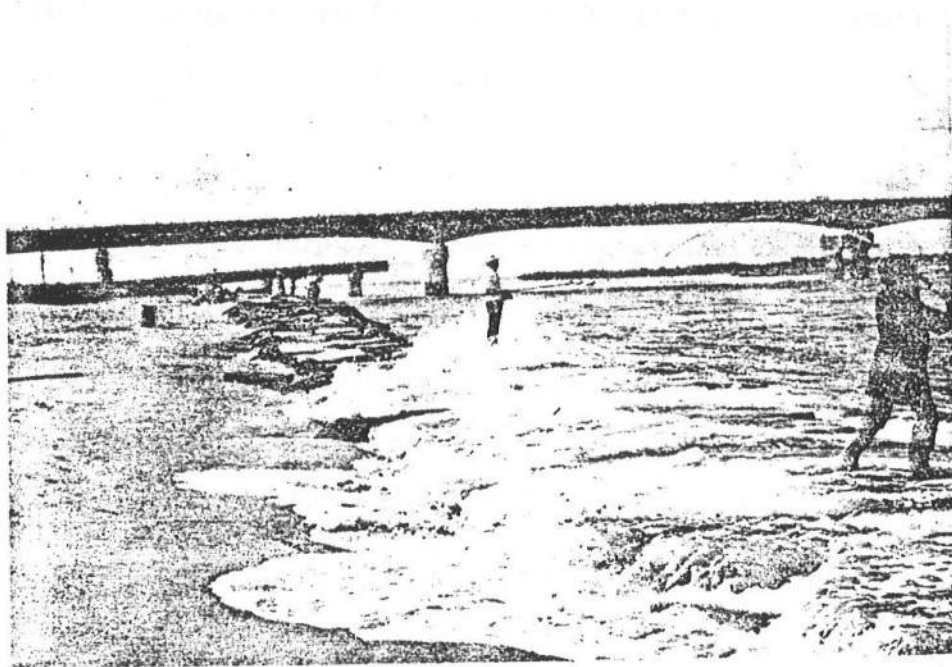
Figure 30 Wave Breaking Over the South Jetty from Inside the Channel

Another (less frequent) means by which sand is carried over the south jetty is the backwash of waves overtopping the jetty from inside the inlet channel. Ocean waves propagating into the inlet (primarily during flood tide) overtop the south jetty as shown in Figure 30. The backwash carries sand into the channel, causing the beach to slope towards the jetty (as seen in the photograph).

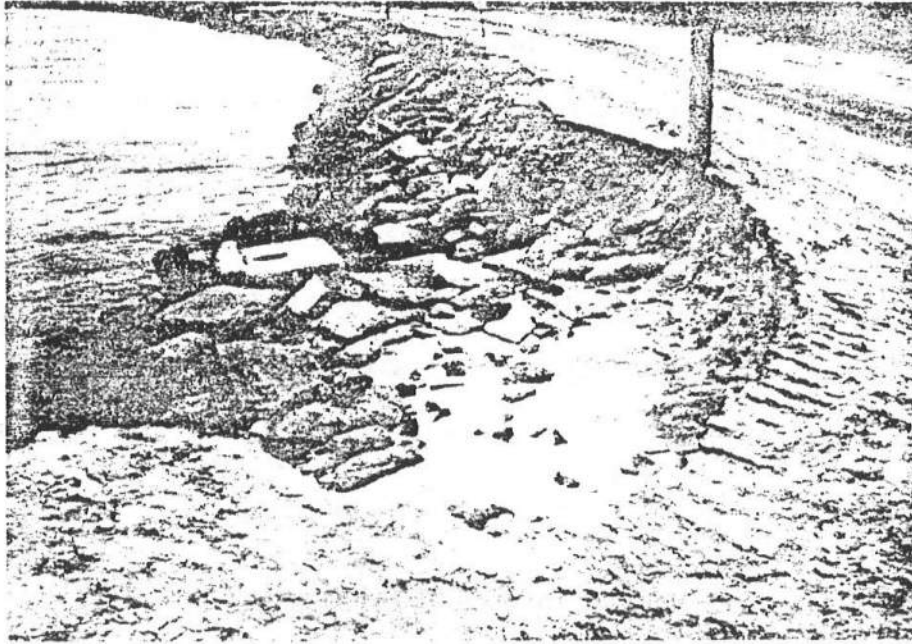
Figure 33 Breach Forming in Earthen Embankment on South Channel Bank

There are several causes of the present channel bank erosion at Indian River Inlet. The ocean waves moving into the channel have been cited by Wicker as the primary cause of this inlet's early bank erosion. This mechanism is believed to be still causing the erosion of the channel banks. As the inlet widens, however,

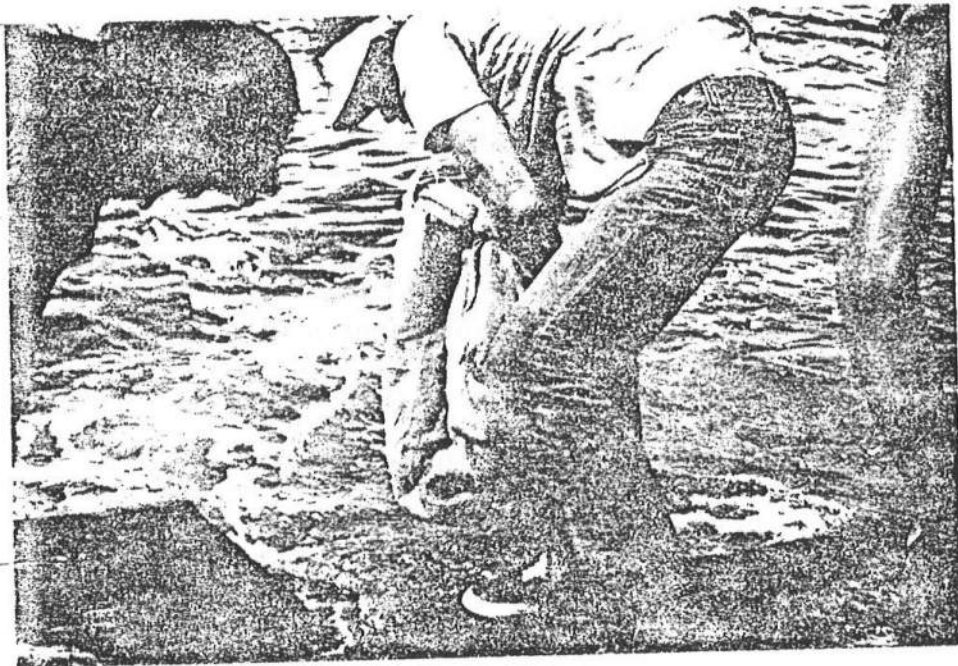
Figure 44 Deployment of Red Tracer Sand in Channel

Five hundred pounds of the red sand was dumped from the south jetty into the inlet at station 8+58I (opposite the berm crest of the south beach where sand passes over the jetty). The red tracer sand was dumped at low water slack (as shown in Figure 44) in order to allow

the major portion of the sand to be carried into the inlet by flood tide.

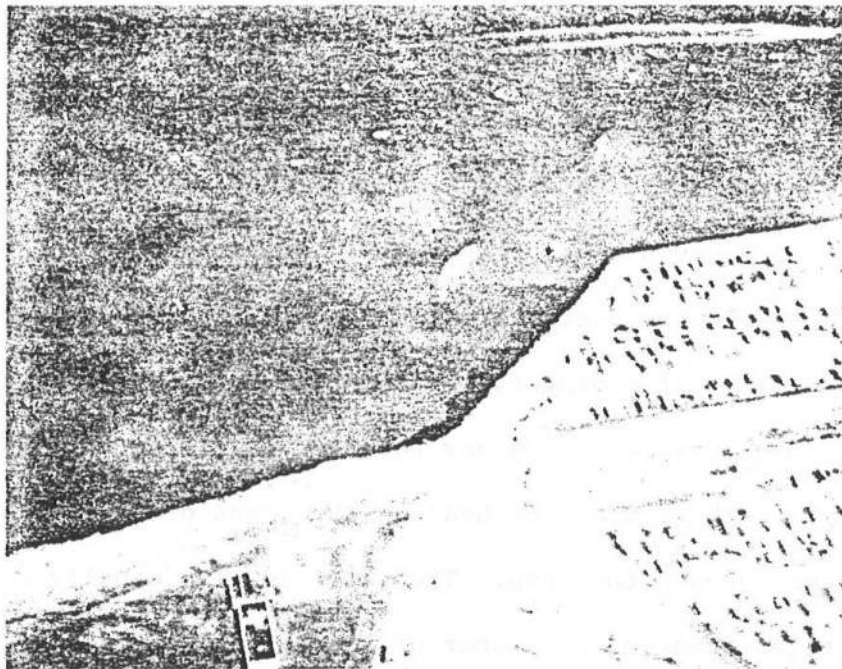
Figure 75 Red Dye Streak and Sewage Treatment Plant Effluent

Currents were measured in the inlet on several occasions as part of this study. Drogues and dye were deployed by boats and then monitored with aerial photography. Figure 75 shows a streak of red dye released from a small buoy. (The large patch of dark water near the shore was released from the small sewage treatment facility at the bottom of the picture.) The drogue and dye studies, however, provided little more than qualitative information on the tidal currents. This was due to problems with transferring the location of the drogues and dye to charts. Also, information could only be obtained while the airplane was overhead; this amount of time was limited by cost.
