A COASTAL ENGINEERING ANALYSIS OF
ROOSEVELT INLET, LEWES, DELAWARE

W. A. Dennis and R. A. Dalrymple

OCEAN ENGINEERING TECHNICAL REPORT NO. 18

1978

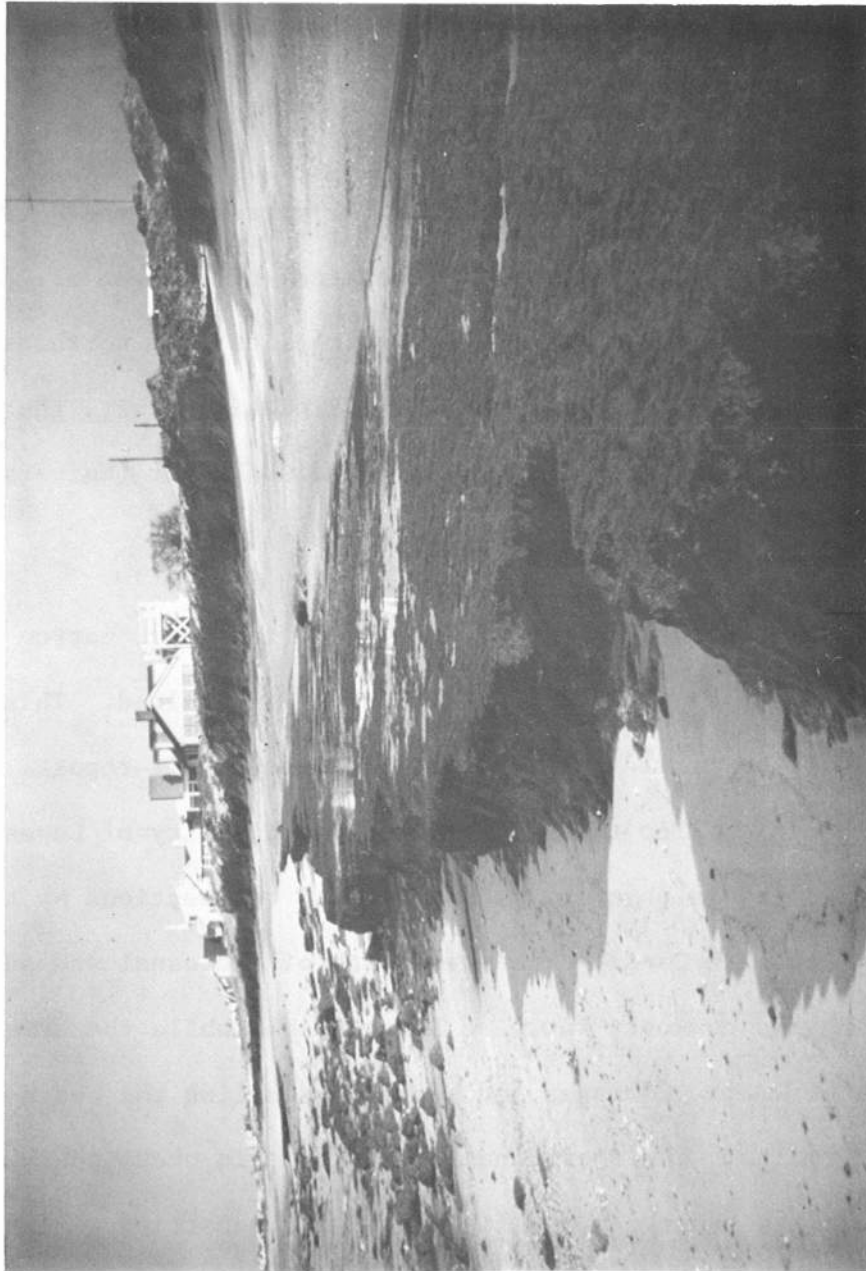
FIGURE 2 Downdrift Erosion Occurring Along Lewes Beach

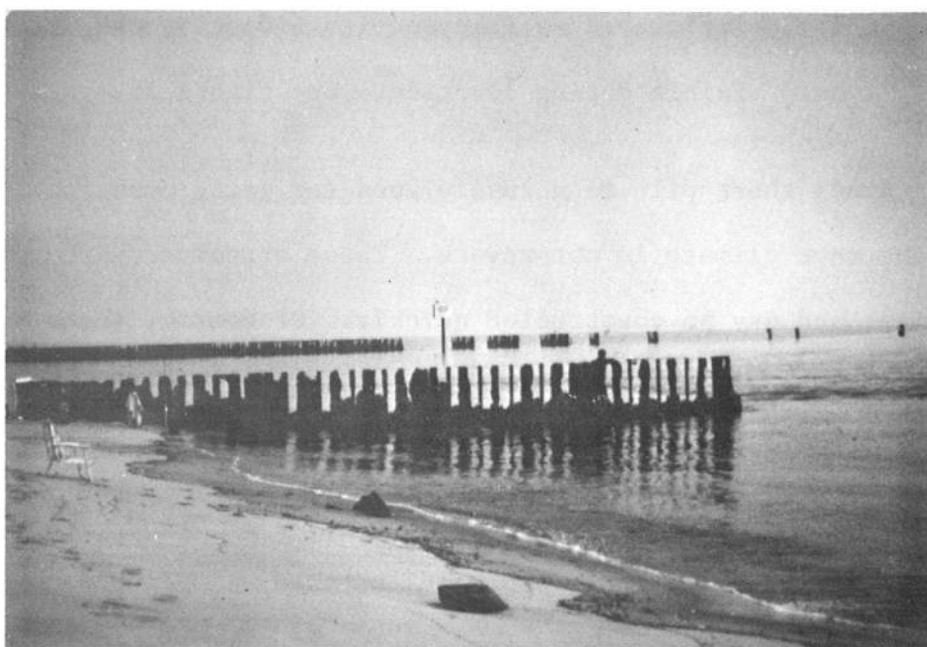
FIGURE 16 The Remains of the Jetties at Roosevelt Inlet After 40 Years in the Harsh Salt Environment

provided a modification to the existing inlet project. The proposal called for a 10-foot depth from Delaware Bay to the basin at Lewes and for extending the jetties to the 10-foot contour in Delaware Bay. With the anticipation of the jetty extensions no further repairs were done, with the thought that both the extensions and repairs could be combined in a single project. At present, no repairs or extensions of the jetties have been made. The steel pile has deteriorated well beyond its effectiveness, with much of it only visible during low tide. See Figure 16.

As a consequence of the condition of the jetties, wave action easily moves sand through, around and over the severed sheet pile. Once inside the inlet channel, the sand is reworked by wave and current action and is usually deposited on lobe-shaped shoals which grow on both the east and west banks. The west lobe is usually larger being on the updrift side of the inlet and hence closer to the dominant source of sand. However, there are times when the eastern lobe is larger. These times presumably occur after periods of heavy northeast winds which remove the sand from Lewes Beach and deposit it within the confines of the inlet. Figure 17 is a photograph showing sand deposition along the east bank of the inlet. This sand had entered the inlet through overtopping of the east jetty under the action of northeast waves. A similar problem is occurring at Ocean City Inlet, Maryland. At this location, the low and permeable inshore portion of the south jetty allows easy passage of sand into the inlet and along the north shore of Assateague Island (Dean and Perlín, 1977).

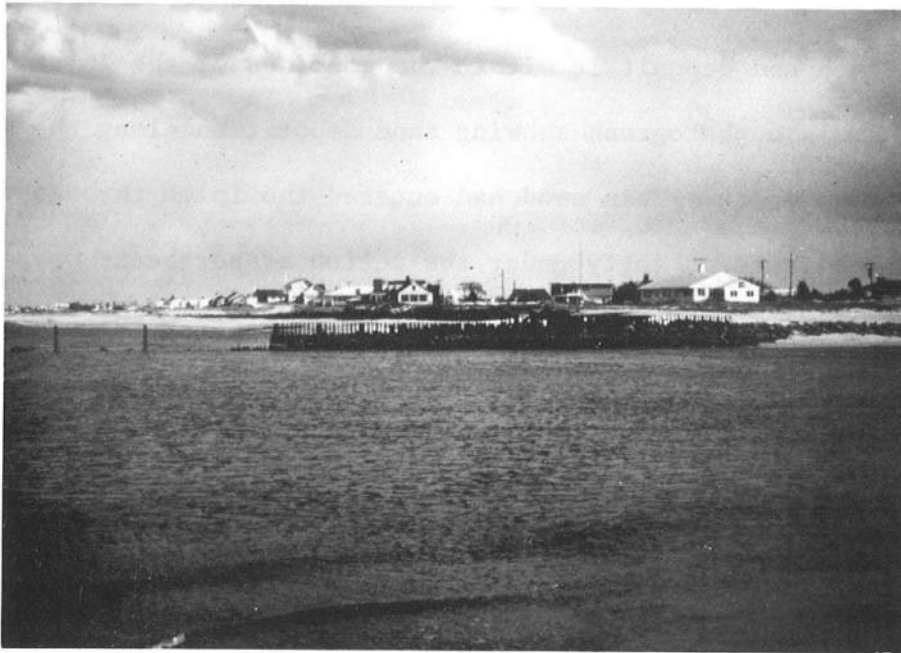
FIGURE 17 The Deposition of a Sand Mound as a Result of Over-topping the East Jetty (Right-Hand Side of Photo)

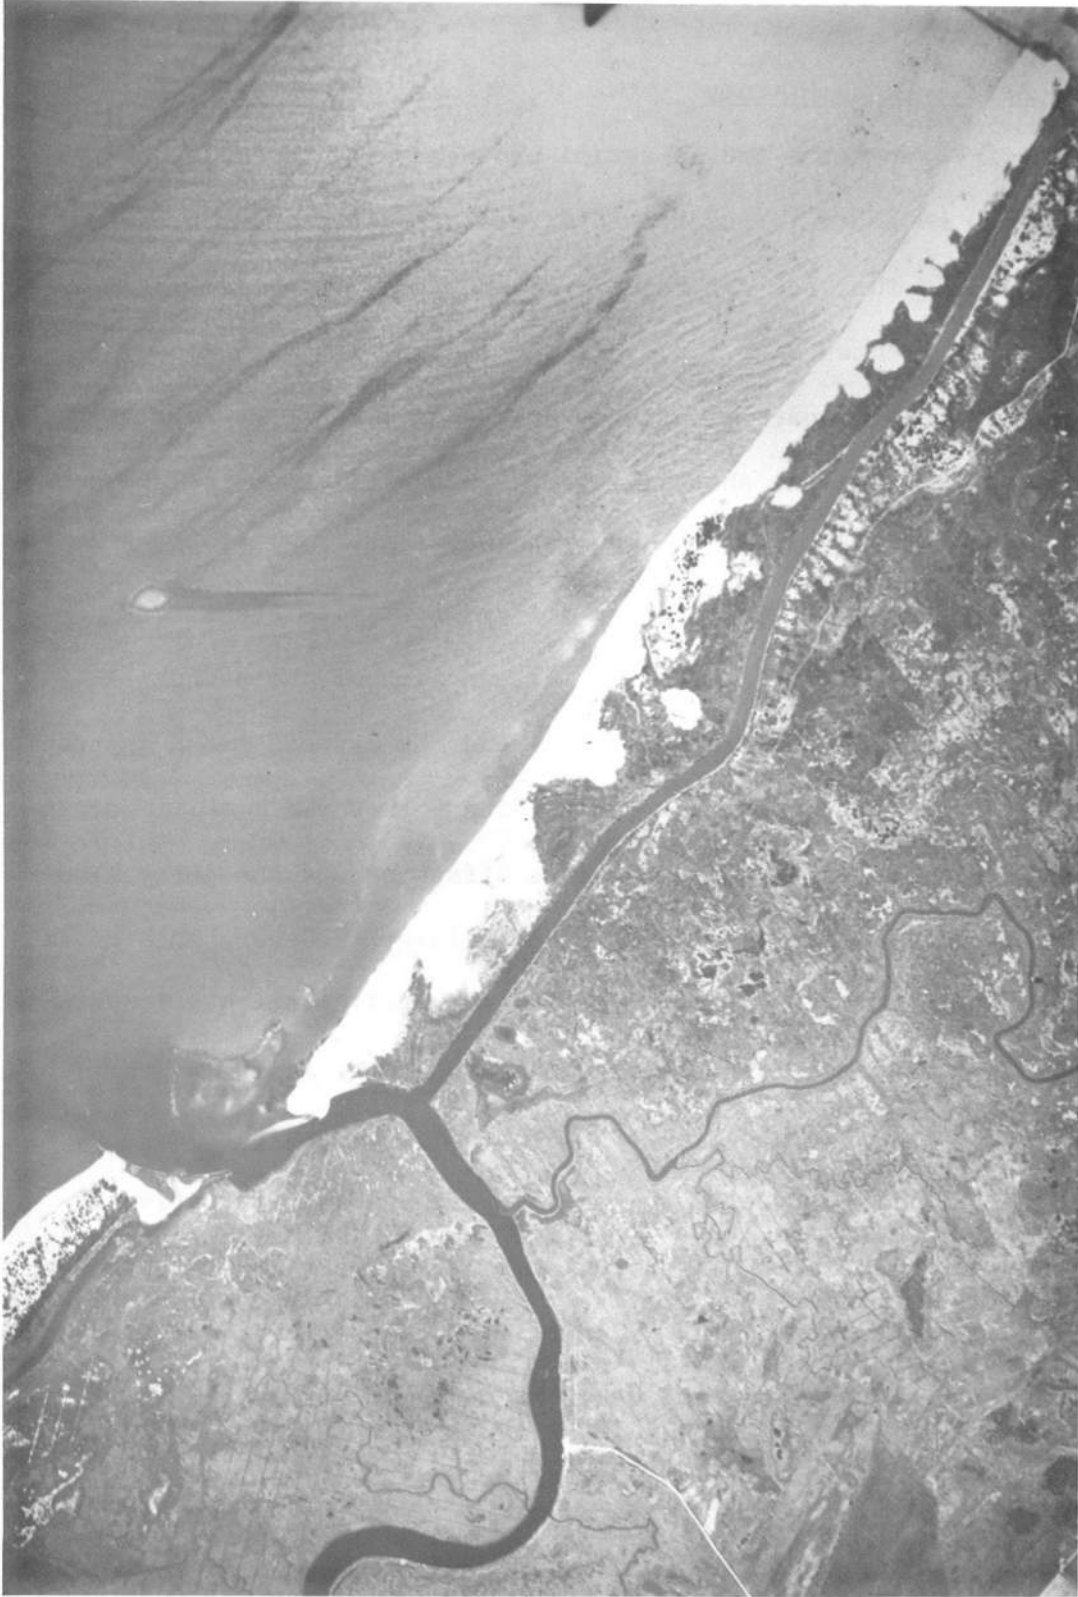
Figure 18 Aerial Photo Showing Broadkill Inlet and Roosevelt Inlet on July 5, 1938 (U.S. Department of Agriculture)

Through the use of aerial photographs an overview of the shoreline response to inlet stabilization and pertinent processes occurring in the area can readily be observed. Figure 18, taken on July 5, 1938 shows both the Broadkill (upper left) and Roosevelt Inlets open. The narrow waterway in the extreme upper left of the photo paralleling the shoreline is the Broadkill Sound. This sound was once the outlet of the Broadkill River (left center) and the Lewes Creek before the inlet was cut and partially stabilized. The wide sand buildup along the western side of the Broadkill jetty (present day, Broadkill Beach) and the exposed marsh outcrop along the tip of the eastern bank indicate that the dominant drift is from west to east. The shoreline offset around the jetty also indicates this. The offset seems quite large; however, much of it is due to the previous curvature of the shoreline at this location. Shoals are visible along the eastern side of the inlet, which eventually were responsible for its closure. Along the west beach (Beach Plum Island) many washover fans are present, indicative of a highly erosive area. The circular-shaped sand mounds are dredge spoils deposited during the widening of the lower Broadkill. Of special interest is the bare shoal located offshore in the Delaware Bay. Features of this nature are fairly common to the vicinity and are indicative of mild offshore slopes and low-energy coastlines. Shoals of this type, however, are quite unstable and migratory in nature.

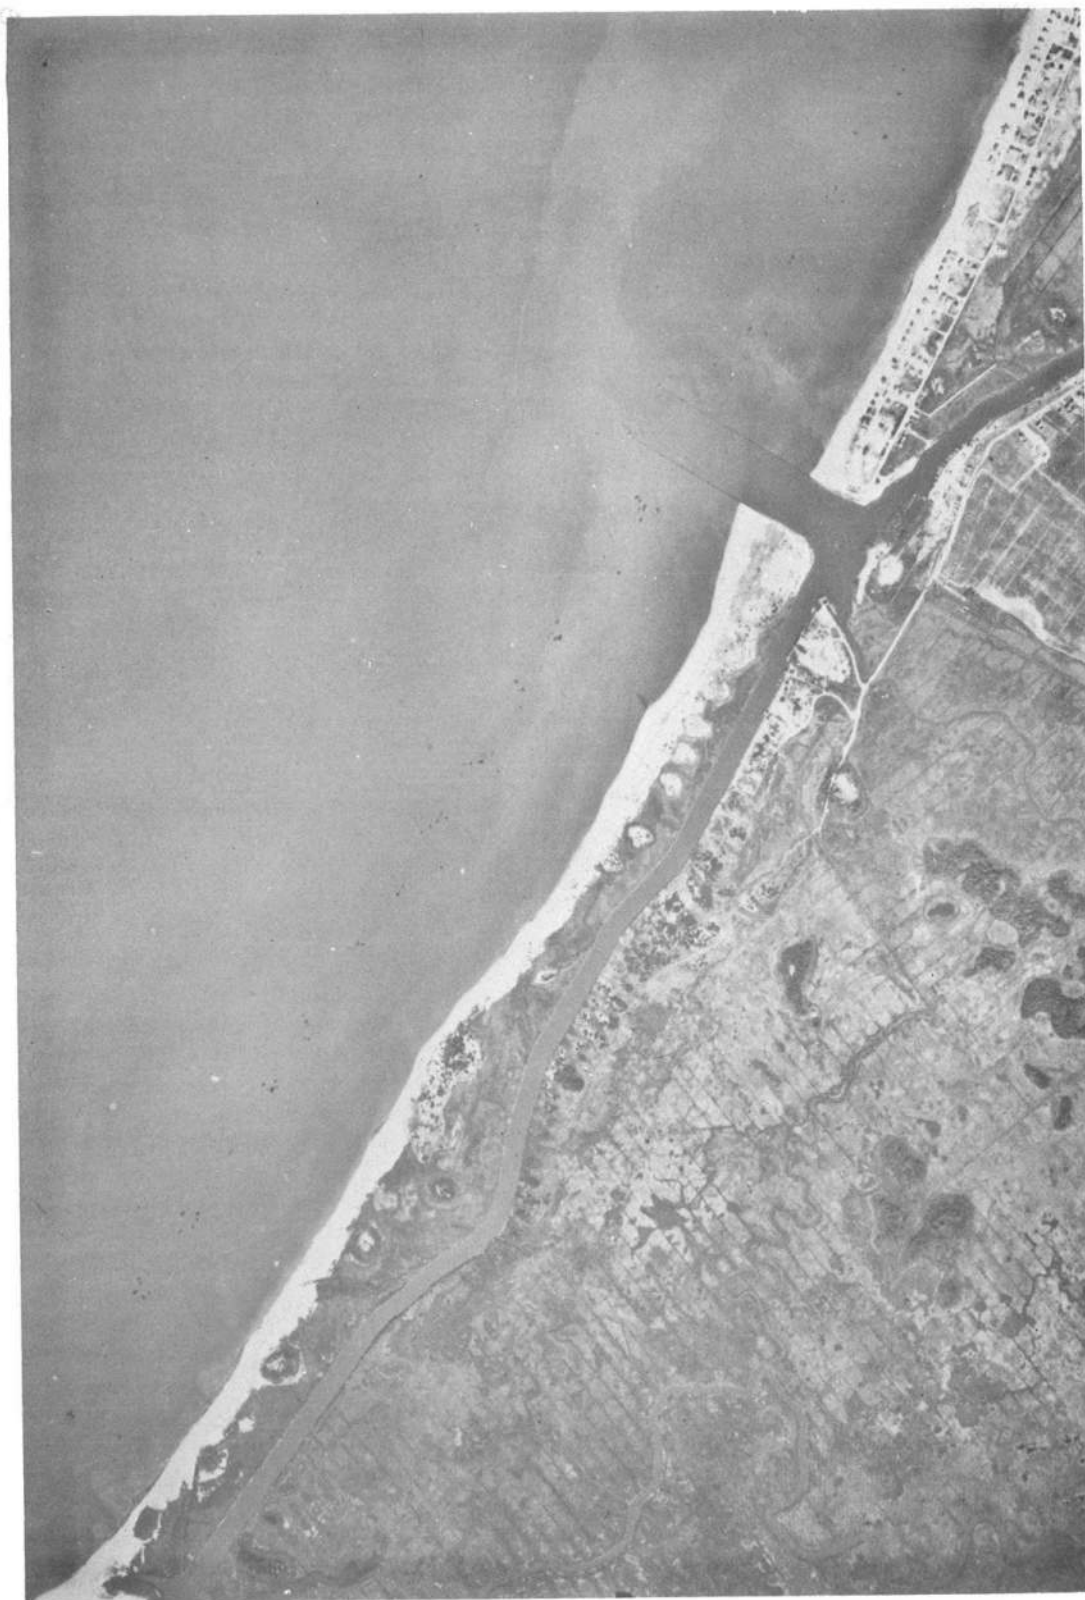
Figure 20 Aerial Photo Showing the Stabilization Effect of Roosevelt Inlet and the Closure of Broadkill Inlet, July 22, 1954 (U.S. Department of Agriculture)

On July 22, 1954, Figure 20, the buildup on the updrift side and the accompanying erosion on the downdrift side of Roosevelt Inlet could be seen. A wreck approximately 2,000 feet west of the inlet has caused a bulge in the shoreline. The sand buildup to the west of the wreck and erosion to the east is further evidence of the west-to-east littoral drift in this vicinity. In the extreme upper left of the photo the complete closure of the Broadkill Inlet is evident. The somewhat irregular shoreline along Lewes Beach has resulted from the construction of six groins between 1948 and 1950 in an effort to alleviate the downdrift erosion problem.

The alignment of the contours indicates that the ebb tidal currents may have some effect in shaping the bathymetry toward the north-northeast. Inspection of Figure 26 shows that contours extending from the tip of the east jetty appear to follow a north-northeasterly trend. This alignment is presumably caused by the easterly deflection of ebb tidal currents from the inlet encountering southeasterly tidal currents of Delaware Bay, also on ebb (refer to Figure 20). This phenomenon also occurs at Indian River Inlet.

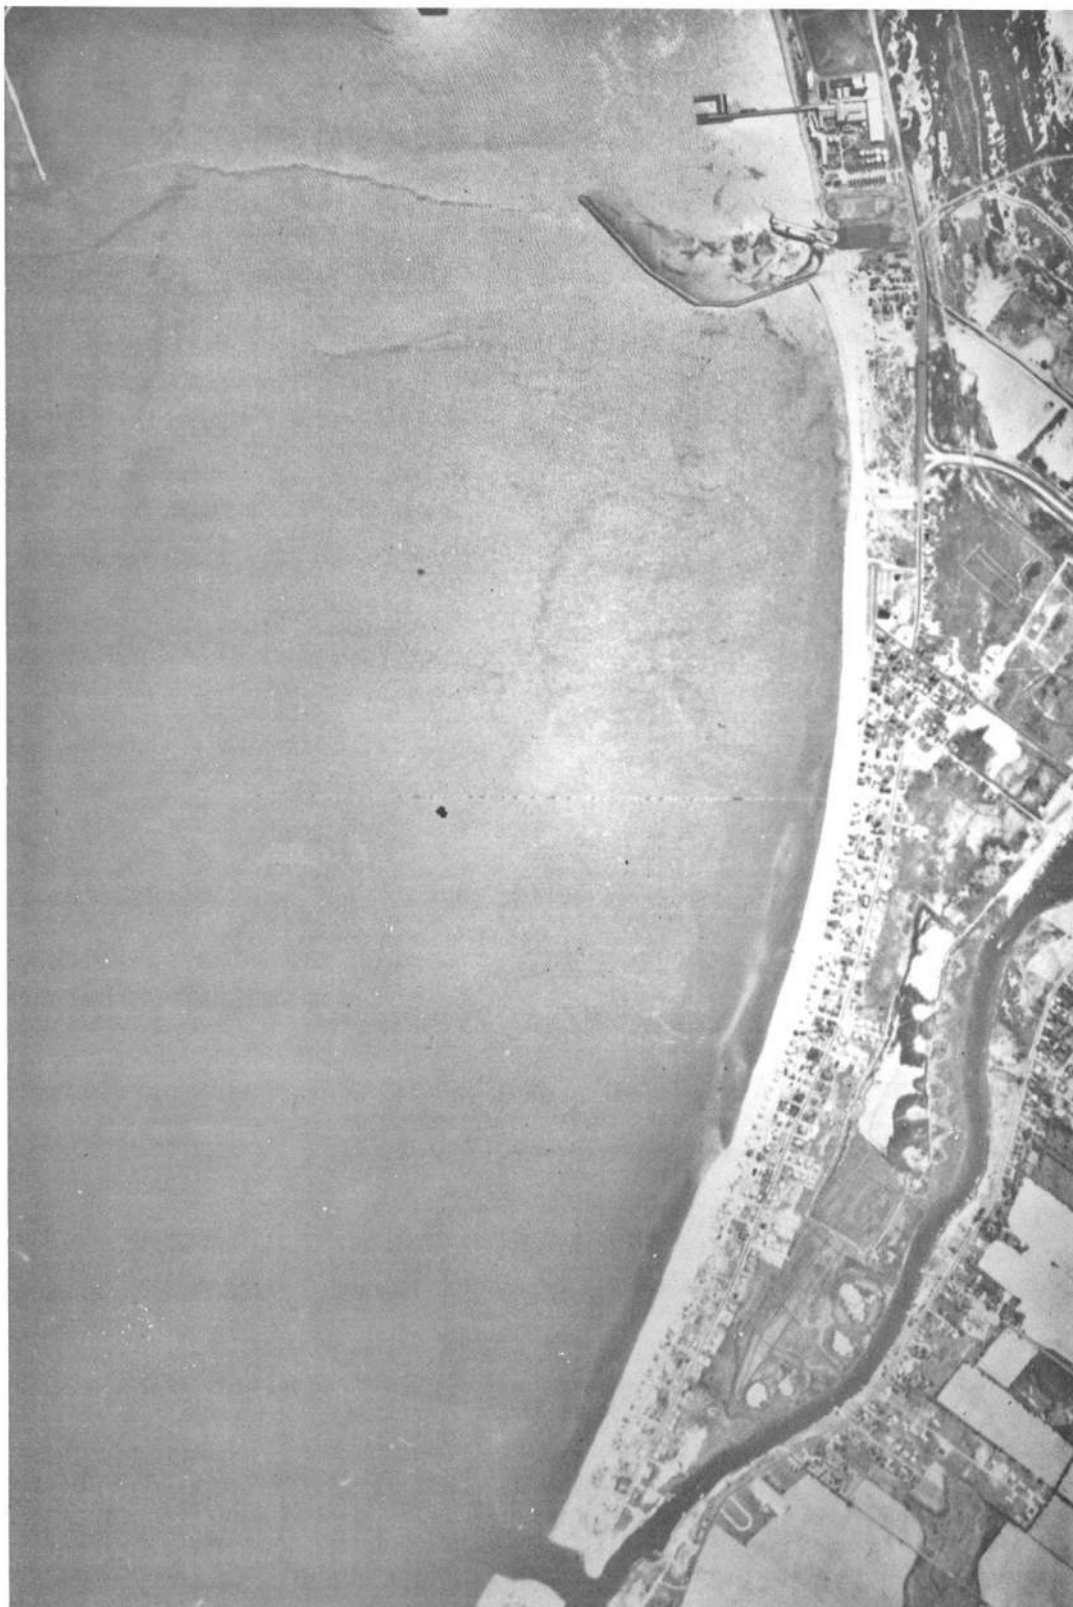
Figure 23 Aerial Photo of Roosevelt Inlet, Lewes Beach and the Ferry Breakwater on May 19, 1968
(U.S. Department of Agriculture)

A continuation of Figure 22 is shown in Figure 23. In the right-hand corner of the photo is the Cape May-Lewes Ferry Terminal protected by a 2,550 foot hooked breakwater. Accretion along the eastside of the breakwater is further indication of the easterly littoral drift along Lewes Beach. This breakwater was constructed in 1964 with stone removed from three ice breakers located at the western end of the outer breakwater in Delaware Bay (U.S. Army Corps of Engineers, 1970). The poor condition of the jetties is also evident from this photo. Compare the distinctness of the jetties in Figure 19 with that of the present figure.

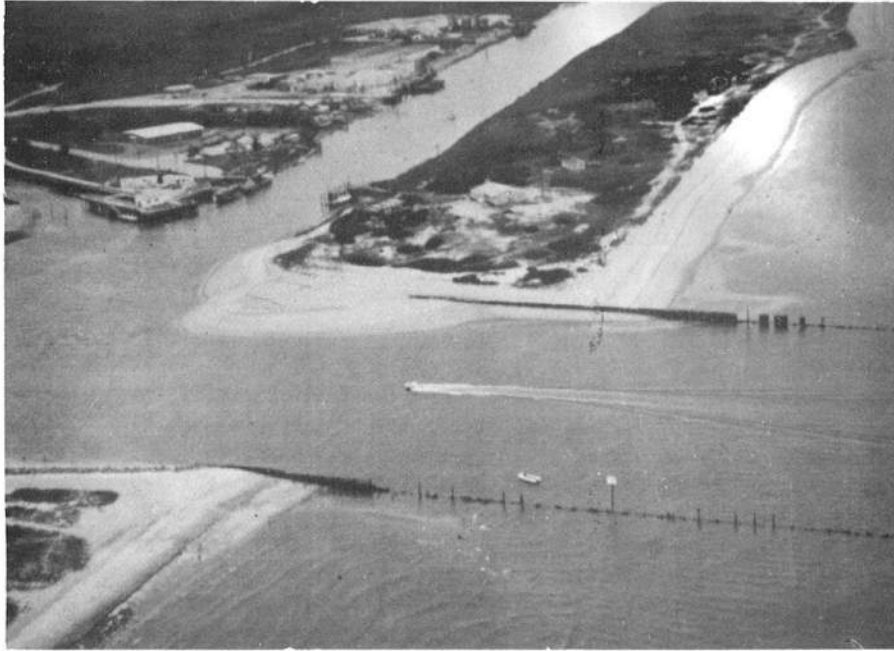
FIGURE 27 Sand Waves in the Vicinity of Roosevelt Inlet, July, 1976

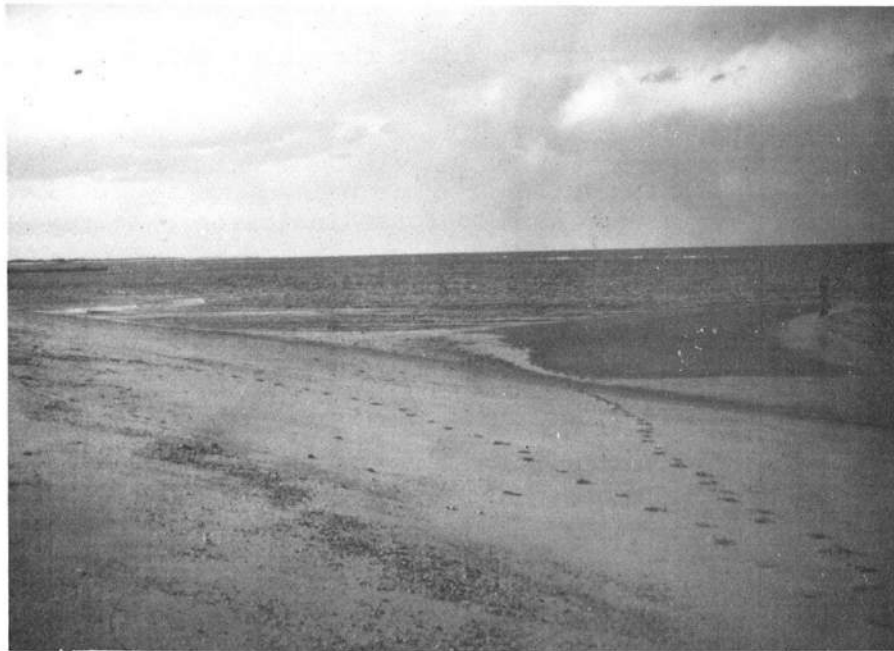
FIGURE 28 A Sand Wave Along the West Beach, April, 1977

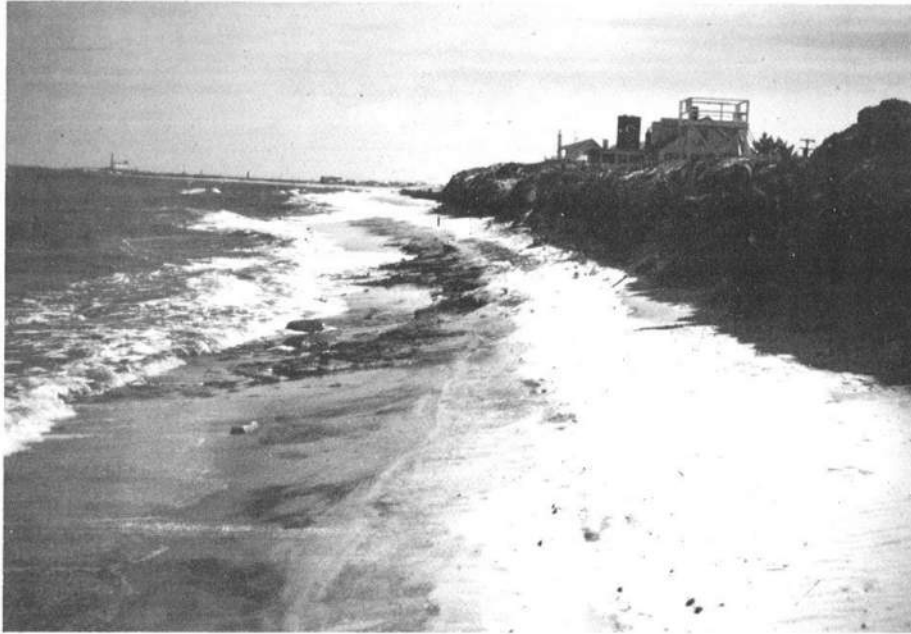
FIGURE 32 Five-Foot Erosional Scarp Along Lewes Beach

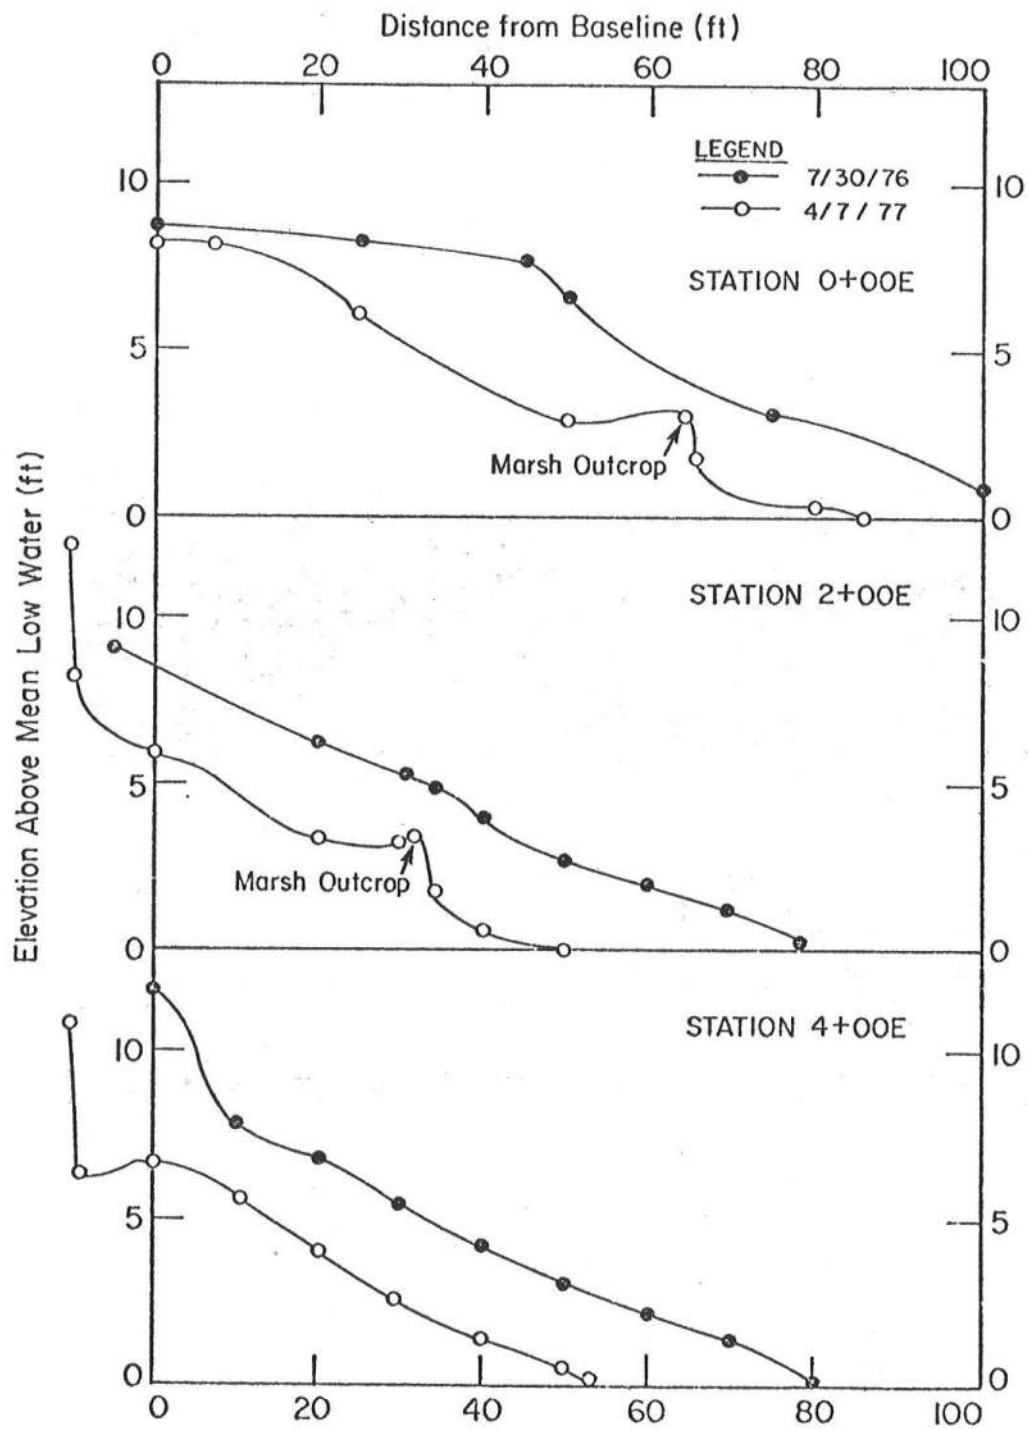
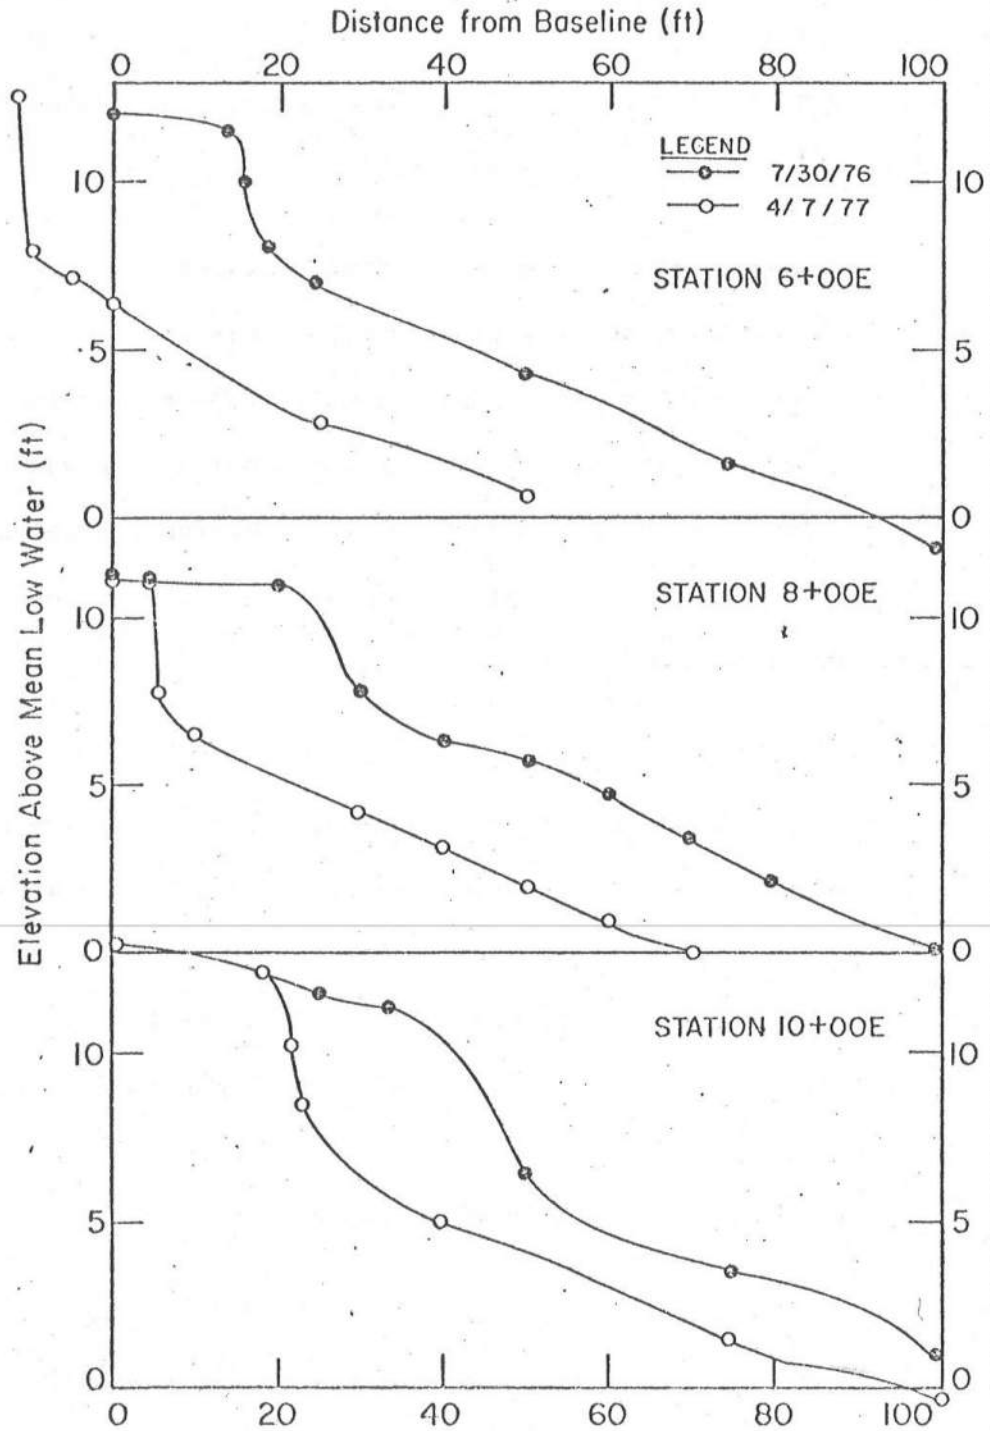
FIGURE 33 Comparative Beach Profile Along Lewes Beach (CONTINUED)

FIGURE 33 (CONTINUED)

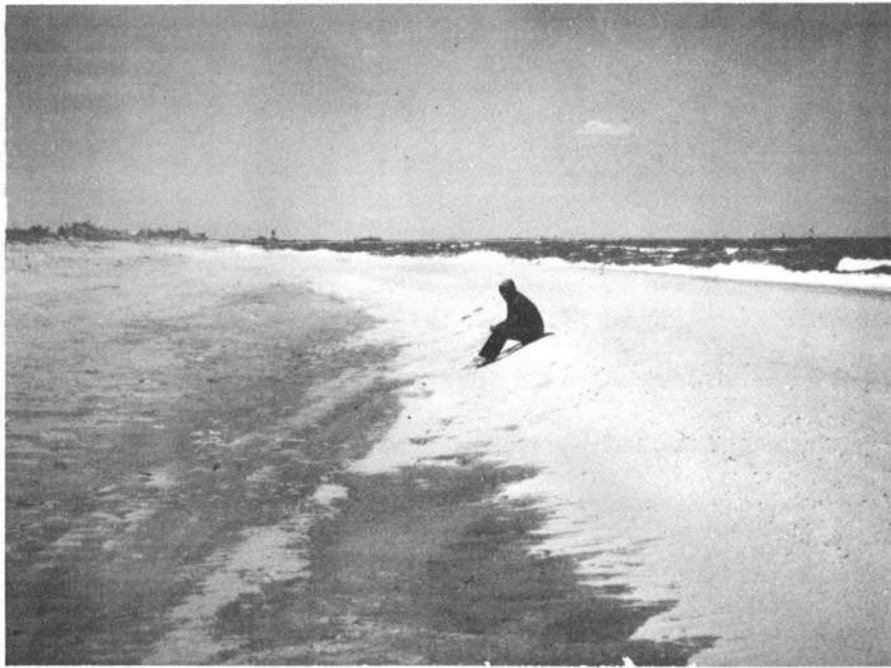
FIGURE 34 A Newly-Deposited Sand Ridge Along Eastern Lewes Beach

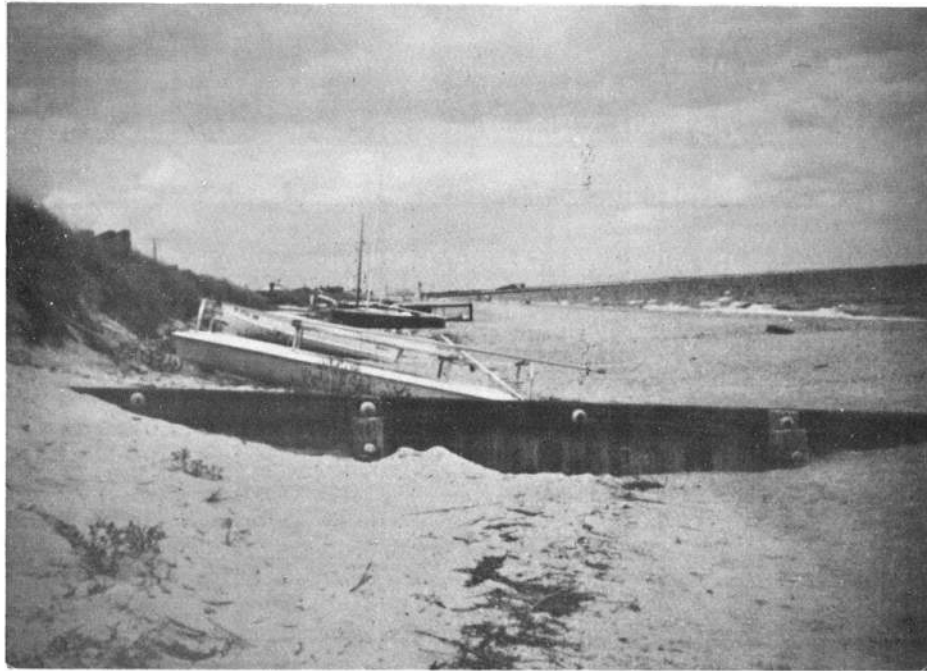
FIGURE 45 Initial Exposure of a Groin Along Lewes Beach, September, 1972 (Courtesy of Department of Natural Resources and Environmental Control, Delaware)

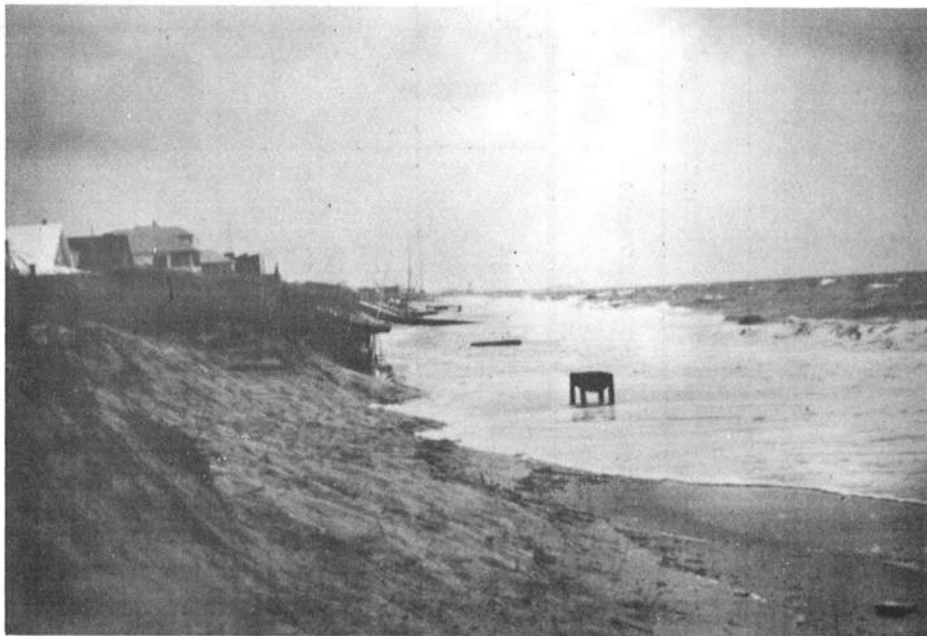
FIGURE 46 Advanced Stage of Erosion Along Lewes Beach, September, 1972 (Courtesy of Department of Natural Resources and Environmental Control, Delaware)

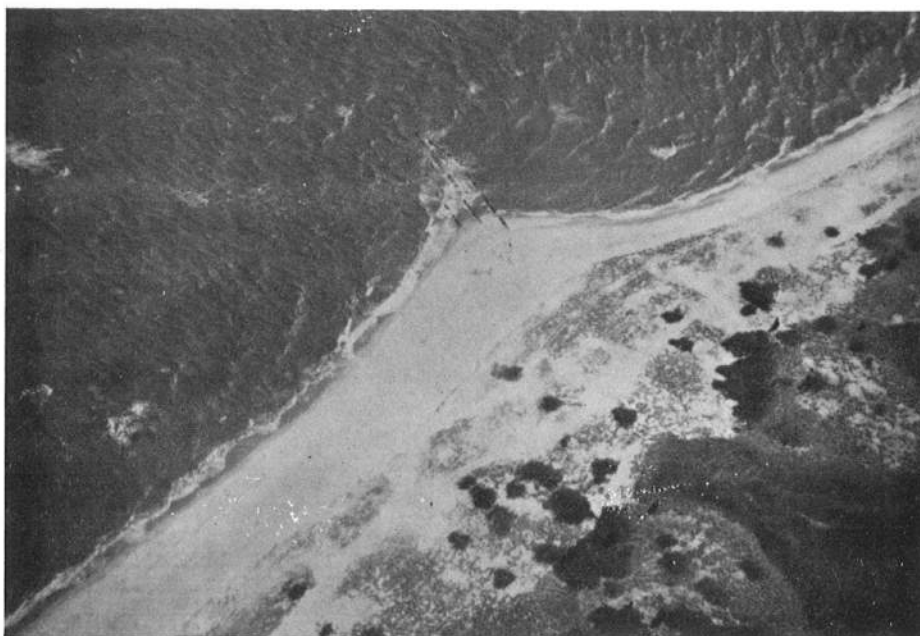
FIGURE 52 Stabilization Effect of the Wreck on the Adjacent Shoreline Along the West Beach
