A COASTAL ENGINEERING STUDY OF SHOALING IN OCEAN CITY INLET

**Ocean Engineering Report No. 19
July 1979**

**DEPARTMENT OF CIVIL ENGINEERING
UNIVERSITY OF DELAWARE
NEWARK, DELAWARE**

Sponsored by Baltimore District, U.S. Army Corps of Engineers

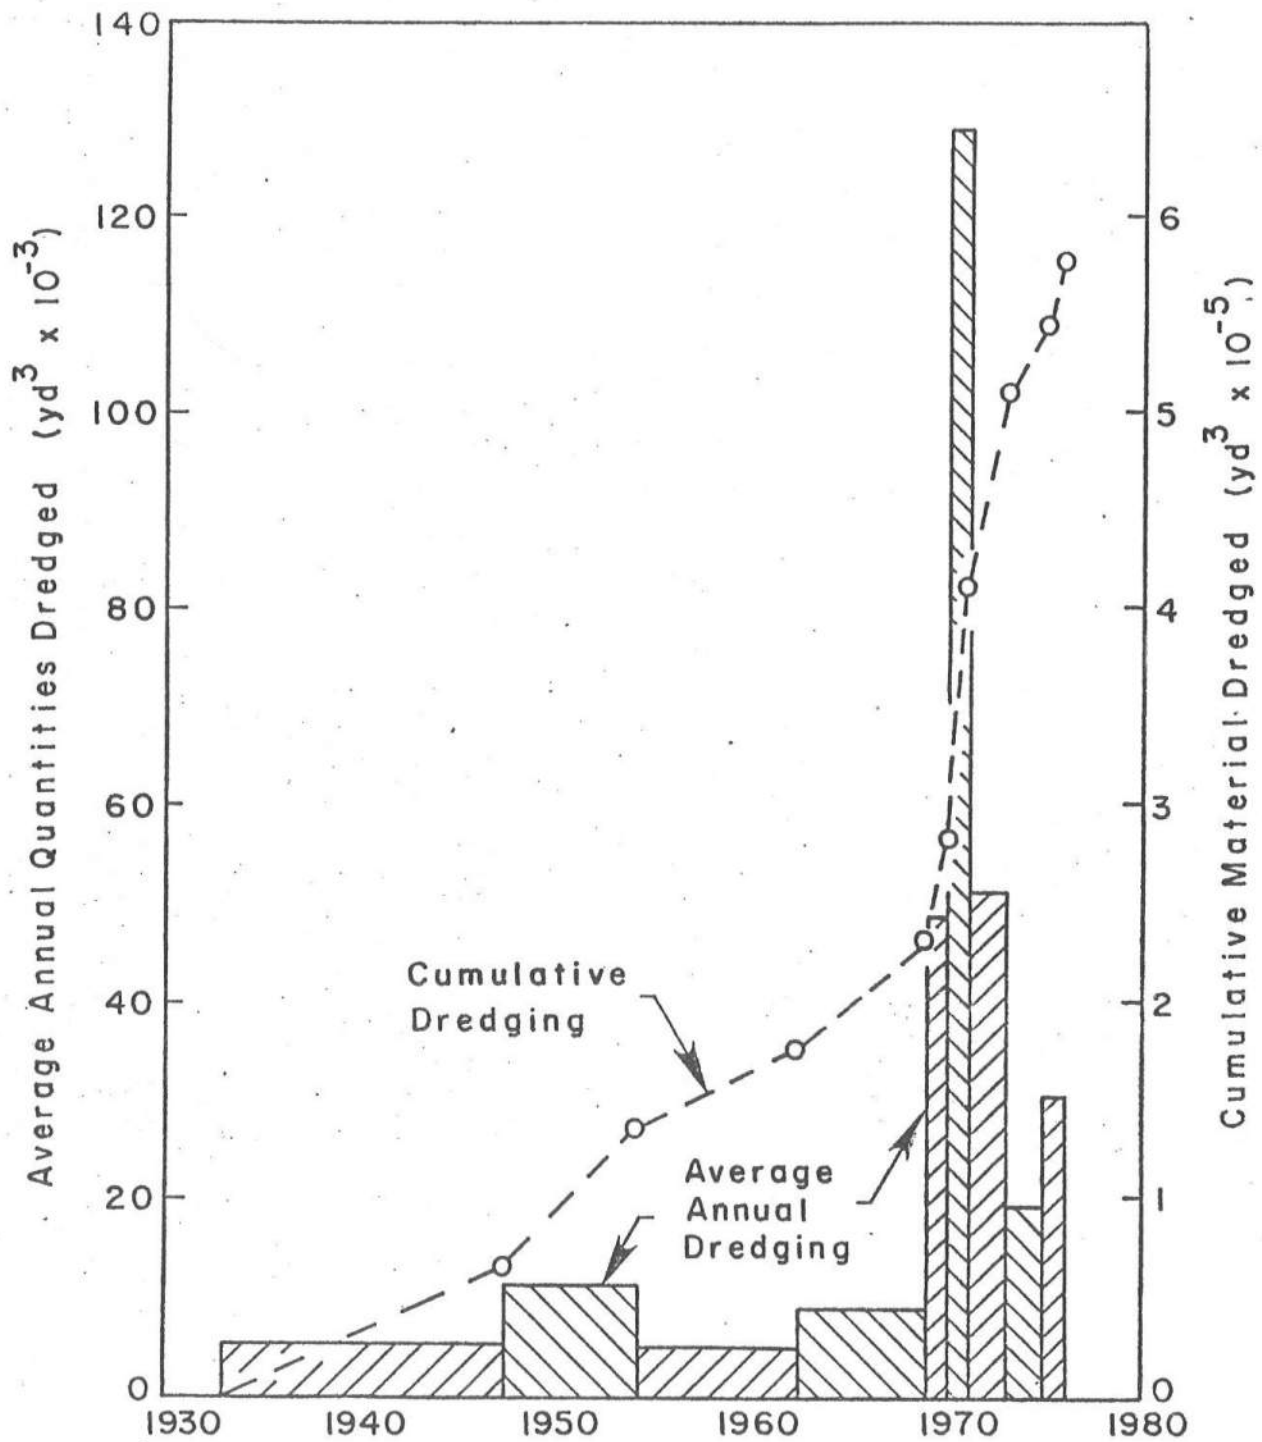
Figure 2. Average Annual and Cumulative Channel Dredging History in Area of Interest, 1933-1977.

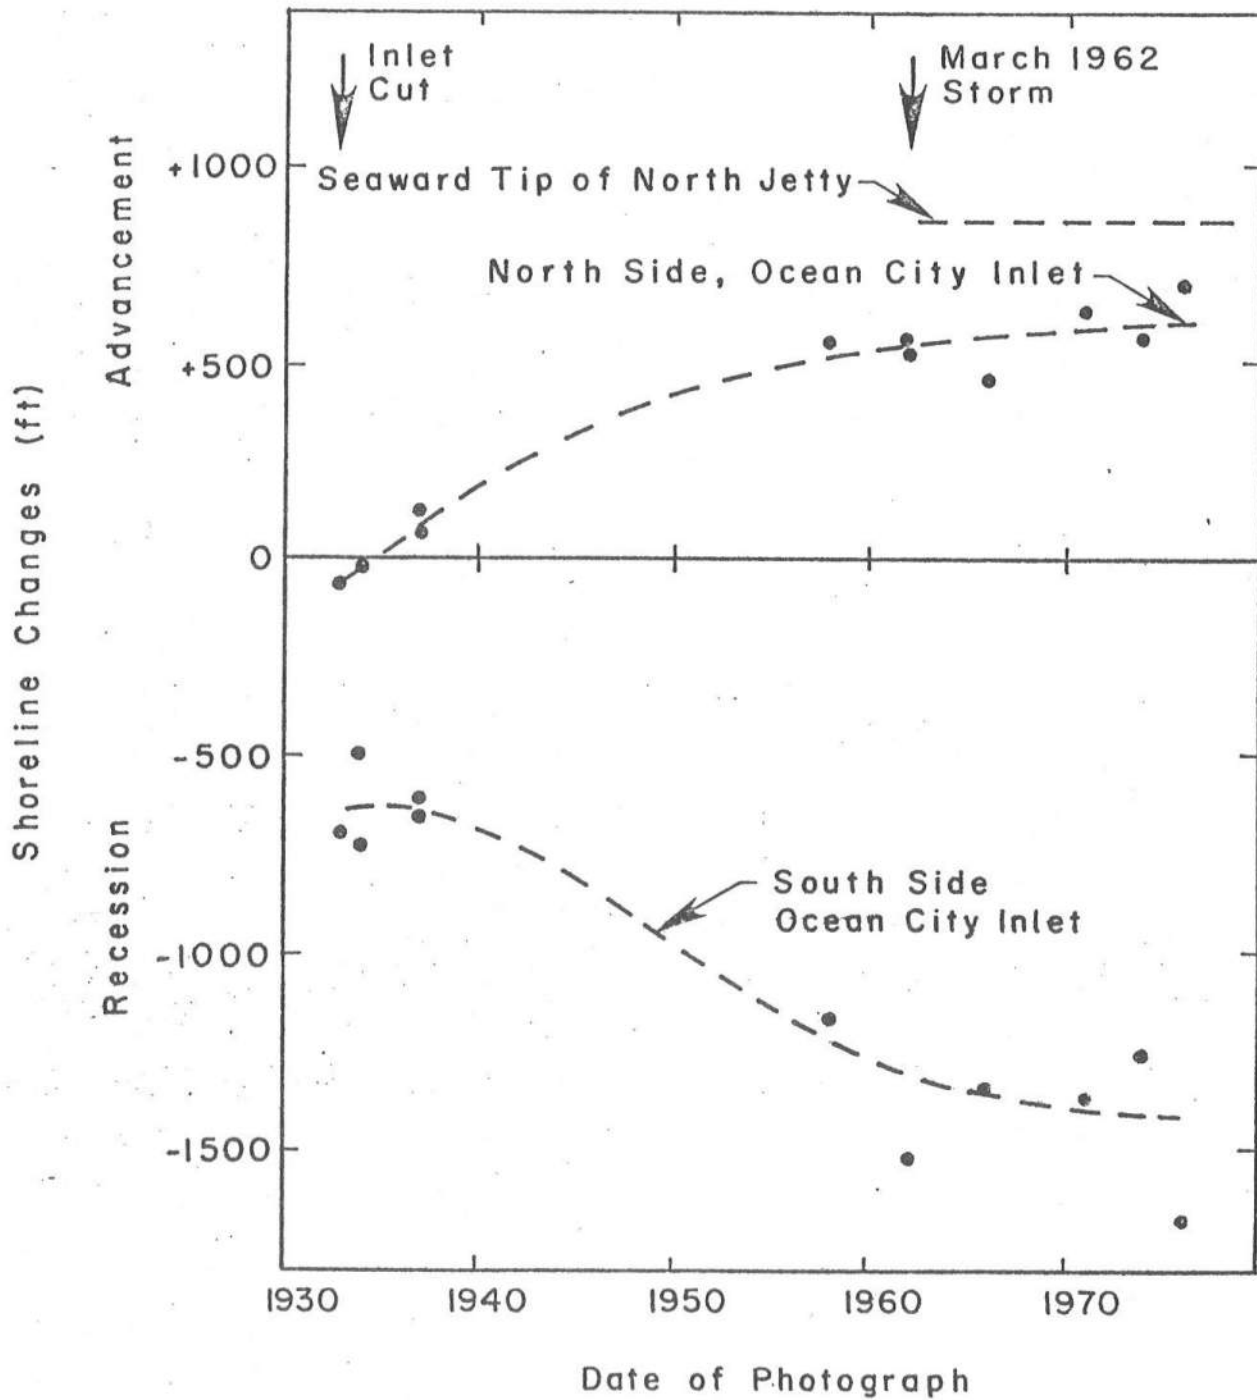
Figure 5. Variations in Locations of North and South Shorelines Immediately Adjacent to Jetties, Based on Aerial Photography.

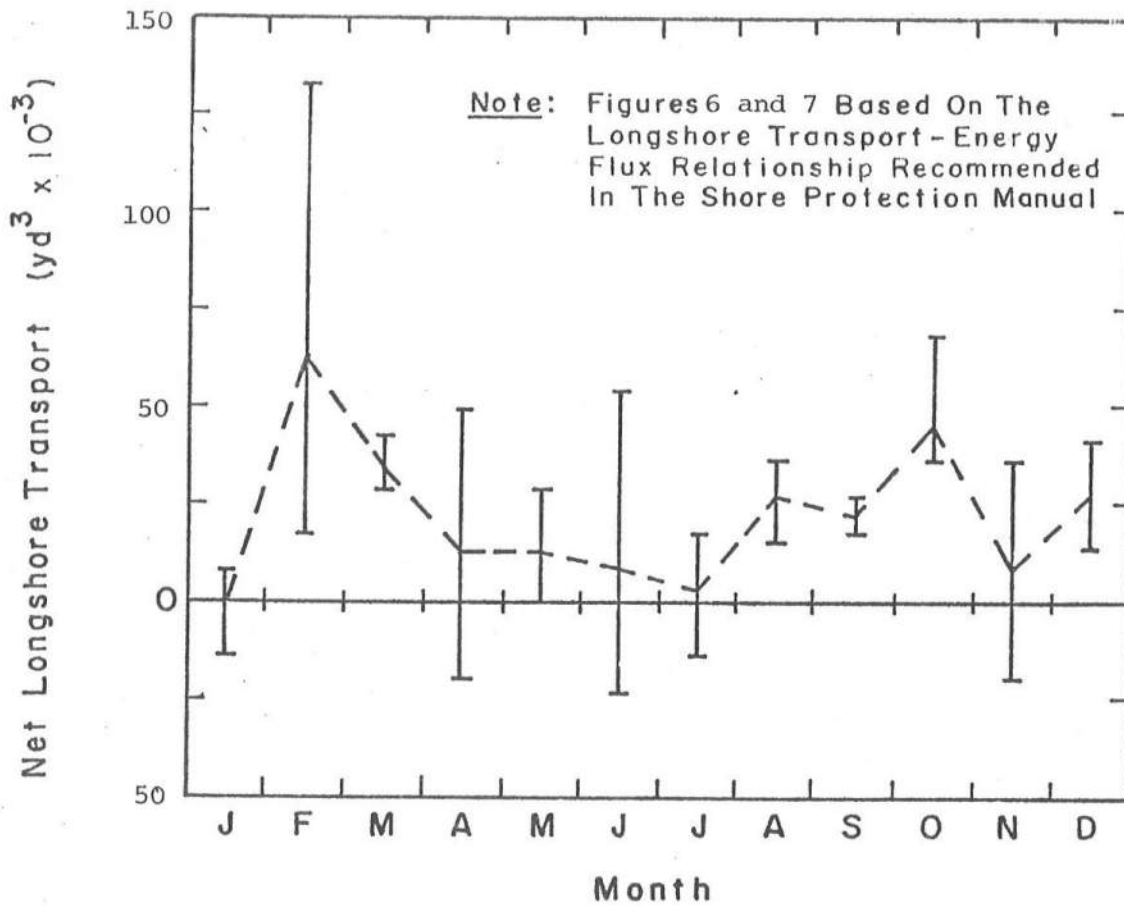
Figure 6. Averages and Ranges of Net Longshore Transport, Assateague Island, Based on LEO Data for the Years 1973, 1974 and 1975.

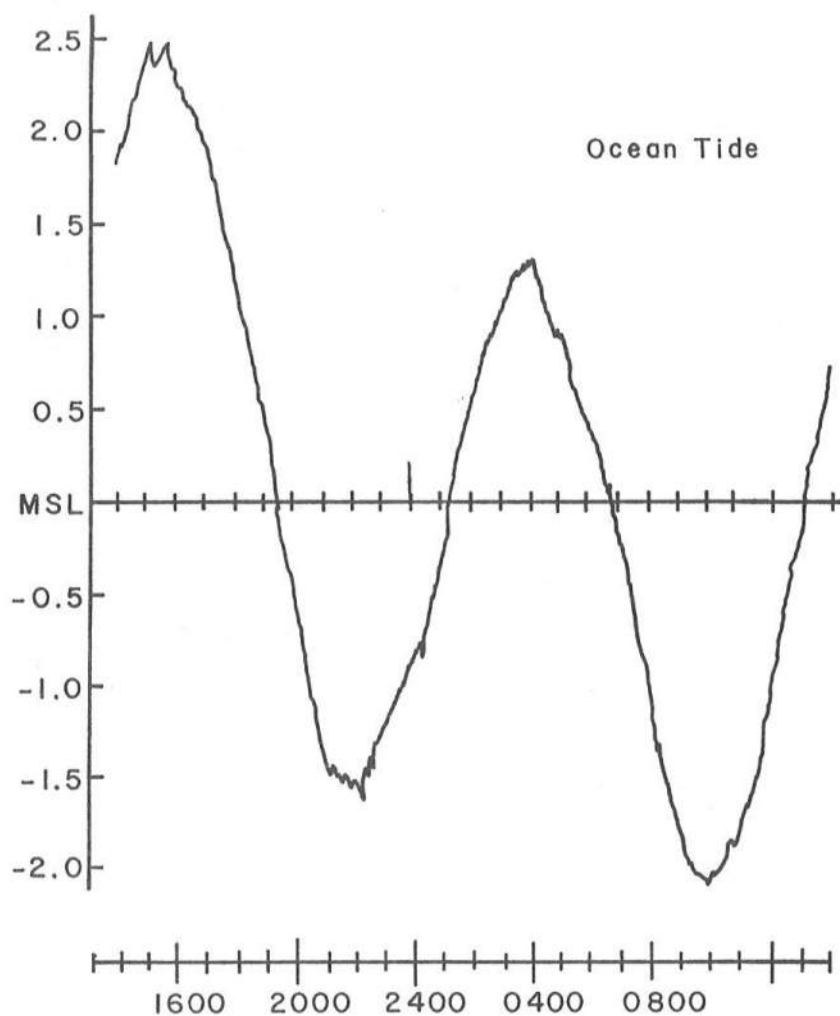
Figure 11. Sample Ocean and Bay Tide Records, August 4-5, 1976.

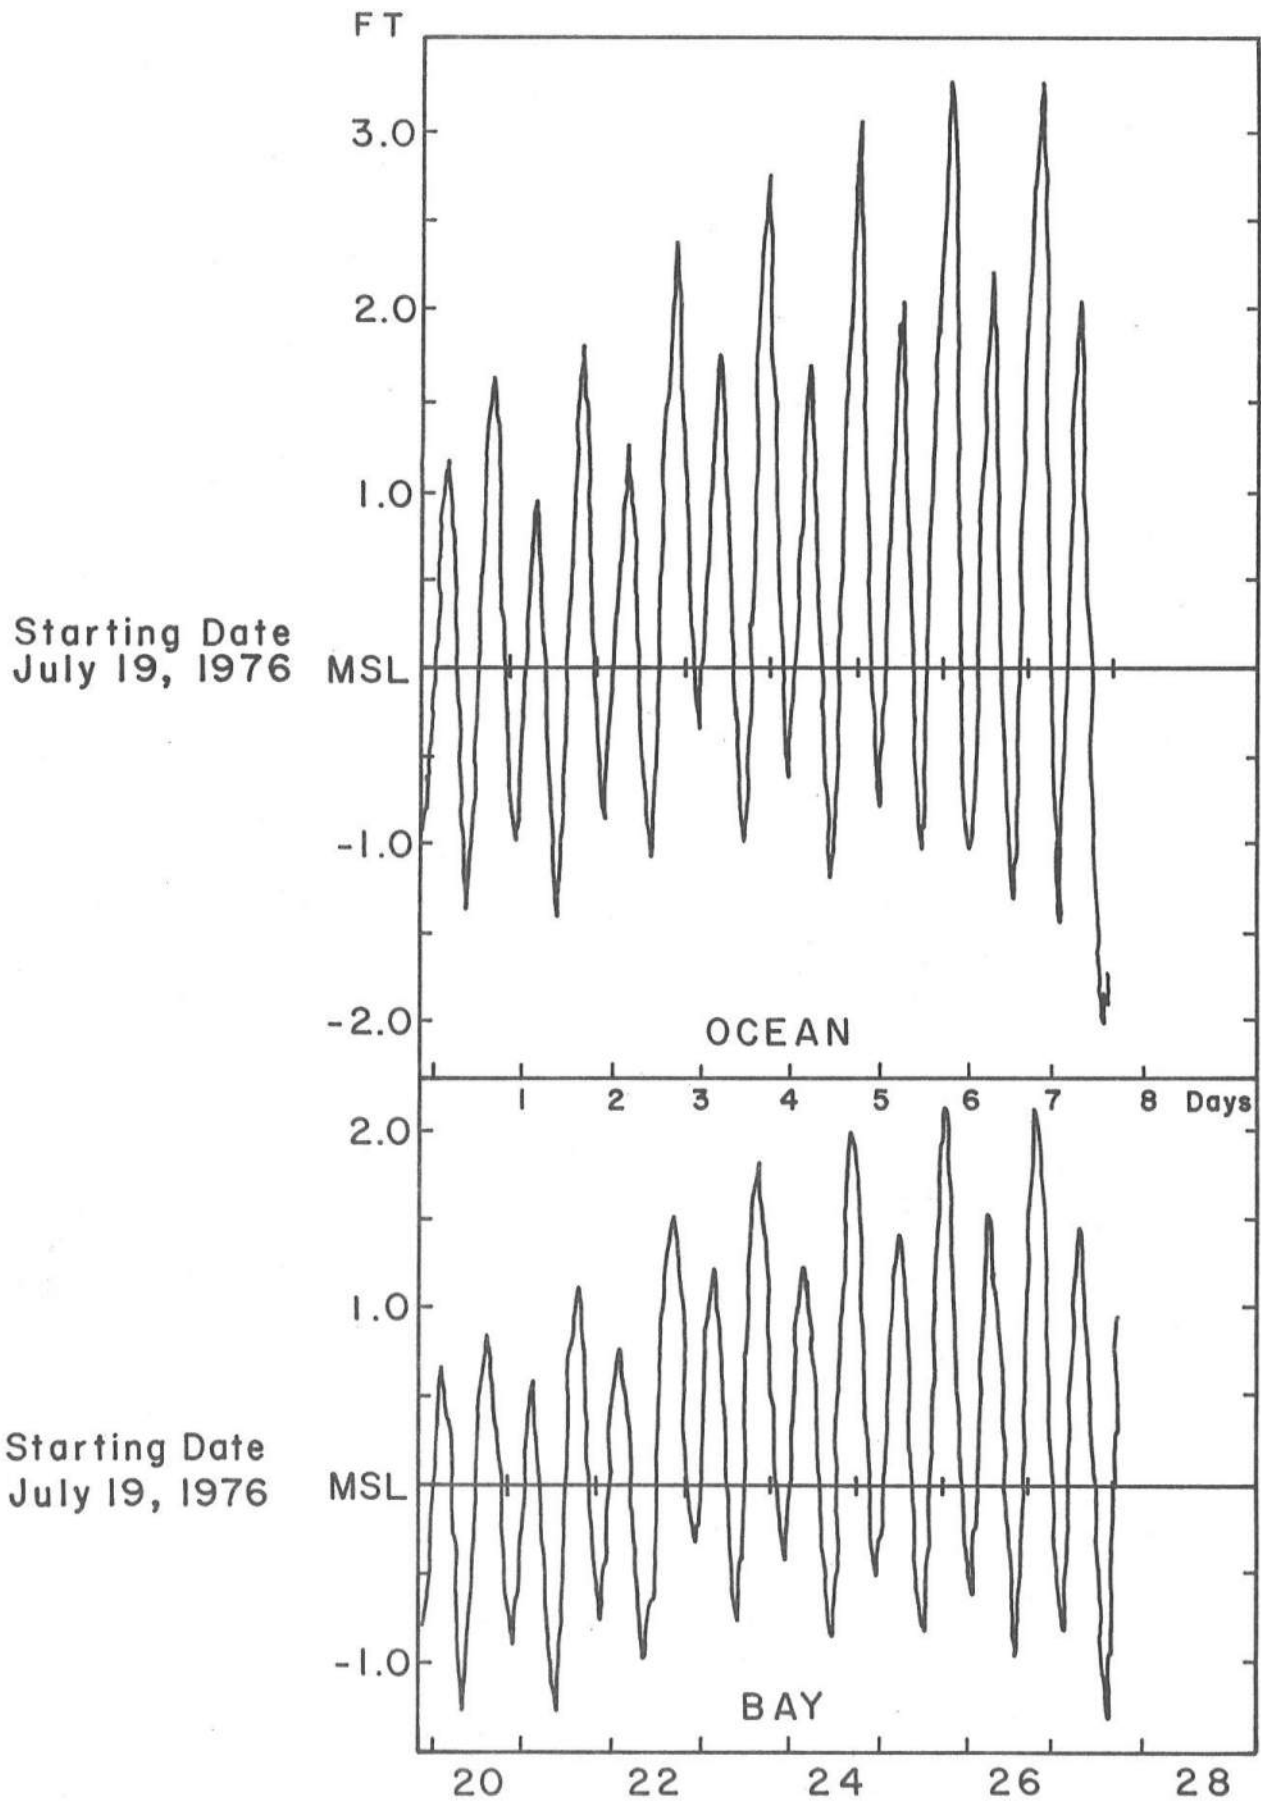
Figure 12. Sample Ocean and Bay Tide Records, July 19-26, 1976.

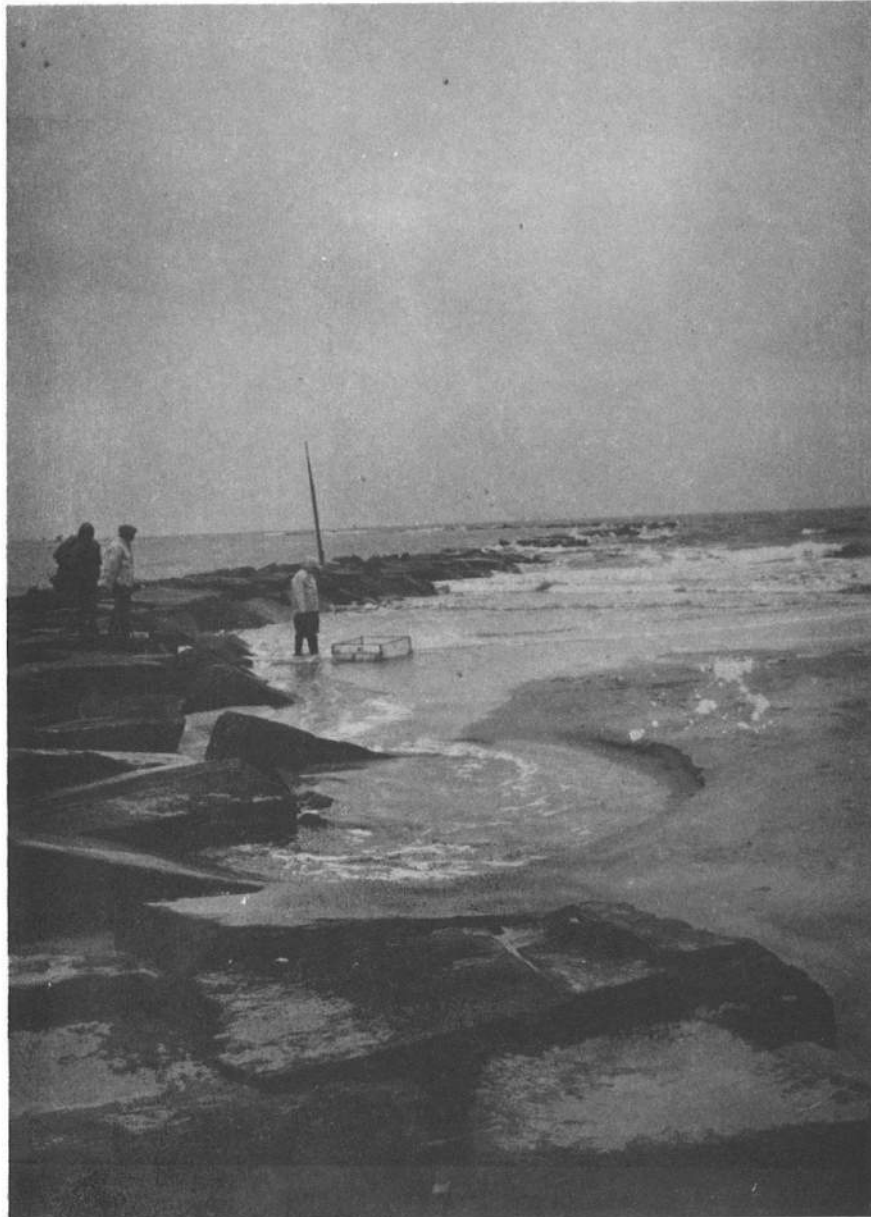
Figure 21. Photograph Showing Use of Sand Trap Looking East From South of South Jetty. Note Channel Transporting Water and Sand to and Through South Jetty.

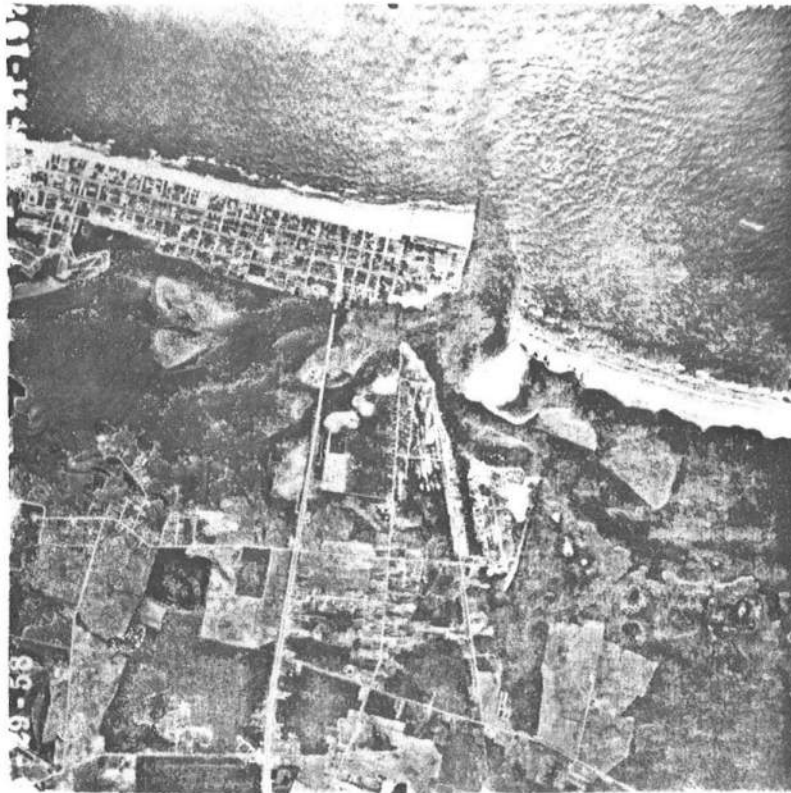
Figure 31. Aerial Photograph of Ocean City Inlet and Interpretation, May 29, 1958.

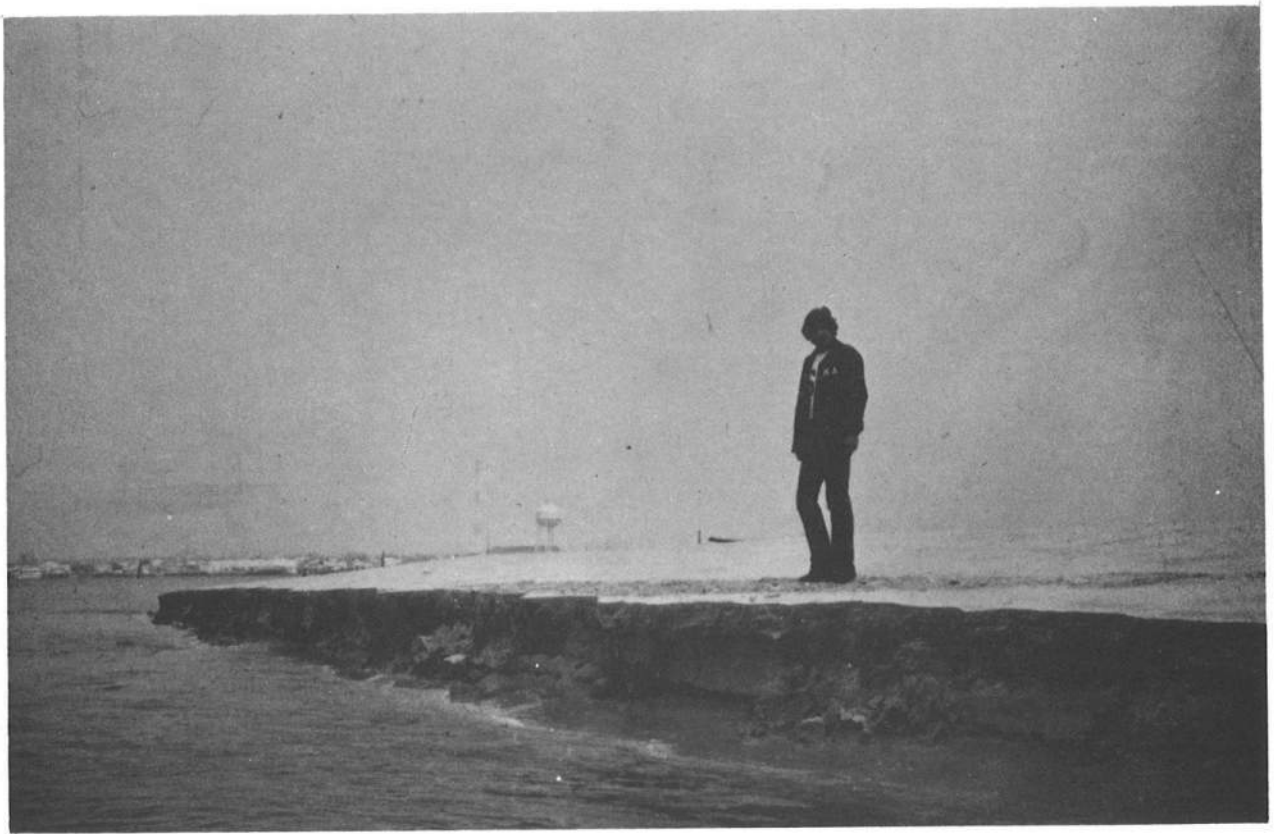
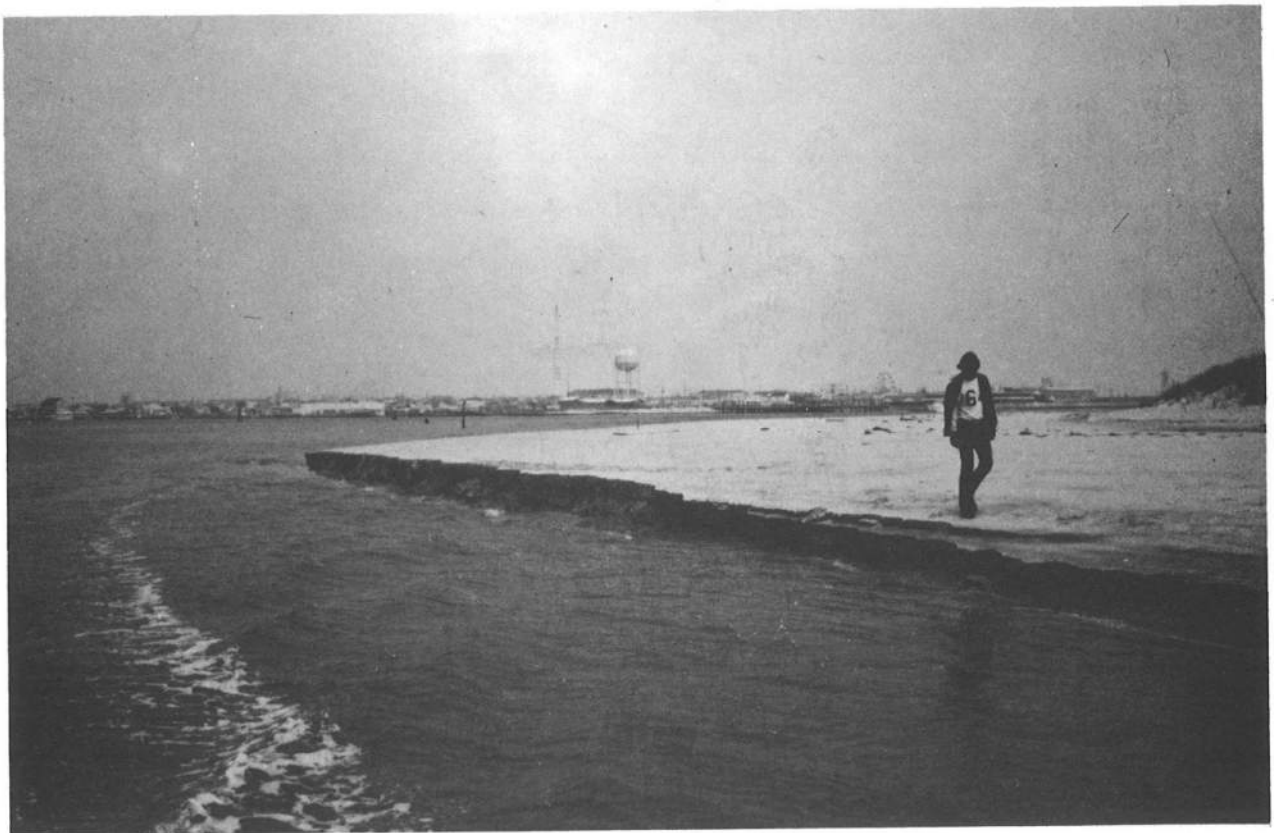
Figure 43. Photographs Looking Northeast Along Northwest Shoulder of Assateague Island Showing Scarp Cut by Spring Tidal Ebb Currents.
