# **Case History: Strain and Force Distribution in HDPE Reinforced Wall**

**Department of Civil and Environmental Engineering  
College of Engineering  
University of Delaware**

**July 2009**

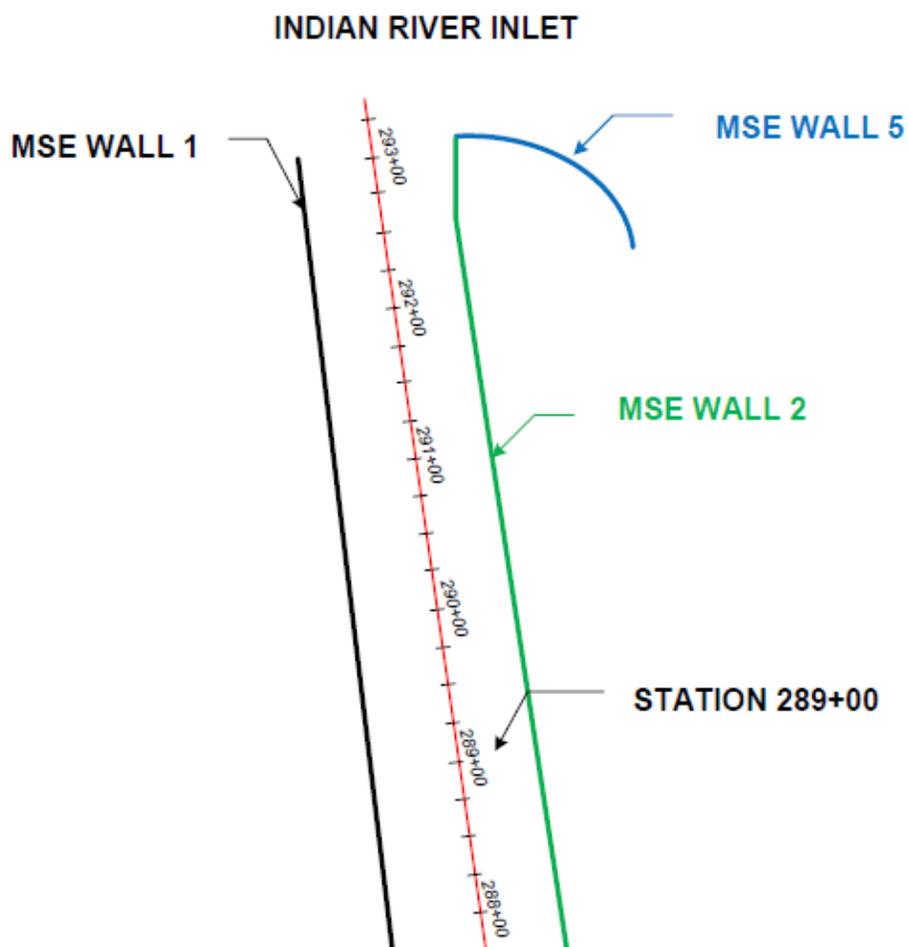
**Figure 2.1** Stationing and wall layout for south abutment, not to scale (Berkheimer, 2007).

in three months. Figure 2.1 shows the stations for the south abutment, as well as the MSE walls that were planned to support the approach slab and the abutment of the new Indian River Inlet Bridge.

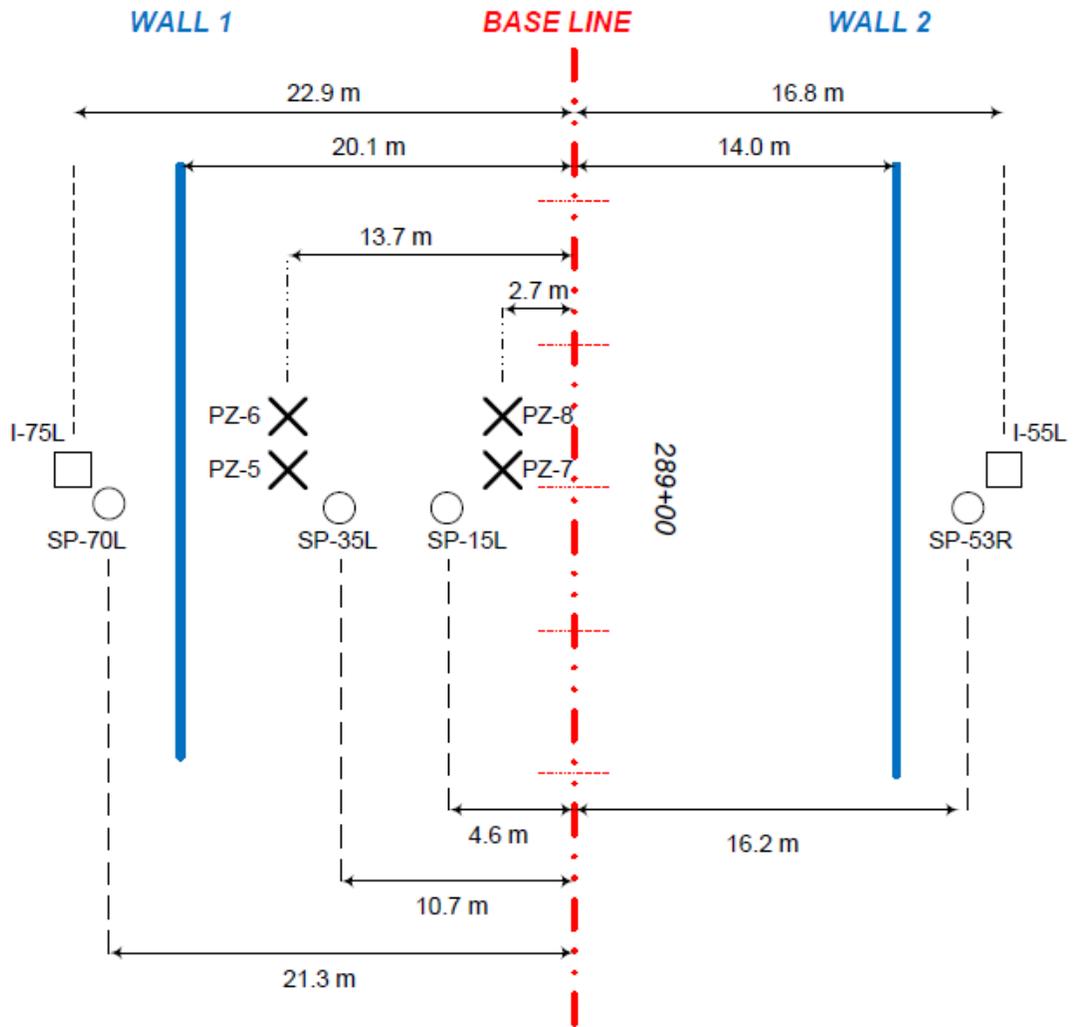
**Figure 2.2 Instrumentation locations at Station 289+00 (not to scale).**

Wall 1 at station 289+00 had been monitored with settlement plates, piezometers, inclinometers and wall targets until deconstruction of the embankment. The Delaware Department of Transportation (DelDOT) was responsible for this monitoring. DelDOT collected data, and shared it with the University of Delaware to compliment the data obtained by the monitored strain gages. Figure 2.2 represents the instrumentation locations at station 289+00.

Figure 2.2 shows the location of the four piezometers, each marked by an “X”, which were installed at Station 289+00. The piezometer data was collected weekly by DeIDOT. Figure 2.7 shows the change in pore water pressure with time (note that hydrostatic pore water pressures prior to the start of construction are not reflected in this graph, as it is  $\Delta u$  that is plotted). Details concerning the installation of these piezometers are shown in Table 2.3.

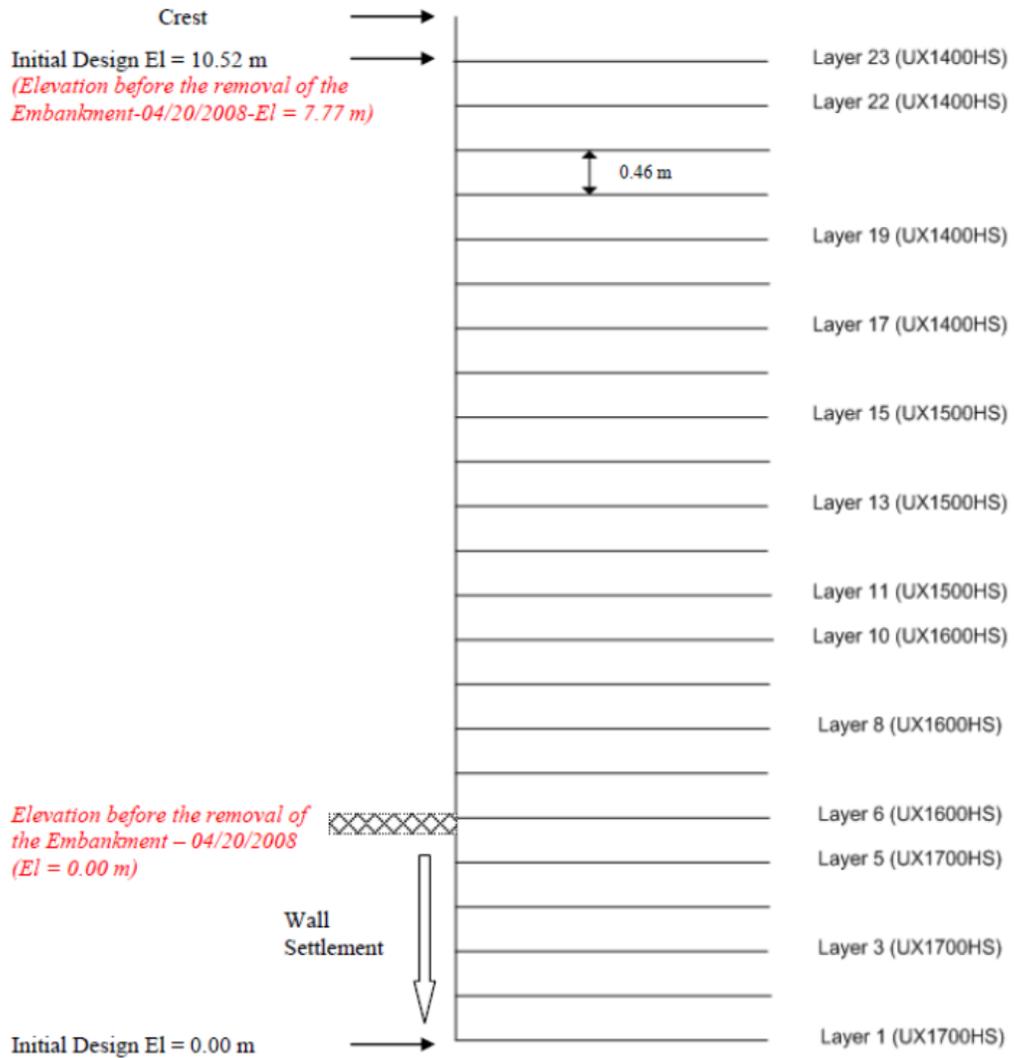
**Figure 2.3 Instrumented geogrid layers at Wall 1 Station 289+00.**

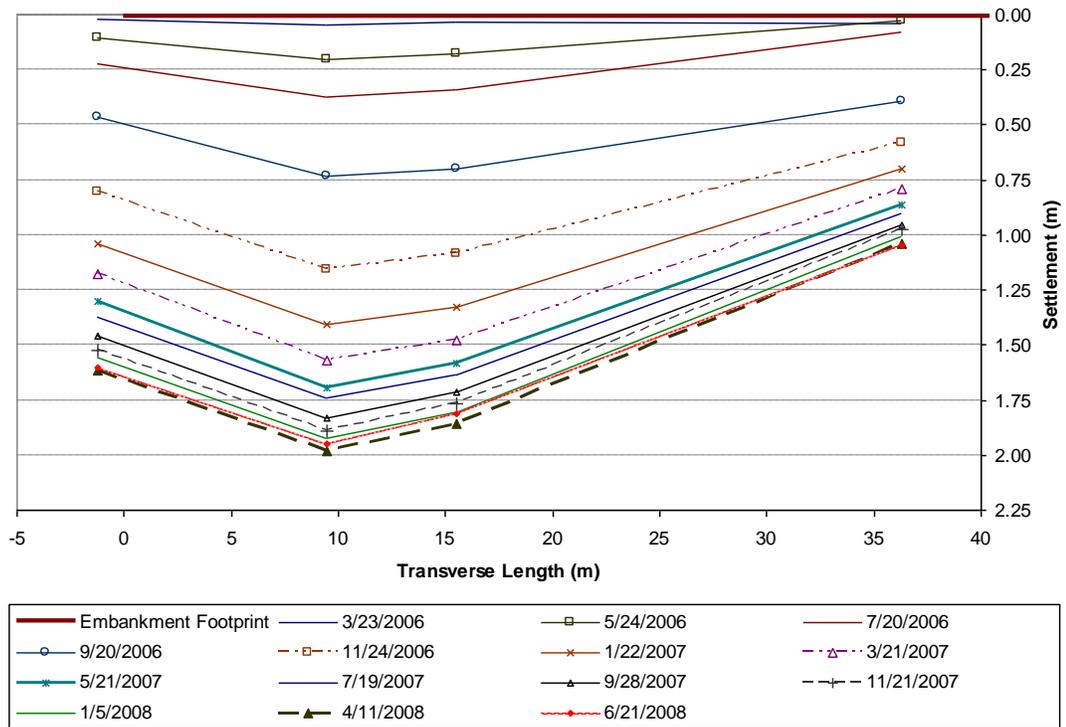
**Figure 2.5 Settlement profile for Station 289+00 (modified after Berkheimer, 2007).**

DelDOT obtained and recorded all measurements and elevations necessary for accurate determinations of settlement data during and after the construction of the embankment. Figure 2.5 represents the settlement profile of station 289+00. It must be noted that the settlement plate 289-53R present smaller settlement than the actual one, since the data for this plate was recorded with a delay of 10 weeks.

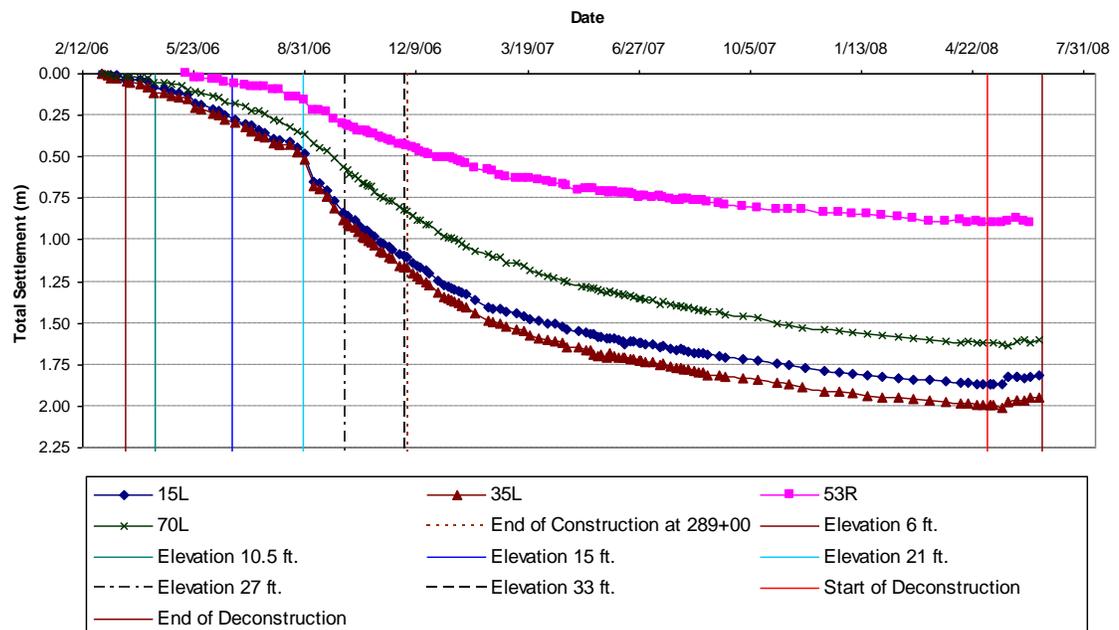
**Figure 2.6 Magnitude of settlement at Station 289+00(modified after Berkheimer, 2007).**

removal, and that more settlement would have likely occurred. However, the asymptotic portions of the curves demonstrate that the soil was likely nearing the end of consolidation at the time of embankment removal.

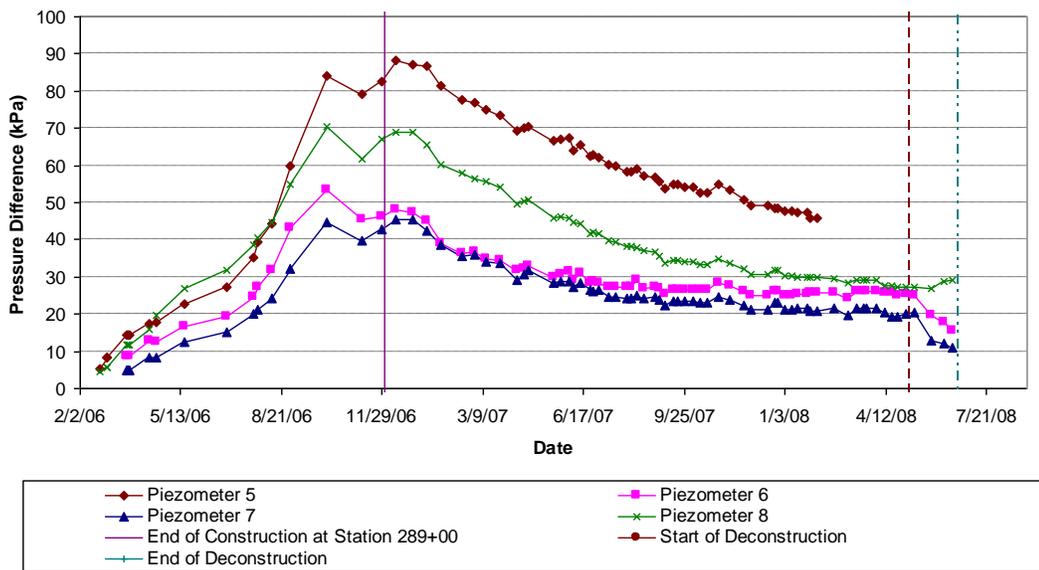
**Figure 2.7 Change in pressure difference with time at Station 289+00 (modified after Berkheimer, 2007).**

Figure 2.7 shows that the excess pore water pressure in the foundation soil increased due to construction of the embankment and dissipated at a slow rate after completion of embankment construction. Piezometer 5 stopped working on 02/04/2008. After embankment removal, there was a rapid decrease in excess pore water pressure due to unloading that was observed, which is expected. Interestingly, this behavior was not reflected in the pore pressure response recorded by piezometer 8. This observation, coupled with the significantly higher increases in pore water pressure that was observed for piezometer 8 (as compared with piezometer 7, which is at the same elevation) at the start of excavation might be an indication that the piezometer 8 readings might not be entirely reliable.

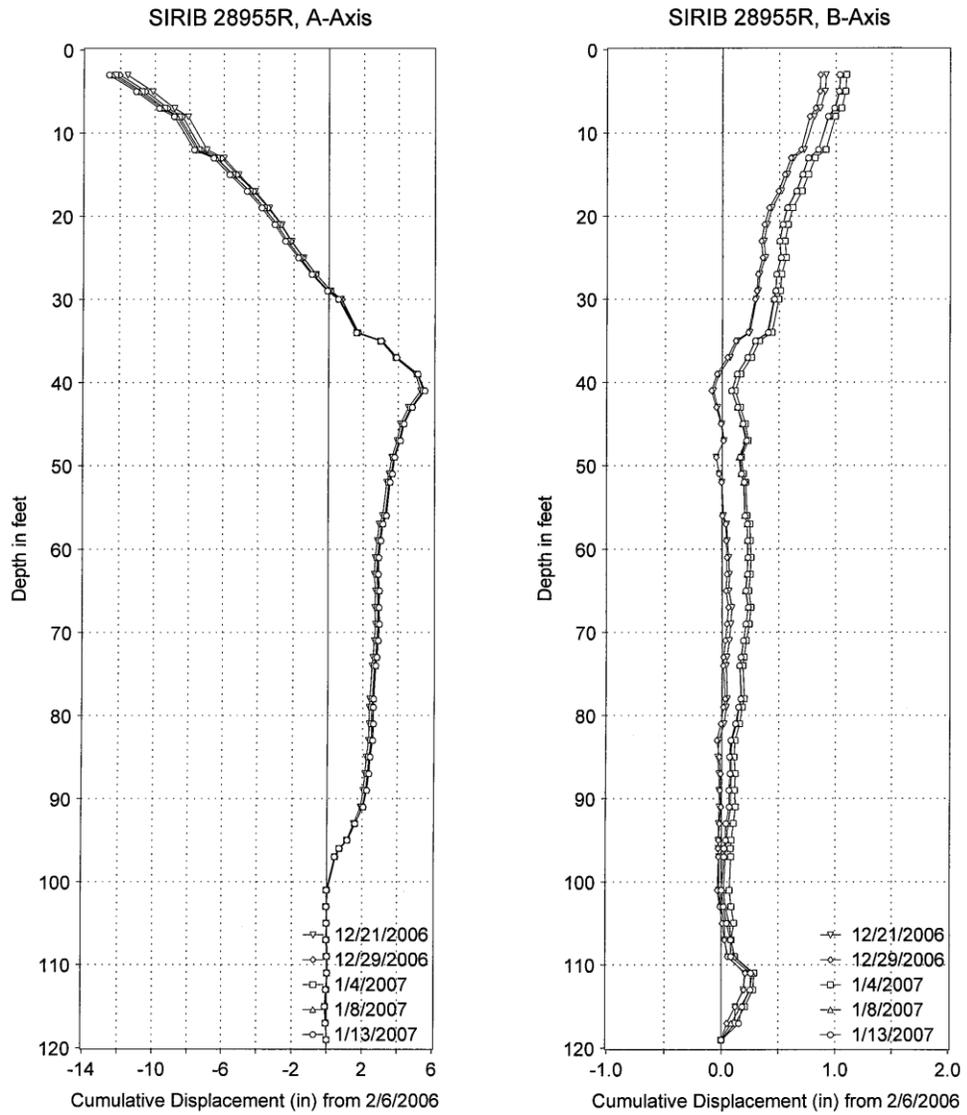
**Figure 2.8 Inclinometer 289-55R data: 12/21/06 – 1/13/07.**

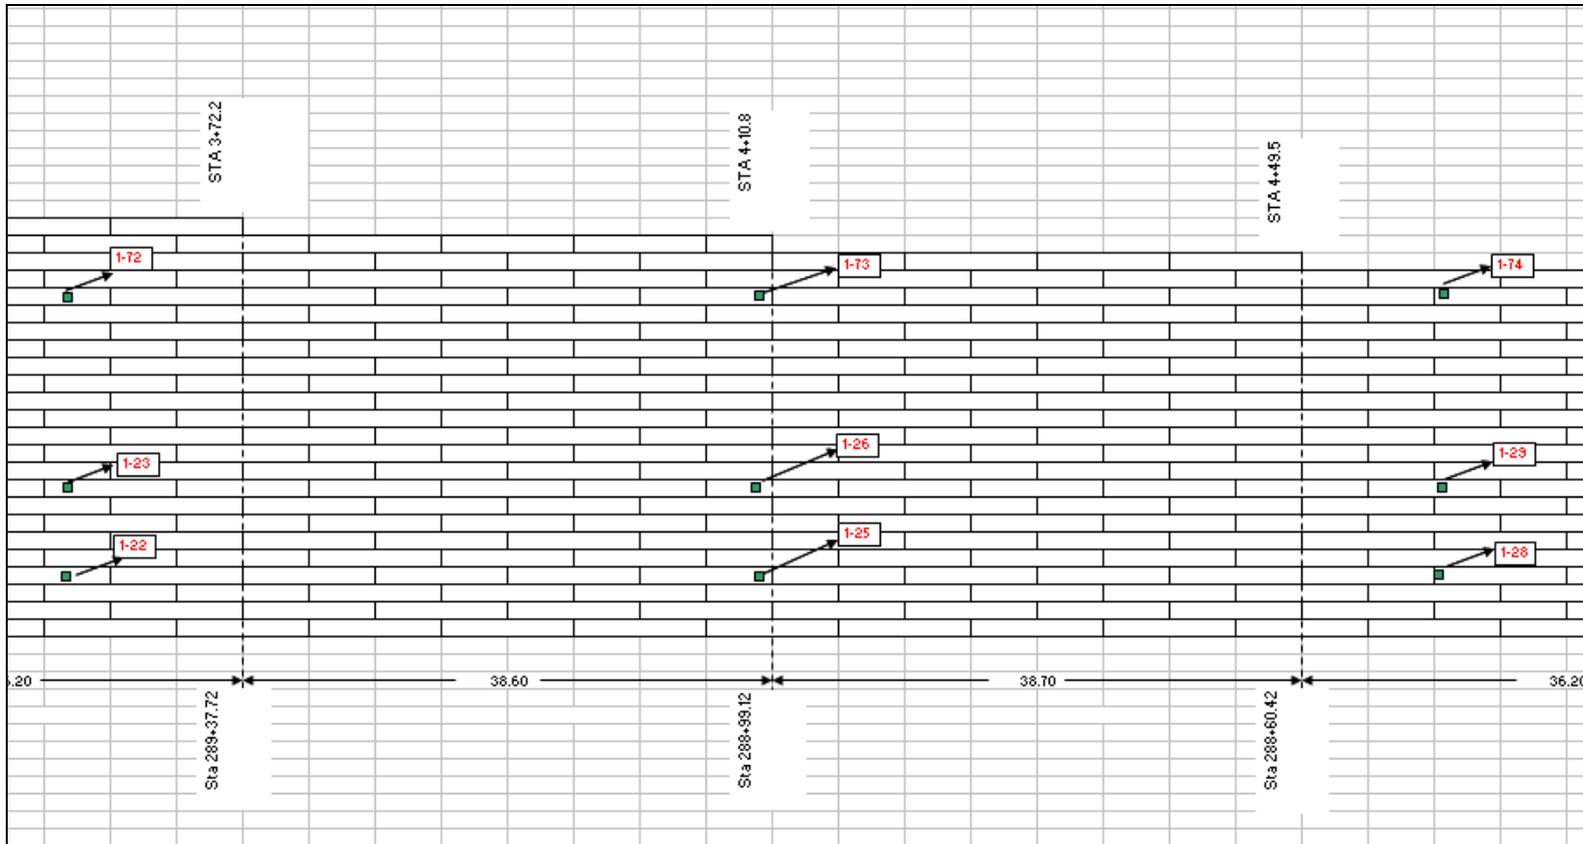
Figure 2.12 Wall target placement at Wall 1 Station 289+00 (not to scale).

Readings of the installed wall targets were taken by DeIDOT. Figure 2.12 presents the placement of the wall targets at Wall 1 Station 289+00. Wall target 1-26 was installed on layer 9 at 4.1 m (13.5 ft) elevation on 07/10/2006 and wall target 1-73 was installed on layer 20 at 9.1 m (30 ft) elevation on 10/19/2006. It should be noted that these elevations changed over time due to the high degrees of settlement that were observed. Wall target 1-25 was installed on 07/10/2006 and became inoperable on 11/05/2006 due to the significantly large amount of settlement that was observed; consequently, it is not presented in the figures. Figures 2.13 through 2.15 present the wall target data.

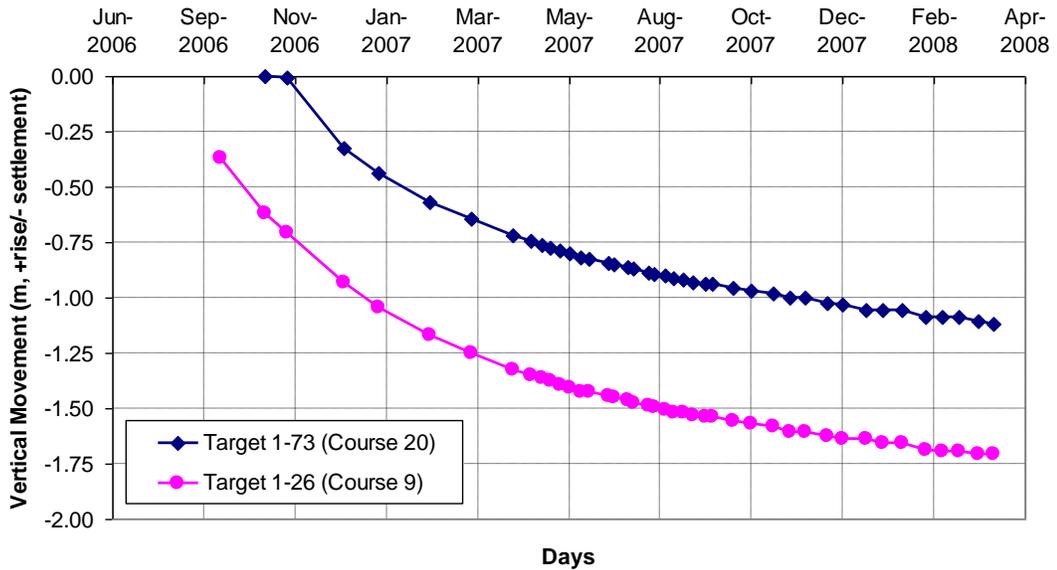
Figure 2.13 shows the vertical movement of Wall 1 at Station 289+00, as recorded by the surface-mounted wall targets. It should be noted that this figure does not present a complete vertical displacement record, since the targets were installed at dates after the construction started. For instance, wall target 1-26, which was installed five months after the start of construction, indicates almost 1.8 m (6 ft) consolidation. However, it is also essential to consider the settlements that occurred during the first 5 months, which means that the vertical movements in Wall 1 Station 289+00 probably significantly exceeded 1.8 m (6 ft). In addition, it can be observed in Figure 2.13 that although the vertical movement was still in progress, the vertical movement was nearing a more stable situation at the time of embankment removal (as evidenced by the asymptotic portions of the curves). Displacements obtained from settlement plates (Section 2.1.2) and inferred from wall target measurements showed good agreement.

**Figure 2.13 Vertical movement versus time Wall 1 Station 289+00 (modified after Berkheimer, 2007).**

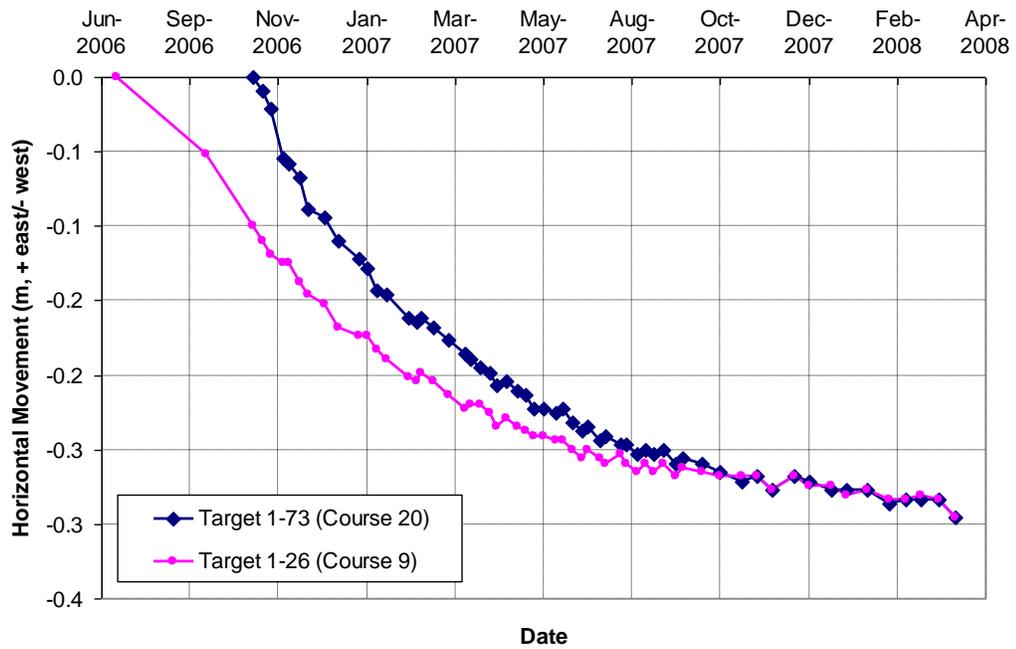
Figure 2.14 presents the horizontal movements of Wall 1 Station 289+00. Again, it should be noted that this figure does not present a complete horizontal displacement record, since the targets were installed at dates well beyond the commencement of construction. The data in Figure 2.14 indicates that the embankment moved about 0.3 m (1 ft) towards the west. To track the rate of horizontal movement, the measured change in horizontal movement between measurements was divided by the interval time between the measurements to determine the movement velocity in meter per day (Figure 2.15). As construction of the embankment continued, the horizontal movement rates tended to increase due to the additional load application over time, which triggered a movement response in the

underlying soil. Over time, the movement rates decreased, which indicates that that the system was likely becoming more stable.

**Figure 2.14** Horizontal movement versus time Wall 1 Station 289+00 (modified after Berkheimer, 2007).

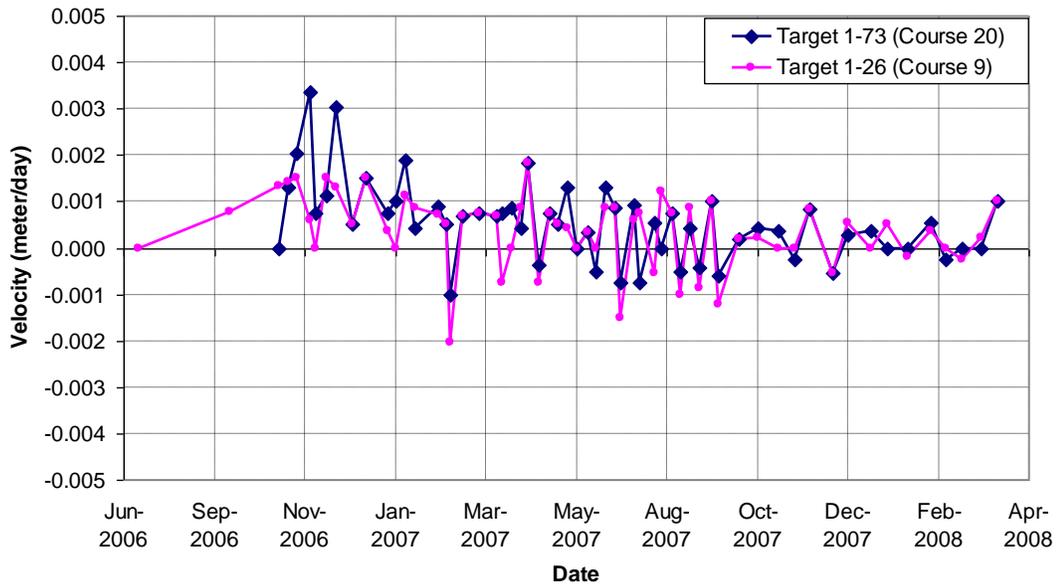
**Figure 2.15 Horizontal movement rates versus time Wall 1 Station 289+00 (modified after Berkheimer, 2007).**

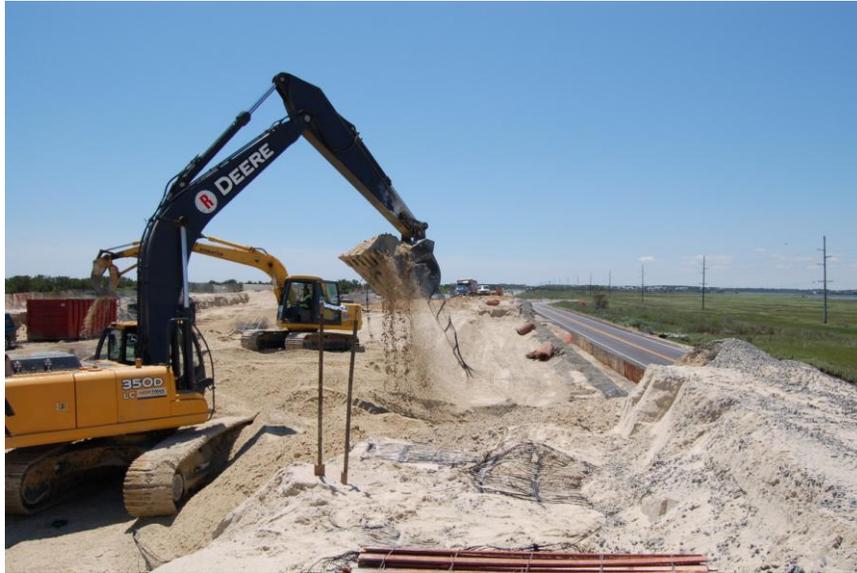
**Figure 3.2** Removal process often damaged the embedded geogrids, mainly at locations different than Wall 1, Station 289+00 (6/2/2008).

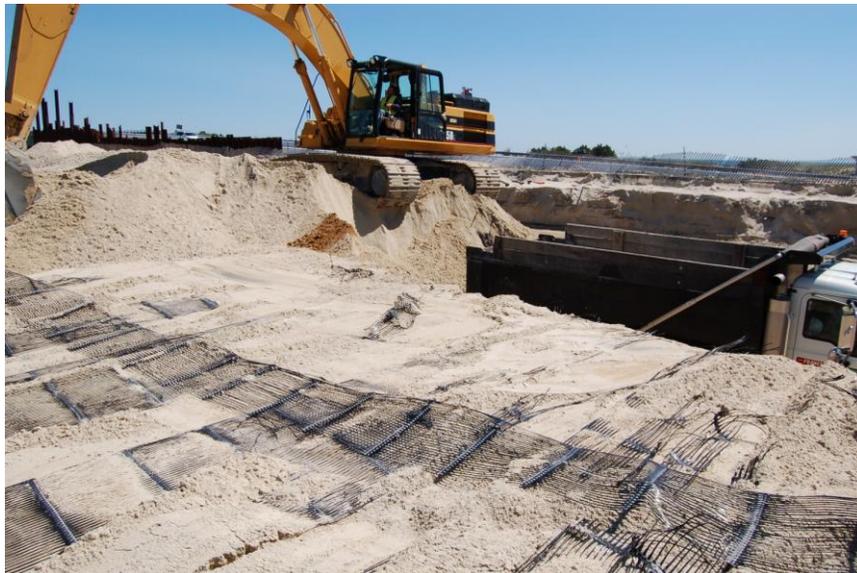
**Figure 3.3** Exposed geogrids, some damaged, and backfill loaded into a truck (6/2/2008).

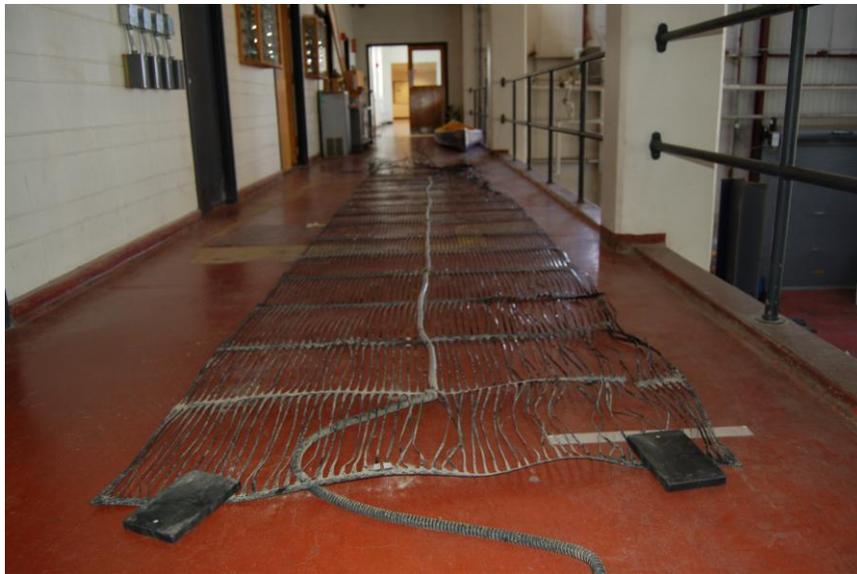
To measure  $L_c$ , each geogrid panel was placed flat on a concrete floor as shown in Figure 3.11. The distance between transverse ribs in undamaged sections was measured using a 600 millimeters long digital caliper with an accuracy of 0.01 mm. There are about 70 apertures per panel between two adjacent ribs. About 10 measurements of each aperture were taken and the average value was used to define the representative  $L_c$  along the length of the panel. In this initial process, the readings were inconsistent, potentially implying that the measurement procedure is deficient.

**Figure 3.11** Recovered geogrid placed flat on concrete floor to measure the post-construction aperture sizes (5/25/2008).

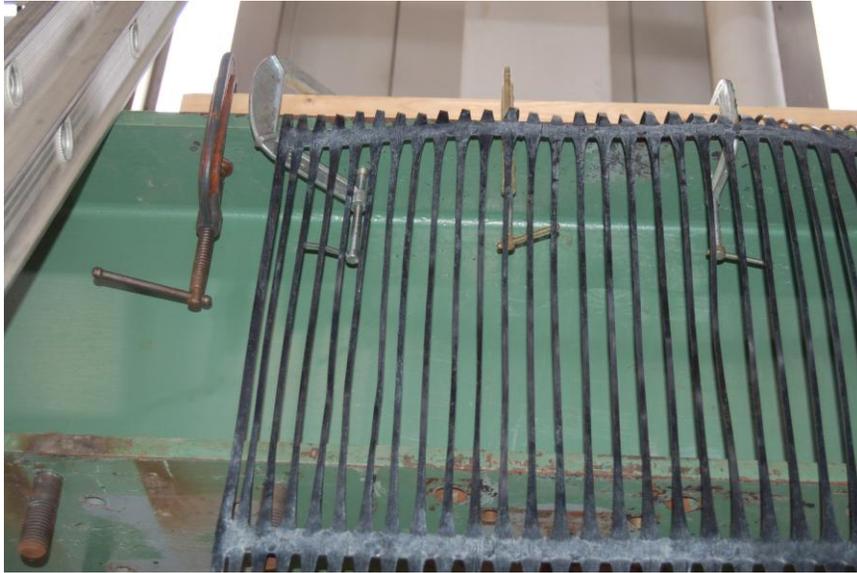
Attempted refinement of this approach led to the use of directly clamped wooden beams on either side of the geogrid, in an attempt to “grab” and evenly hold the geogrid without applying the potentially damaging stress concentrations that were observed with the “hooking” method (Figures 3.15 and 3.16). This technique did not work efficiently. The geogrids were damaged at the top and at the bottom section of the panel. Also, it was difficult to hang weights on the bottom. Further refinement was attempted by using iron bars threaded through the geogrid apertures to hang the geogrid (Figures 3.17 and 3.18). As shown in Figures 3.17 and 3.18, this approach did not work well either, as it damaged the geogrid and did not allow for an accurate aperture length measurement with the caliper.

**Figure 3.15** The geogrid held and stretched by clamping its top between the wooden beam and the steel girder (7/10/2008).

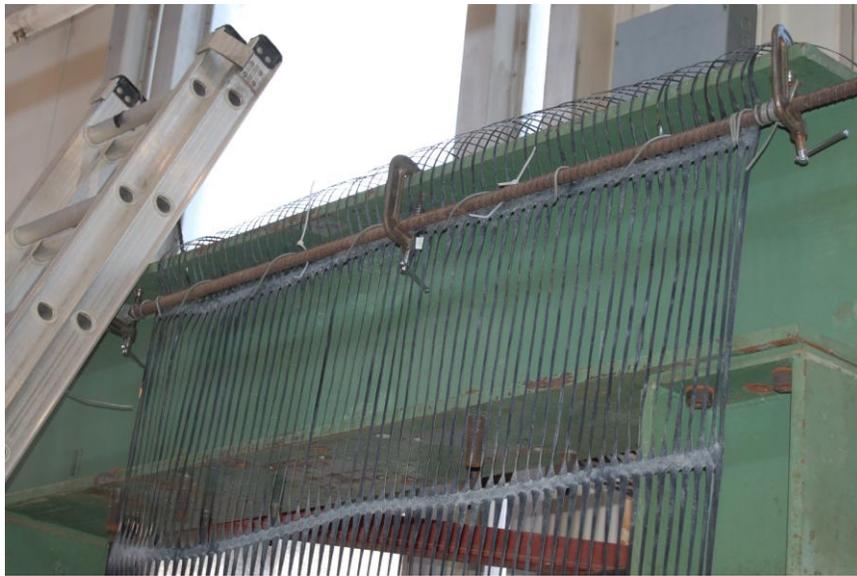
In the final refinement, a flexible cable was used to attach the geogrid panel to the iron bar. This modification led to a tension load that was distributed uniformly across each geogrid panel. This type of connection did not damage the geogrid as did other techniques.

**Figure 3.19 Flexible cable attaching the geogrid panel to a fixed iron bar (7/17/2008).**

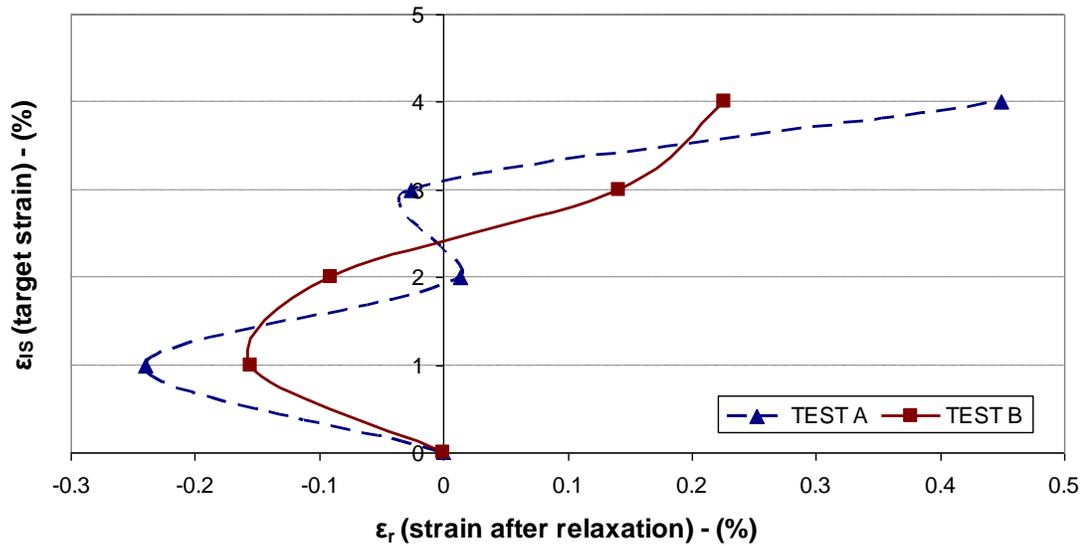
**Figure 3.24 Results of Test A & Test B attempting to simulate relaxation after inducing a history of rapid loading and unloading.**

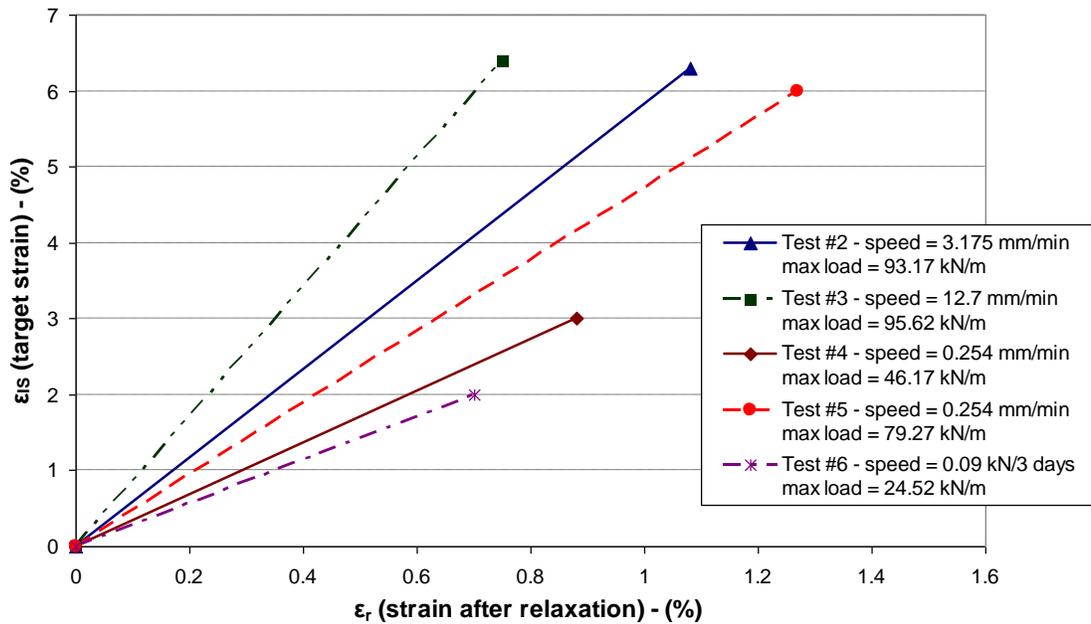
**Figure 3.33 Tests attempting to establish the relationship between total strain, residual strain and load.**

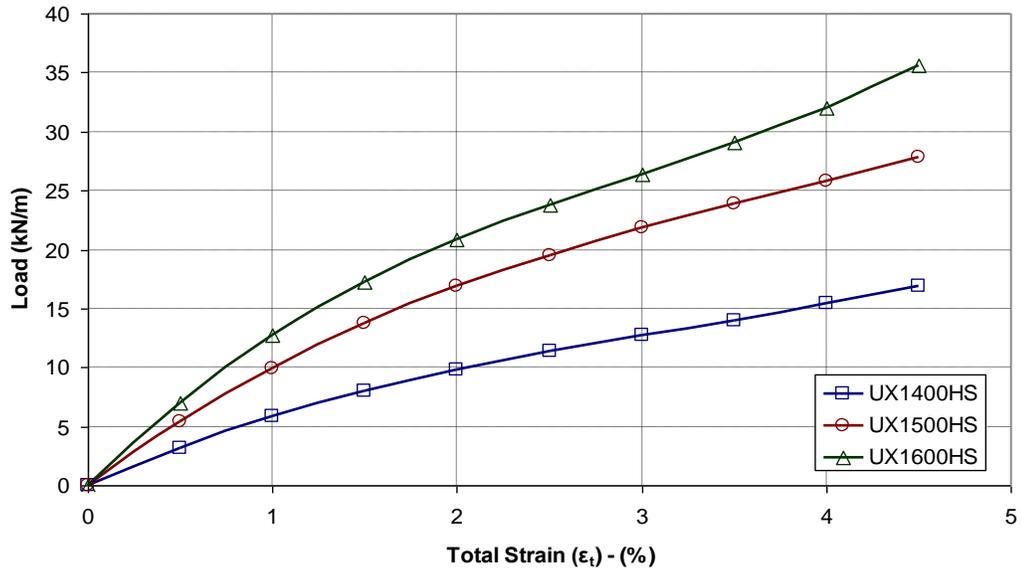
**Figure 4.17 Summary chart of load versus total strain.**

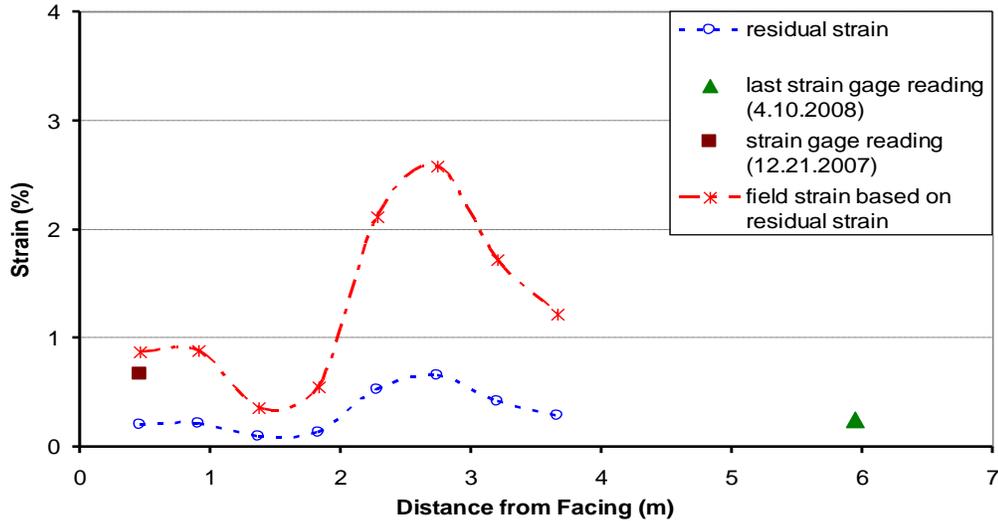
Figure 5.1 Strain distribution of the exhumed geogrid (Layer #23).

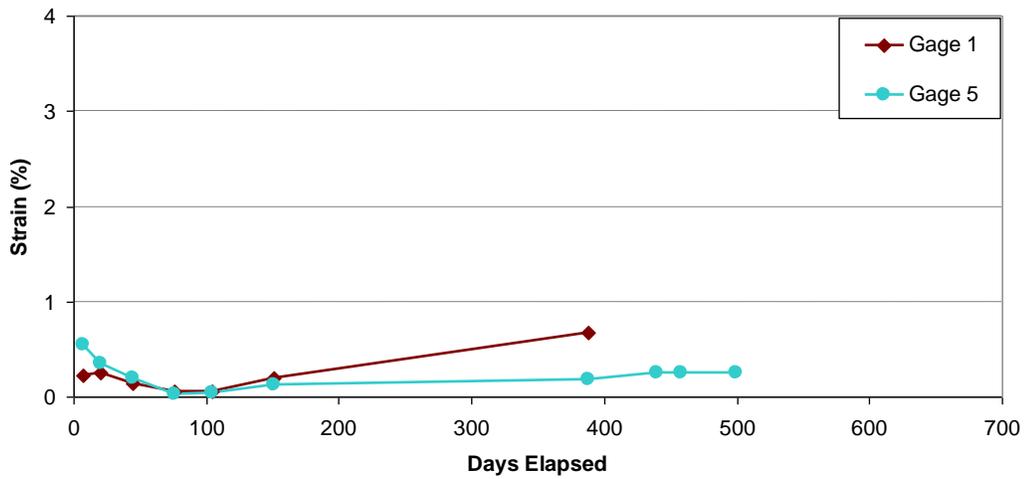
**Figure 5.2** Field strain gage measurements from the installation date to the removal date (end of construction coincides with installation of this final layer 12/01/2006) (modified after Berkheimer, 2007) (Layer #23).

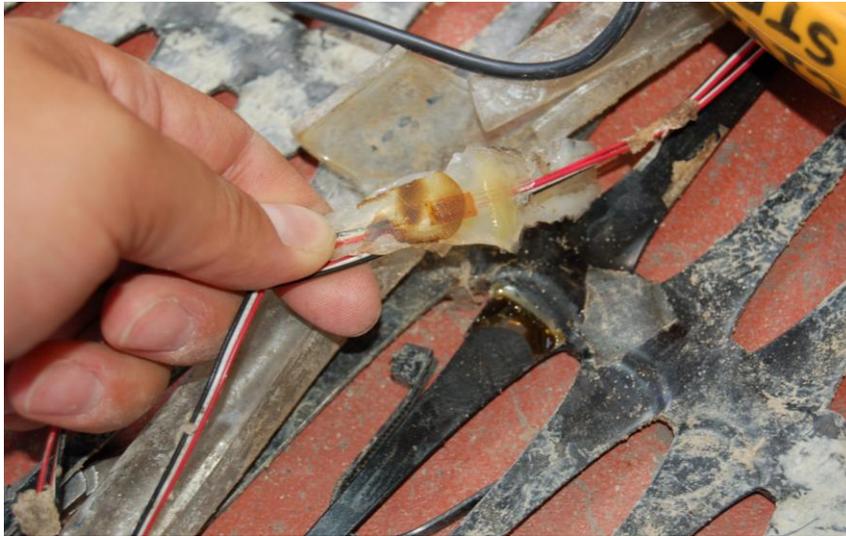
**Figure 5.28** Poorly-bonded strain gage completely debonded from the geogrid (layer #8, gage #3).

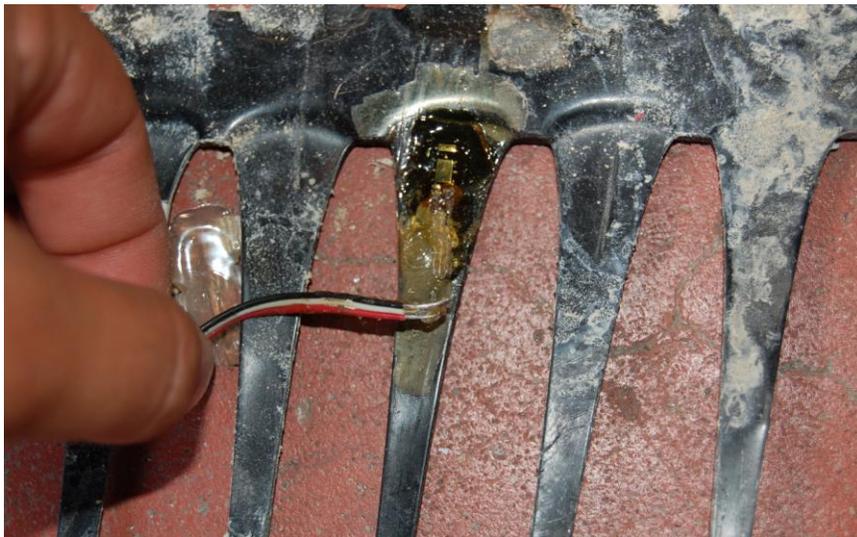
**Figure 5.30 Cable connection failure (layer #15, gage #2).**

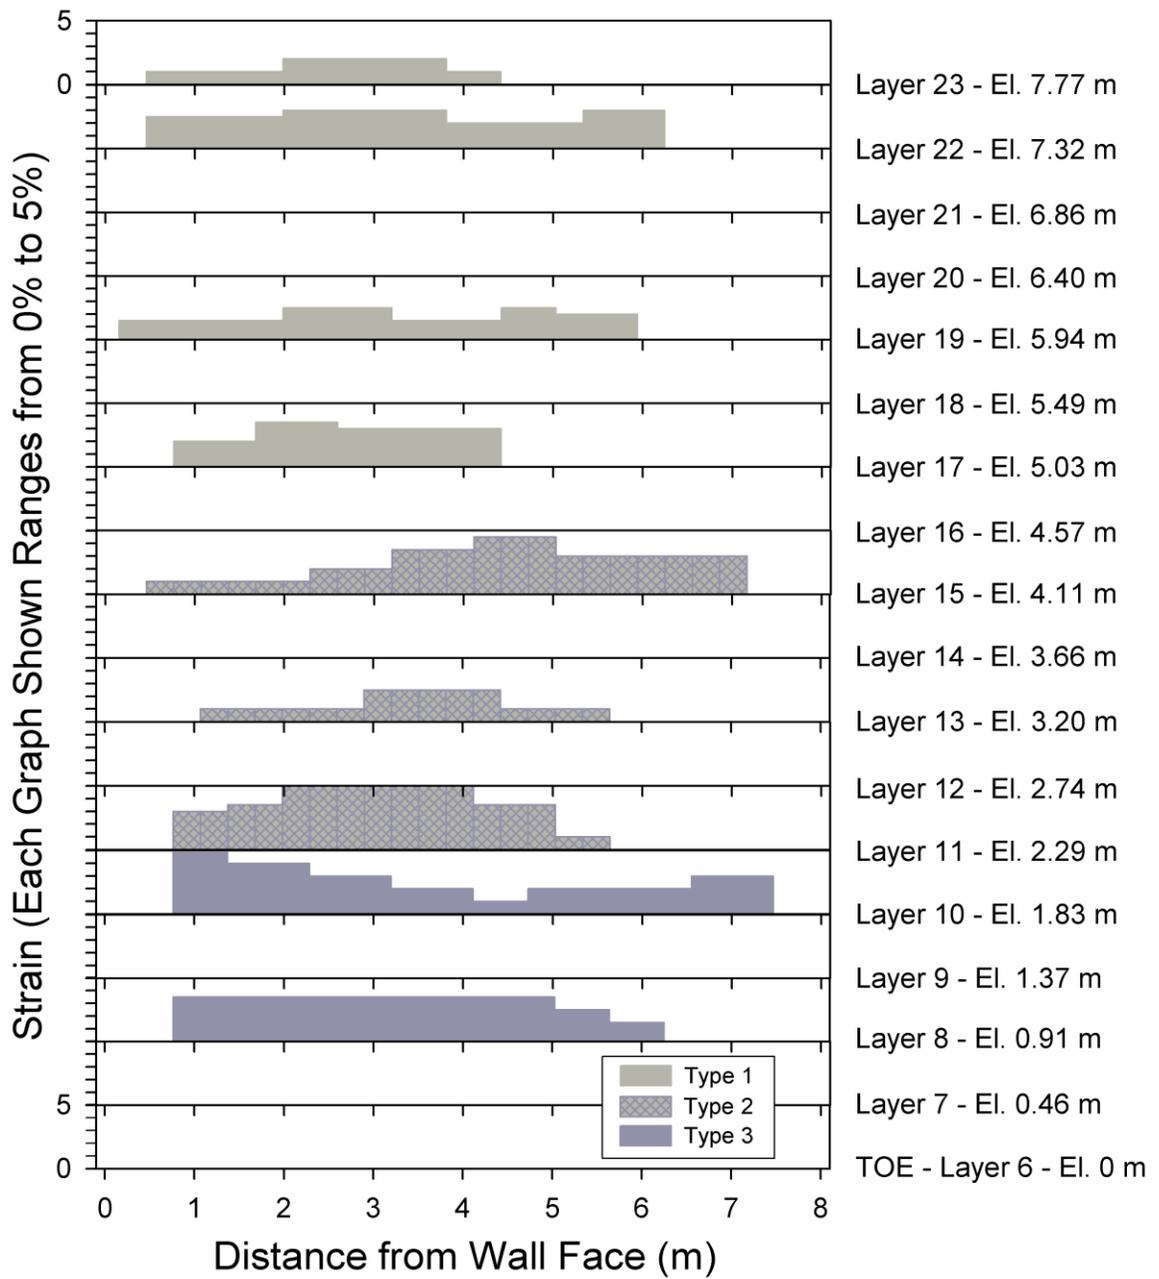
**Figure 5.31** Back-calculated total strain distributions on the instrumented geogrid layers.

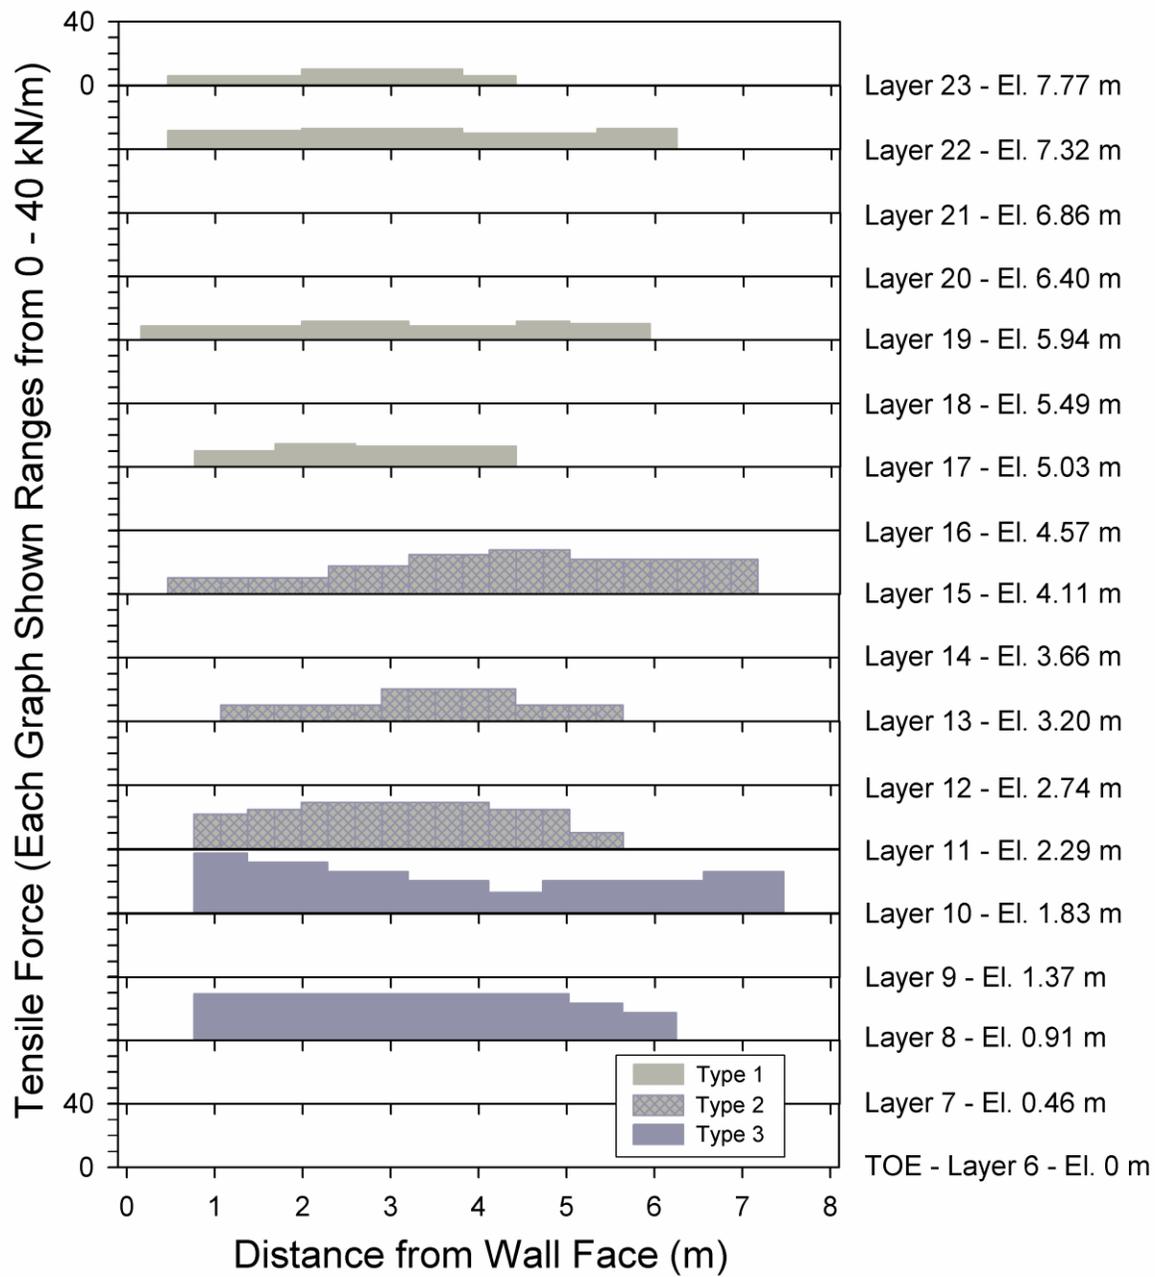
Figure 5.32 Tensile force distributions of the instrumented geogrid layers.

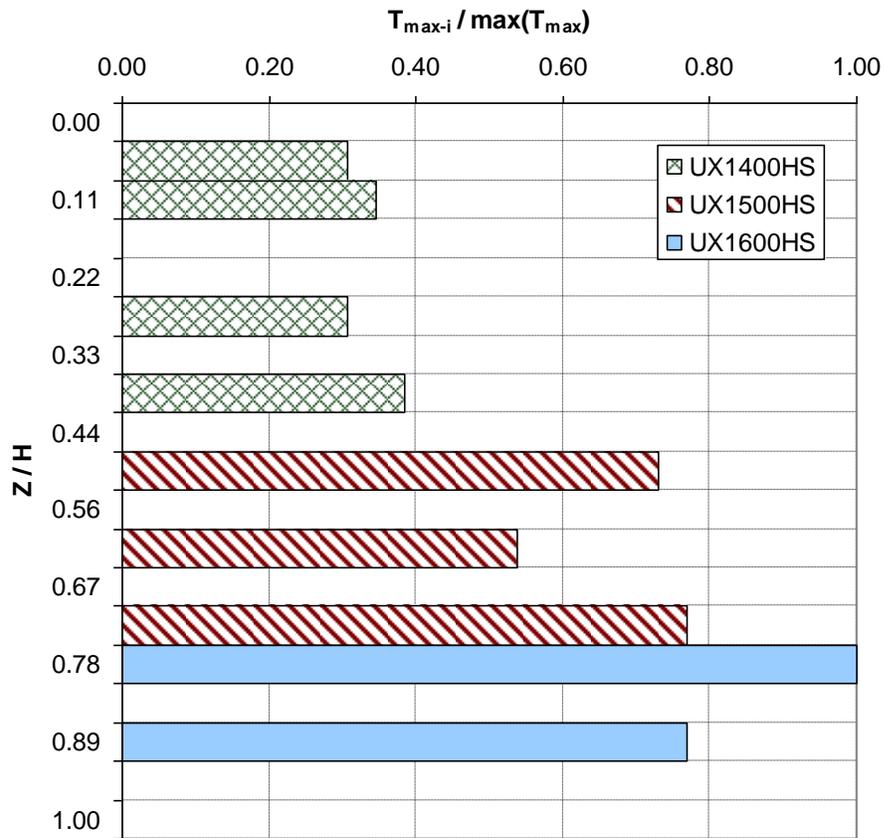
Figure 5.33 Measured normalized  $T_{\max}$  for each layer.

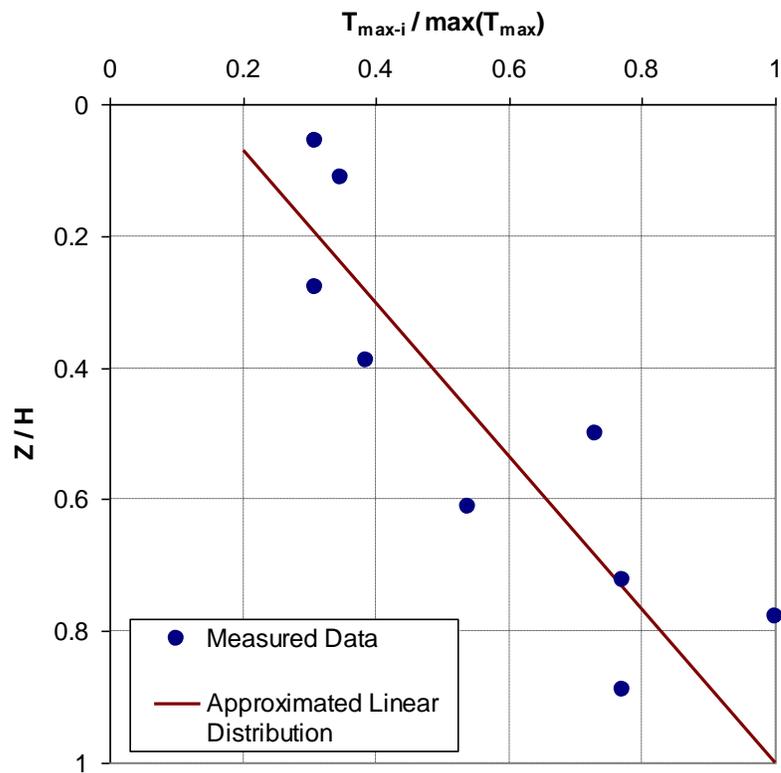
**Figure 5.34** Distribution of the measured data and the approximated linear distribution.
