Determination of the Impact of Heavy Axel Loads on Short Lines

Determination of the Impact of Heavy Axle Loads on Short Lines

**Prepared for
Delaware Department of Transportation
Delaware Transit Corporation**

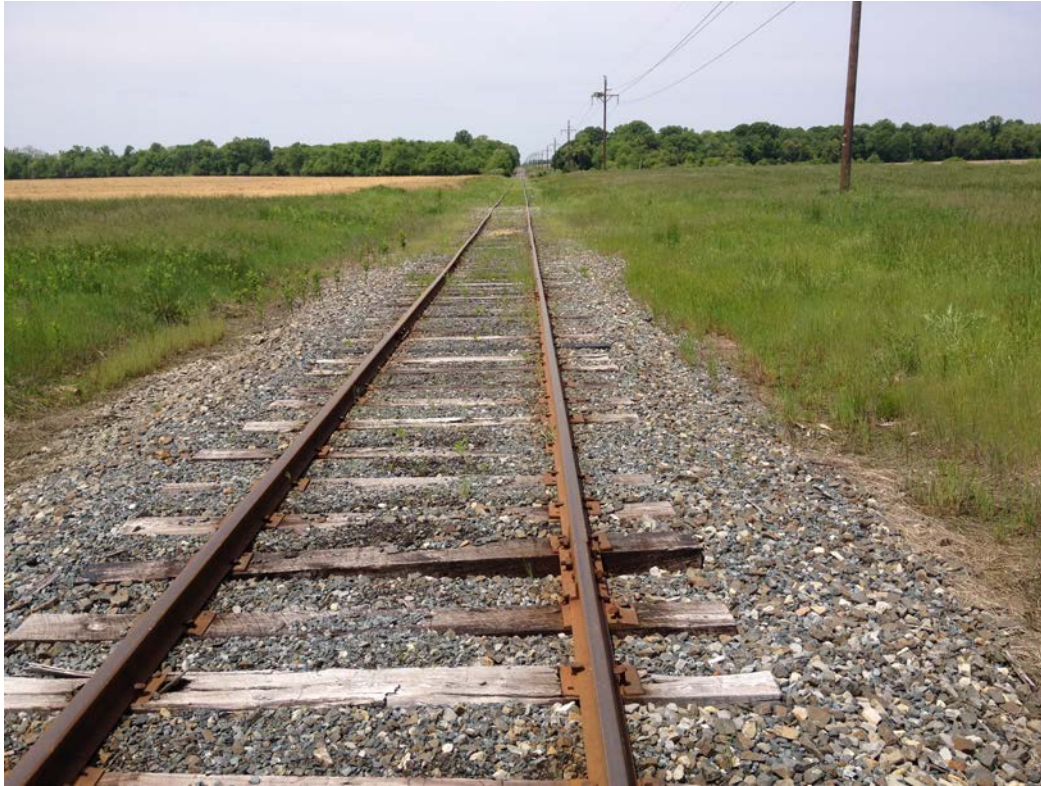
Figure 1: Overview of short line track condition

This is particularly true for track with light rail sections, moderate to poor tie conditions, poor ballast, and similar conditions as common in short line railroad track. This is illustrated in Figure 1.

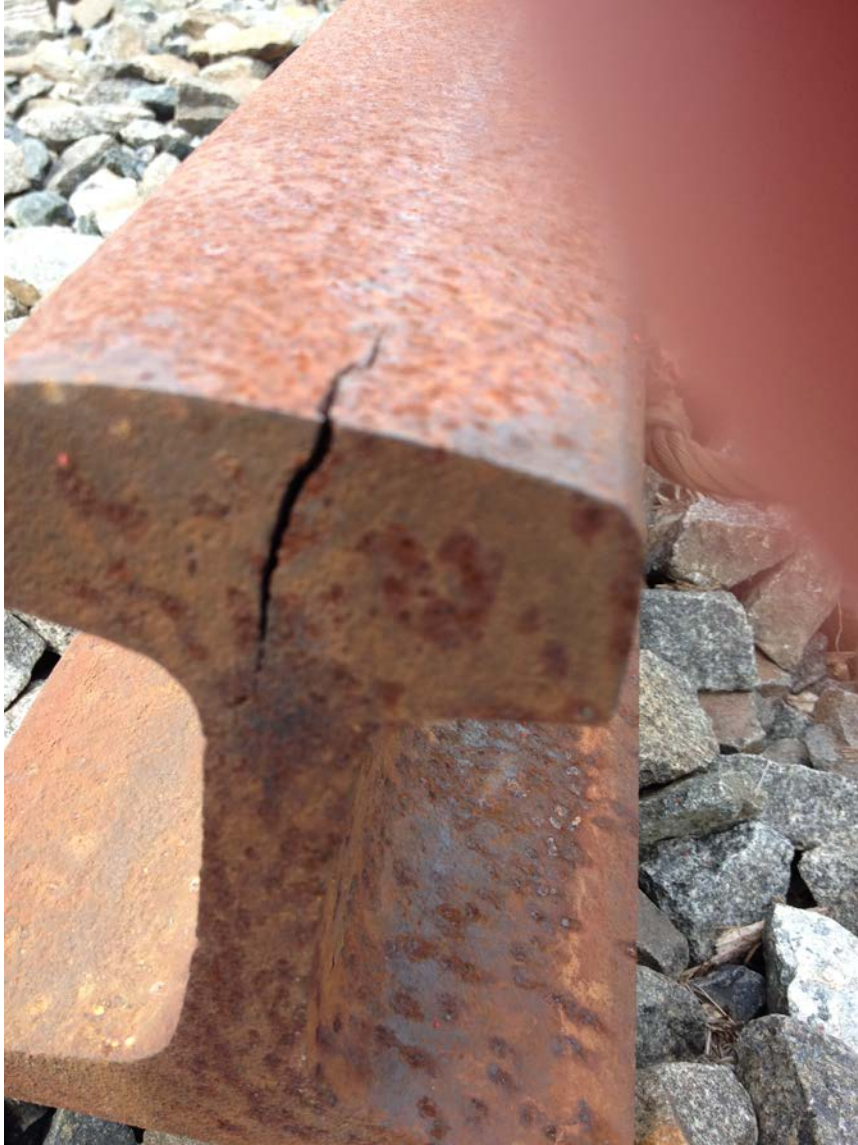
Figure 2: Vertical Split Head on 85 lb. rail.

Increased axle loads, particularly on lighter rail sections can result in an increased occurrence of rail defects, particularly fatigue defects as well as joint defects. The two short lines discussed here-in both have experienced rail problems on their light rail sections (85 lb. rail) under 286,000 lb. loading. This will increase with heavy axle load operations. The broken rail defects include vertical split head defects (Figure 2) , head and web separations (Figure 3) , and broken bolt holes (Figure 4) as well as broken joint bar failures (Figure 5). Note the vertical split head in 85 lb. rail shown in Figure 2 represents one of the largest classes of rail failure on the light rail sections. Thus Maryland and Delaware reported 9 broken rails requiring replacement on the Centerville Line in 2013, 12 on that line in 2012, and 14 in 2011. On their Chestertown line they reported 14 in 2012 and 16 in 2011. Maryland and Delaware Railroad also reported reports rail joint problems to include numerous broken joint bars (1 per week). In 2013 on one 16 mile long Segment, they replaced 17 rails – all 85 lb. rail and 25 bars. Joints are major problem with batter, loose bolts, surface degradation etc. Delaware Coast Line also reports 6 to 7 broken rails a year, many of which are joint related.

Primary rail defect appears to be vertical Split Head (VSH); many observed in stockpiles and on right of way; due primarily to small head of 85 lb. rail. Some broken bases also observed as well as failure from bolt hole crack. One head and Wed Separation (H&W) observed on rail with VSH as well.

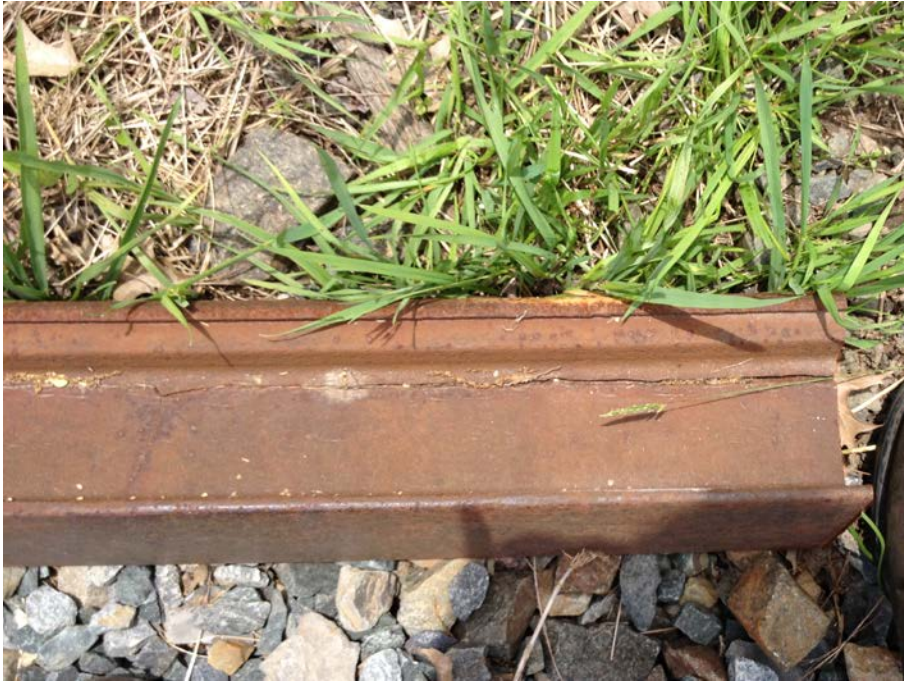
Figure 3; Head and Web separation

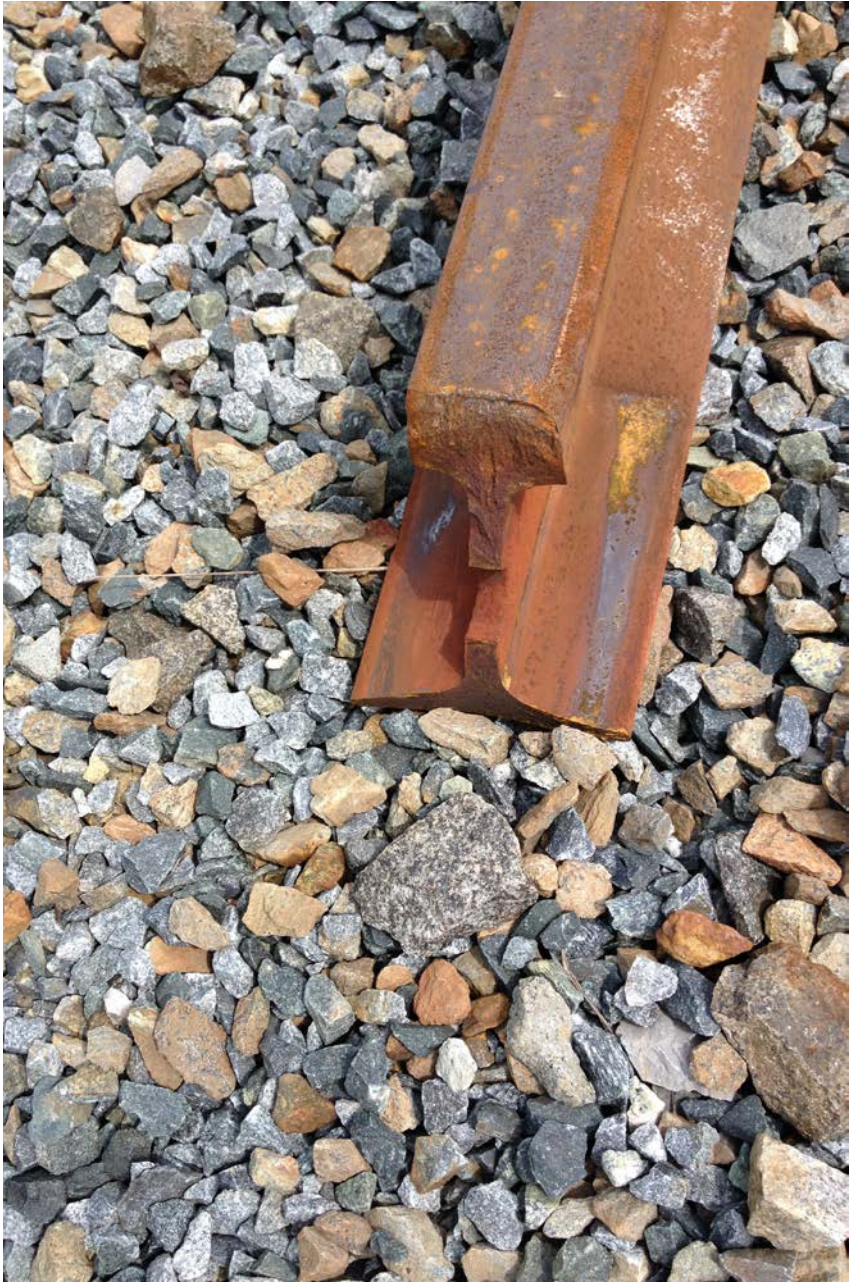
Figure 4: Bolt Hole failure

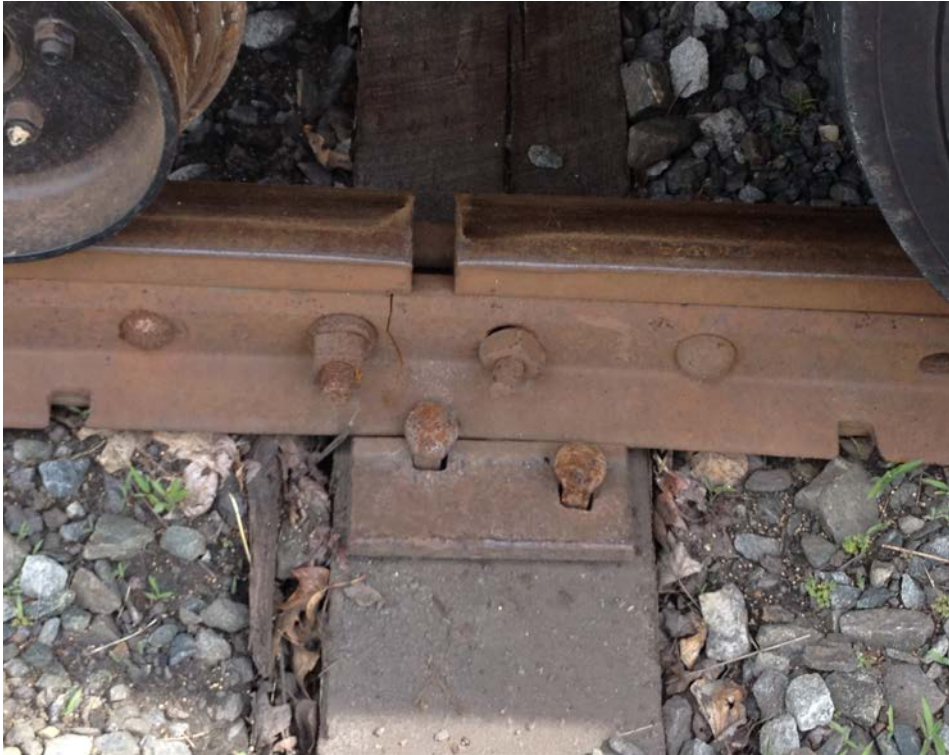
Figure 5 Broken Joint Bar

Numerous joint bar conditions including cracked joint bar, loose bolts, large gaps, and a wide assortment of different joint bars on the 85 lb. rail. In some location square (opposite) joints observed instead of usual stagger).

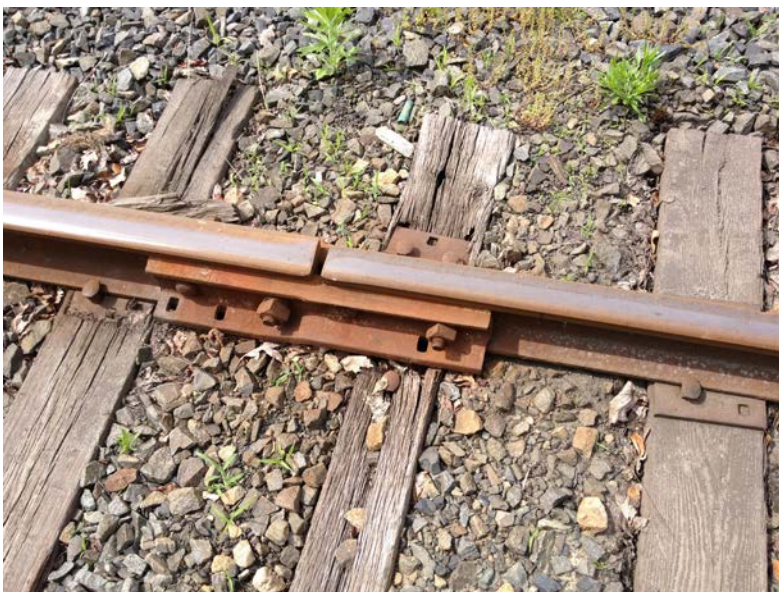
Figure 6: Compromise Joint Bar Between two different rail sections

Compounding the problem is the need for multiple sets of compromise joint bars due to the frequent changes in rail section. (see Figure 6)

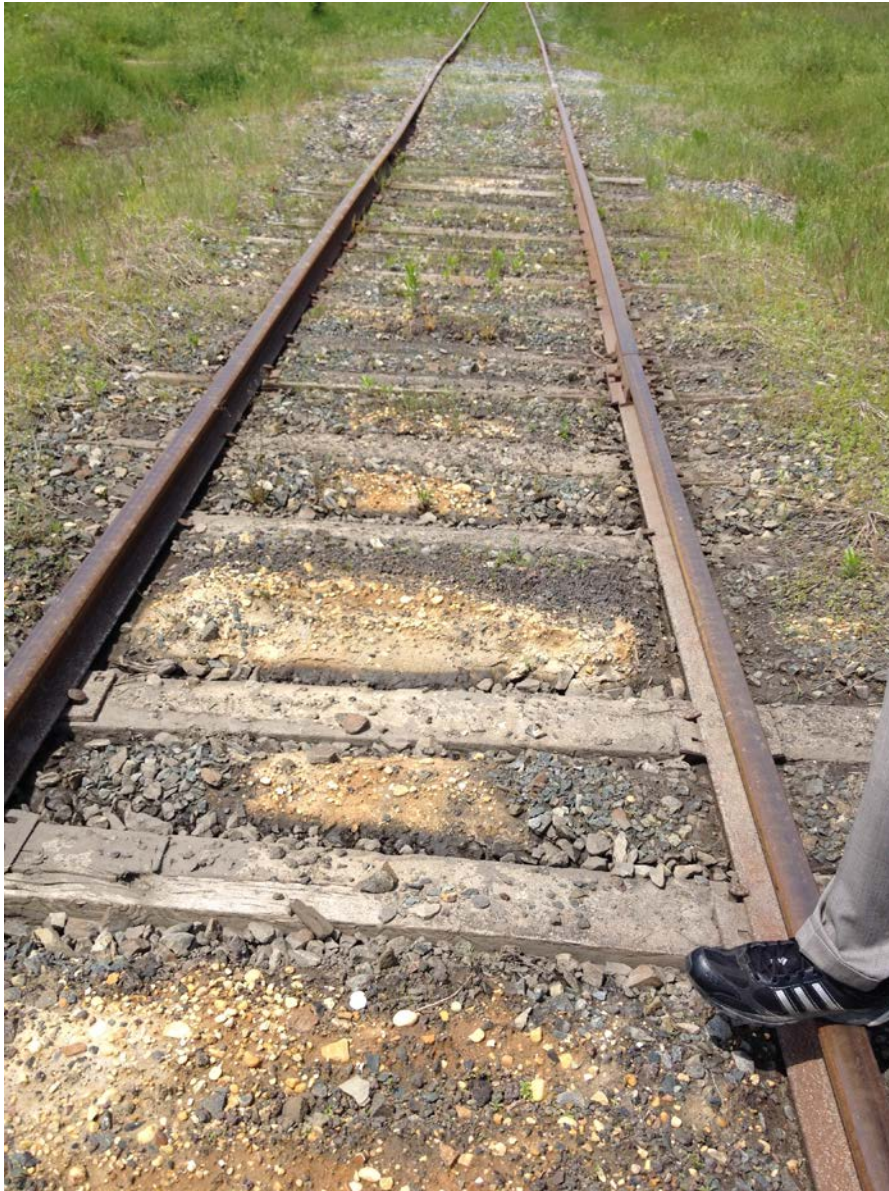
Figure 7: Surface degradation on 85 lb. rail track

Increased axle loads can result in increased rate of track geometry degradation to include surface. Line, cross-level, warp/twist, etc. This is especially true in conjunction with poor ballast and degraded joints. Poor joints (and underlying tie condition) can increase dynamic loading and result in increased loss of track geometry as illustrated in Figures 7 and 8.

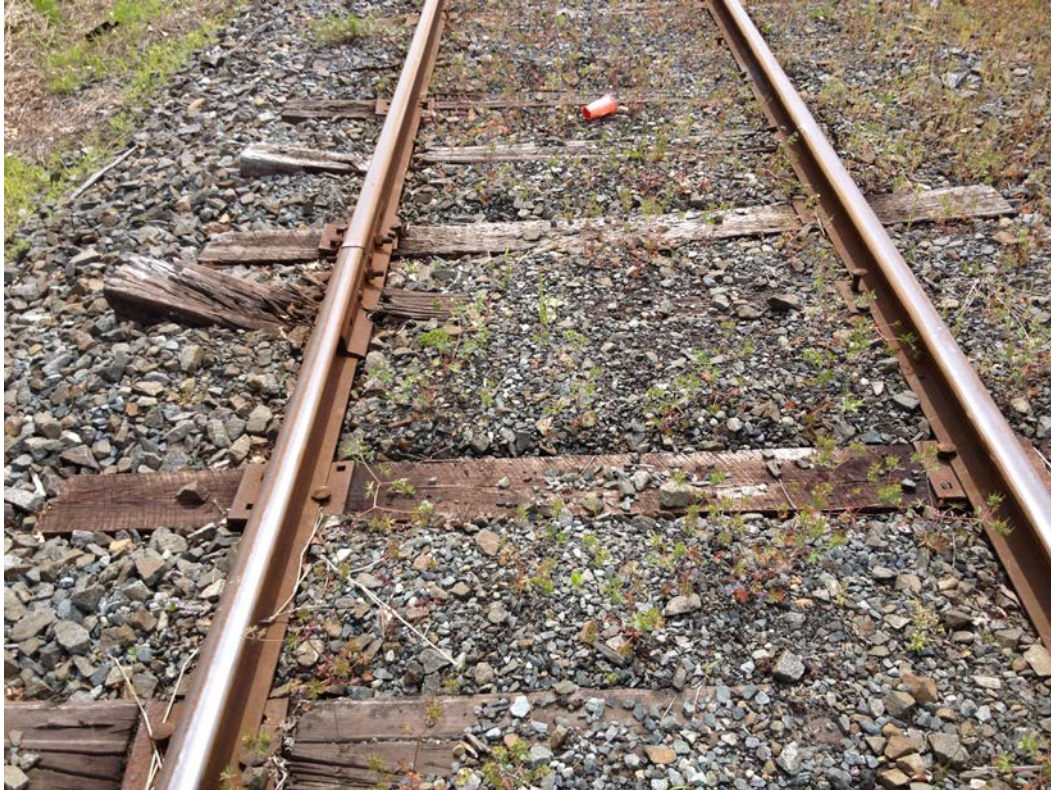
Figure 9: Poor tie conditions

Tie represents still another major area of impact of heavy axle loads, with the need for good tie condition considered to be a key factor in operating heavy axle load track. Poor tie condition, to include decayed and/or missing ties, as illustrated in Figure 9, also represents a major maintenance cost area for short lines. In many cases, inadequate tie/fastener condition, particularly on curves, necessitates the use of gage rods in lieu of good ties (often referred to as the poor man fix of weak tie/fastener condition)

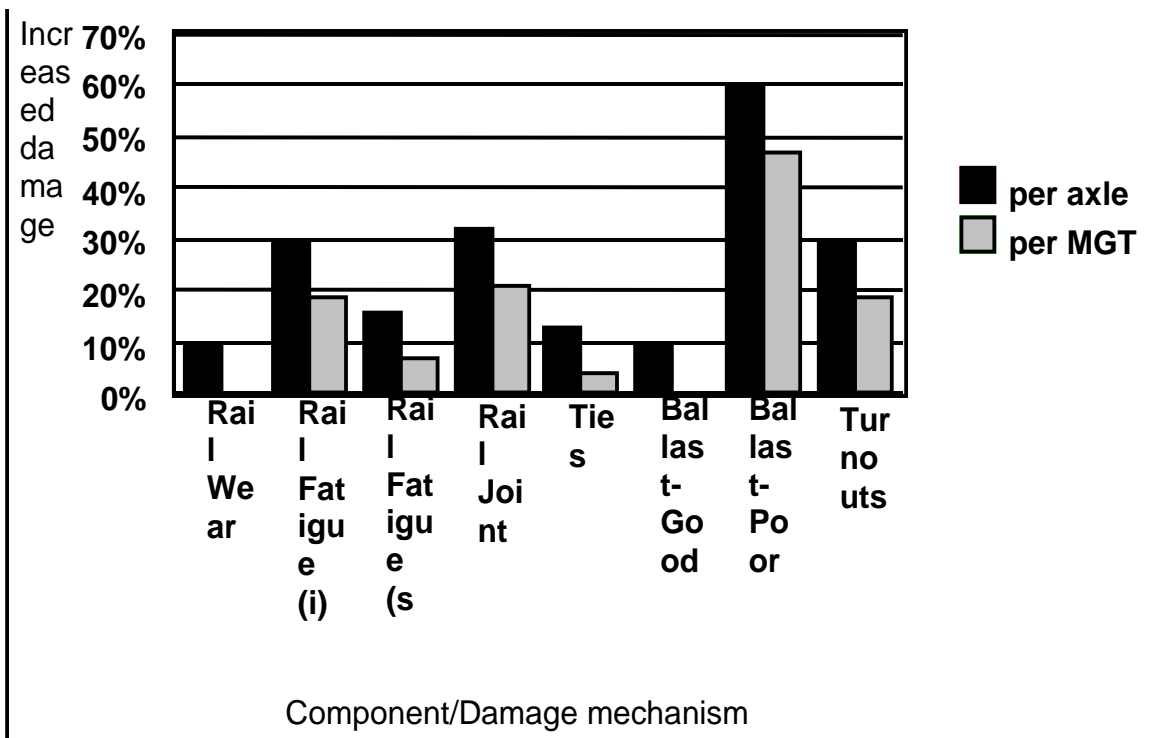
Figure 10: Heavy Axle Load damage Increases by Track Component

As noted in the previous section, even after upgrade of components to allow for increased axle loads, there can be an expected increase in track maintenance costs associated with these heavier axle loadings. This is discussed in detail in references 1 through 6 and the results summarized in Table 5 and Figure 10. Note the difference in the per axle and per MGT increases is due to the fact that under 286,000 car operation, there are fewer axles carried per MGT (due to the higher per axle loading) and as a result the actual maintenance cost increase effect is reduced because of this. Thus the per MGT column is the proper column to use in assessing the impact of increased axle loads (going from 263,000 lb. cars with 33 ton axle loads to 286,000 lb. cars with 36 ton axle loads).

Damage* (per axle)	Damage* (per MGT)
Rail Wear	+9%	0%
Rail Fatigue (internal)	+29%	+19%
Rail Fatigue (surface)	+16%	+ 7%
Rail Joints	+32%	+21%
Ties	+13%	+ 4%
Good Ballast	+9%	0%
Poor Ballast	+60%	+47%
Turnouts	+29%	+19%

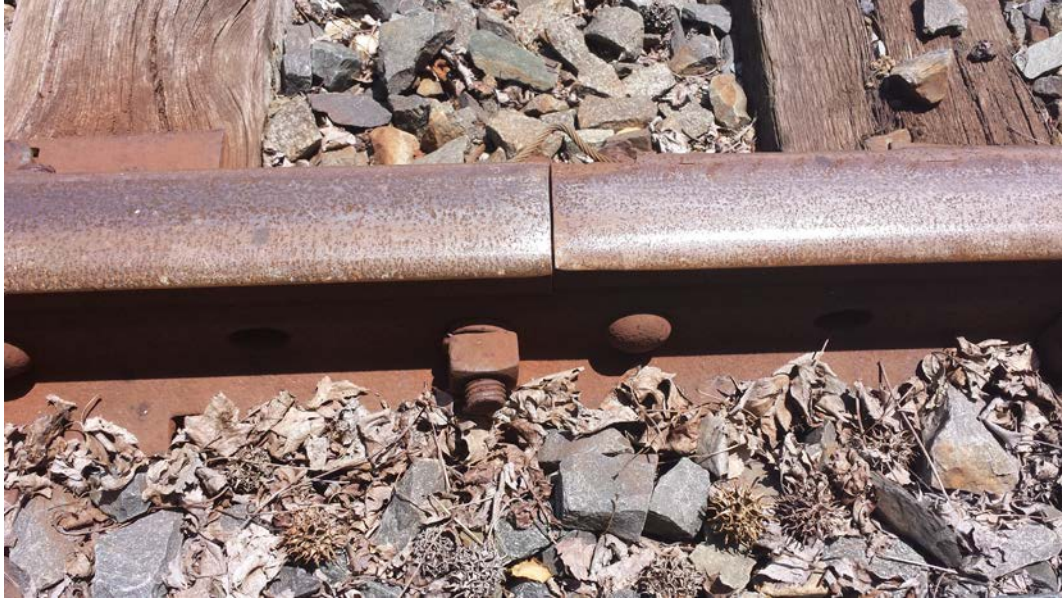
Figure 11: Observed Tight Joints

There was an observed problem with movement of rails in direction of loaded traffic (south) and reports of sun-kinking of track due to tight joints (observed- see Figure 11). Note, tight joints, such as due to running of the rails (as observed here) creates an 'equivalent' CWR condition that can result in track buckling or sun-kinks.

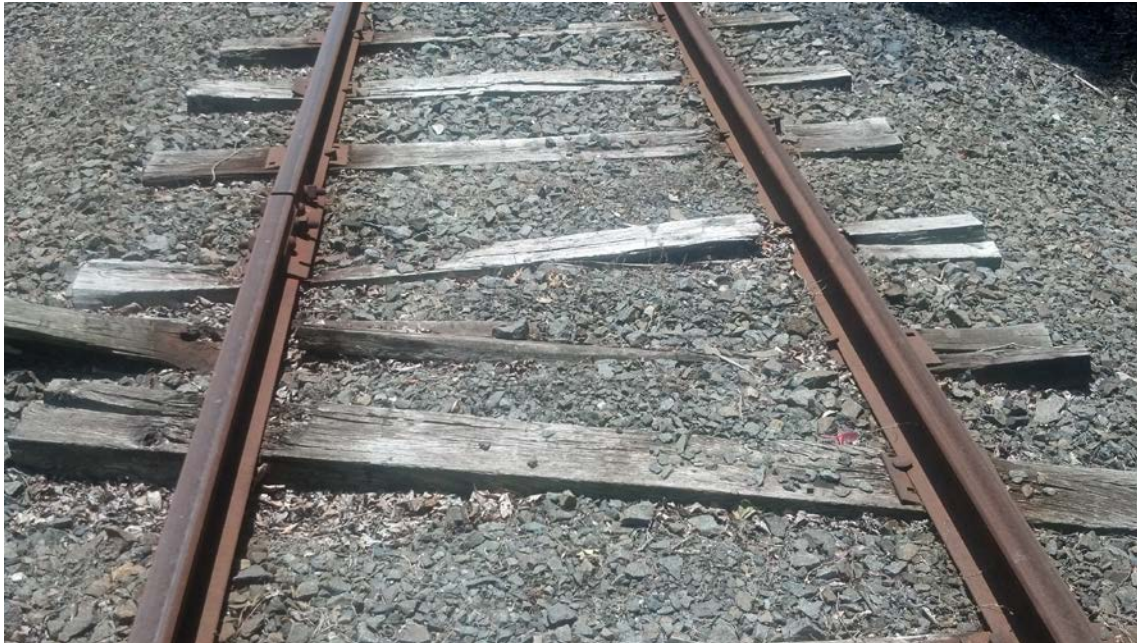
Figure 12: Significant Tie Movement Due to Running of Unanchored Rails

Some locations have anchors every 2 or 3 ties in direction of loaded movement. However, in the areas where significant tie movement was observed (see Figure 12), no anchors were observed. It is strongly recommended that anchors be used on this line and should be carried through the entire line. Note only need anchors on one side (North side) to prevent rail running south.

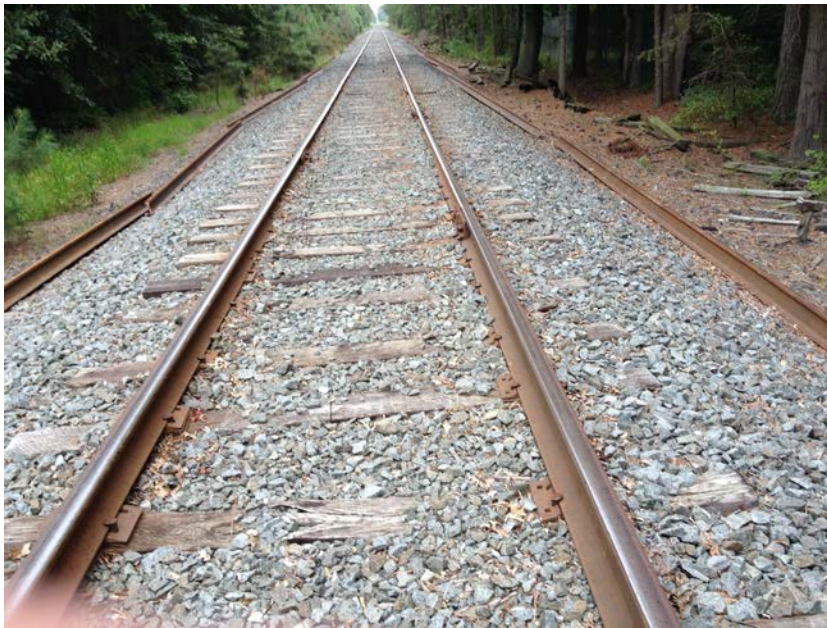
Figure 13: Delaware Coast Line Track near Airport Industrial park with new 132 RE rail awaiting installation.

Overall, the track was in excellent condition in 132 RE rail section; rail, tie, and ballast were in excellent condition (Figure 13) with some limited batter at joints observed. In the 85 RE Rail Sections, to include the 1500 feet leading up to the switch and several hundred feet past the switch, the track was also good condition with good ties and ballast (Figure 14). The rail was primarily 4 hole bars but some 6 hole 85 lb. rail bars were observed. Of these six hole bars, 2 were observed with cracks in the joint bars, which will require replacement, particularly since 286,000 lb. cars operate on this segment. Note 6-hole joint bars for 85 lb. rail are subject to excessive flexure and cracking. The ties are 6x8 industrial ties, with an ongoing program of approximately 500 new ties installed per year. The fasteners are cut spikes with single shoulder tie plates. Ballast on the observed track on this line was good, with large ballast particles and minimum fines and gravel. Track geometry was very good for a Class 1 track. It was noted, that an FRA inspector recently went over the line and found no reportable defects.

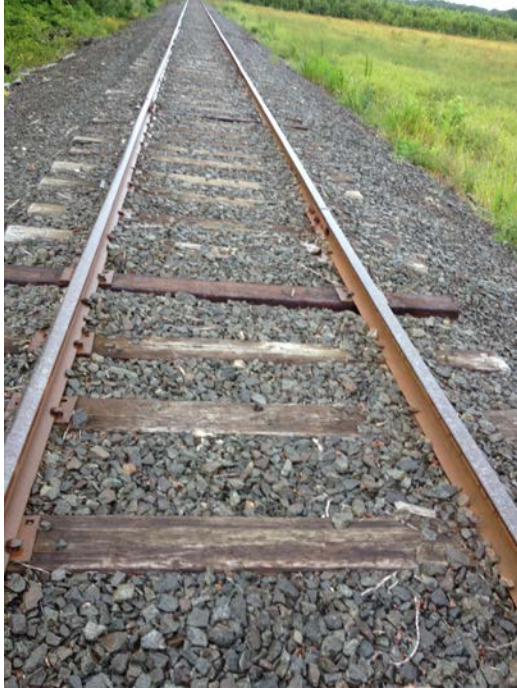
Figure 14: Segment of Track past Industrial Park Switch

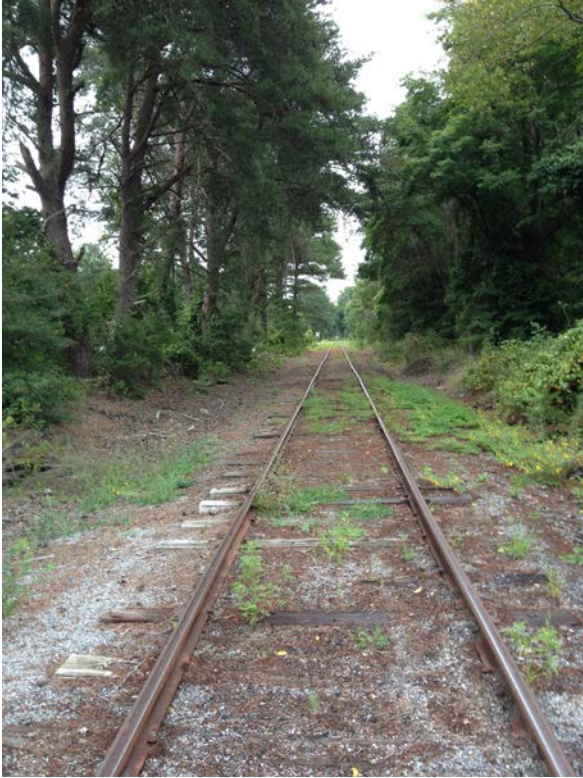
Figure 15: Segment of Milton- Ellendale line

Milton Industrial line to Ellendale [NS] is not in as good condition. The track is again 85 lb. rail with 6x8 industrial ties and poor ballast. Since there had been no traffic on this line for many years, prior to the recent opening of the Wilson Baker facility in Milton, no ties had been installed. Thus tie condition is not as good as on the Georgetown-Lewes line. Ballast condition is likewise not as good, with gravel and dirt predominating as shown in Figure 15. Tie and Ballast problems also include some locations where ties are covered with pine needles and earth (see Figure 16). However, the track does meet FRA Class 1 standards as verified by the recent FRA track inspection.

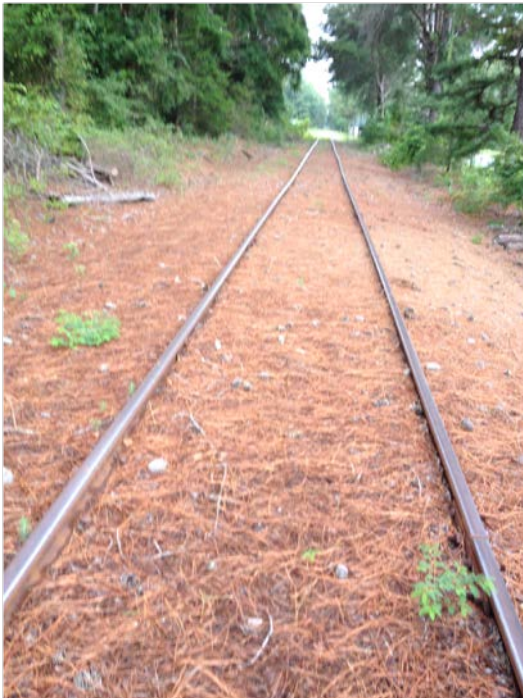
Figure 16: Segment of Milton- Ellendale line covered with Pine Needles

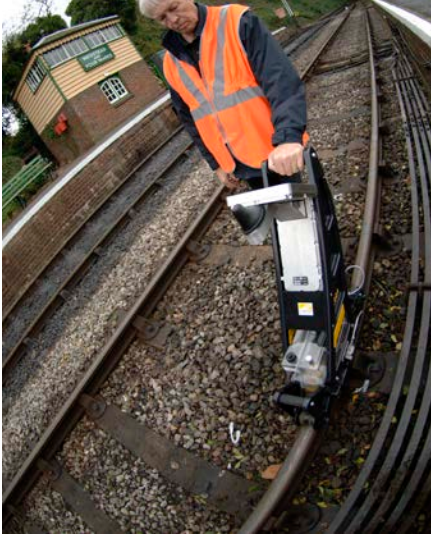
Figure 17: Hand Pushed Walking Stick for Rail Ultrasonic Testing

- Performance of ongoing rail testing with the frequency of testing based on number of defects found and annual tonnage levels. This is necessary because of the increased risk of rail fatigue defects associated with the HAL traffic.
 - A walking stick ultrasonic test system that can be used by one man walking along the track may be appropriate for these operations (see Figure 17).
