Instrumented Geogrid Reinforced Mechanically Stabilized Earth Wall Undergoing Large Settlement

**Department of Civil and Environmental Engineering
College of Engineering
University of Delaware**

May 2007

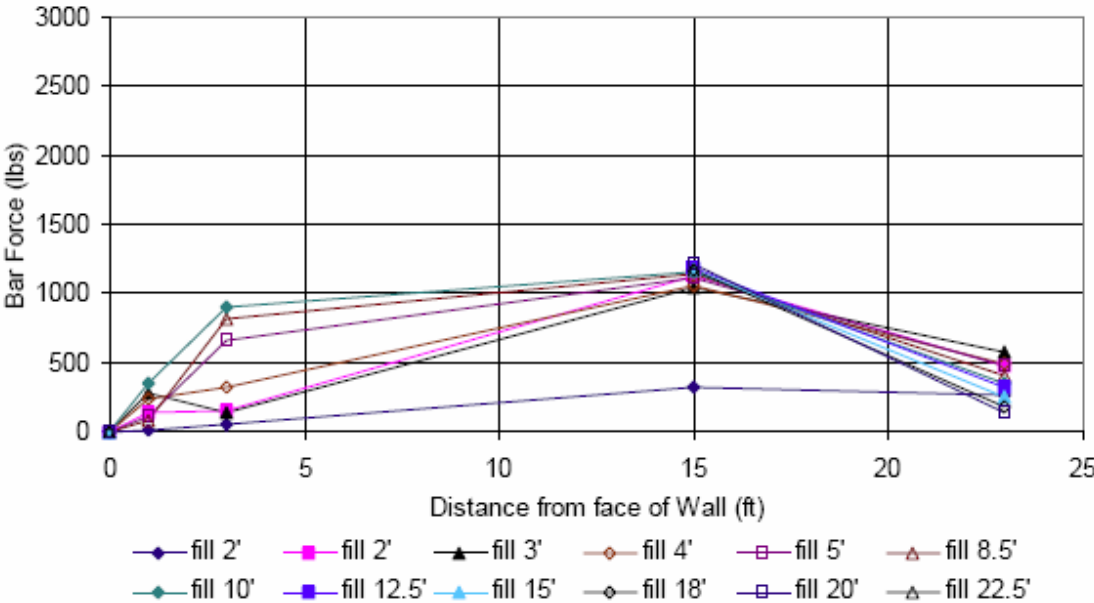
Figure 2.3 Measured Bar Forces for Primary Reinforcement Only Layer 2 (Bay et al., 2003)

fill heights above the mat level. An example of the measured bar forces is shown in Figure 2.3.

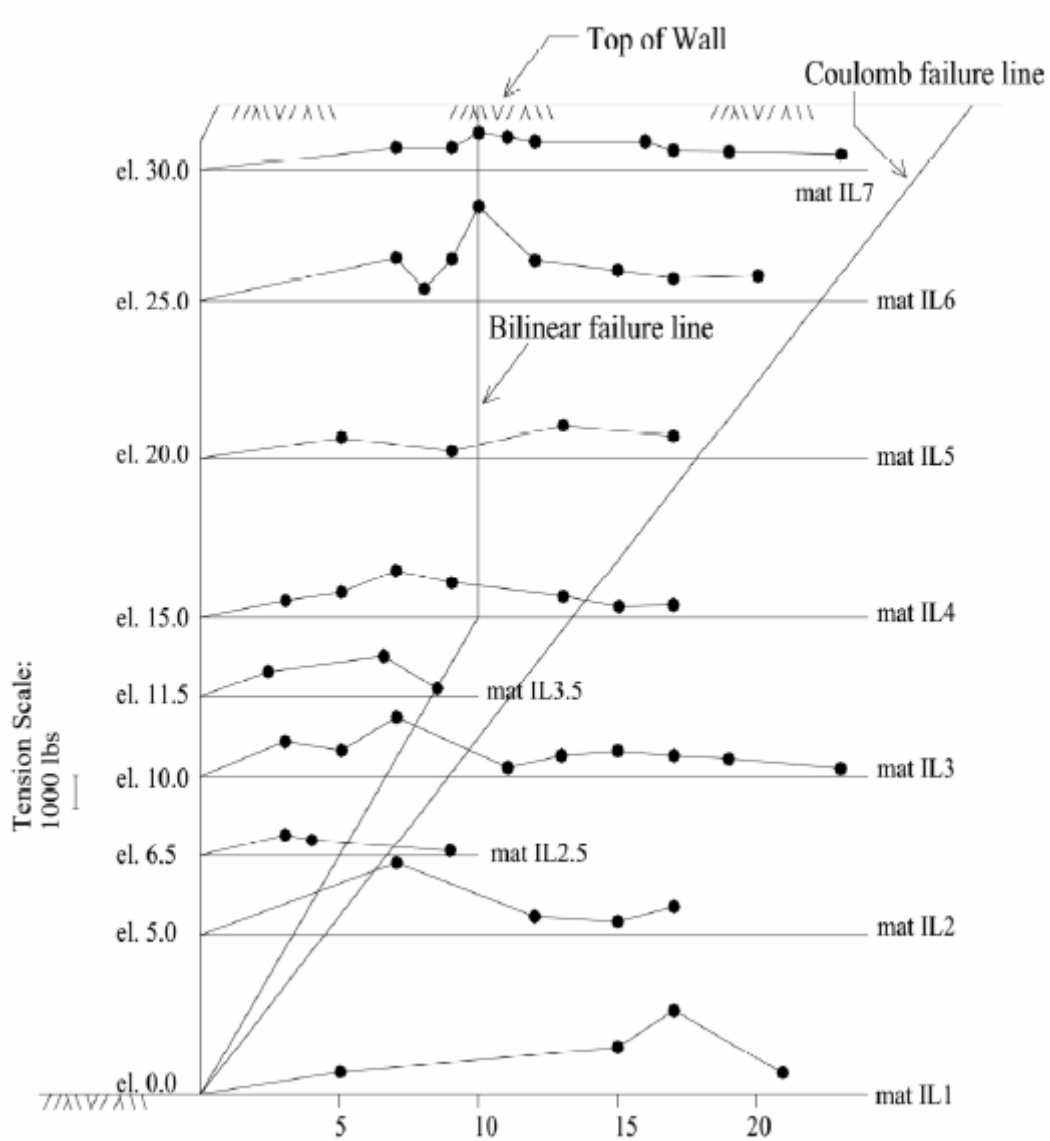
Figure 2.4 Tension Distribution in Bar Mats in the Primary and Intermediate Reinforced Wall Section (Bay et al., 2003)

The strain gages were also used to determine the loci of maximum tension in the bar mats. Figure 2.4 illustrates an example of the tension distribution measured before the completion of construction in the section of wall containing both primary and intermediate reinforcement.

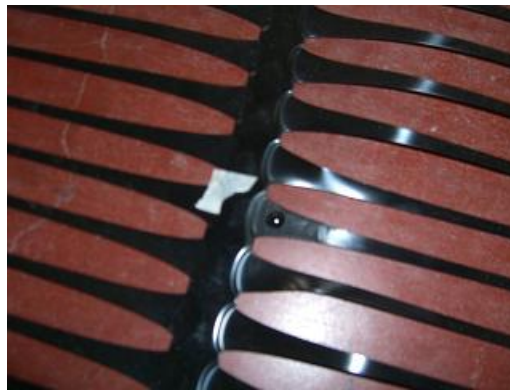
Figure 3.2 Epoxy Drop to Bond Strain Gage onto Longitudinal Rib

should be placed on the heated area of the geogrid using an applicator. Figure 3.2 shows the epoxy drop size and the location of the gage attachment. Now, a taped strain gage should be placed on the epoxy and lightly pressed directly with a finger into place. This procedure must be quickly repeated for each gage to be installed, as the epoxy will set in approximately ten minutes.

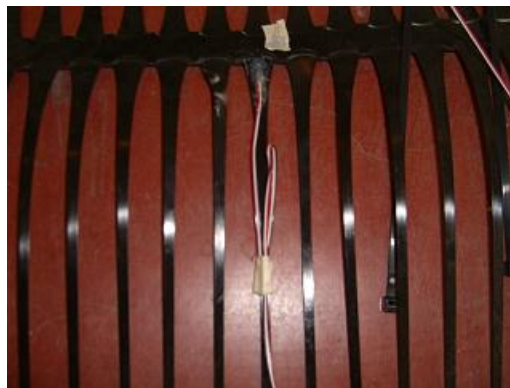
Figure 3.3 Lead Pigtail

as shown in Figure 3.3. This technique prevents the wires leading to the measurement device from exerting tension onto the strain gage. Each wire extending from each strain gage is then joined together with the other wires to be run down the center of the geogrid. A piece of one-half inch outside diameter PVC tubing should be cut long enough to encase and protect the wires. Then, the tubing is split along its length. Now the wires can be run inside the tubing, which should be wrapped around the longitudinal ribs of the geogrid. The tubing should be secured in place using cable ties. The geogrid panel can then be loosely rolled up to be transported to the construction site.

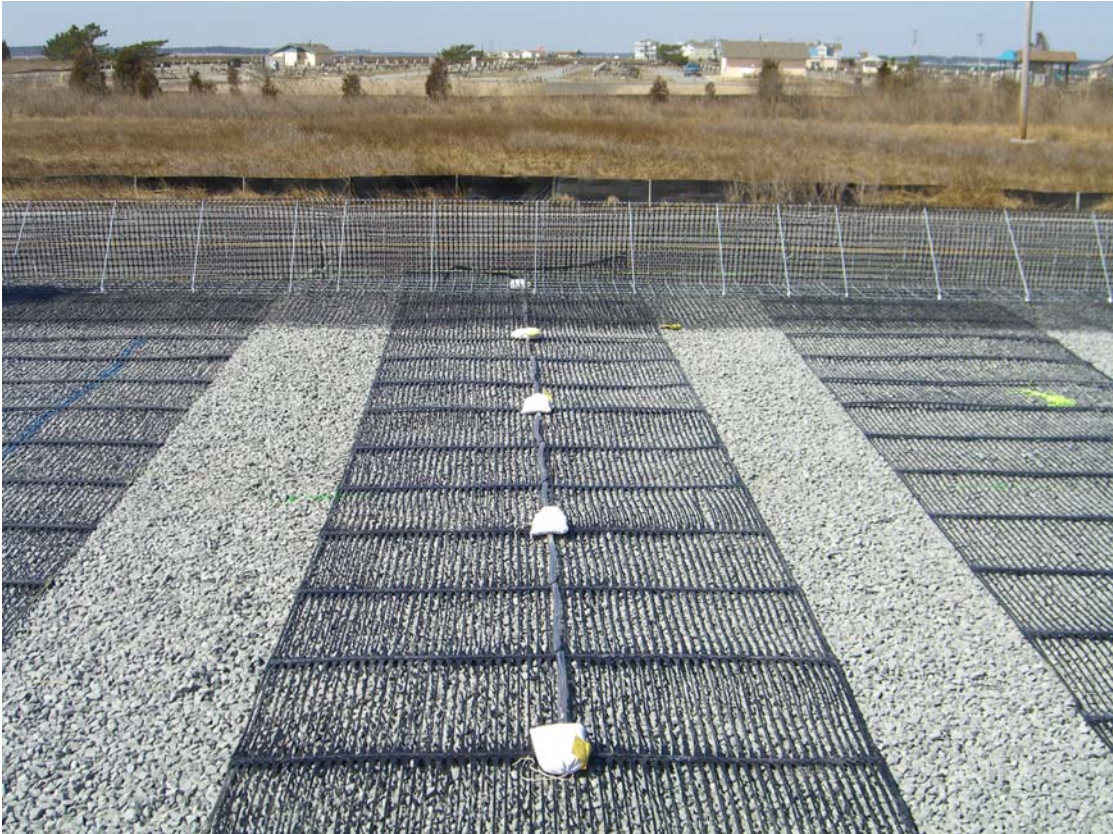
Figure 3.5 Installed Instrumented Geogrid Panel: PVC pipe protects the wires and sandbags protect each strain gage

The installation of the instrumented geogrid panel was completed by the contractor in the same manner as the non-instrumented geogrid was installed elsewhere in the wall. The only difference is that small sand-filled bags were placed over the gage locations to protect the gages from being damaged by placement of the backfill. This is shown in Figure 3.5. Care was taken during backfilling to avoid damaging the strain gages.

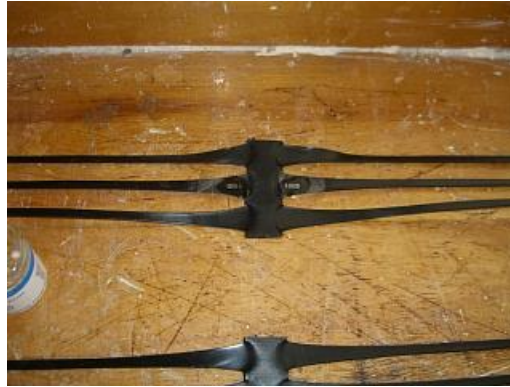
Figure 3.6 Location of Strain Gages on Geogrid Calibration Test Sample

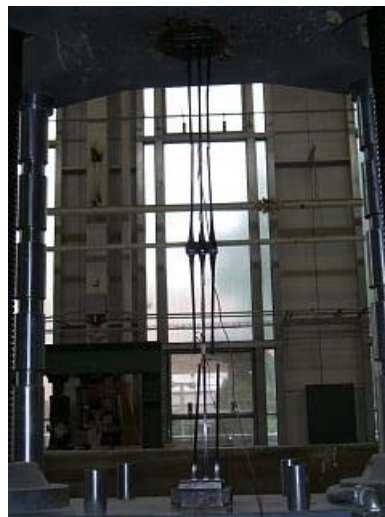
Figure 3.7 Calibration Testing Sample Setup

The testing was performed using a 200-kip Tinius Olson machine. The sample was secured in the machine using standard machine grips, which were tested for slippage before running the tests so that no slippage during testing will occur. Each specimen initially was comprised of three longitudinal ribs – see Figure 3.6. After secured in the testing machine, the two outside strands of the geogrid were cut, leaving the central rib, to which the gages are attached, as the load barrier. An ohmmeter was attached to the leads of each strain gage. Figure 3.7 shows the sample setup. The test data was recorded by a computer linked to the testing machine. The test was also recorded using a camcorder, which was focused on the output display of the testing machine and the ohmmeters. Having a video recording of each test allowed for the video to be watched and stopped at any point in the test to record the load, displacement, and elapsed time from the testing machine, along with the corresponding resistance reading from the ohmmeters. The described test setup is shown in Figure 3.8.

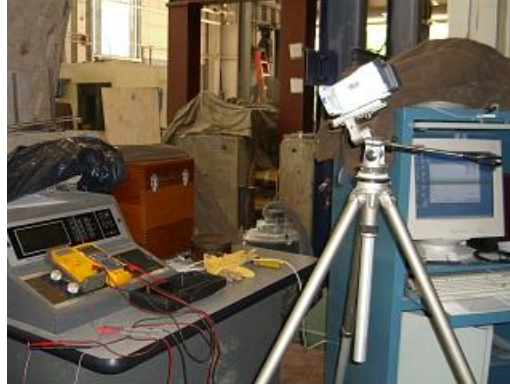
Figure 3.8 Calibration Testing Data Recording Setup

The testing apparatus measured and recorded the displacement between the jaws continuously during each test. Using a displacement from any point in the test, the strain in the sample for that time was determined by dividing the recorded displacement at that time by the original distance between the jaws, which was measured before the test commenced. The testing apparatus also continuously measured and recorded the applied load during the test. Therefore, the force per unit width that corresponds with any strain can be determined. Force per unit width was calculated by multiplying the measured force by the number of longitudinal ribs in one foot of geogrid width. The two ohmmeters continuously measured the resistance in each strain gage during each test.

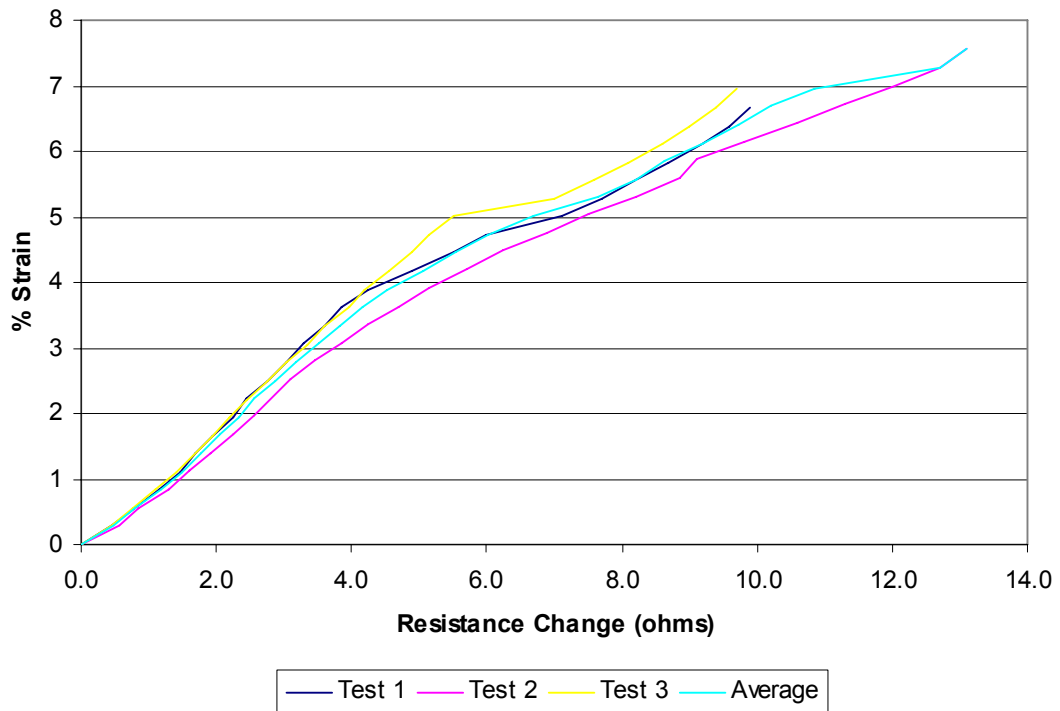
Figure 3.9 Calibration Test Results for Half Percent Strain Rate Tests on UX1700HS HDPE Geogrid

specimen for a large number of time increments throughout the test. Watching the video recording of the test allowed playback of the test to be paused at any desired increment to record the corresponding resistance readings displayed on the ohmmeters. For each increment, a resistance reading was determined by averaging the two readings from the ohmmeters. Once this was completed for a number of increments throughout the test, a graph was constructed showing the percent strain in the geogrid versus the resistance change of the strain gage. Since three tests were run at a rate of half a percent strain per minute, the average of these three tests was determined. An example of the strain versus resistance change graph, as well as the average half percent strain rate plot is shown in Figure 3.9.

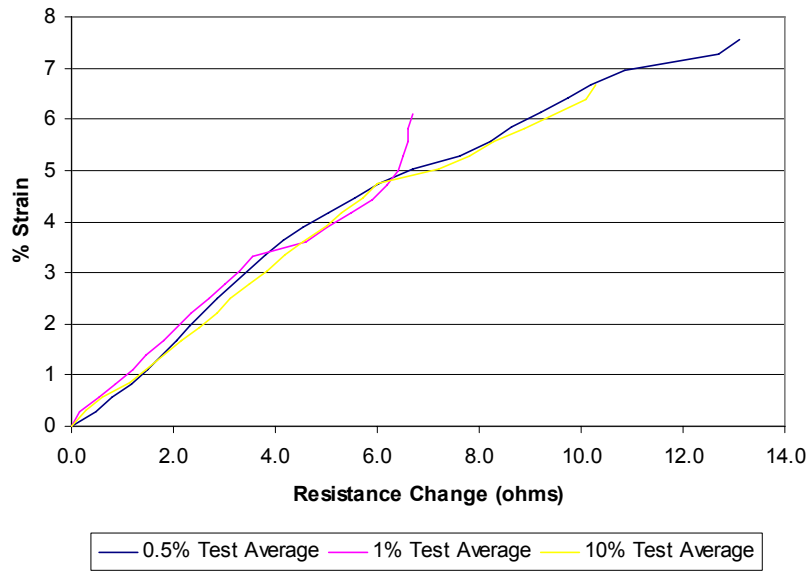
Figure 3.10 UX1700HS % Strain vs. Change in Resistance Curves

Two graphs were constructed for each geogrid tested. The first graph shows the relationship between the change in resistance and percent strain in the geogrid; the second shows the applied force and resulting percentage of strain. Each graph includes the curve for the one percent per minute and ten percent per minute strain rate tests, as well as the average curve for the half percent strain per minute tests. The test results are shown in Figures 3.10 through 3.17.

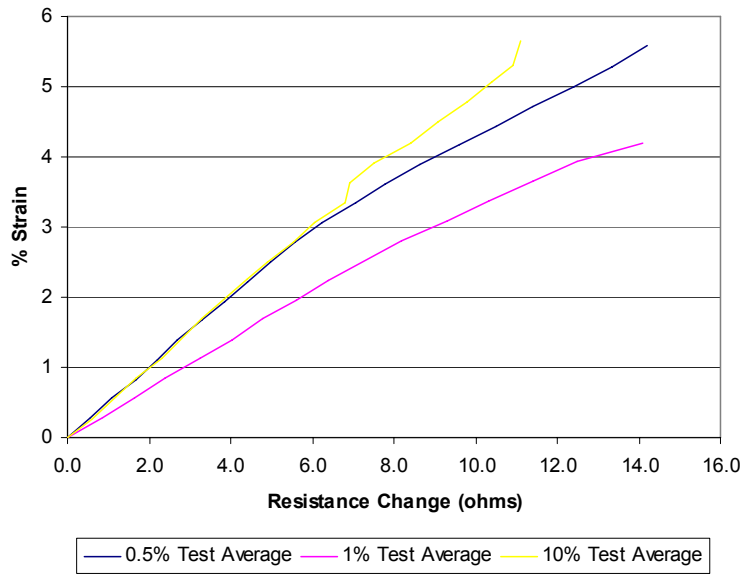
Figure 3.14 UX1500HS % Strain vs. Change in Resistance Curves

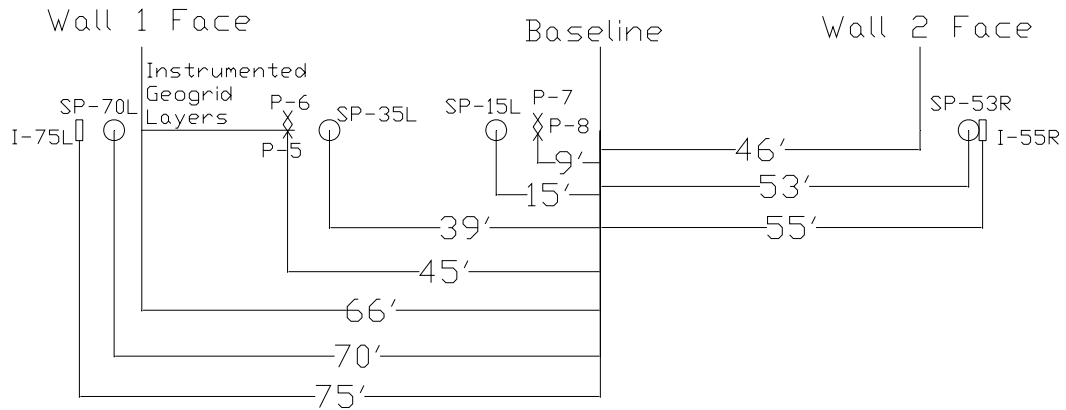
Figure 3.18 Instrumentation Locations at Station 289+00

Four settlement plates were installed at different offsets at station 289+00. The initial reading for three of these settlement plates was taken on March 1, 2006. For settlement plate 289-53R, the initial reading was not taken until May 16, 2006. The locations of the settlement plates can be seen in Figure 3.18, denoted by circles. Table 3.1 shows the offsets and elevations of the settlement plates.

Two inclinometers were originally installed at station 289+00. In October, the inclinometer offset -75 feet was replaced, as it became inoperable. The probe could not be lowered to the bottom of the casing. Most likely, the casing was shifted too far from its original vertical orientation due to large movements in the soil. In January, the inclinometer offset 55 feet began to give unreliable readings, and it was replaced. The locations of the two original inclinometers, as well as the replacement, are shown in Figure 3.18. The installation details for the inclinometers are shown in Table 3.3.

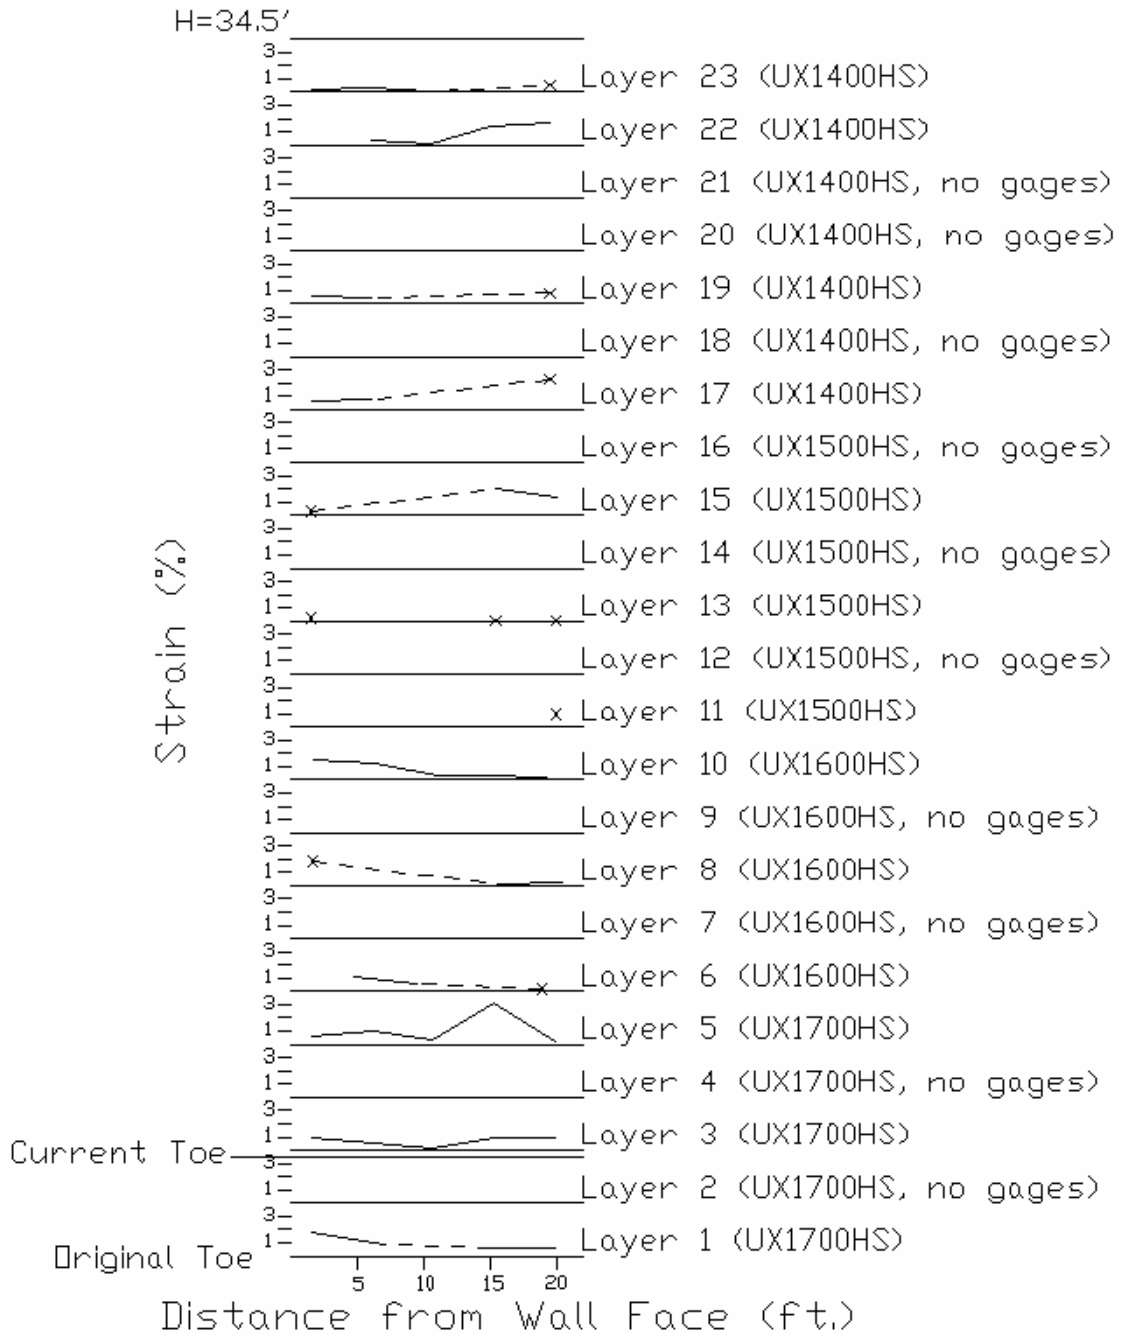
Figure 4.10 Strains Measured 12/5/06

As can be seen in Figure 4.10, the highest value of strain measured up to this point occurs in geogrid layer 5, about 15 feet from the wall face. This value is 3.18 percent strain. It is interesting to note that at the next time gage readings were taken, this gage was no longer functioning. This is seen in Figure 4.11. It is most likely that the large amount of strain caused the gage to malfunction.

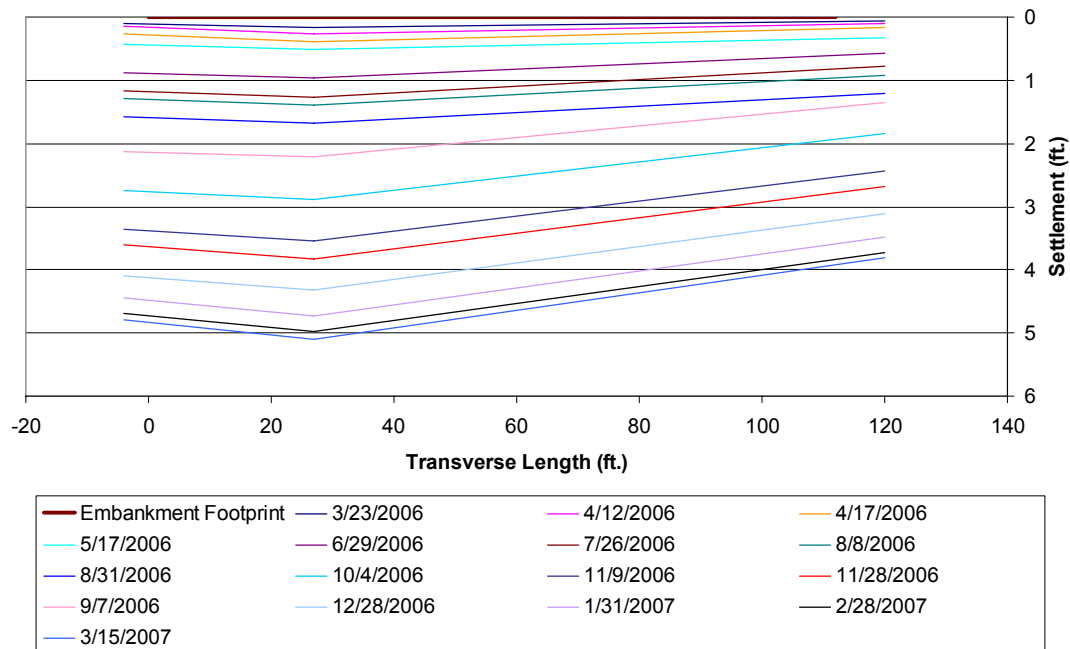
Figure 4.27 Settlement Profile for Station 289+00

Readings were taken from the settlement plates at least on a weekly basis by the Delaware Department of Transportation. The data was looked at to determine the status of the embankment to verify that construction could be continued. If excessive settlement occurred over a period between readings, construction was delayed temporarily. Figure 4.27 shows settlement plate data for station 289+00. Each date shown corresponds to a date during which an instrumented layer of geogrid was installed, up until November 28, 2006, with one exception. The measurement for September 7, 2006 is included though no instrumented layer of geogrid was installed on this date. This addition is to show the very high rate of settlement that occurred since the previous reading, taken on August 31, 2006. After November 28, 2006, the dates shown were chosen to illustrate the continued settlement. It should be noted that construction at this wall section was completed on December 1, 2006. After this date, no additional load was applied. Data for settlement plate 289-53R is not shown since the initial reading was not taken until more than 10 weeks after the initial readings were taken for the other three settlement plates. As a result, the settlement that occurred at this offset point over those 10 weeks is not represented in the readings, and therefore, the readings show an incorrectly low amount of settlement for this offset.

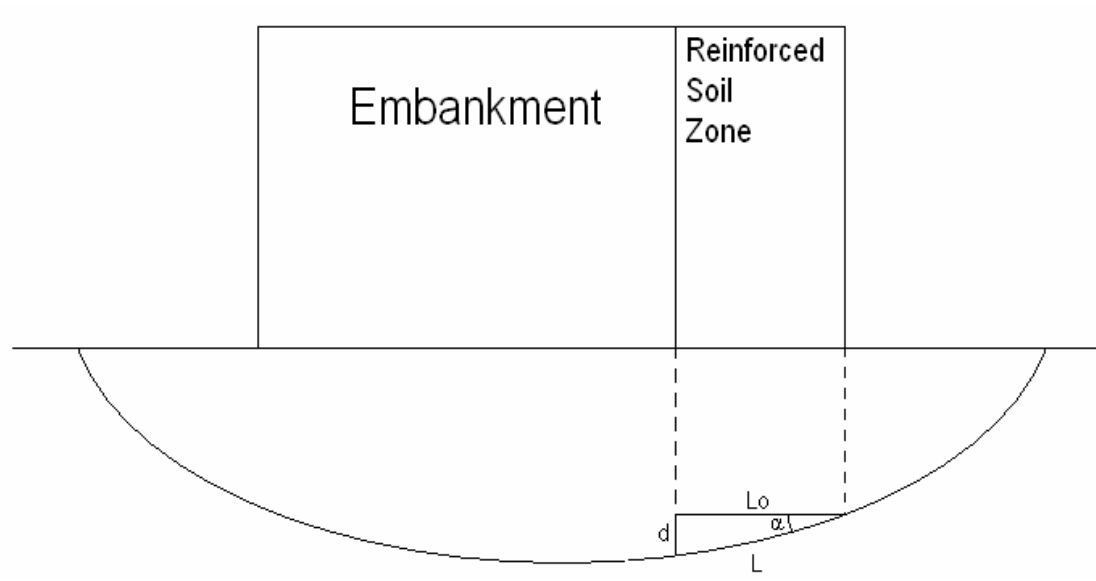
Figure 5.1 Schematic for Assessing Average Strain Due to Large Settlement

It is recommendable to include a parameter in design to account for average strain in the reinforcement. Figure 5.1 shows an example settlement profile for an embankment constructed over soft foundation soil. Assume that L_0 represents the length of the reinforcement, as installed. L is the length of the reinforcement after it has been strained from settlement. Then, d is the differential settlement between the two opposite ends of the reinforcement. The angle α is a measure of how much the reinforcement has rotated downward due to the settlement, assuming the front of the reinforcement is fixed at the face of the wall.
