Use of Roundabouts as Alternatives to All-Way Stop Controls

**Department of Civil and Environmental Engineering
College of Engineering
University of Delaware**

August 2010

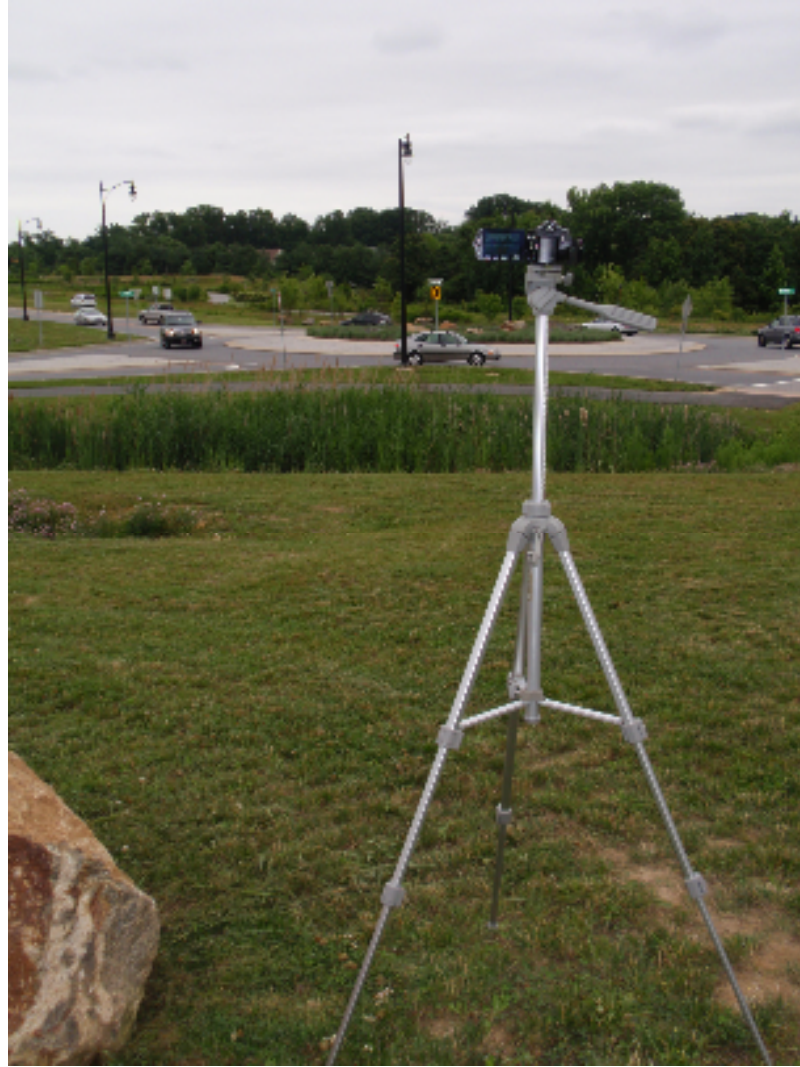
Figure 3 Camcorder mounted on tripod to videotape vehicles at roundabout

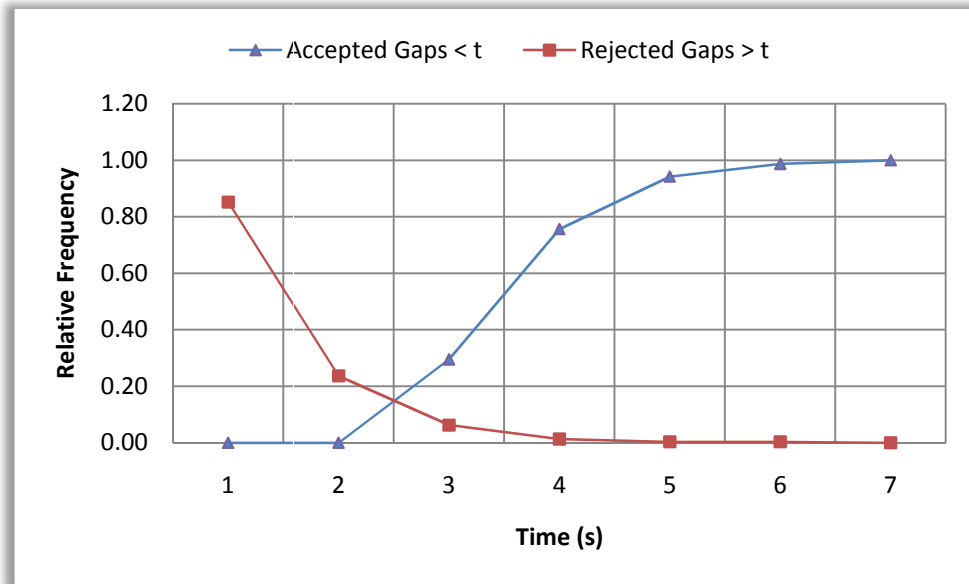
Figure 7 Critical gap at MD 18 and Castle Marina Road in Queen Anne’s County had reduced from 3.91s when measured in May 2005 to 2.5s (June 2009)

Table 7 shows the rejected and accepted gaps observed at the roundabout in Chester, Maryland. Figure 7 shows the critical headway obtained from the data.

The results summarized in Table 9 show that at both locations the critical gap reduced. The critical gap had reduced from 3.91s to 2.5s for the roundabout at MD 18 and Castle Marina Road, and from 3.85s to 2.6s at MD 273 and MD 276. Even though a statistically rigorous approach was not used to establish this reduction in critical gap is indeed significant, the researchers surmise that it is a good indicator of a trend which has also been observed in other studies. NCHRP Report 572 [12] shows that the critical gap varies between 4.2s and 5.9s. This range of values is larger compared to the values obtained at the locations in Maryland in 2009. This considerable reduction in the critical gap over the four year period may be attributed to

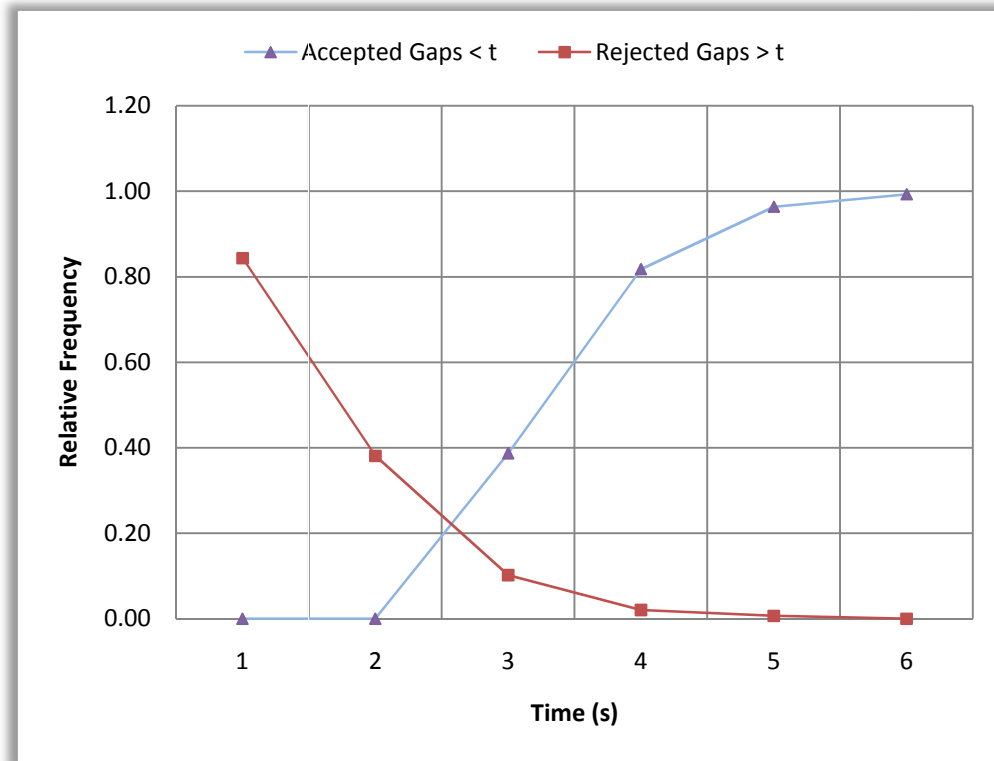
Figure 8 Critical gap at MD 273 and MD 276, Cecil County Maryland, reduced from 3.85s when measured in May 2005 to 2.60s (June 2009)

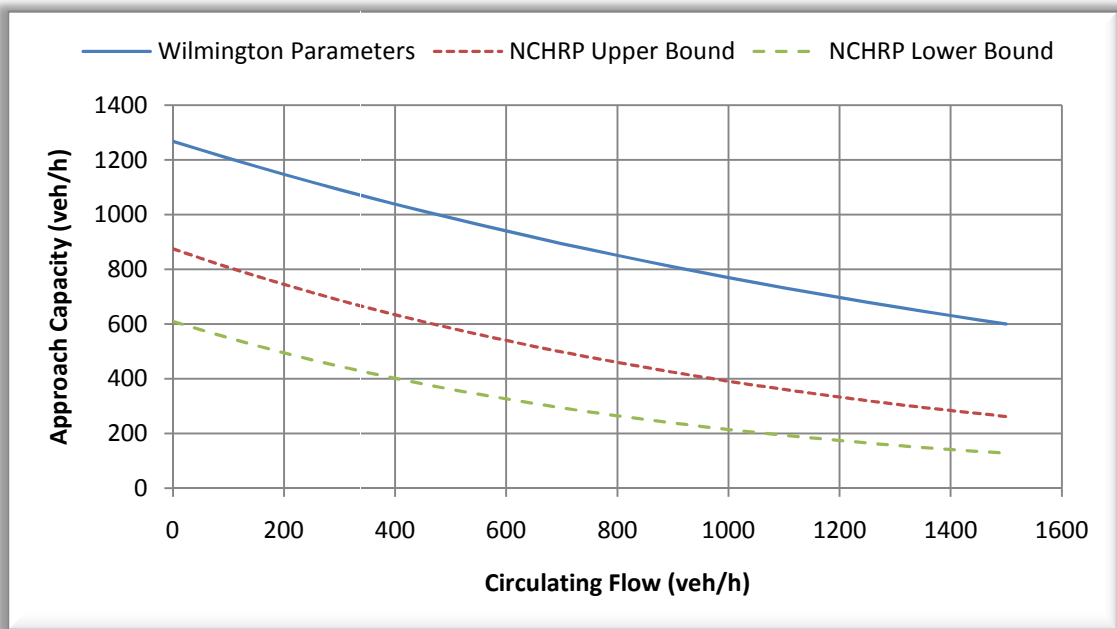
Figure 9 Approach capacity using the NCHRP methodology and parameters from Wilmington, DE

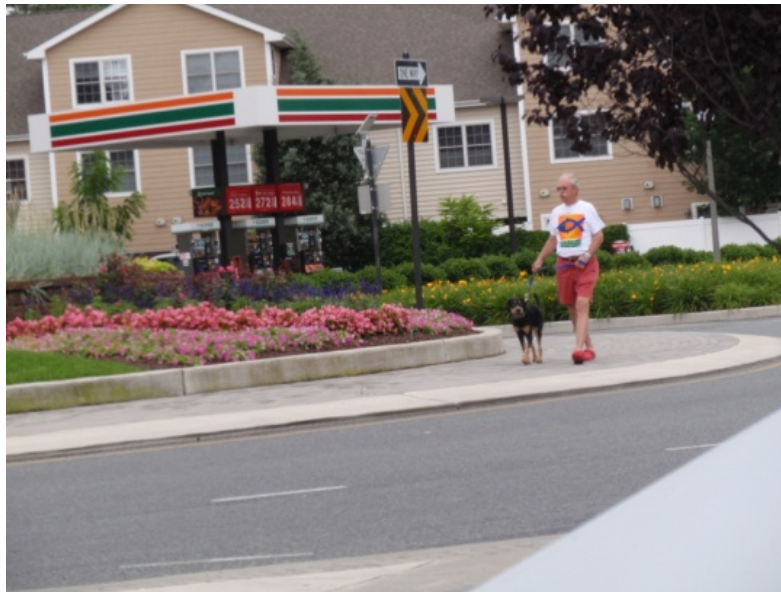
Figure 12 A pedestrian in restricted area of roundabout

crosswalks making use of the islands as refuge when necessary. Another observation of interest was where crossings were being initiated – within boundaries of the crosswalks or otherwise. Most pedestrians crossed the street at the crosswalks provided however a few did not use this designated location for crossing. Some pedestrians crossed at the yield line, the entry point into the circulating lane, instead of the crosswalk. This caused further delay to vehicles which could otherwise have merged into the circulating lane had the pedestrians used the crosswalk behind these vehicles. Also in one instance a man was observed walking a dog on the truck apron – a location where pedestrians are not permitted to be. This has been captured in Figure 8 below. All the pedestrian crossings observed were either “normal” or pedestrian “hesitates” before crossing. These terminologies are define as follows [12]: “normal” implies pedestrians cross the street at normal pace or walking speed; “hesitates” implies pedestrian hesitates on the curb or splitter island because of an approaching vehicle while trying to make visual contact with driver.

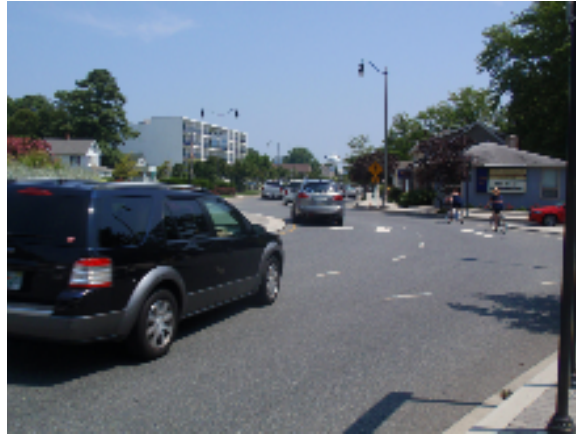
Figure 13 Bicyclists use lanes to navigate roundabout

During the period of data collection, no bicyclist was found at any of the roundabouts except Rehoboth Avenue and Grove Street. The bicyclists were generally beach goers. No bike paths are provided in the circulating lanes. Observations Rehoboth showed that that most bicyclists used the travel lanes to maneuver around the roundabout as shown in Figure 13 below. In some instances some bicyclists kept to the edge of the road thus sharing the lane with drivers. Others however drove close to the middle of the lane so other drivers could not pass. Some bicyclist using the travel lanes will sometimes use hand signals to indicate the direction they are traveling at the roundabout. Very few bicyclists used the sidewalks as they approached the roundabout and only did so when pedestrians were not present. No definitive statements can be made about bicycle-pedestrian interactions at this time since there were hardly any such events.
