Long-Term Performance Monitoring of a Recycled Tire Embankment in Wilmington, Delaware

**LONG-TERM PERFORMANCE MONITORING OF A RECYCLED
TIRE
EMBANKMENT IN WILMINGTON, DELAWARE**

Final Report

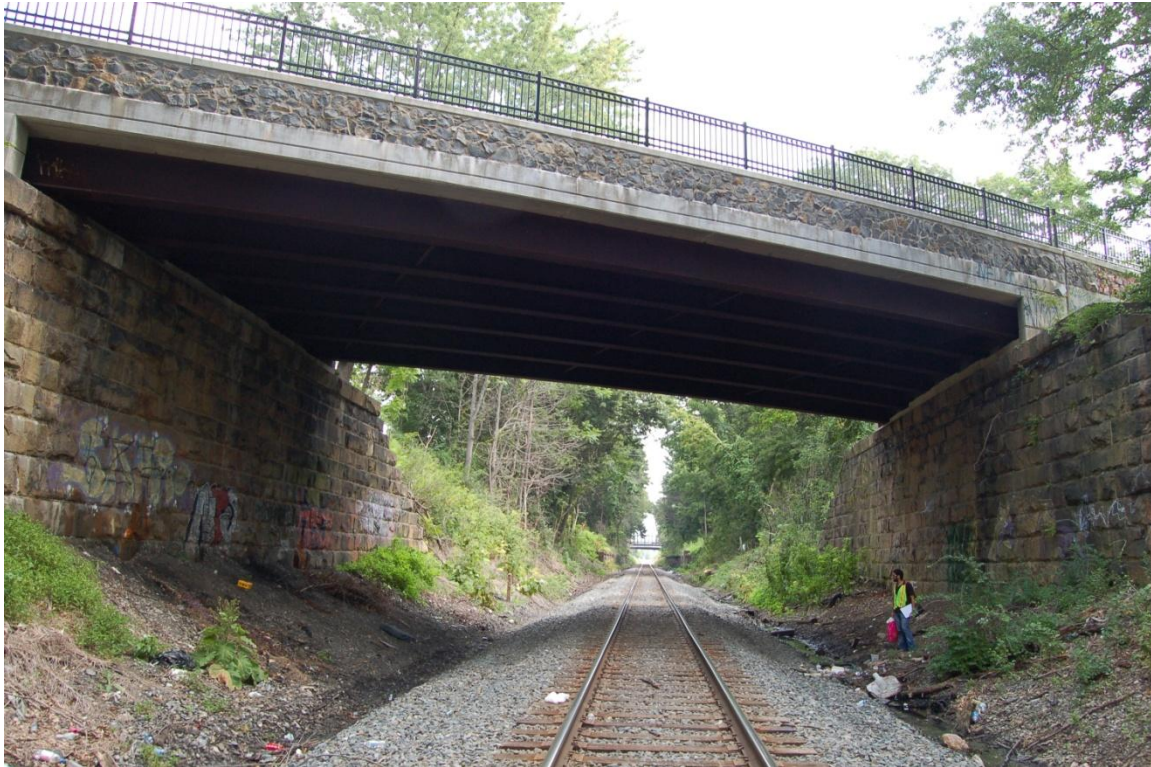
Figure 5.1 Picture of Bridge 1-609M in 2010.

Bridge 1-609B carries 6th Street over the CSX tracks in Wilmington, Delaware (Figure 5.1).

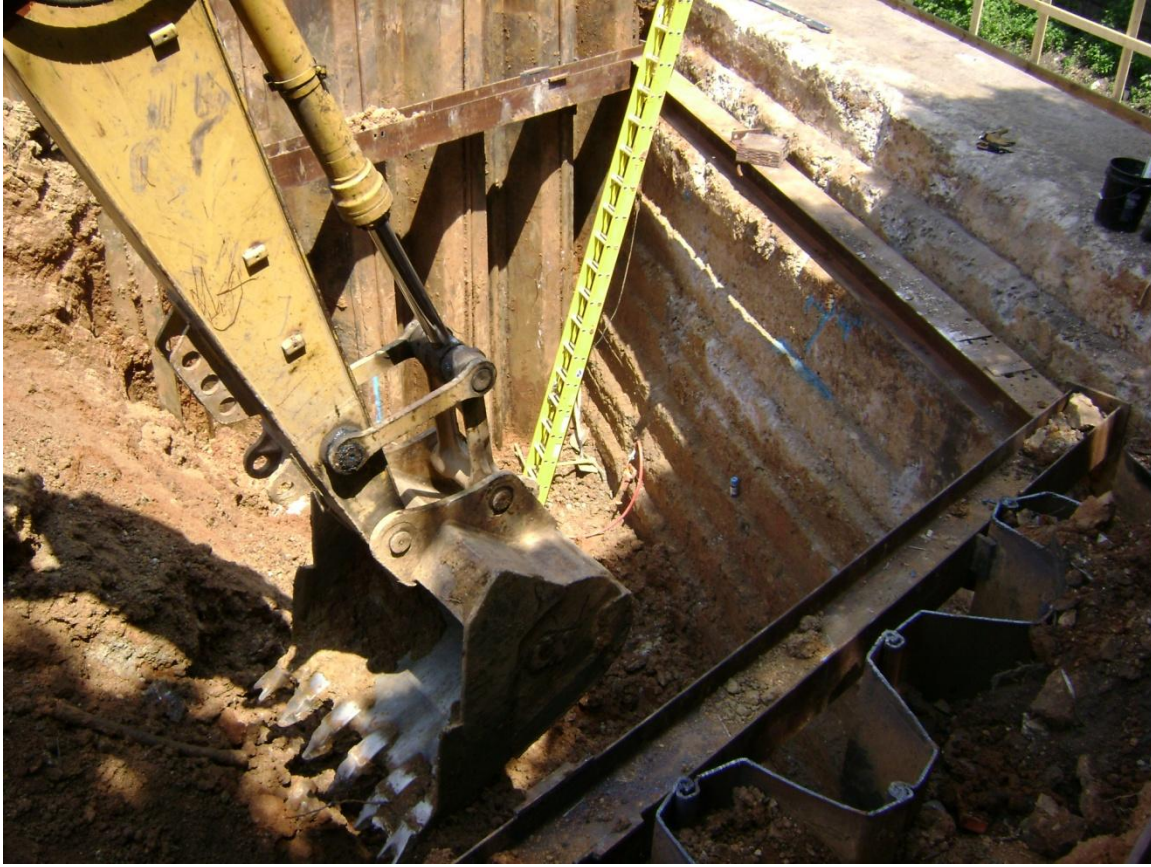
Figure 5.2 Excavation of Rear Face of North Abutment

The first step in the construction of the abutments for Bridge 1-609B involved the removal of the existing backfill material (Figure 5.2).

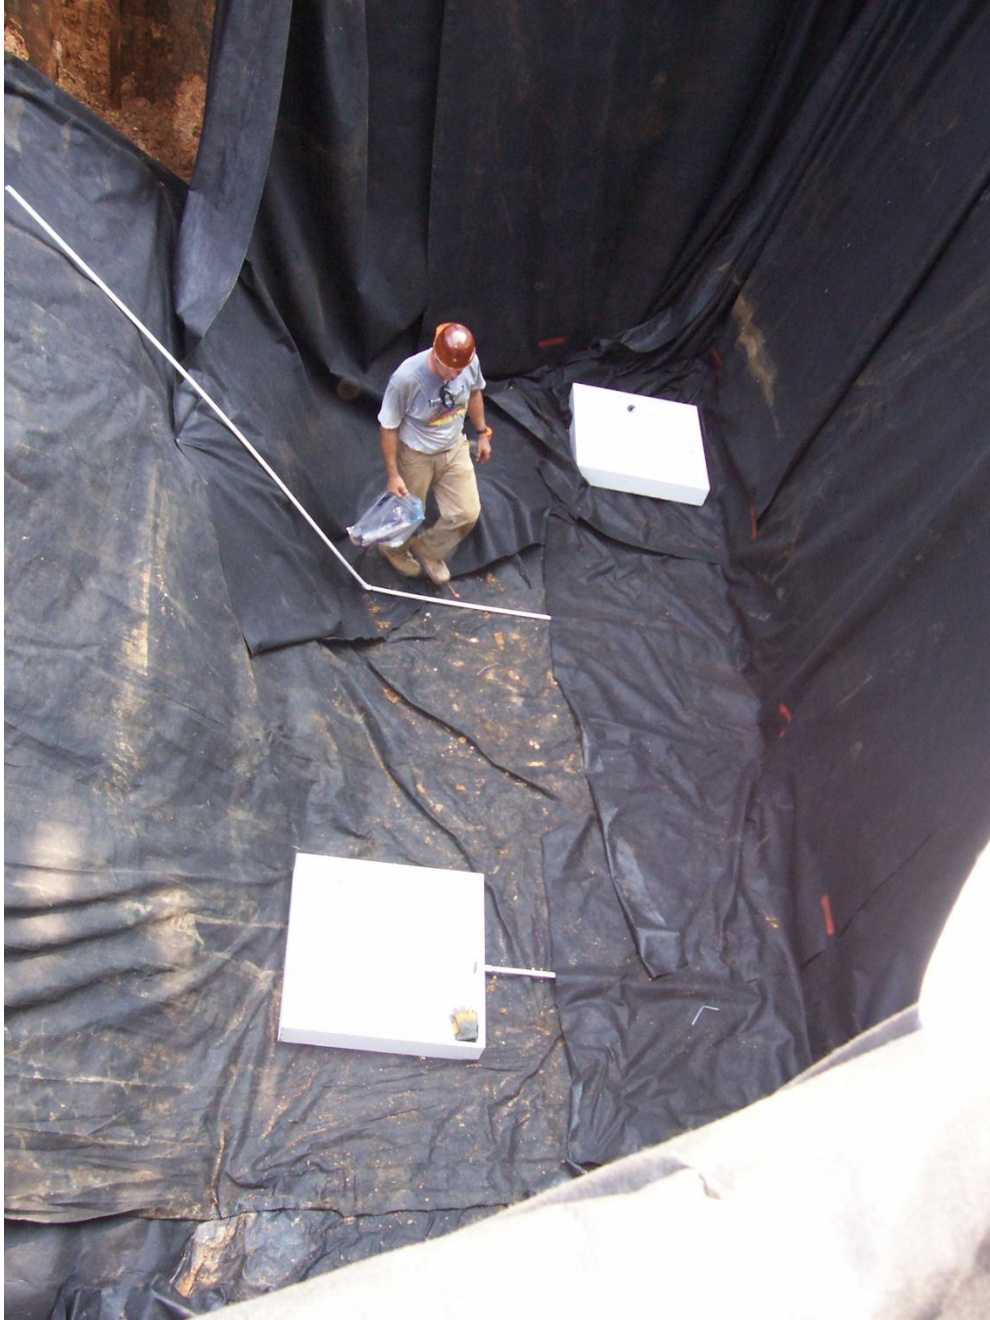
Figure 5.3 Polymeric Material in Excavation

After the excavation process was completed, polymeric material was spread over the excavations (Figure 5.3). The tire-derived aggregate (TDA) was next dumped in both abutment excavations and compacted (Figure 5.4). The presence of leachate pans (for environmental monitoring) required special care in spreading the TDA (Figure 5.5).

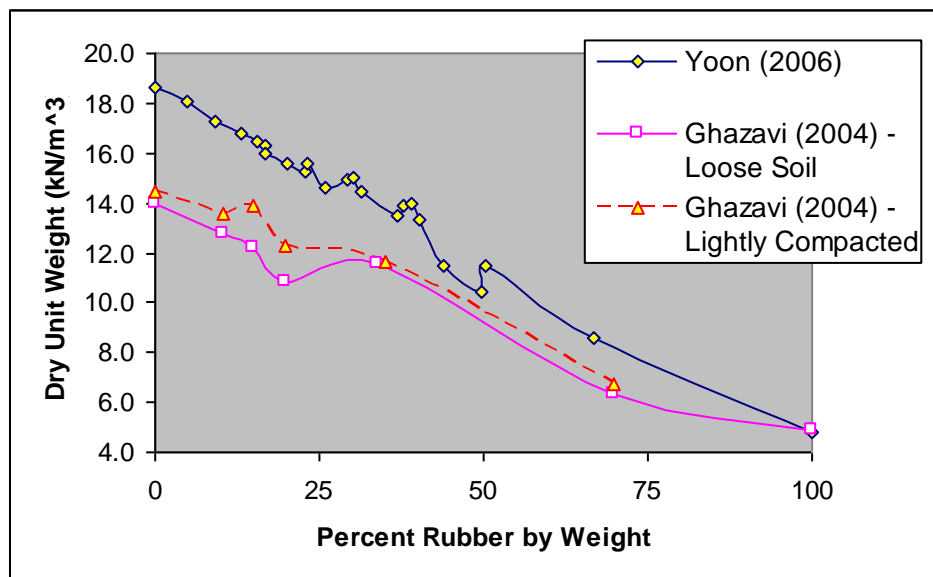
A detailed survey of the literature related to TDA was performed. While the scope of the surveyed papers varied widely, some graphical summaries of findings were made. Figure 6.1 summarizes the effect of rubber (in percent by weight) on the unit weight of soil-tire mixtures. The results presented by Yoon et al. (2006) involved 25 mm or smaller tire particle sizes mixed with poorly graded sand (SP classification). The loose, and lightly compacted soil data of Ghazavi (2004) involved 7 mm or smaller mixed rubber particles mixed with poorly graded sand. The decrease in unit weight realized in going from 0 to 100% of rubber (by weight) is rather dramatic. It is timely to note that the backfill in the Bridge 1-609B abutments consisted of essentially 100% tires.

Figure 6.1 Unit Weight of Shredded Tire/Soil Mixtures

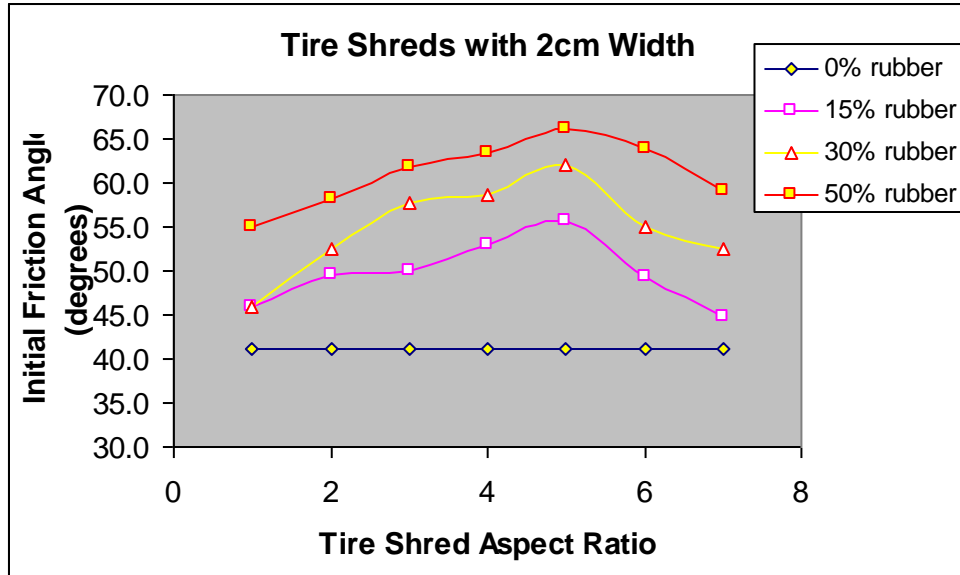
Figures 6.2 and 6.3 show the effect of the percent of rubber in a soil/rubber mixture on the initial friction angle. Clearly the friction angle increases with increasing percentages of rubber. However, some of the initial friction angles measured are likely manifestations of using too small of a specimen, resulting in the tire piece spanning the entire width of the specimen.

Figure 6.2 Effect of Percentage of Rubber on the Initial Friction Angle of Shredded Tire/Soil Mixtures: $\gamma_m = 16.8 \text{ kN/m}^3$.

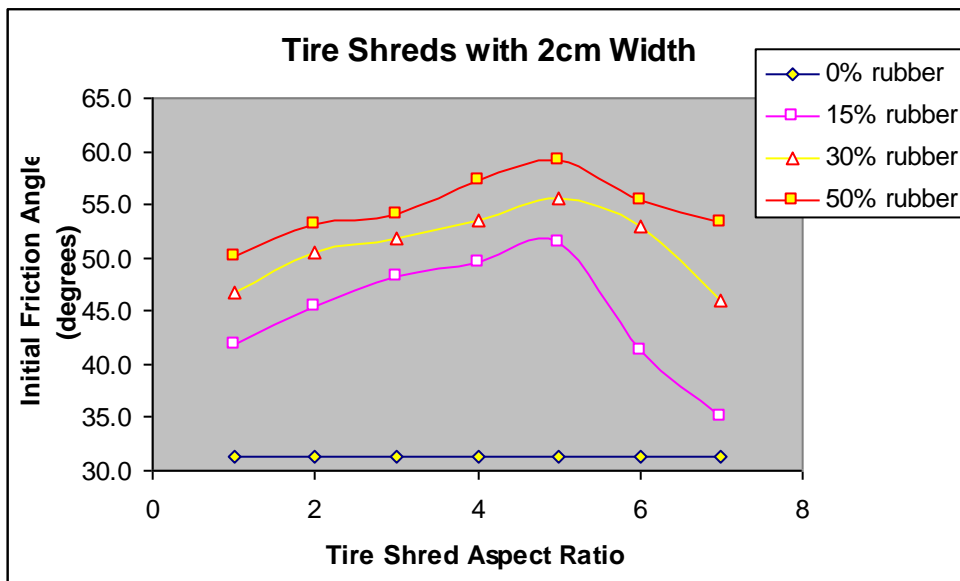
Figure 6.3 Effect of Percentage of Rubber on the Initial Friction Angle of Shredded Tire/Soil Mixtures: $\gamma_m = 15.5 \text{ kN/m}^3$.

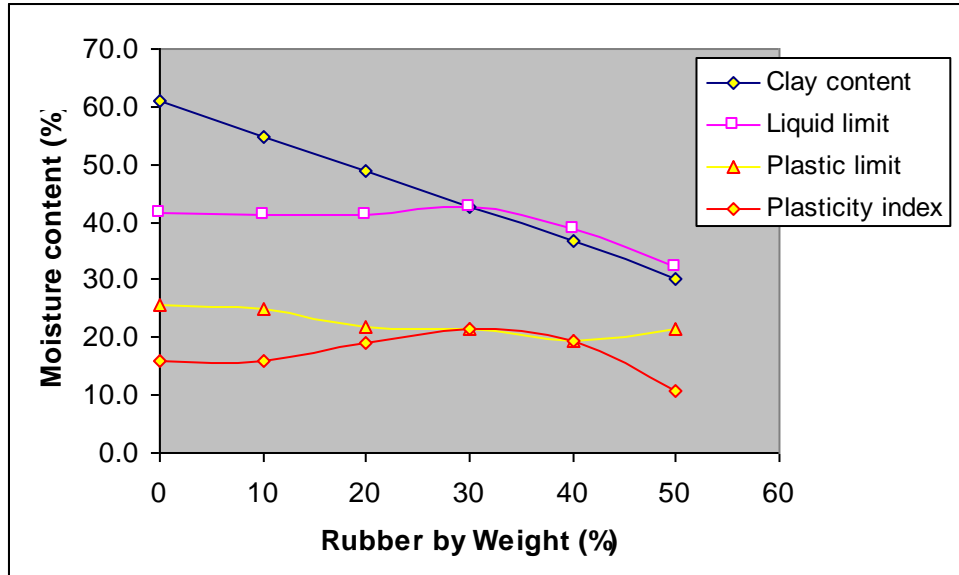
Figure 6.4 Effect of Percentage of Rubber on the Clay Content and Atterberg Limits

Figure 6.4 shows the effect of rubber content on the Atterberg limits and on the clay content. Although these limits decrease somewhat with increase in percentage of rubber, there is seemingly no general trend.

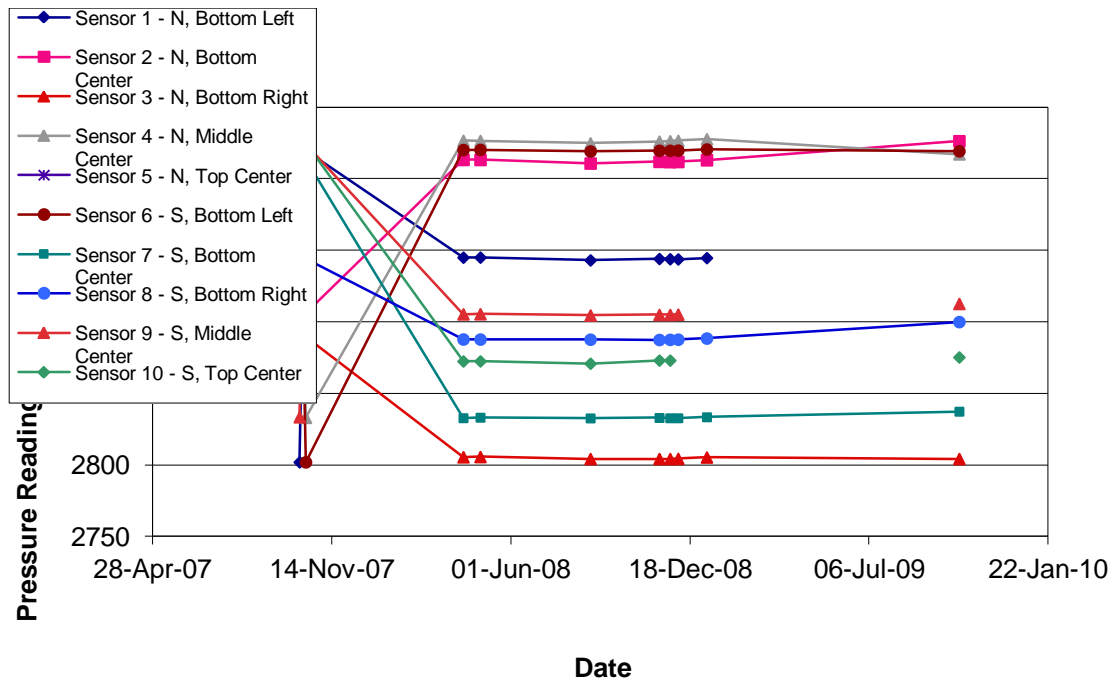
Although pressure transducers that measure lateral pressure on the abutment walls were successfully installed, the calibrations factors were lost. As such, the absolute pressures on the abutment walls cannot reliably be determined. The *changes* in pressure with time can, however, be inferred from changes in the pressure time history. As seen from Figure 7.1, the changes in pressure on the abutment walls with time are negligible. This implies that no detrimental effects due to potential settlement of the TDA have been detected.

Figure 7.1 Lateral Pressure Readings on Abutment Walls

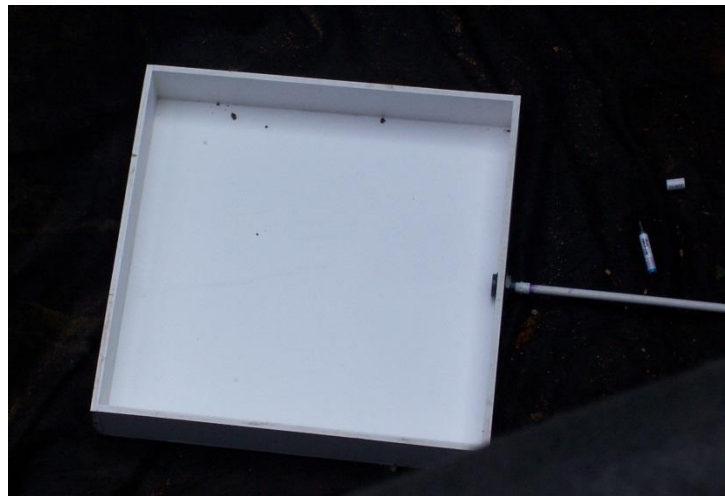
Figure 8.1 is a photograph of one leachate basin. Figure 8.2 illustrates the placement of the two of the basins at the bottom of the South embankment. Figure 8.3 shows the emplacement of tire shreds on top of the leachate collection basins in the South Embankment.

Figure 8.1. Photograph of leachate collection basin and PVC pipe that drained leachate.

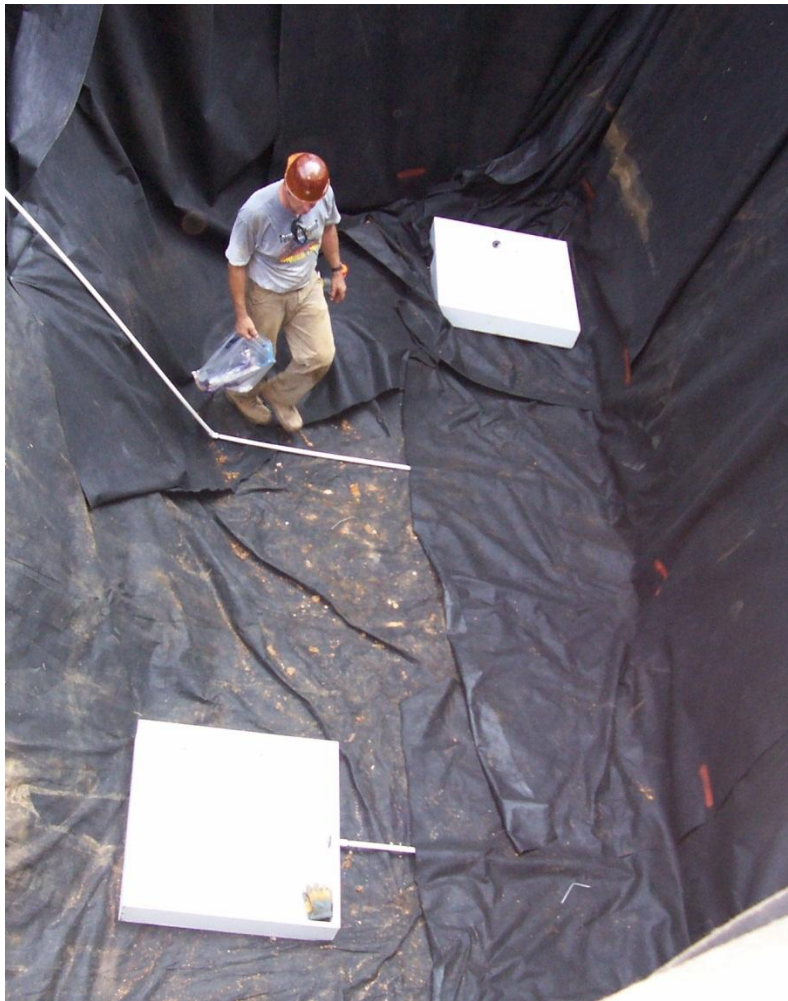
Figure 8.2. Photograph of two of the three leachate basins installed at the bottom of the South Embankment.

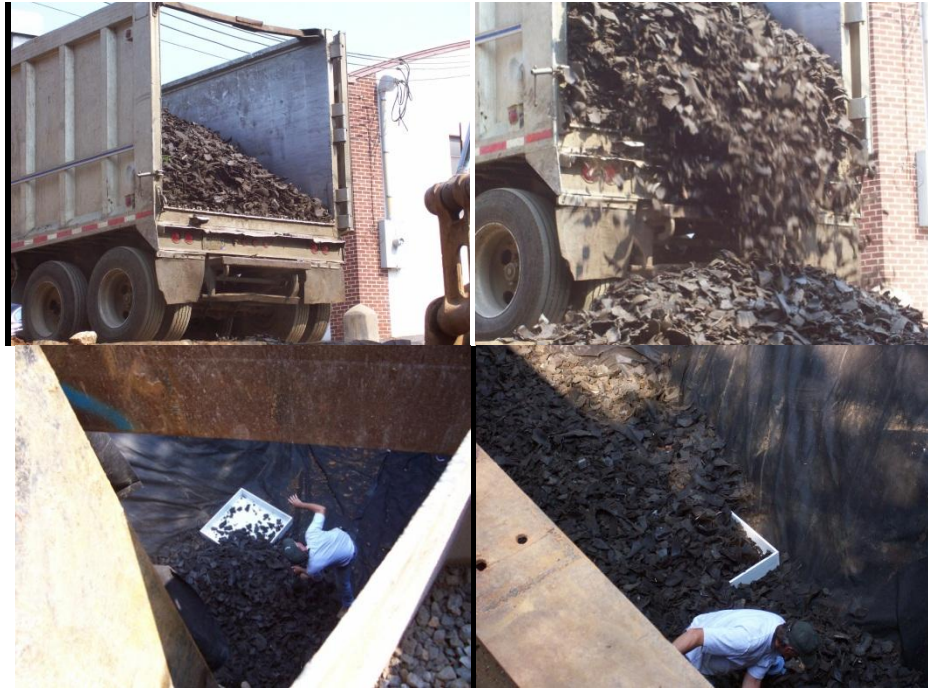
Figure 8.3. Placement of tire shreds on top of a leachate collection basin.

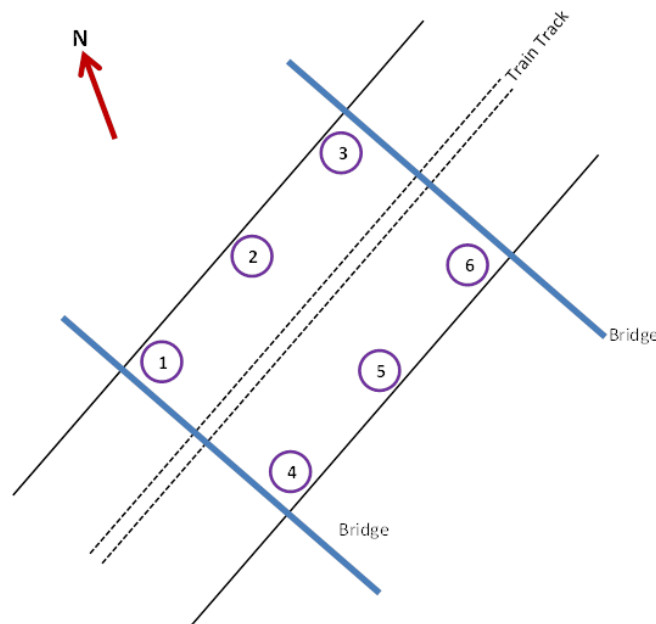
Figure 8.4. Plan view showing the location of the sampling ports on the north and south abutments.

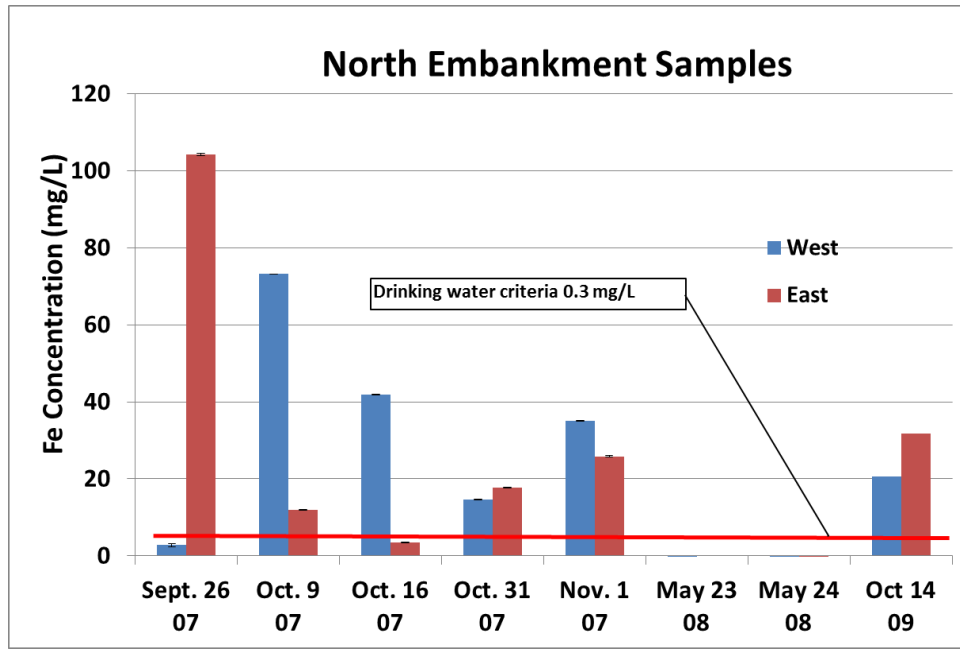
Of the elements analyzed, the only two that were frequently higher than the water quality or drinking water limits were Fe and Zn. Concentrations of Fe are shown for samples taken from the North and South Embankments in Figures 8.5 and 8.6, respectively. Results are plotted for two ports on each embankment, labeled West and East. These correspond to ports 1 and 2 on the North Embankment, and ports 4 and 5 on the South Embankment. Only at these ports was sufficient leachate collected to allow for sample analyses.

For the North Embankment, Fe concentrations are frequently above 10 mg/L. Sample concentrations generally decreased with time and were below the detection limit in May 2008. However, samples collected in 2009 were again elevated and above 10 mg/L. The reason for the variability in sample concentrations is unknown but is undoubtedly associated with nonuniform water infiltration in the embankment. The pH of the leachate for all samples collected ranged between 6.2 and 6.9 over all sampling events for both embankments.

Figure 8.5. Fe concentrations from leachate samples from the North Embankment.

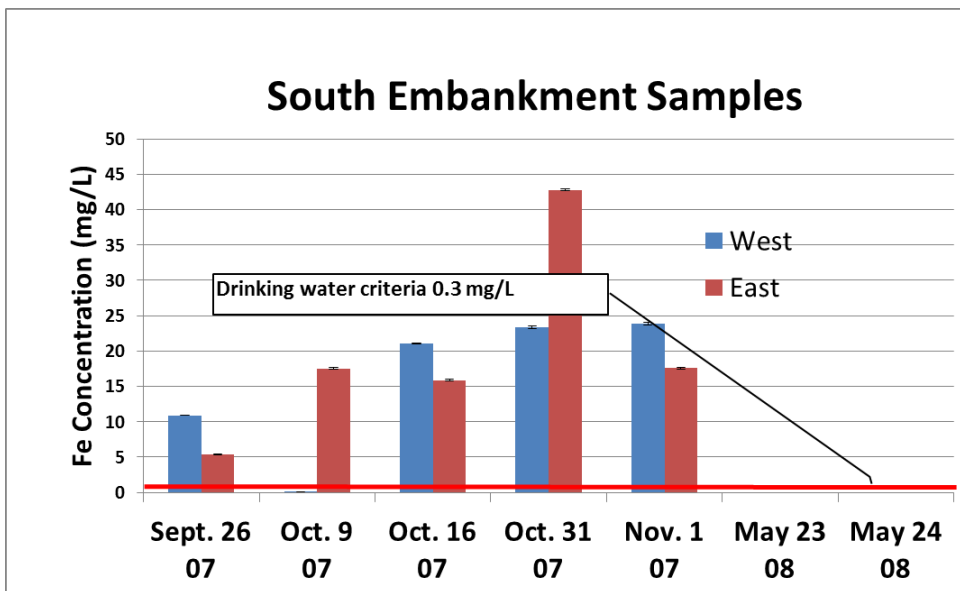
Similar trends are seen for data collected from the South Embankment in Figure 8.6: total Fe concentrations decrease with time and are below the detection limit in May

2008. However, sufficient leachate was not collected in 2009 to measure Fe concentrations. Thus, it is impossible to ascertain if the increase in Fe concentration observed in 2009 for the North Embankment leachate also occurred for the South Embankment. The drinking water limit for Fe is 0.3 mg/L.

Figure 8.6. Fe concentrations from leachate samples from the South Embankment.

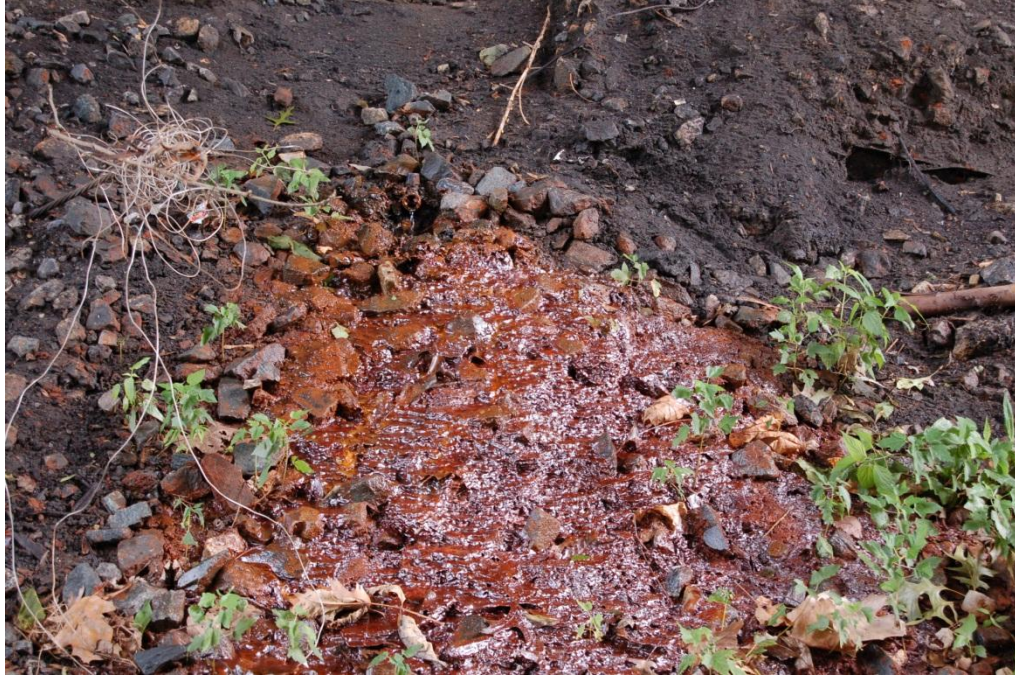
Of the six ports in Figure 8.4, the only port where the gravel surrounding the sampling port did not indicate excessive Fe concentrations was Port 5. A photograph of this port is shown in Figure 8.9; no iron oxide precipitate is evident in this photograph.

Figure 8.8. Photograph of Port 2 in September 2011. Note the red iron oxide on the gravel, and the reddish color of the leachate, also indicative of iron oxide.

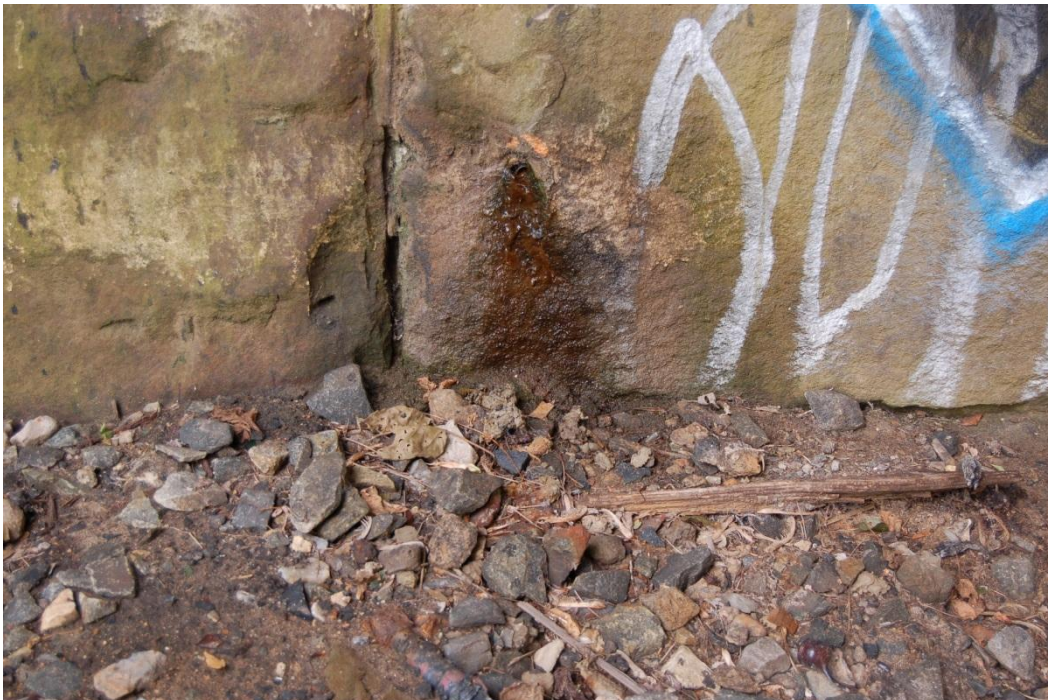
Figure 8.9. Photograph of Port 5 in September 2011. The leachate appears clear and there is no evidence of significant iron oxide precipitate on the gravel or abutment wall.

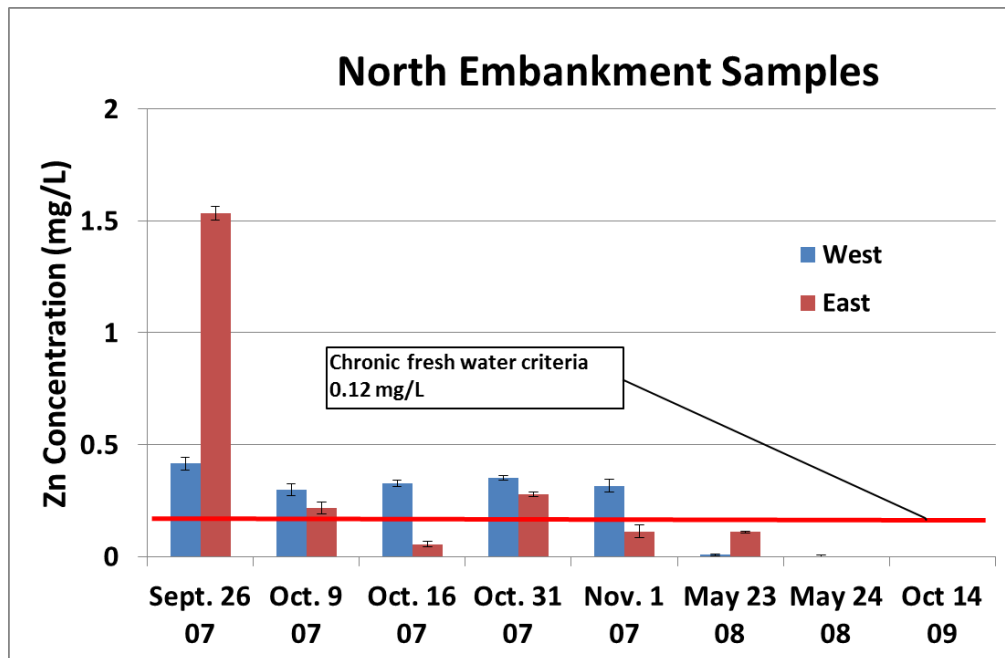
Zn concentrations exceeded water quality criteria (0.12 mg/L) for most sampling events in 2007. Concentrations are shown for the North and South Embankments in Figures 8.10 and 8.11, respectively. However, just as for the Fe measurements, concentrations decreased in 2008 and 2009 and were below water quality criteria from the North Embankment for samples collected in both years. For the South Embankment, sufficient leachate was not collected in 2008 or 2009 to allow for sample analysis. The pH for all samples ranged between 6.2 and 6.9. Because of error in sample storage for samples collected in 2010 and 2011, Zn concentrations could not be quantified in leachate for these measurement periods.

Figure 8.10. Zn concentrations from leachate samples from the North Embankment.

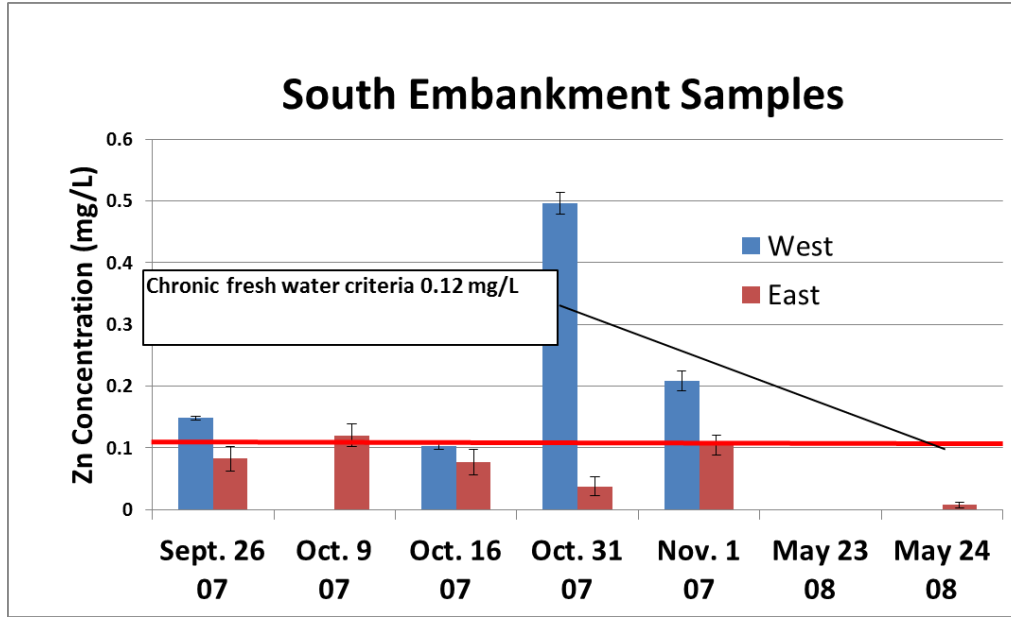
Figure 8.11. Zn concentrations from leachate samples from the South Embankment.

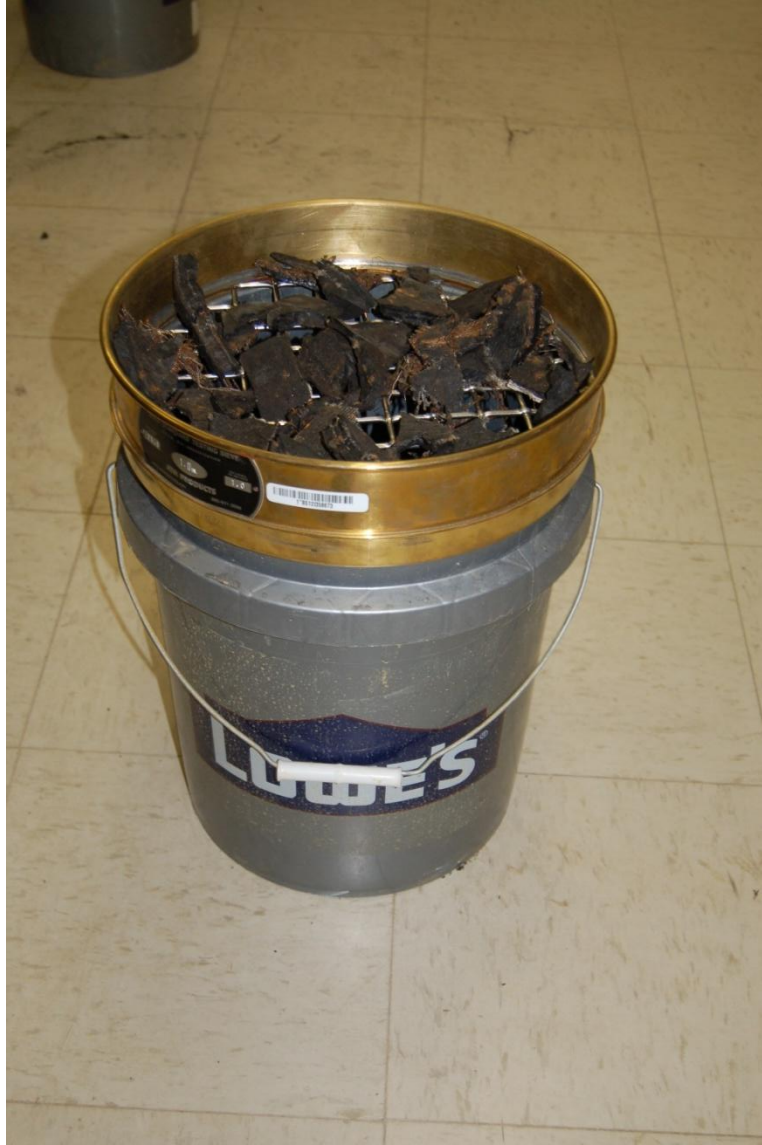
The material used were tire chips smaller than one inch in size. Tire chips were sieved to ensure that all particles were indeed smaller than one inch in size. Figure 9.1 shows some typical tire chips before sieving.

Figure 9.1. Shredded tire chips before sieving.

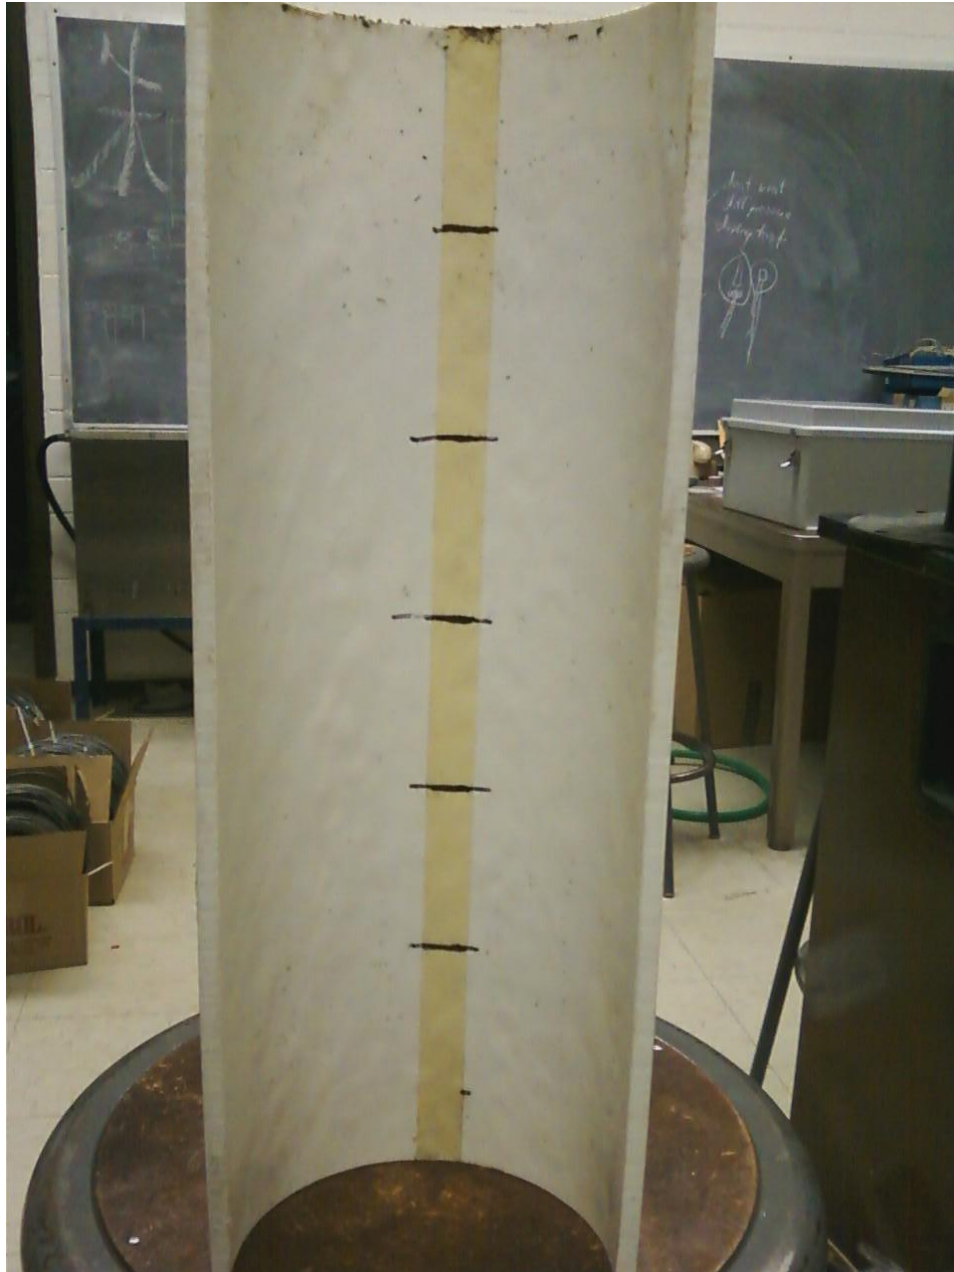
Samples were prepared to a unit weight of 47 pcf by placing six lifts of 1.53 lbs and compacting them in a PVC forming jacket to a height of 2 inches. Figure 9.2 shows one-half of the forming jacket; the height of the six lifts is evident from the lines made with a black marker. Figure 9.3 shows the entire forming jacket.

Figure 9.2. One-half of the PVC forming jacket. Black lines denote lift thicknesses.

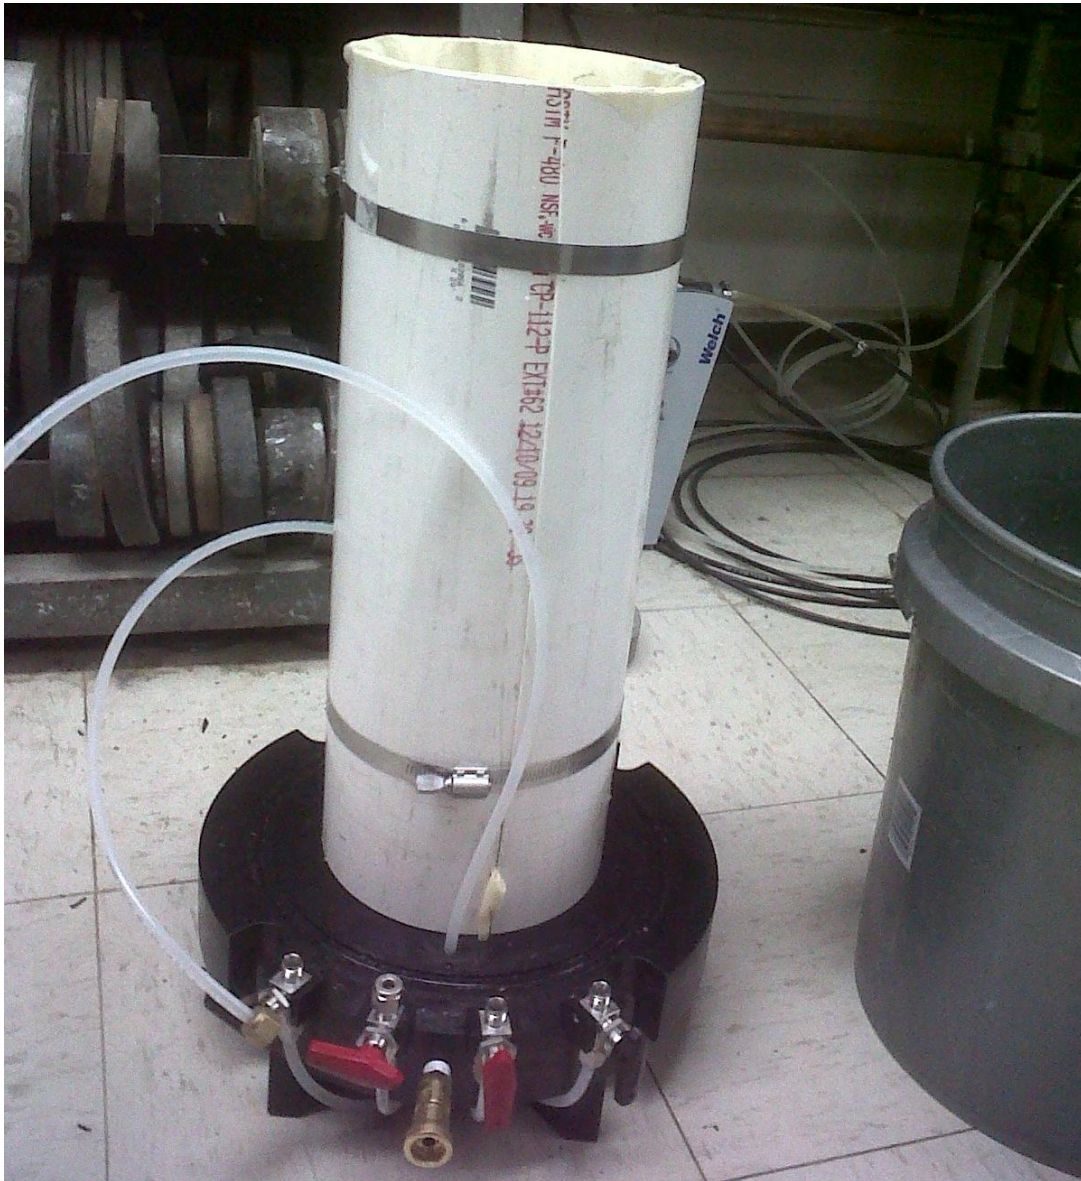
Figure 9.3. PVC forming jacket connected to base.

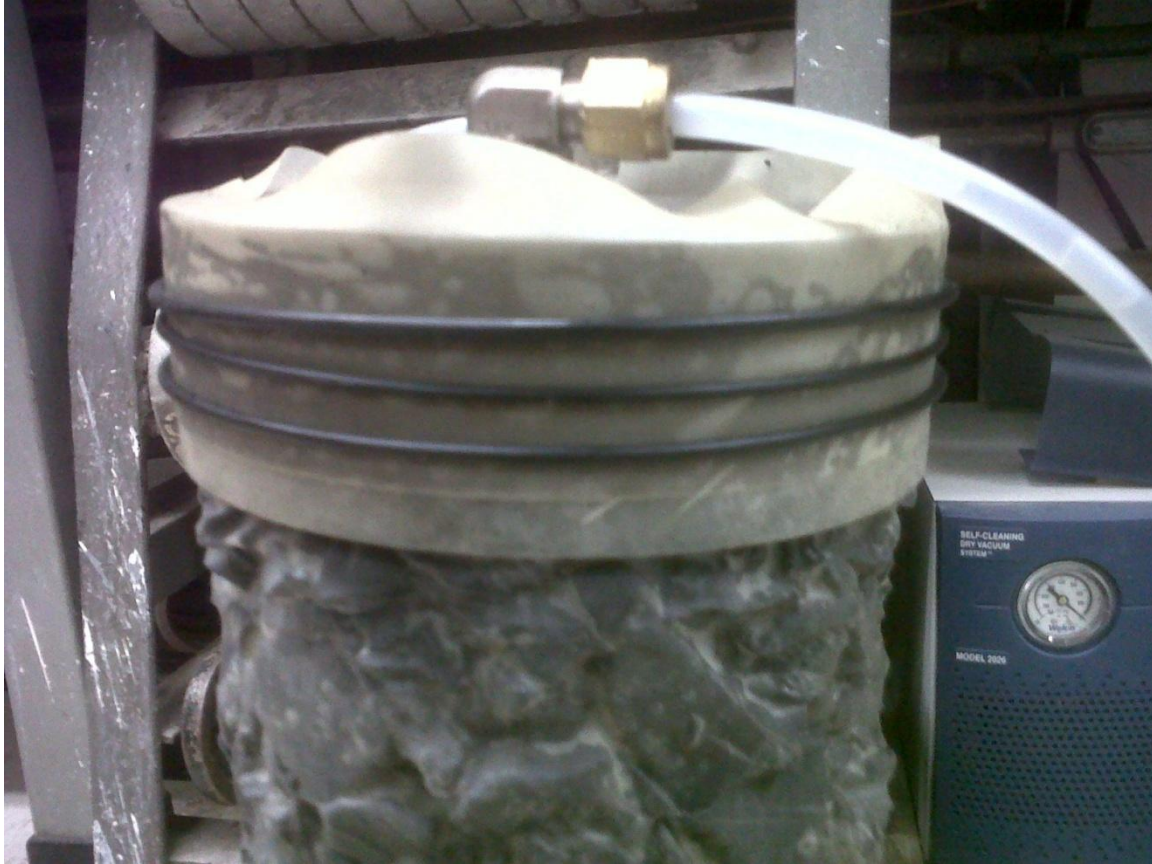
The above process created a sample that was 12 inches in height and had a diameter of 6 inches. Samples were then sealed with three o-rings on both the top and bottom platens (Figure 9.4). A vacuum of approximately 5 psi was placed on the samples to help them retain their rigidity while moving them to the Trautwein large capacity triaxial testing device (Figure 9.5).

Figure 9.4. Typical sample encased in rubber membrane and sealed with o-rings.

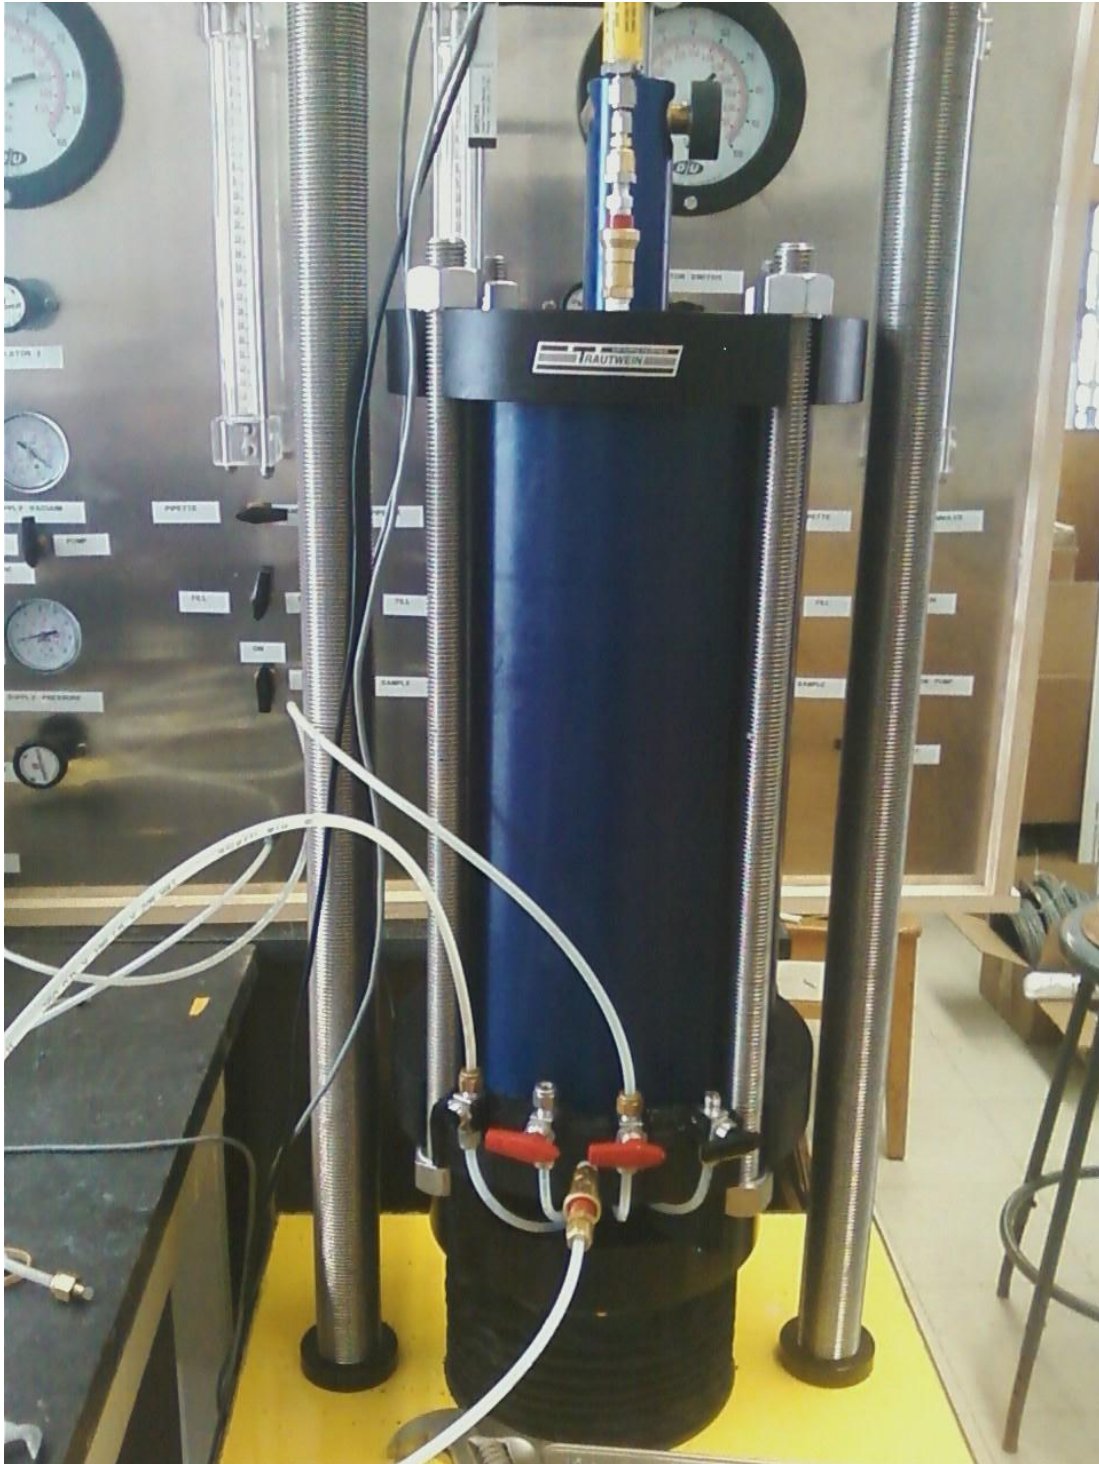
Figure 9.5. Typical sample large capacity triaxial testing device.

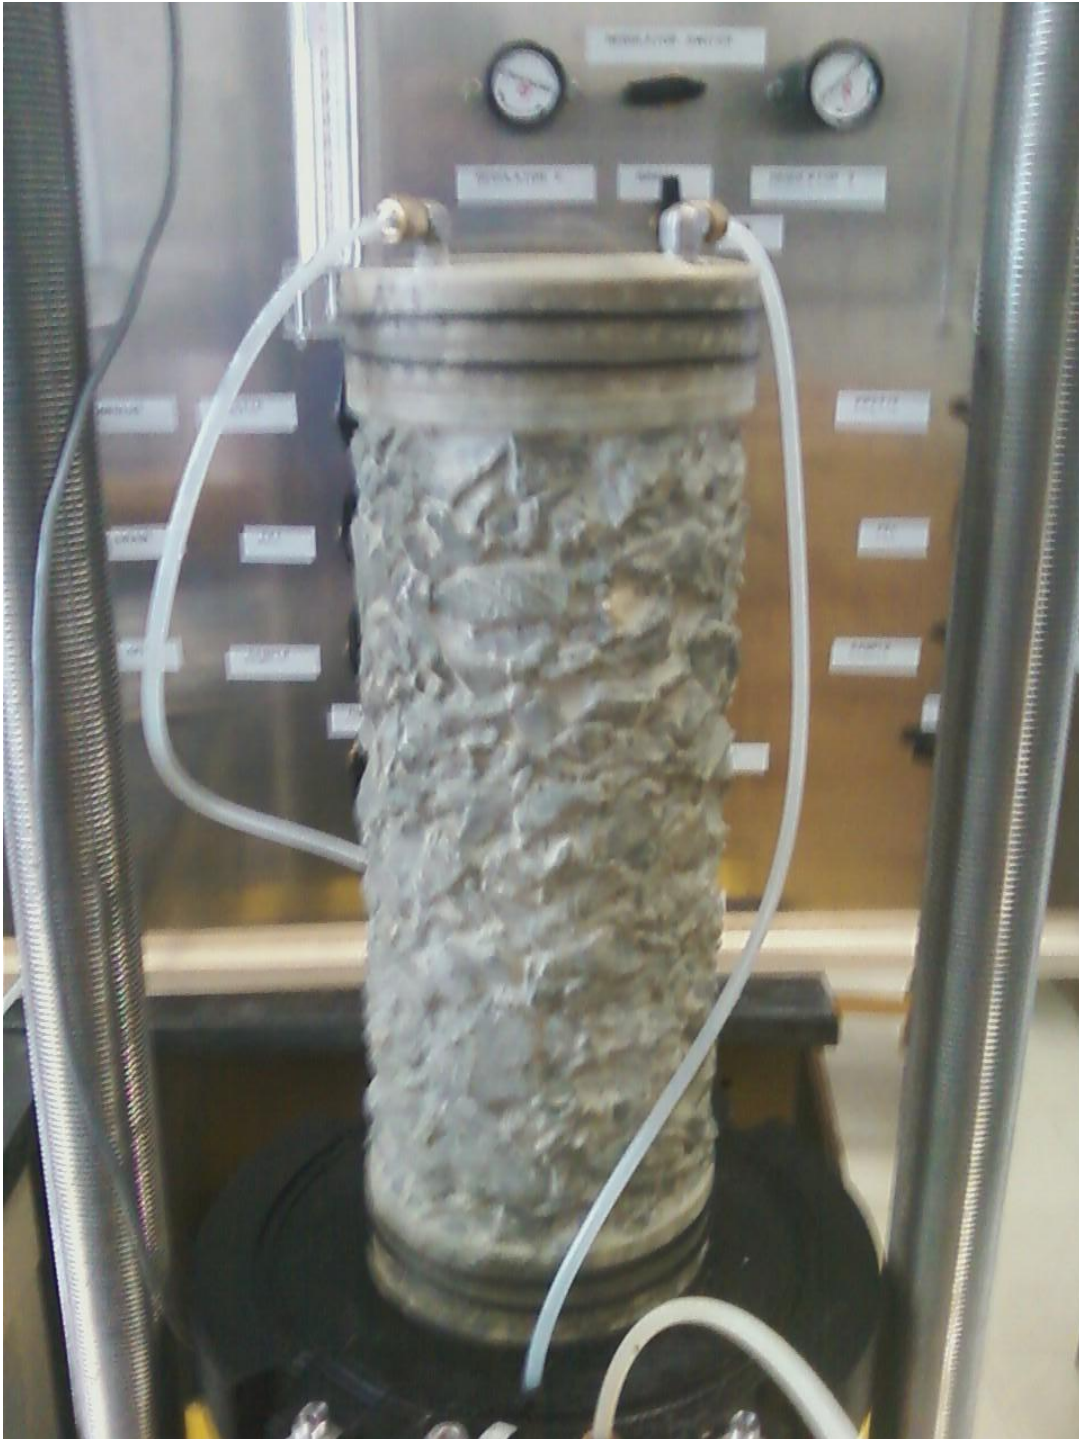
Samples were then tested using a consolidated undrained (CU) triaxial testing procedure in general accordance with ASTM standard test method D4767-11. Failure was defined by the maximum deviatoric stress, which in all cases occurred at approximately 15% axial strain. Figures 9.6. and 9.7 show typical samples at failure.

Figure 9.6. Failed sample at 6.5 psi confinement pressure.
