Long-Term Performance Monitoring of a Recycled Tire Embankment in Wilmington, Delaware

**LONG-TERM PERFORMANCE MONITORING OF A RECYCLED
TIRE
EMBANKMENT IN WILMINGTON, DELAWARE**

Final Report

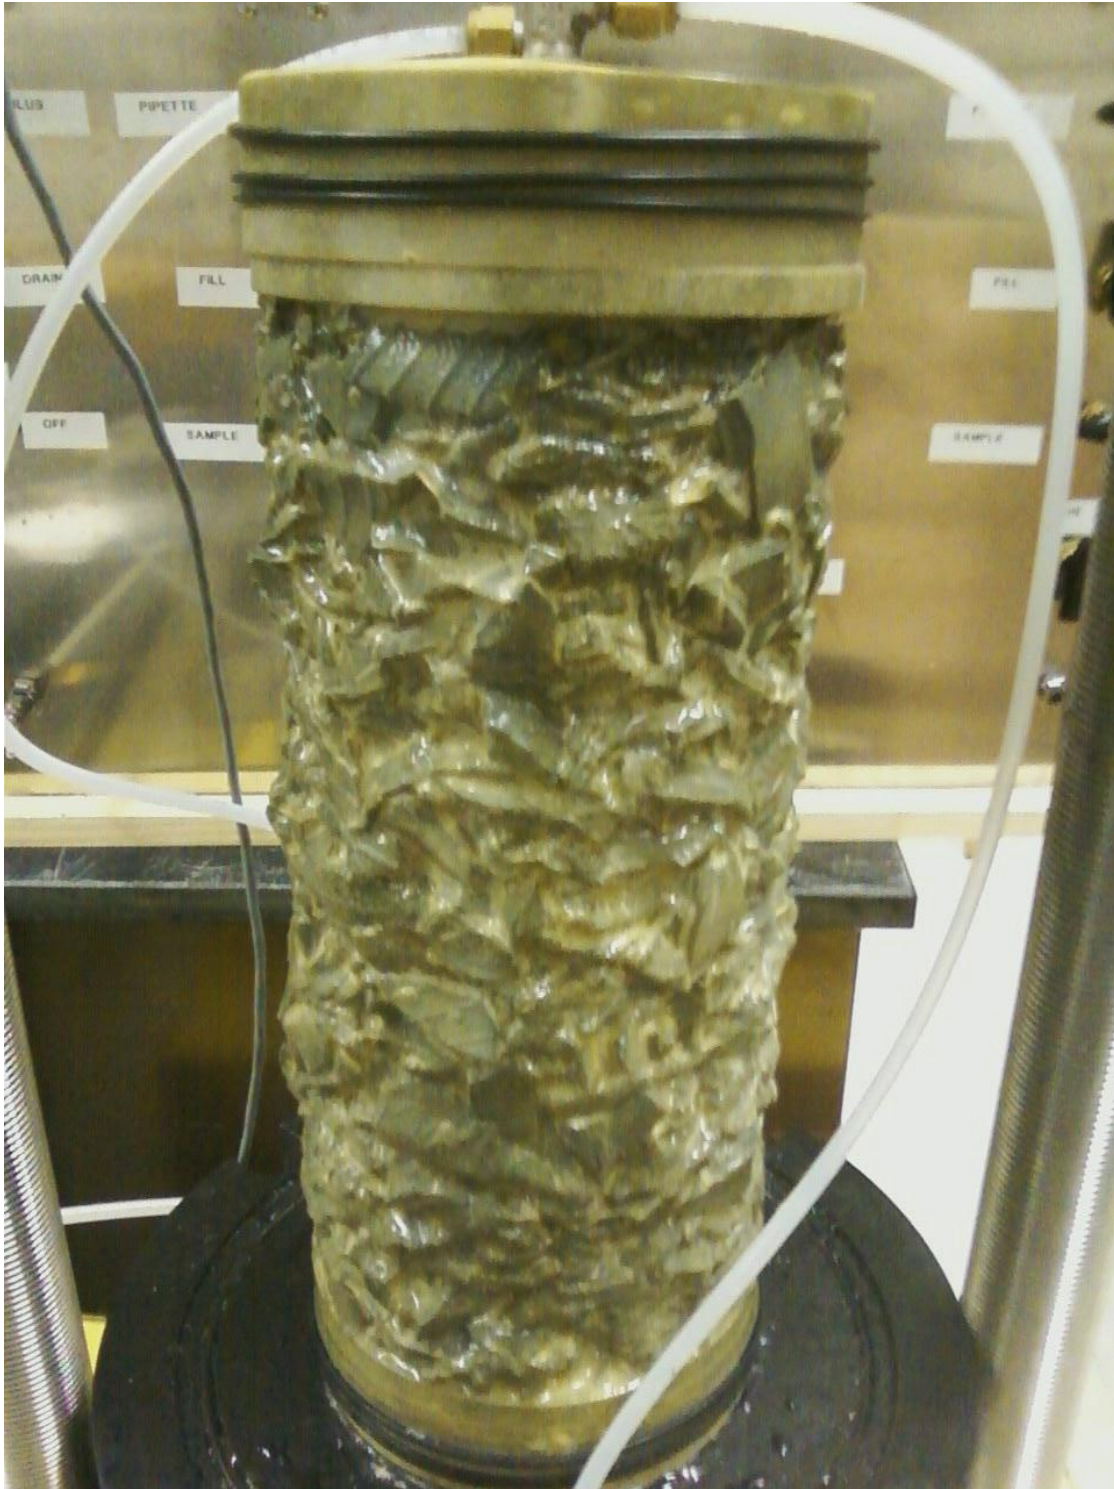
Samples were then tested using a consolidated undrained (CU) triaxial testing procedure in general accordance with ASTM standard test method D4767-11. Failure was defined by the maximum deviatoric stress, which in all cases occurred at approximately 15% axial strain. Figures 9.6. and 9.7 show typical samples at failure.

Figure 9.7. Failed sample at 23.0 psi confinement pressure.

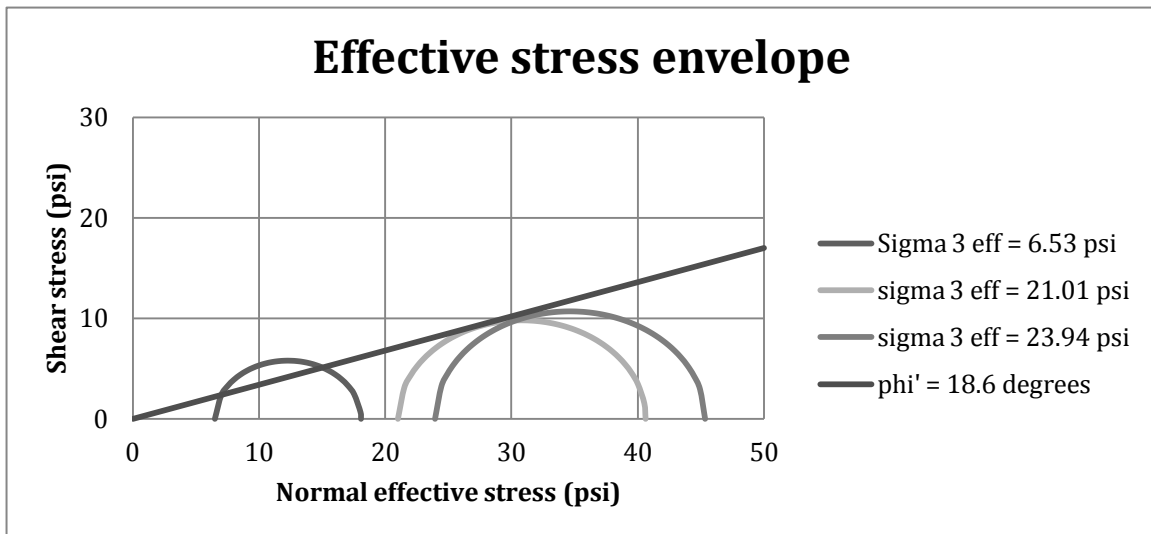
Samples were assumed to have no cohesion and as such the failure envelope was forced to pass through the origin during the analysis. Figure 9.8 shows a typical effective stress failure envelope.

Figure 9.8. Typical effective stress failure envelope.

The friction angles obtained were at the low end of what is listed in the literature. This is likely due to the removal of the steel belting. In addition, many of the previous studies described in the literature used larger particles as compared to those tested in the present project.
