Analysis of the Field Behavior of a Geosynthetic Reinforced Soil Integrated Bridge System During Construction and Operation

December, 2016

**Delaware Center for Transportation
University of Delaware
355 DuPont Hall
Newark, Delaware 19716
(302) 831-1446**

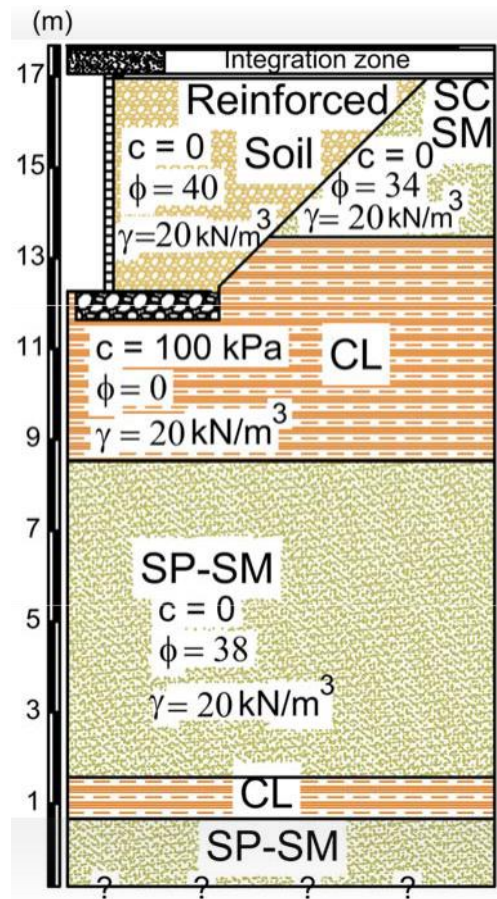
Figure 3.3 Soil layering and engineering properties used for the design of the GRS-IBS

Using the results from these laboratory tests, published correlations, and engineering judgment, a simplified soil layer geometry, associated soil unit weights, and necessary strength parameters for design of the GRS-IBS were determined; this information is provided in Figure 3.3 (note that some conservatism was used in the determination of some of the estimated parameters).

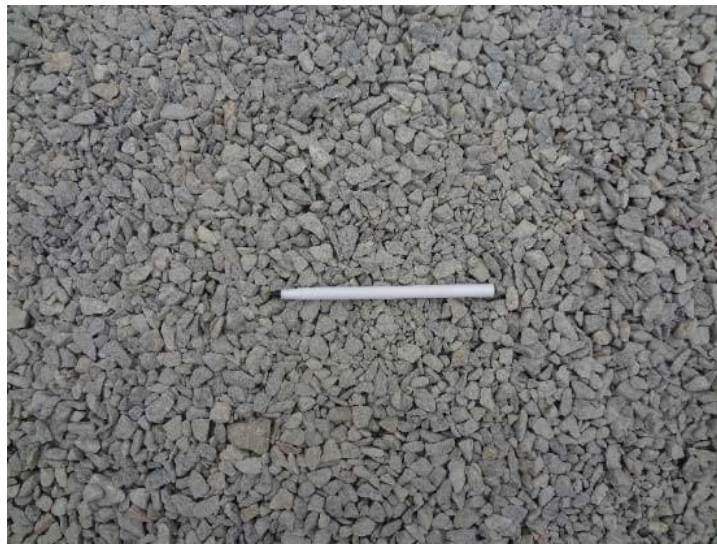
Figure 3.4 No. 8 stone material utilized in the project

Based on these requirements, No. 8 stone was utilized for the backfill material in the reinforced soil zone. This crushed stone is a coarse material with a relatively uniform gradation, as shown in Figure 3.4. This material has DelDOT approval for use in construction and generally conforms to the associated material specifications (Adams et al. 2011) for GRS-IBS backfill material.

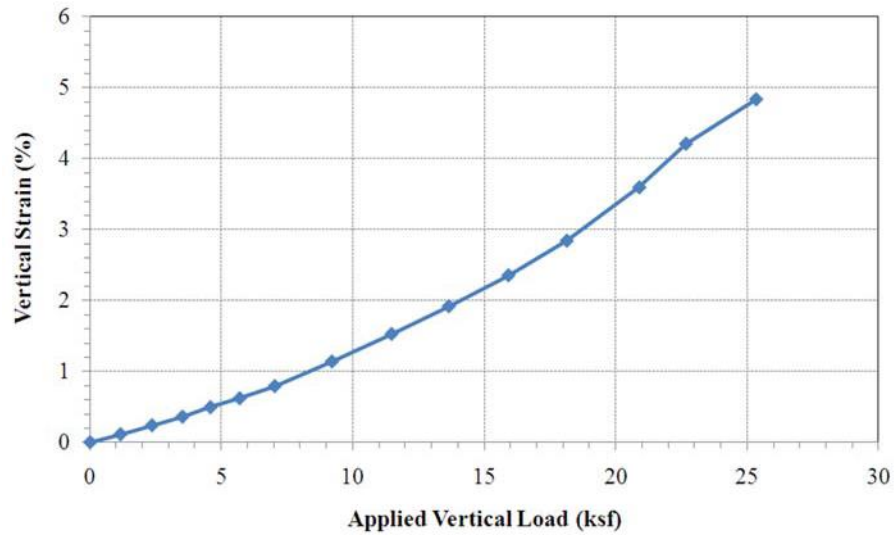
Figure 3.11 Assumed design envelope for vertical capacity and strain at 8-inch reinforcement spacing (Adams et al. 2011)

The empirical method uses the load test results of a performance test on a GRS composite material identical (or very similar) to that used in the field. The ultimate capacity (q_{ult}) is found empirically as the stress at 5 percent vertical strain from the stress-strain curve determined from the load test. For the current project, there was no performance test data available; consequently, the performance test results determined by Adams et al. (2011) were used (Figure 3.11).

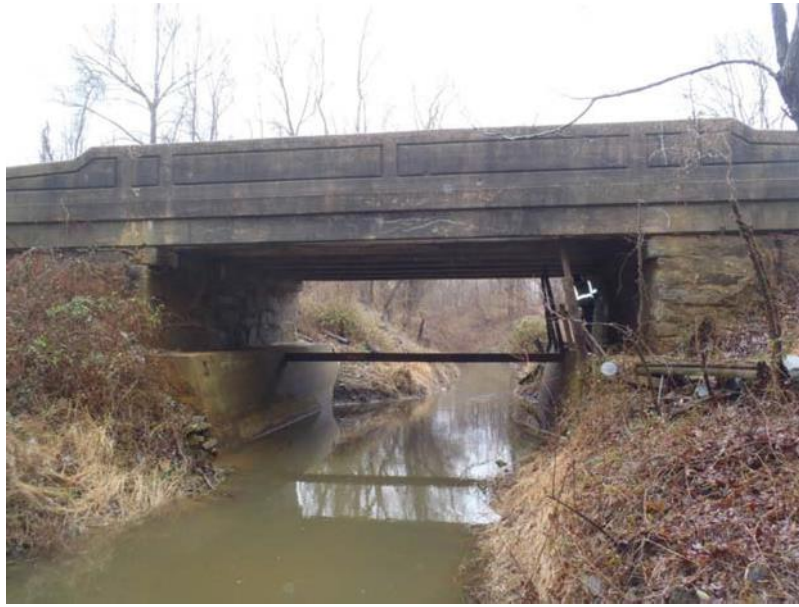
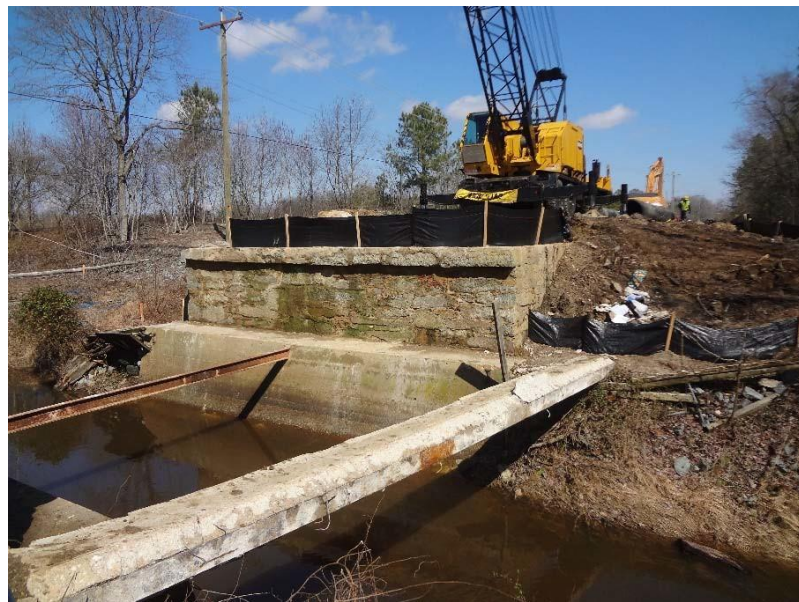
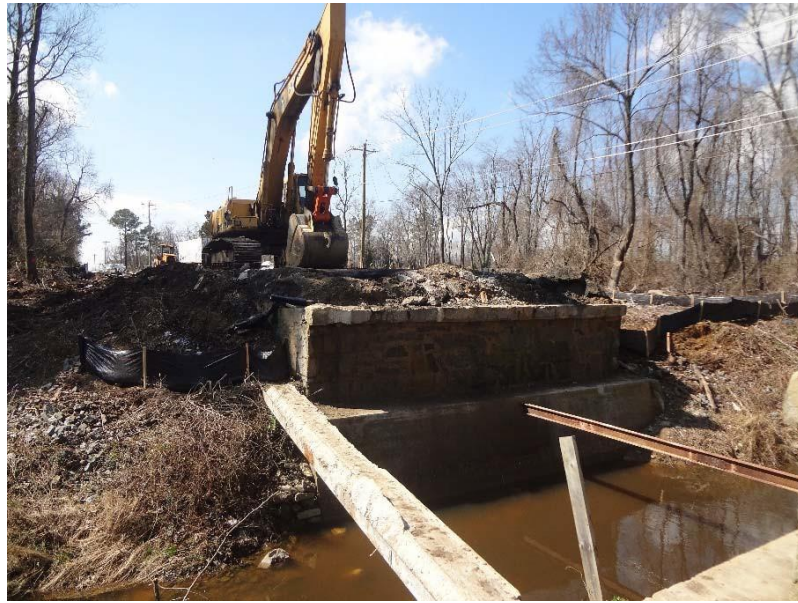
Figure 3.13 Existing bridge before and after demolition

Construction of Delaware's first GRS-IBS structure, in New Castle County on Chesapeake City Road over Guthrie Run, began in March 2013 via demolition of the existing bridge and abutments at this location. Figure 3.13 shows some photos related to the existing bridge, before and after its demolition. Excavation for the east abutment foundation began on March 22, 2013; construction of the new east abutment was completed on April 5, 2013. Figures 3.14 through 3.19 show photos of the east abutment construction process. Excavation for the west abutment foundation began on April 3, 2013; construction of the new west abutment was completed on April 23, 2013. Figures 3.20 through 3.24 show some photos of the west abutment construction process.

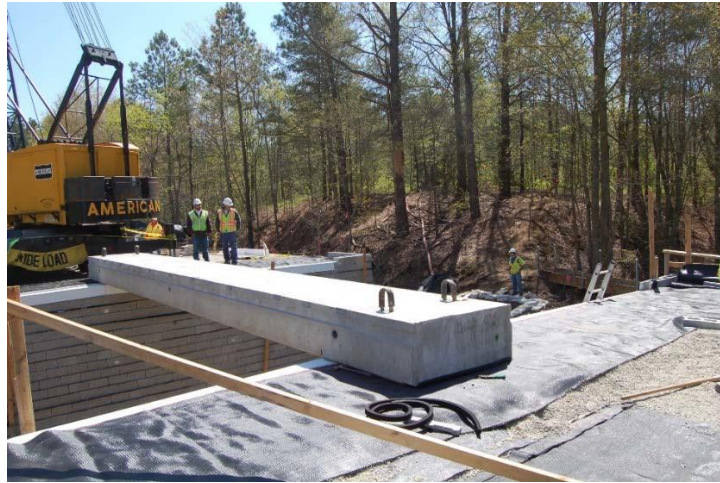
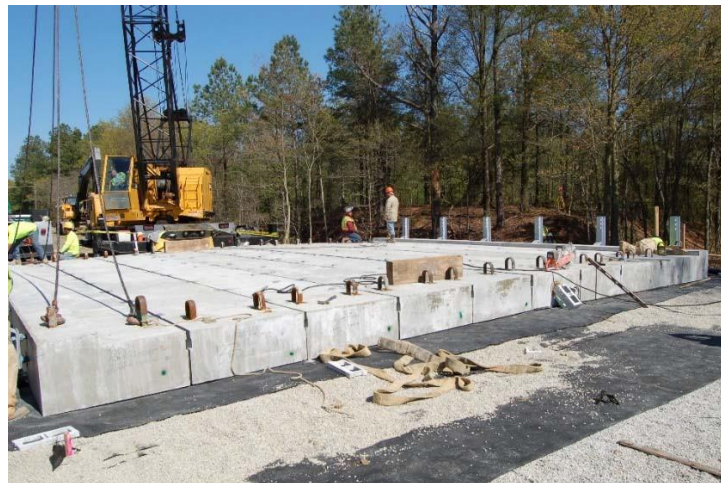
Figure 3.25 Bridge placement operation

After abutment completion, the bridge beams were placed using a crane on April 25, 2013, and the integrated zone was constructed over the following three weeks. Figure 3.25 and 3.26 show some photos of the bridge placement and integration zone construction process.

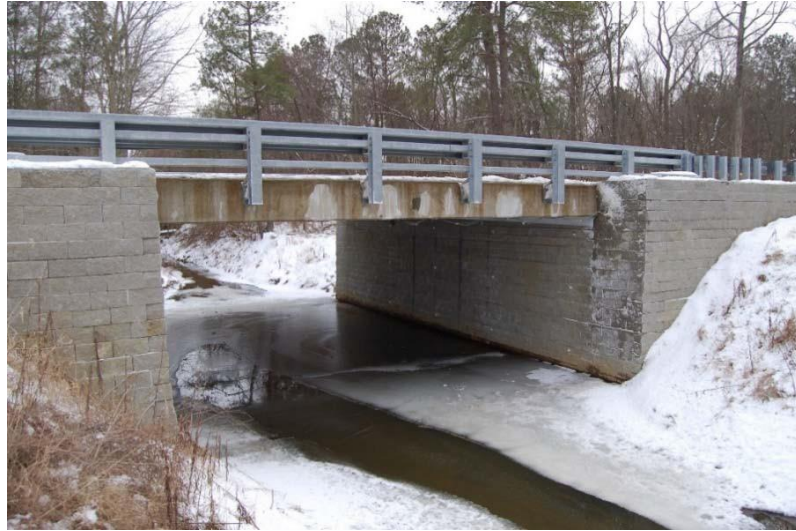
Figure 3.27 Completed bridge and abutments, eight months after construction

After paving and guard rail installation, the GRS-IBS was completed; a picture showing the GRS-IBS in service months after its initial construction (during the first winter) is provided in Figure 3.27. Although this was the first GRS-IBS constructed

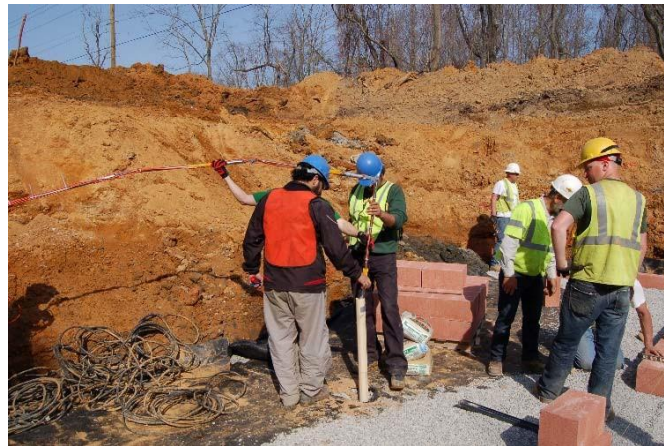
Figure 3.29 Inclinometer sensor and its installation

Four In-Place Inclinometer (IPI) sensors were installed in the clay foundation layer (Figure 3.3) to monitor displacement of this layer during construction and subsequent bridge operations. There is a relatively stiff sandy layer beneath the clay layer; consequently, the inclinometer casing was advanced through the clay layer and was terminated in the sandy soil. Figure 3.29 shows the sensor and its installation at the site.

and the sensors were installed once excavation had reached the base elevation from which new construction was to take place. The IPI sensors that were utilized in this project provide an in-place alternative to traditional traversing probe-type inclinometers, by employing a fixed chain of sensors affixed to a series of connected rods. Vertical biaxial IPIs were used, allowing for displacement measurements in both the N-S and E-W directions.

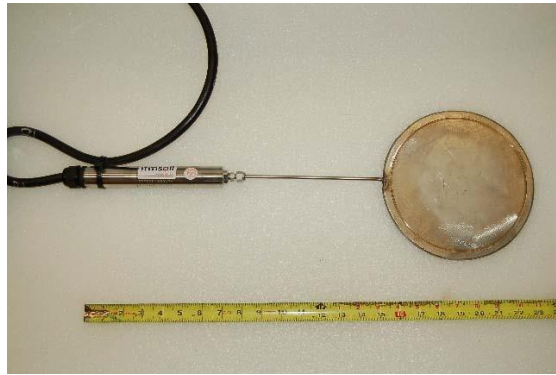
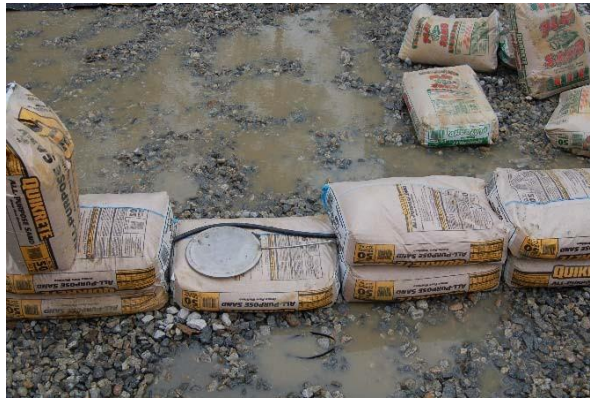
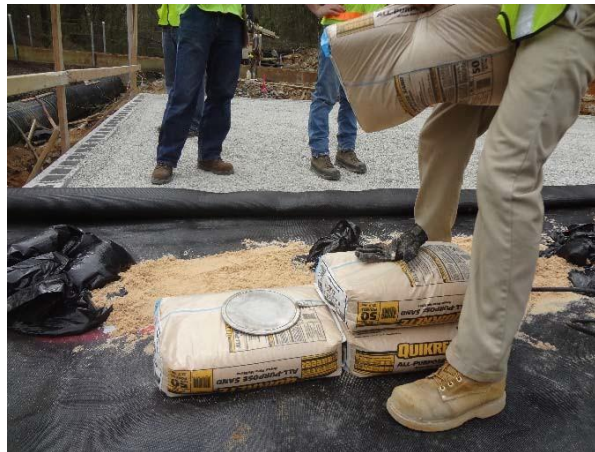
Figure 3.31 A total pressure cell and its installation

Eight vibrating wire pressure cells were installed for the GRS-IBS, including four beneath the foundation, three within the west abutment, and one between the end of the concrete bridge and the integration zone (Figure 3.28). The cells installed in the foundation measured the static pressure and its distribution in the foundation. Finally, the pressure cell between the concrete bridge and integration zone measured the horizontal stress induced by loads and temperature-induced changes in the bridge deck. The pressure cells installed within the abutment are capable of measurement of both static and instantaneous pressure produced by live load on the road provided a data logger with high frequency of data collection is utilized. As seen in Figure 3.31, sand bags were utilized at the top and the bottom of the cells to provide a flat surface around the cells, to hopefully prevent stress concentrations from forming at the location of the sensor. The pressure range for these cells is 0-300 kPa. Figure 3.31 shows a typical pressure cell and its installation process. The results measured using the foundation static pressure cells will be discussed in Chapters 4, 7, 8 and 9. The results measured using the abutment pressure cells will be discussed in Chapters 4, 7 and 9.

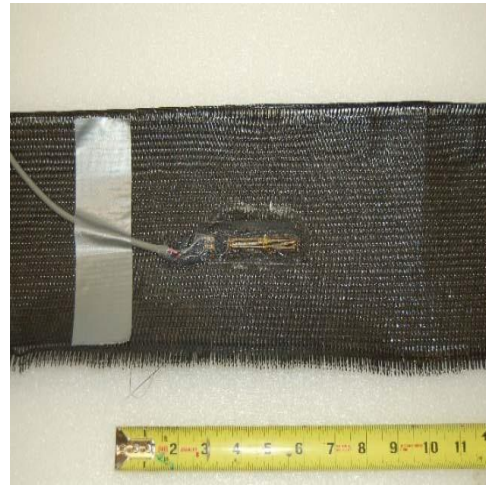
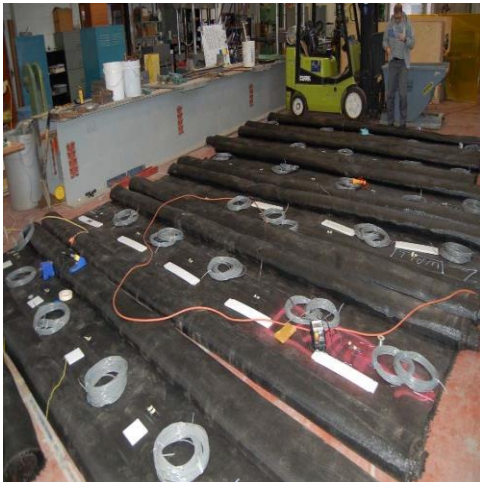
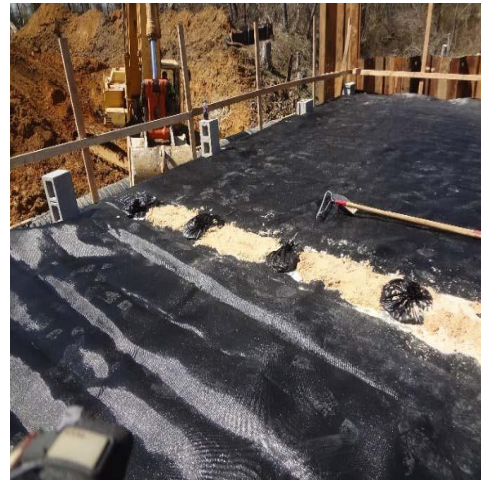
Fifty (50) strain gauges (EA-06-20CBW-120 and EP-08-250BG-120 provided by Micro-Measurements) were installed in each abutment to monitor the strain in the geotextile (Figure 3.28). Two different types of strain gauges (long and short) and two different attachment techniques (Leshchinsky and Fowler 1990; Wu et al. 2013) were utilized to assess the effect of the strain gauge installation methodology on the resulting strain readings. Figure 3.32 shows the strain gauges being attached to the geotextile (Figure 3.32a and 3.32b) and their protection in the field (Figure 3.32c). The strain gauges were installed on the geotextiles, waterproofed and wired in the University of Delaware lab before construction (Figure 3.32d). As shown in Figure 3.32, the gauges were protected against the granular fill material by placing sand above and below each sensor area. All operational gauges survived the construction process intact using this installation approach. Ten (10) additional strain gauges were attached on the underside of the bridge beams to monitor the response of the concrete superstructure during GRS-IBS operation (Figure 3.28).

Figure 3.32 Strain gauges and their installation: (a) short gauge, (b) long gauge, (c) gauge wiring in the lab before their installation at the site, and (d) gauge protection at the site

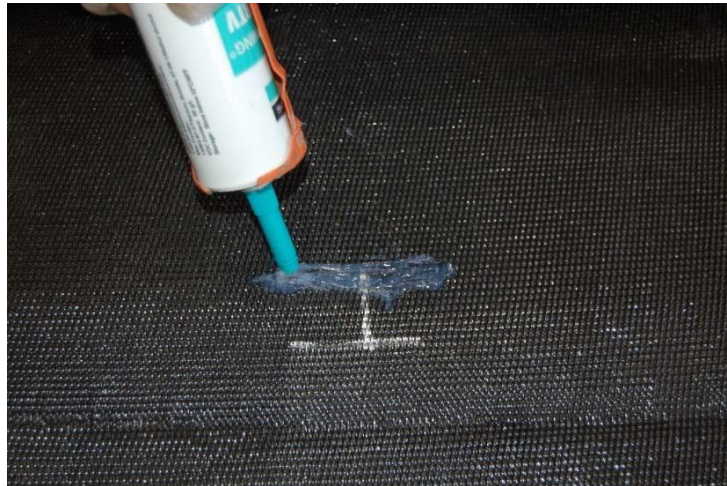
Figure 3.33 RTV application to the geotextile surface

- 1- The geotextile surface was cleaned off with hydrogen peroxide.
- 2- Dow Corning 3145 Silicone Adhesive (RTV) was applied to the geotextile surface, where the strain gauge is to be placed (Figure 3.33).

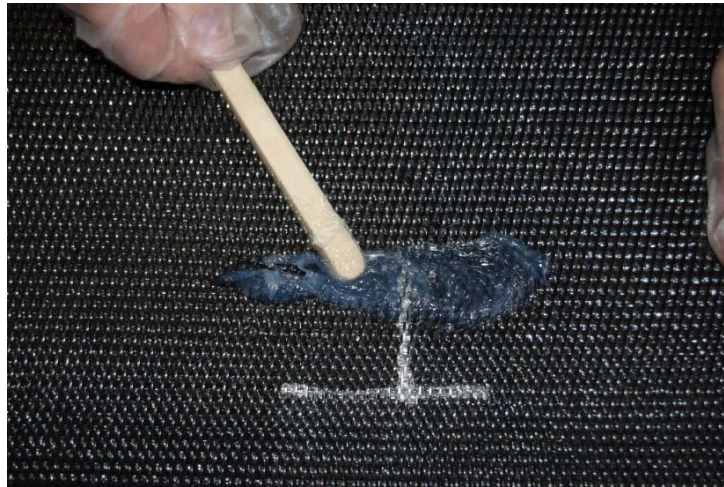
Figure 3.34 RTV smearing out on geotextile

- 3- The RTV was smeared out (with a popsicle stick) so that the underside of the strain gauge and tab were covered (Figure 3.34).

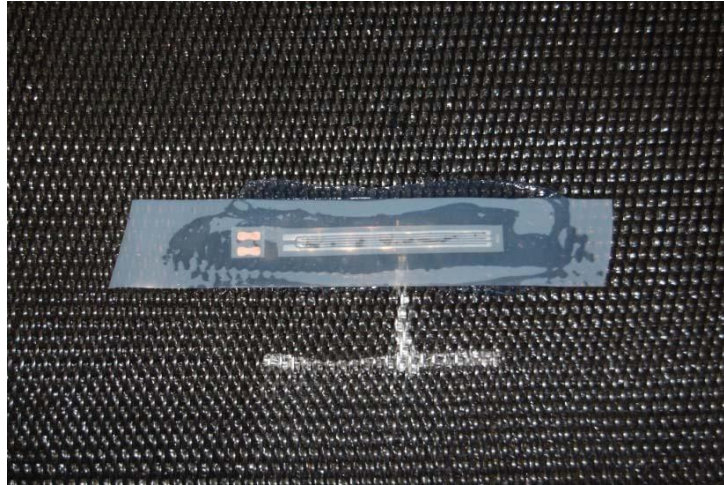
Figure 3.36 Covering the gauge using Teflon tape

- 6- The strain gauge and tab were covered with a piece of Teflon tape (Figure 3.36).

- 7- After the Teflon tape placement, the tape was carefully pressed downward so the gauge and tab were moved into place, becoming embedded into the RTV.
- 8- A Teflon plate was then placed on top of the Teflon tape. A weight was also placed on top of Teflon plate (Figure 3.37).

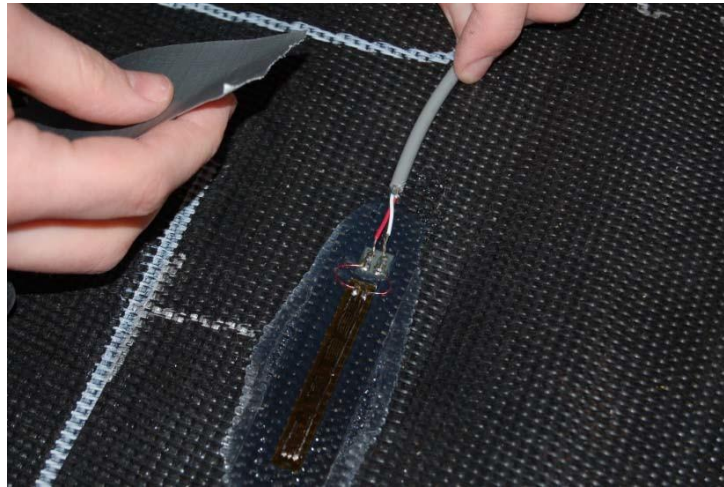
Figure 3.38 Wired long strain gauge

- 9- The RTV was cured for approximately 24 hours. This time frame was varied using judgment for thicker RTV applications, as necessary.
- 10- After the time frame set in step 9, the weight and Teflon block were removed after assuring that the RTV was fully dried. The Teflon tape was also removed.
- 11- Wires were then soldered onto the gauge leads and tabs. (Figure 3.38)
- 12- To provide a water seal (and provide additional protection), a thick coat of RTV was spread over the top of the gauge, tab and surrounding wires for waterproofing purposes, so that the gauge was effectively sealed (Figure 3.39).

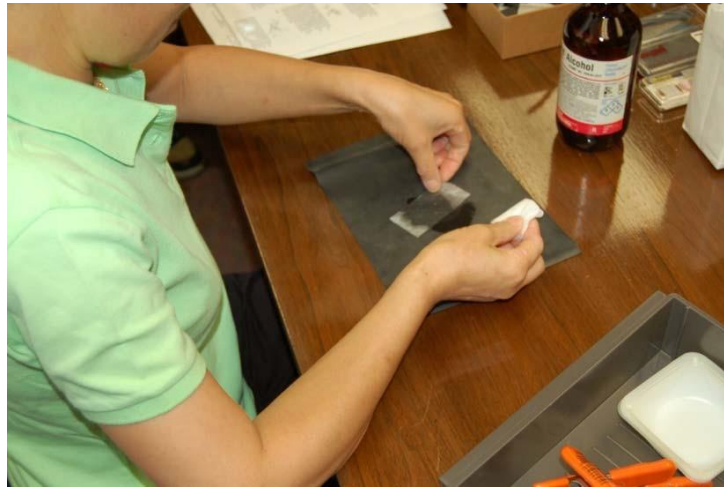
Figure 3.40 Cleaning off the dummy fabric with hydrogen peroxide

- 1- A small rectangle of a dummy fabric was cut and was cleaned off with hydrogen peroxide (Figure 3.40).

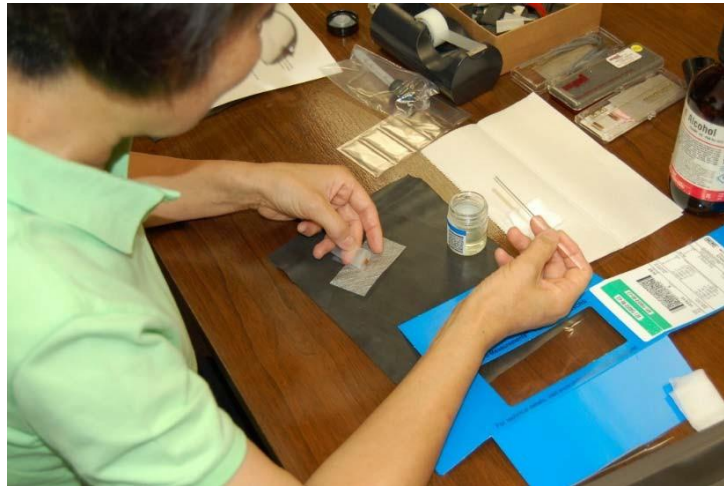
Figure 3.42 Adding epoxy to the ends of the gauge

- 2- The geotextile surface was cleaned off with hydrogen peroxide.
- 3- Using a small piece of scotch tape, the top surface of the strain gauge was covered and the gauge was placed on the dummy fabric (Figure 3.41).
- 4- Mbond epoxy provided by VISHAY was mixed in this step and a few drops of epoxy were placed on one end of the underside of the strain gauge using the mixing rod (Figure 3.42).
- 5- Step 4 was repeated for the opposite end of the strain gauge.

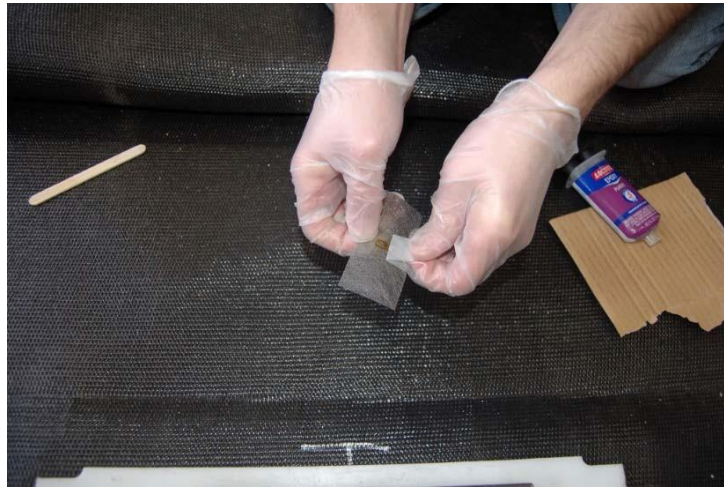
Figure 3.44 Removing the scotch tape from the system

7- After drying process completed, the scotch tape was removed from the system (Figure 3.44).

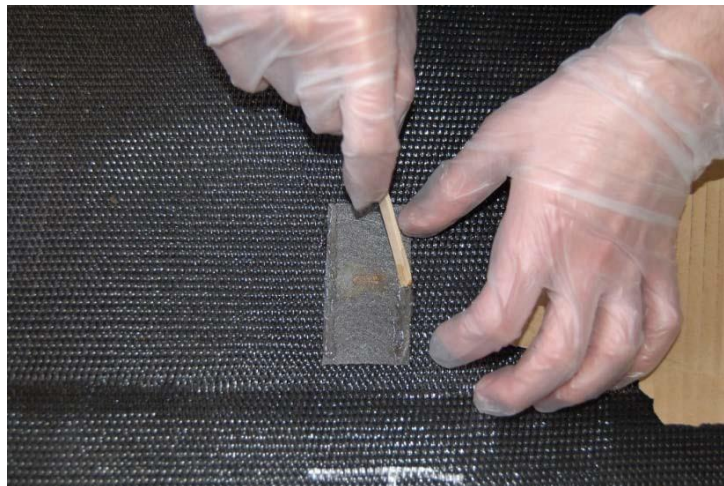
Figure 3.45 Spreading epoxy only on each end of the dummy fabric

Epoxy was carefully spread only on each end of the dummy fabric. Then, the dummy fabric/system was flipped over and placed in the location and an additional layer of epoxy was applied to the top surface of the dummy fabric (Figure 3.45).

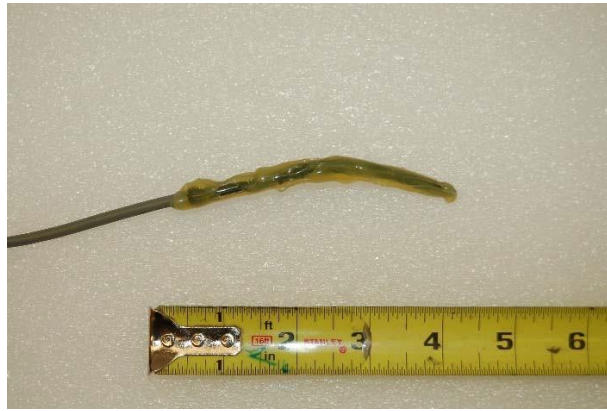
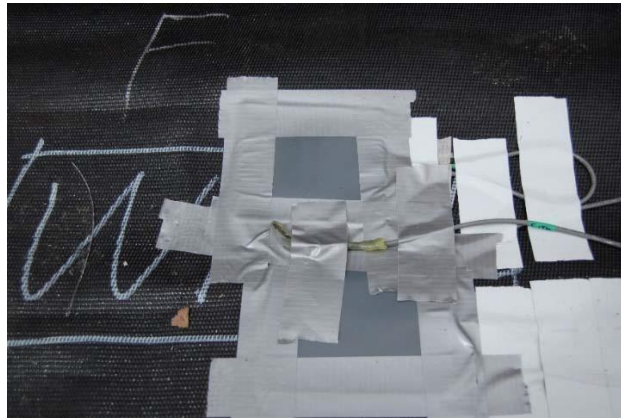
Figure 3.47 Thermistor and its installation

Twenty-five (25) thermistors (the YSI 55000 series, provided by Therm-x) were installed per abutment to monitor temperature and its effect on measured strains in the geotextile (Figure 3.28). The thermistors were waterproofed and wired in the University of Delaware lab before construction. One thermistor was placed at each installed strain-gauge location on the geotextile (between the two types of strain gauges that were installed), as shown in Figure 3.28. Figure 3.47 shows a typical thermistor and its installation. The goal of using thermistors was to investigate the effect of the temperature on the readings. The details about this effect will be discussed in more detail in Chapters 5 and 6.

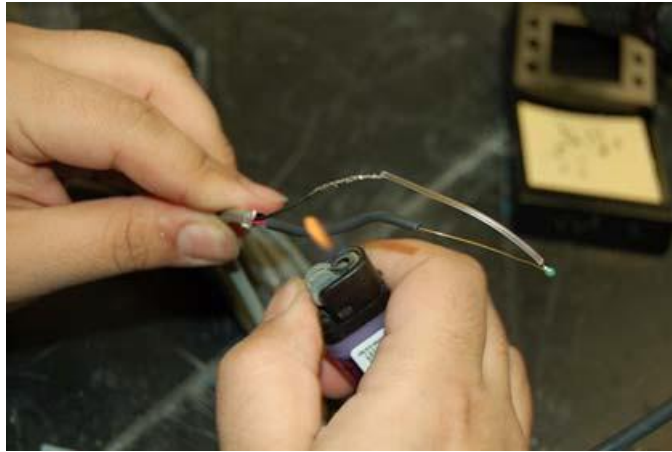
Figure 3.49 Shrinking the heat shrink tubing around the thermistor

- In this step, the small diameter heat shrink tubing was slid down to cover the second solder joint. Then the lighter was utilized to shrink the tubing, as shown in Figure 3.49.

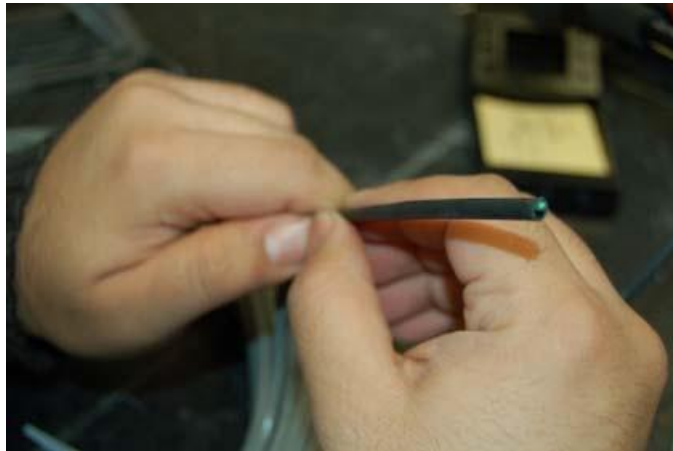
Figure 3.50 Sliding the large diameter heat shrink tubing to cover the thermistor leads

- The large diameter shrink tubing was then slid down to cover the two solder joints. This tubing was then shrunk using a heat gun. Figure 3.50 shows the large diameter shrink tubing covering the whole thermistor length.

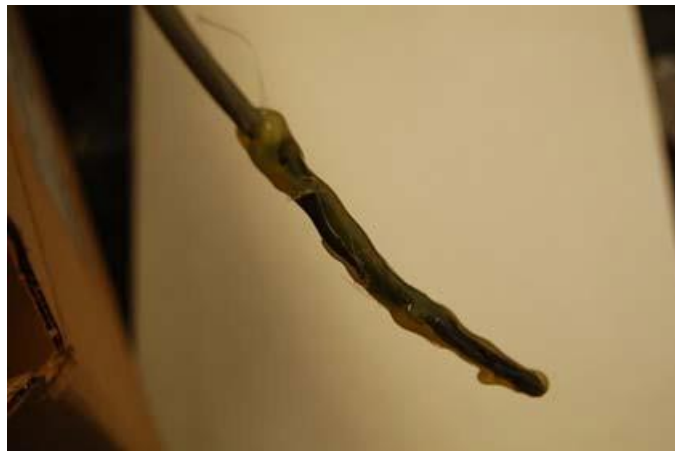
Figure 3.51 Hot glue utilization to waterproof the thermistor

- Finally, to make the thermistor as waterproof as possible, it was completely covered by hot glue, as shown in Figure 3.51. As can be observed in this figure, the hot glue formed a thick layer over the thermistor probe.

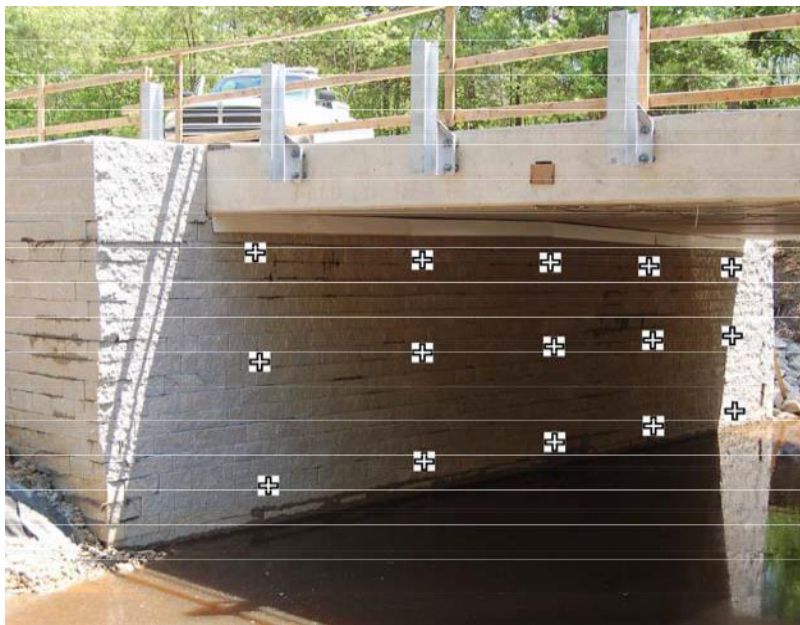
Figure 3.53 Surveying points on the west abutment

frequency which was then changed to monthly after the first year, once no significant displacements had been observed. The finest graduation of surveying measurement was 0.02 ft (or 6 mm) in the surveying operation. Figure 3.53 and Figure 3.54 show the surveying points that were used on the west and the east abutment, respectively. The corresponding surveying results are presented and discussed in Chapters 4, 7 and 9.

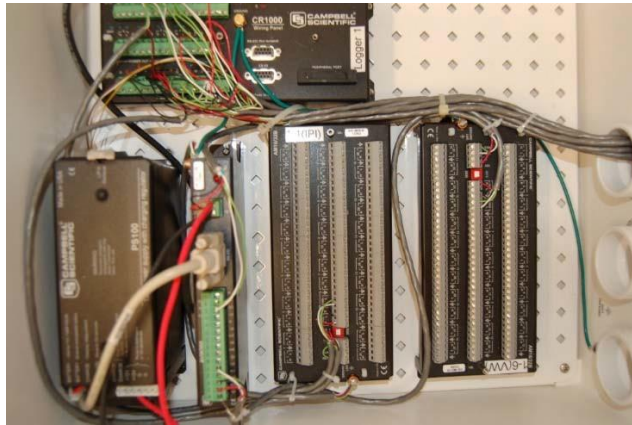
Figure 3.55 Logger CR1000 and its multiplexers

Figure 3.55 and Figure 3.56 illustrated the implemented loggers for this project.

The logger is programmed with CRBasic. The source code of the logger program named Logger1 CR1000.CR1 is supplied on the USB drive. It can be viewed with an ASCII editor such as Notepad. The logger program was already loaded into logger 1 by itmsoil USA before shipping. The PC200W program provided by itmsoil USA was used to send the program to the logger.

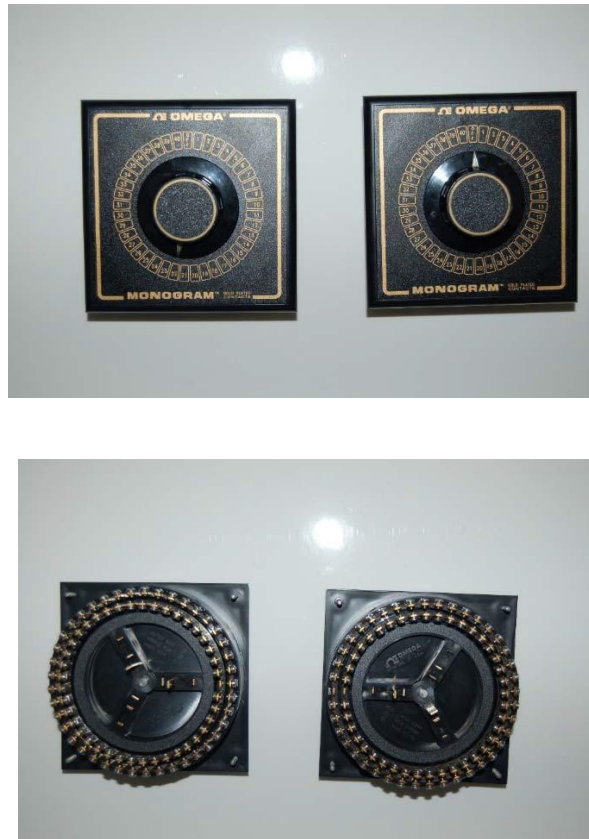
Figure 3.57 The rotary data switches, (a) front view, (b) back view

For 75 sensors installed in the east abutment, two rotary data switches manufactured by Omega (OSWG5-40) were utilized to collect the data, as shown in Figure 3.57. In case of the east abutment, the raw data (in ohms) was taken manually approximately every week over the long term using the rotary switches. In the early stages of the project (i.e., immediately post-construction), the data was collected every day to monitor the stability of the abutment.

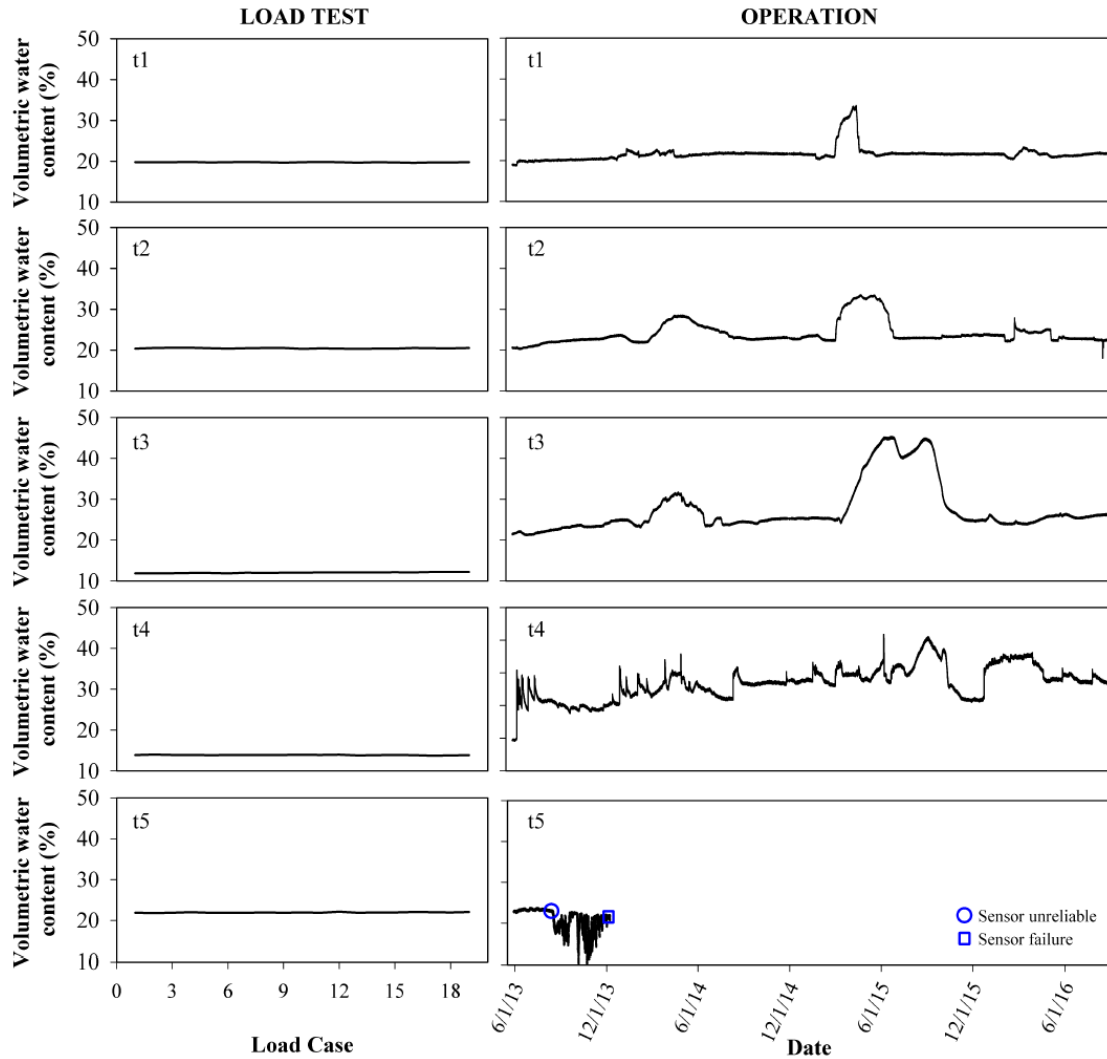
Figure 4.1 Change in the west abutment volumetric water content during load testing and over more than three years of operation

The later winter and spring months tended to exhibit a fairly significant increase in volumetric moisture content, which was observed across the three years of monitoring. This behavior is not surprising, given Delaware's generally wet spring weather, which can increase water infiltration into the abutment, and which can also cause the water level in the river channel to increase significantly. Interestingly, the peak moisture content values for the second year and the beginning of the third year were appreciably higher than the first year. The data from sensor t4 has fluctuated more than the other three working sensors. This is not surprising, as this sensor is generally located near the surface of the water level in the channel beneath the bridge; this water level tends to fluctuate with different weather events and the associated water runoff conditions that then feed water into the channel beneath the bridge.

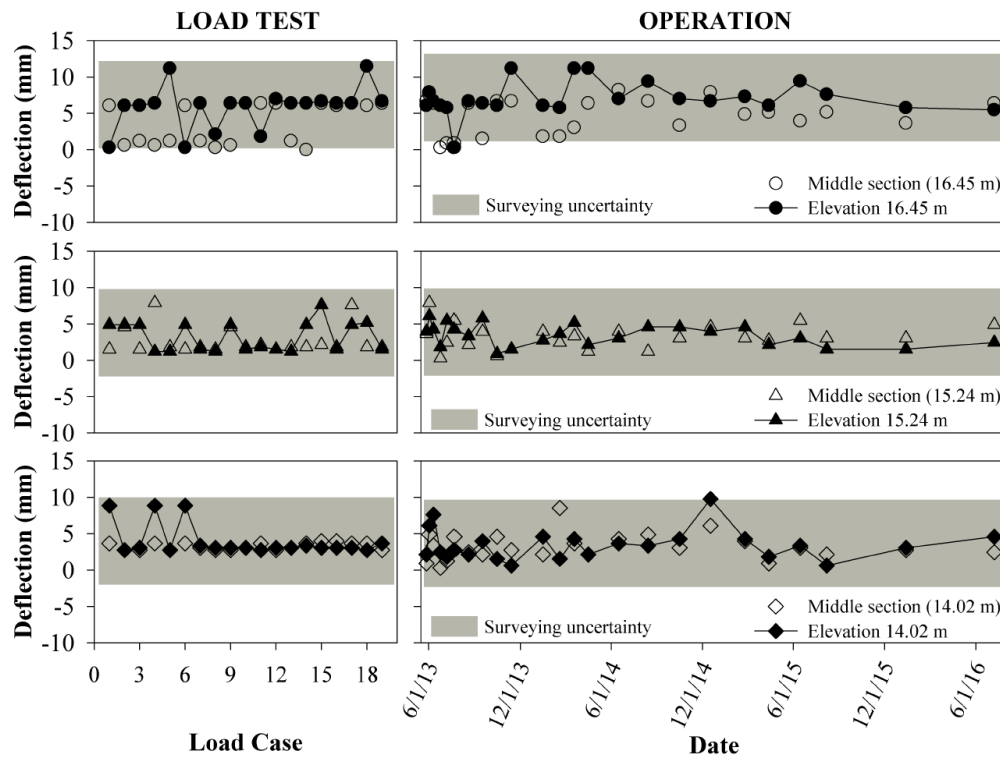
Figure 4.9 Lateral deflection of the east facing wall at 5.6 m offset from the abutment centerline, in the upstream direction

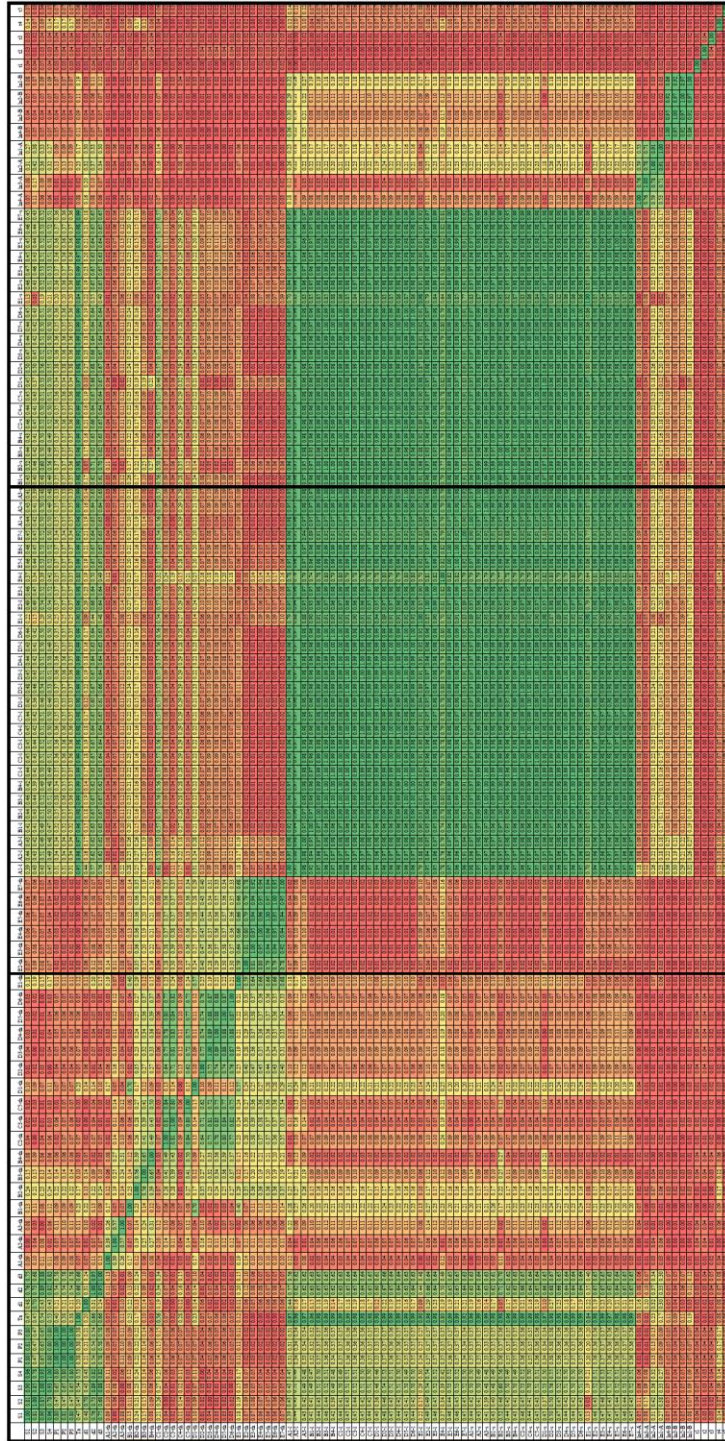
Figure 5.1 The average correlation coefficient between different sensors

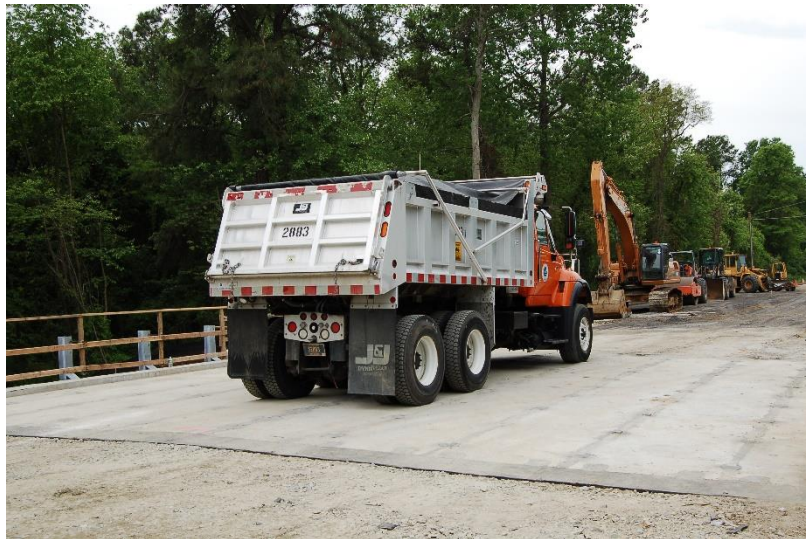
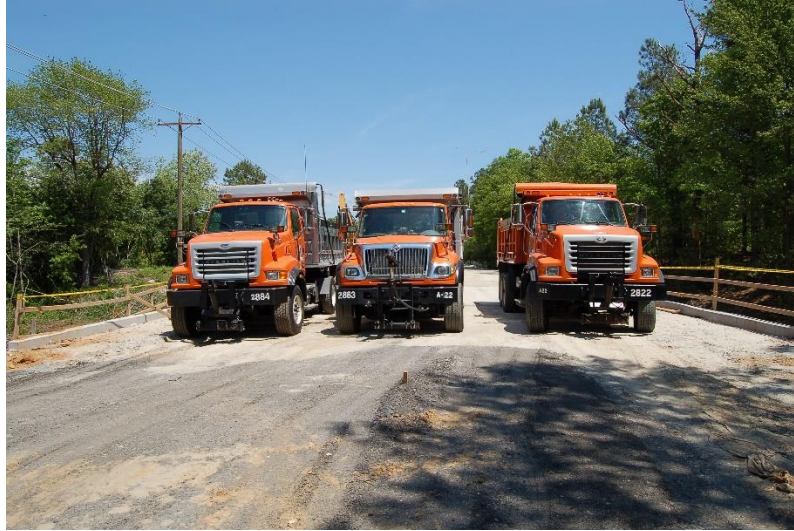
Figure 7.1 Truck type utilized for live load testing

Trucks with a single axle on the front and double axles on the rear were utilized to conduct the load test (Figure 7.1). The spacing between the two rear axles and between the front axle and the center of the two rear axles are shown in Figure 7.2. The spacing between the front wheels and also the rear wheels are also shown in Figure 7.2. The criteria used to select the maximum truck weight was based on the AASHTO LRFD Design Load of HL93, which consists of a Design Truck having a total weight of 72 kips and a Lane Load of 0.64 kip/ft and the Design Tandem Load having a total weight of 50 kips and Lane Load of 0.64 kip/ft.
