# Access Guide for The Ohio State University

**Authored by members of the Spring 2020 English 4591 (Rhetorics of Illness and Disability):**

Created for the 2020 Society for  
Disability Studies (SDS) Conference at  
The Ohio State University

First Edition, April 2020

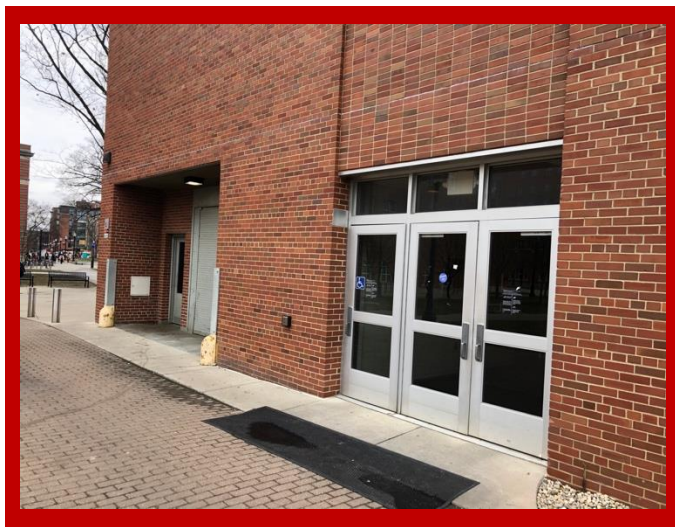
##### **West Entrance:**

The western entrance sits at ground level. A black mat attempts to bridge the divot between the narrow concrete sidewalk alongside the building and the rough, brick path next to it. During busy periods (weekdays during class changes), the brick pathway is very busy and the three west entrance doors open up into flows of sidewalk traffic. All three doors open with bar handles approximately 33" from the ground, and the leftmost door also opens automatically with a button on the brick wall to the left. It is also important

to note that the two left doors open into each other, so opening one door may cause a collision with users entering or exiting through the other door. In addition, during rainy weather, large puddles form along the border between the concrete sidewalk and brick pathway, partially obstructing access to the west entrance.

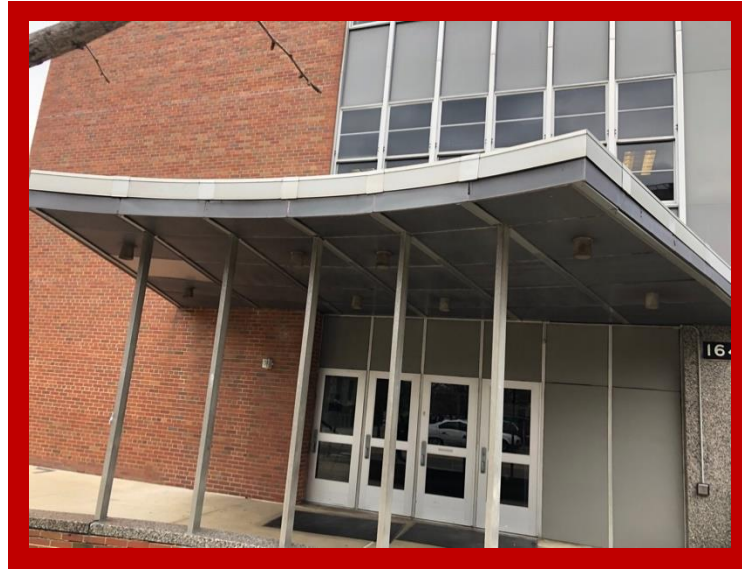
**South Entrance:**

Pictured is the south entrance. Each of the four doors opens outwards to the right with a bar handle. The far right door also opens automatically with a button on the concrete wall to the right. This entrance is separated from the main walkway with a partial brick wall and an overhang, which protects users from rain or snow when entering the building. This entrance opens into the southern side of the southwest interior with carpeted mats, stairs to the left, and seating directly ahead. View of the elevator is obstructed from this entrance by a partial wall behind the seating.

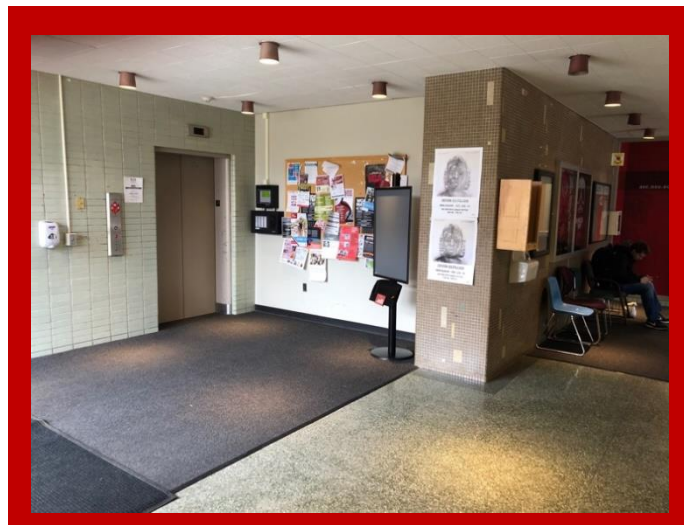
This image displays the western half of the southwest interior. Pictured to the left are an automatic hand sanitizer dispenser, the west elevator, and a display board. To the left of the elevator is the west entrance/exit. The floor in this area is carpeted with two mats, and users of the space must travel from the western carpeted section onto smooth tile flooring and back to carpeted mats in order to reach the water fountain and four chairs for seating on the south side of the space. The narrowest stretch of the interior space, which exceeds 59" is located on the flat-surfaced section. To the right of the pictured space are the south entrance and the southwest stairwell.

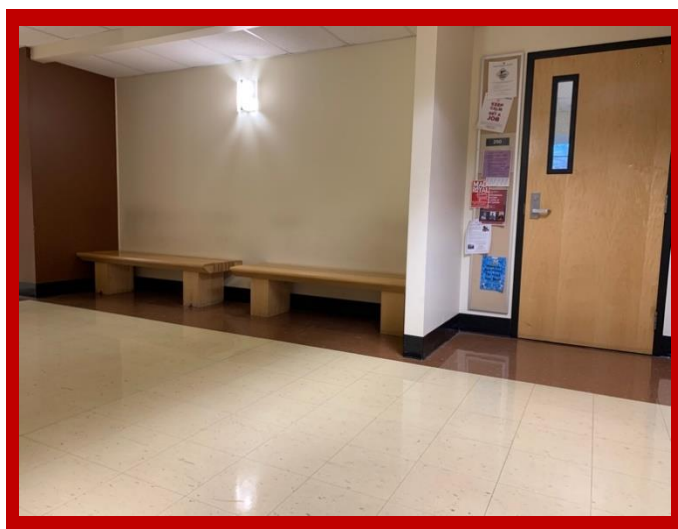
### Hallway:

In the left half of the photo, there are two wooden benches, above which is a bright fluorescent light. A small protruding wall to the right separates the benches from the nearby classroom door. To the left of the classroom door is a narrow floor-to-ceiling length bulletin board featuring flyers for courses and events. The floor is covered in laminate tile.

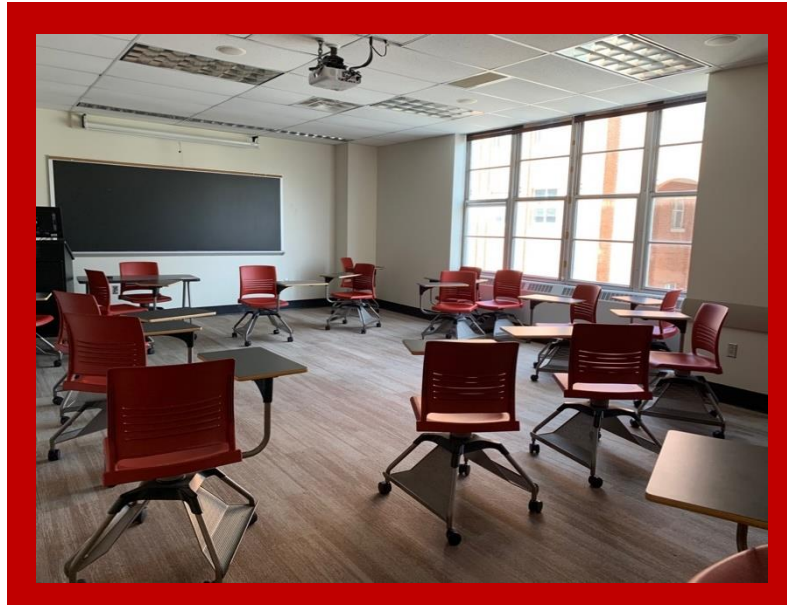
Depicted is a north-facing second-floor classroom. Rolling desks are scattered throughout the room. On the far left wall, there is a black board, above which is a rolled up projector screen. To the left of the black board there is a podium with a desktop computer on it. On the far right wall, transparent windows overlook the North Quad and let in natural light. There is fluorescent overhead lighting (turned off in the picture), and the floor is carpeted.

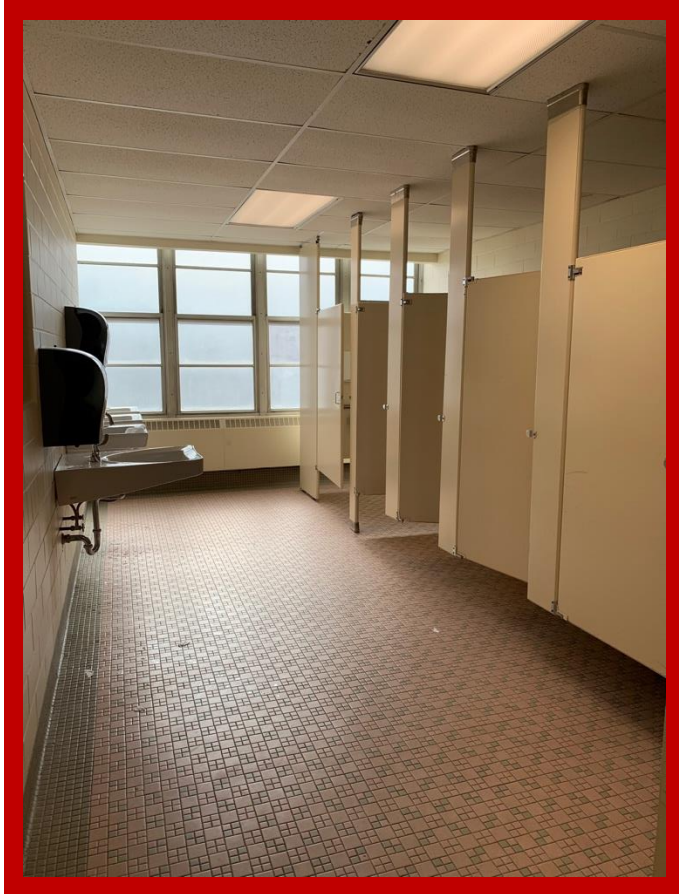
**Restrooms:** There is one men's restroom and one women's restroom on the second floor. Each has a total of six stalls, one of which is accessible. All stalls lock from the inside. There are no family restrooms, gender-neutral restrooms, or single-user restrooms.

Depicted is the second-floor women's restroom. On the left wall are four sinks--one is lower than the others and allows wheelchair clearance. Above the sinks are two soap dispensers and three paper towel dispensers--one of each is lowered to be accessible to seated users. There are translucent windows along the far wall that let in natural light. To the right are six restroom stalls; the stall nearest the windows is accessible.

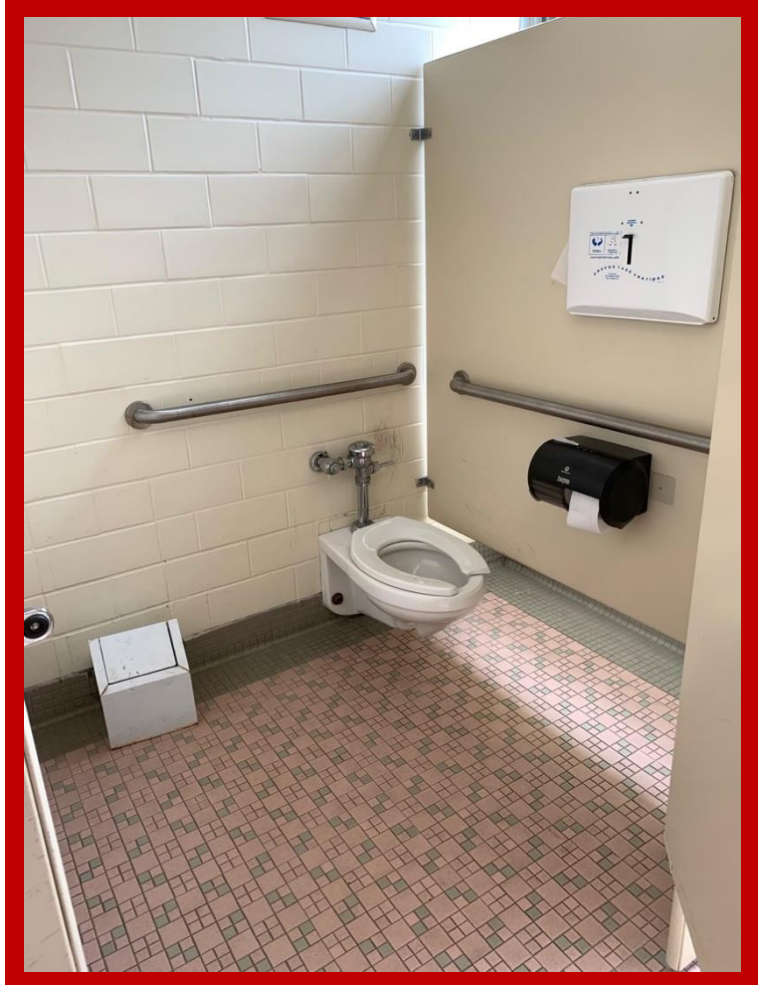
Depicted is the accessible stall in the second-floor women's restroom. On the far left wall is a disposable seat cover dispenser, below which is a grab bar, below which is the toilet paper dispenser. On the adjacent concrete wall is a second grab bar, below which is the toilet. On the ground to the left of the toilet is a menstrual product receptacle. The floor is made of green and pink tile.

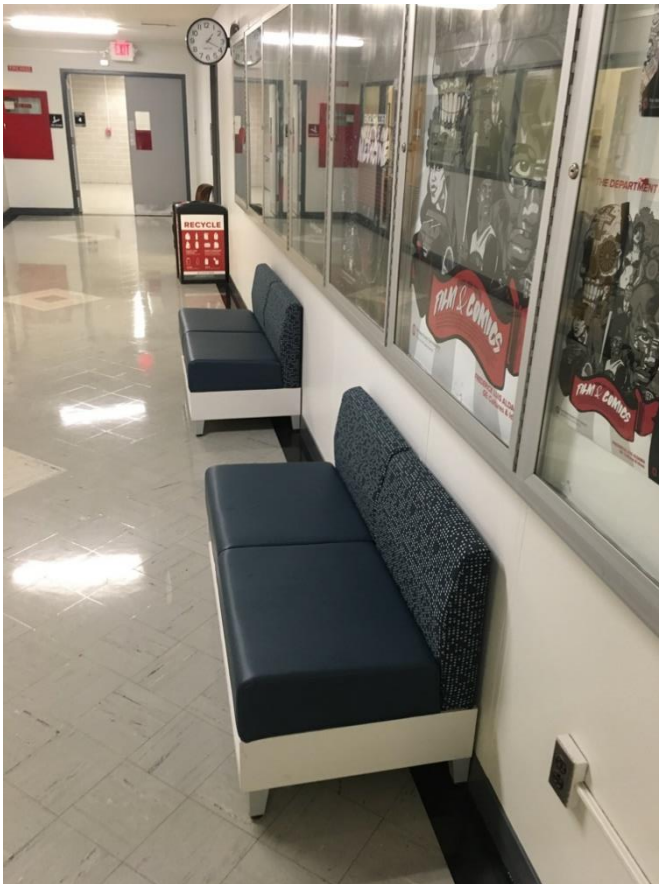
**4th Floor Hallway of Denney Hall**

A fluorescent-lit hallway with a smooth tile floor leads to the west-end stairway of Denney Hall. Along the wall are two sets of cushioned seats, with a wall outlet beside one of the seats.

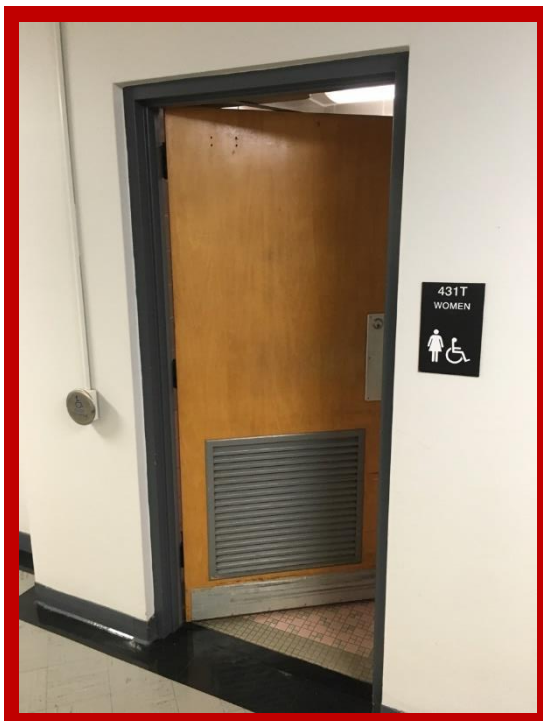
The image to the right shows the door of the fourth-floor women's restroom. To the left of the door is a button to automatically open the door. Behind the door is a sharp turn, but the path is wide enough to pass through without the waste bin.

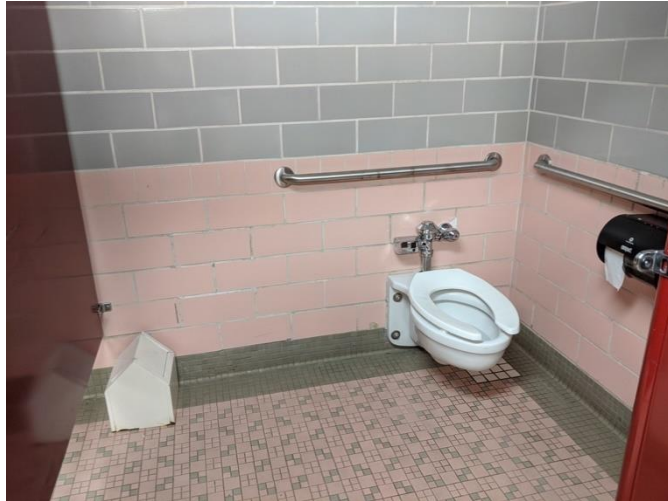
**Fourth-Floor Women's Restroom Stall**

The widest stall of the fourth-floor women's restroom is shown in the image on the next page and is adequately spacious to accommodate wheelchair users. Handrails are on the wall adjacent to and behind the toilet. There is a small waste bin to the left and back of the stall.

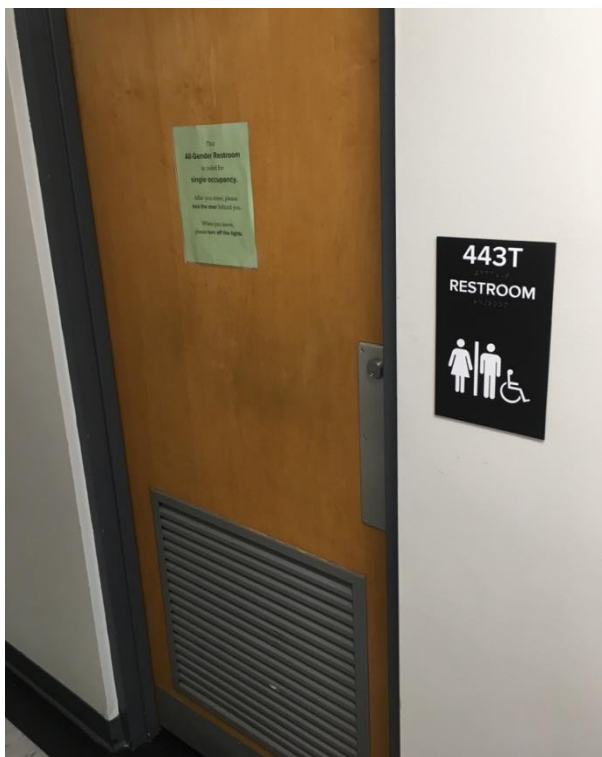
**Fourth-Floor Gender-Neutral Restroom**

The door to room 443T has a sign that reads, "This **all-gender restroom** is coded for **single occupancy**. After you enter, please **lock the door** behind you. When you leave, please **turn off the lights**." Inside are one urinal and one spacious stall that has handrails adjacent to and behind the toilet. There is a small waste bin to the back and right of the stall.

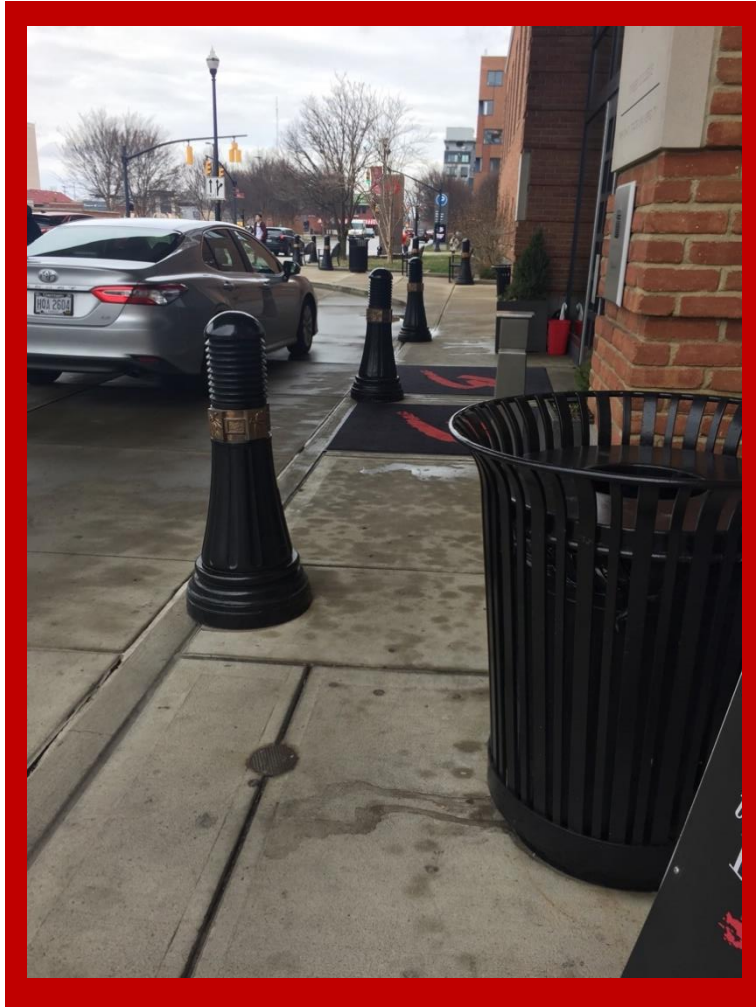
The main entrance to the building, which faces Tuttle Park Place, is accessed by a sidewalk that is at street level, so there is no curb. There are bollards between the sidewalk and road to stop cars from driving onto the sidewalk, but there are no colored bumps on the ground to indicate where the sidewalk stops and the road starts. The entrance is on a small loop covered by a high roof that is separate from the main road and is therefore not close to traffic. The entrance can be reached from this loop or the sidewalk from the left and right, which can be narrow between the side of the building, the trash cans, and the bollards. At the narrowest point, the distance between the trash can and bollards is roughly 40 inches.

Description: A trash can is in the foreground. Just beyond it on the sidewalk is the first of three bollards. There is a narrow pathway on the sidewalk between the trashcan and bollard. The sidewalk is flush with the driveway, and the automatic door button to enter the hotel can be seen in the background.

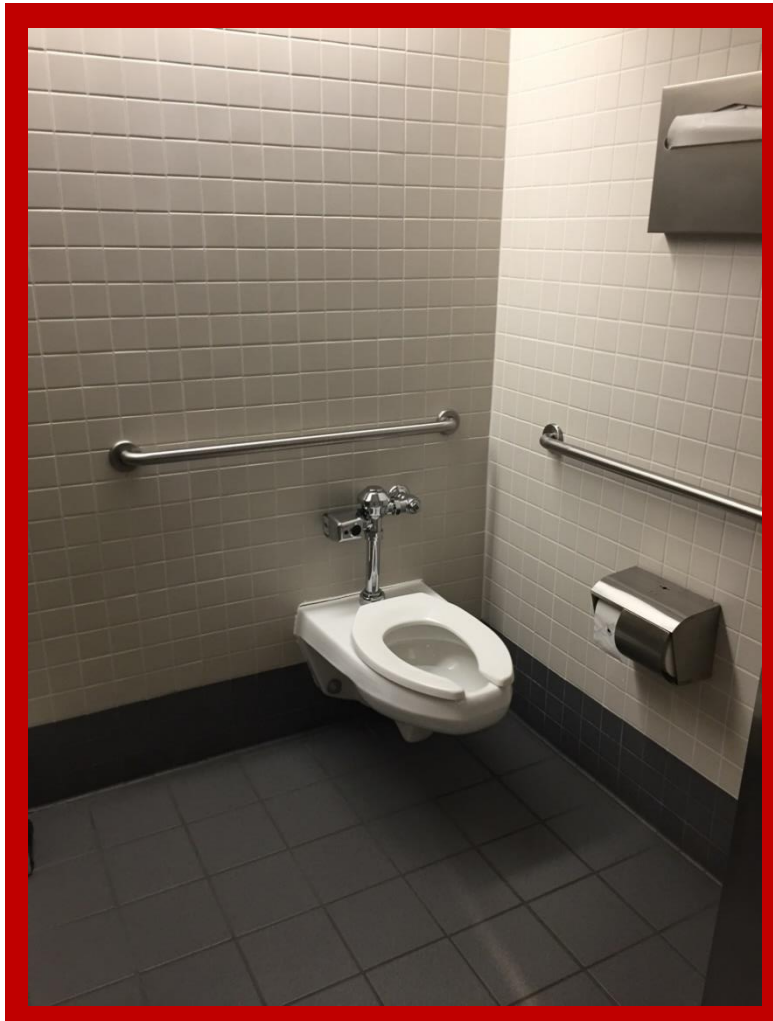
Each public restroom in the building has one accessible stall. The entrance to each accessible stall is 33 ½" wide, but, due to the space the door occupies when it is open, is realistically only 32" wide. There are grab bars on each adjacent side of the toilet, and the transfer to the toilet can be from the side or the front, as it is located in a corner. The seat starts 9 ½" from the closest wall on its left side, and the toilet paper is 12" from the seat directly and 22" off the ground. Toilet seat covers are also available and are located 62" from the ground.

Description: An automatic flush toilet sits just to the left of a corner. There are grab bars behind and to the right of the toilet. Below the right grab bar is a toilet paper dispenser. Roughly two feet above the grab bar is a toilet seat cover dispenser.

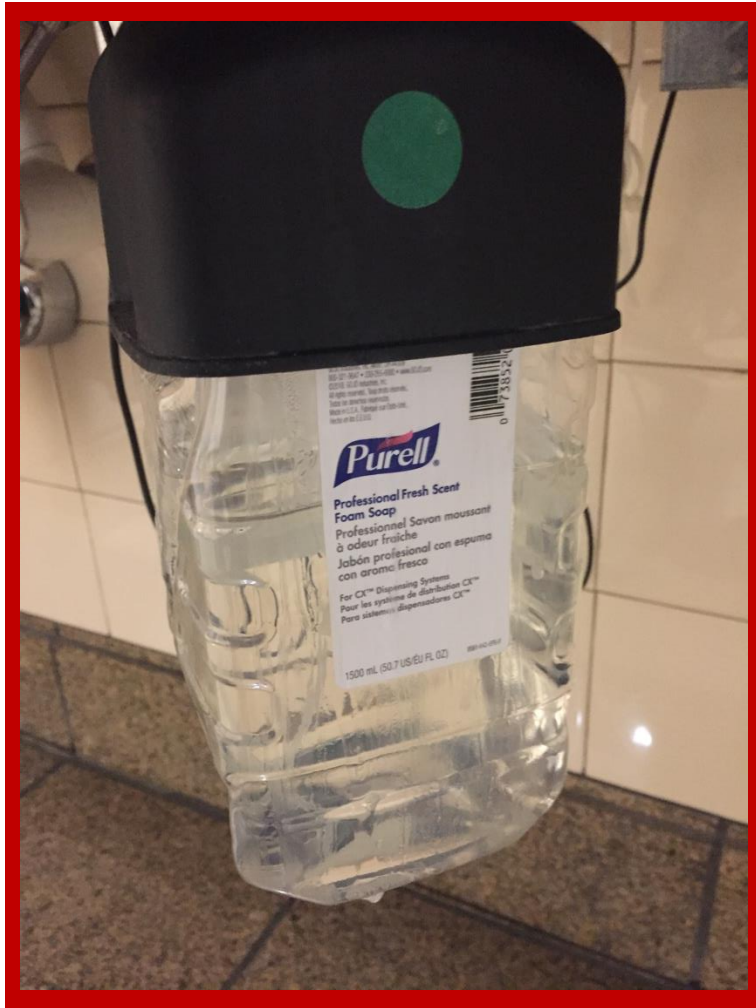
The soap used in the restrooms is Purell's "Professional Fresh Scent Foam Soap." Soap dispensers are located on the sink counter and dispense automatically. While the counter is 22 inches deep, the automatic faucets are 6 inches from the wall and the soap dispensers are 7 inches from the wall. The soap containers are connected to the dispensers and hang below the counter, which may be an obstruction for wheelchair clearance in certain areas at the sinks. The soap brand and information is displayed on the container.

Description: A plastic soap container is the focal point of the image. The container hangs below the sink counter and shows the Purell logo and specific type of soap on a label, written in English, French, and Spanish.

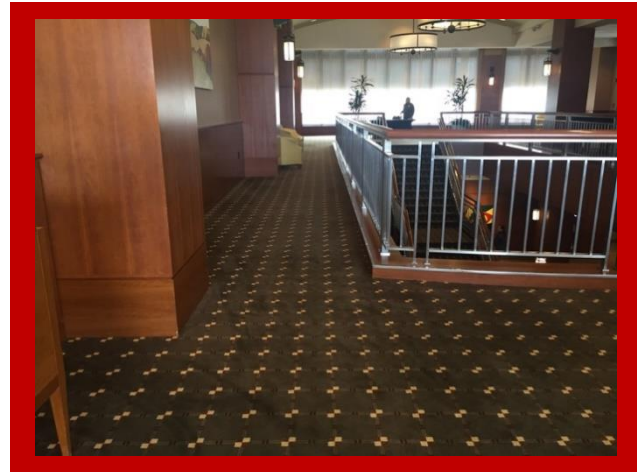
landing surrounds the grand staircase in an overlook that is surrounded by handrails. On the right side of the staircase, the pathway is 48" wide from handrail to wall. Chairs that are placed in shallow alcoves also protrude into the pathway, making it more difficult to maneuver. This furniture can be moved for events upon request. On the left side, the hallway that leads to the bathrooms is 50" wide.

Description: Railings encircle a view of the lobby to the right. On the far side of this rectangular cutout, the stairs can be seen. The space between the railings and wall is narrow. Two yellow armchairs and a few columns further protrude into this space.

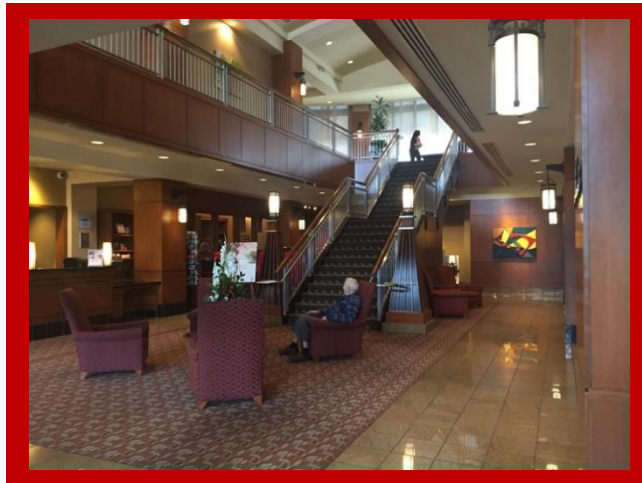
### Main Lobby and Atrium

The front desk is to the left of the entrance, and has two heights. The middle desk is roughly 4' tall, while the two areas to either side are closer to 2' tall. There is a hallway to Pfahl, elevators, and a small seating area on the right. A staircase is in the middle, but is slightly off-center and has a small seating area in front of it.

Description: The front lobby stretches the width of the building. The check-in desks are along the left wall and the elevators along the right wall. A carpeted staircase is the central focal point. In front of it, there are 4 armchairs facing each other. Two other chairs can be seen to the right side of the staircase.

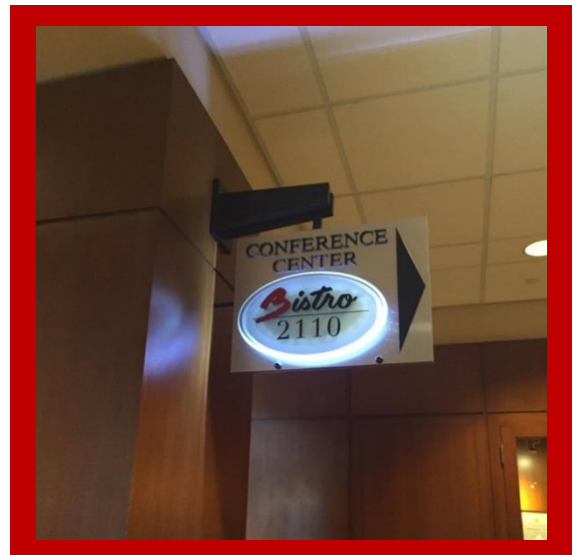
Signs next to restrooms, ballrooms, and elevators include braille beneath the non-tactile words. The sign in the lobby that points visitors to the Bistro and conference center is placed high on a pillar, but is outlined in neon light as a visual cue for those with light perception difficulties.

Description: A sign is mounted on a column just below the ceiling. The top reads "Conference Center" in all caps. Below, there is an oval of blue fluorescent light and the inside reads "Bistro 2110." On the right side, a large arrow points to the right.]

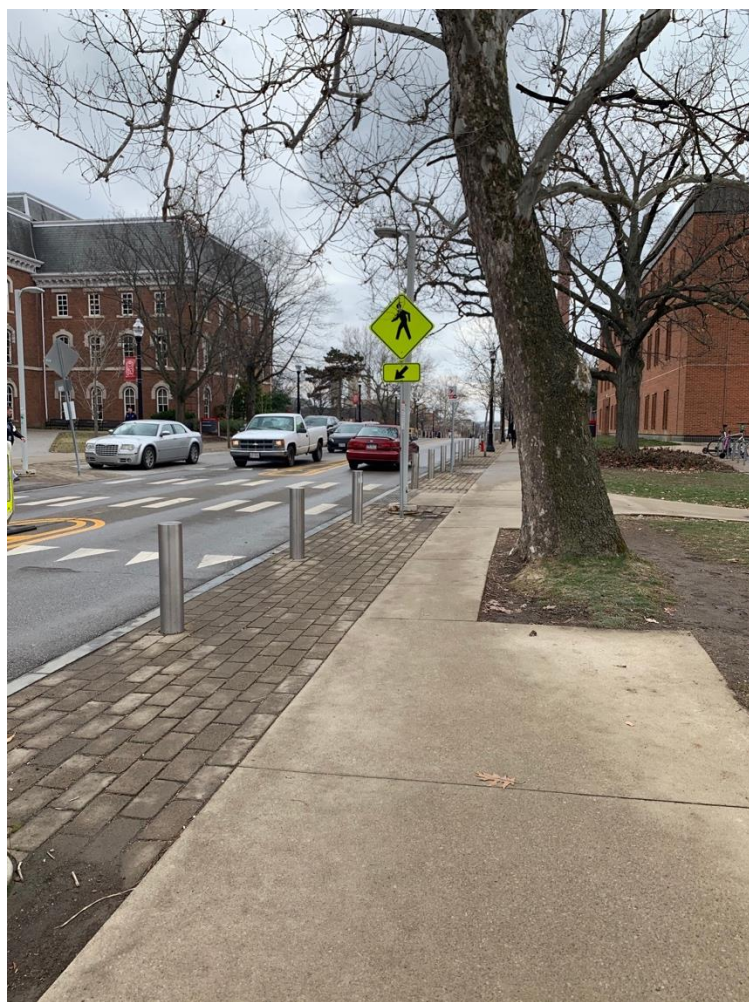
The pathways along the street outside of Denny are about eight feet wide and are at an even height with the road. There is no risen curb edge that would make wheelchair maneuverability difficult and the sidewalk is sufficiently wide to allow a wheelchair or guide-dog to pass through. There is, however, one location along Annie and John Glenn road where the sidewalk narrows to about a third of its usual width due to the presence of a tree that takes up space that would otherwise be paved over by the sidewalk. We took a photograph of this narrow part of the sidewalk and have submitted it with our report under the title “Narrow-Sidewalk.”

In this photograph, one can see that the otherwise sufficiently wide sidewalk narrows to about a third of its original length for a short stretch to accommodate for the growth of a large tree. Other than the presence of this one tree, the pathways along Annie and John Glenn are fairly exemplary of accessible sidewalks. There is a nice zero-step curb between the street and the sidewalk which can be seen in the “Narrow-Sidewalk” image, affording wheelchair-bound individuals the same opportunity to cross the street at any location as other more able-bodied individuals. The only other complaint with the sidewalks could be the transition from smooth pavement to a brick path between the sidewalk and the road, which could make for a bumpy or unpleasant surface for wheelchair transit. This can also be seen in the “Narrow-Sidewalk” image.

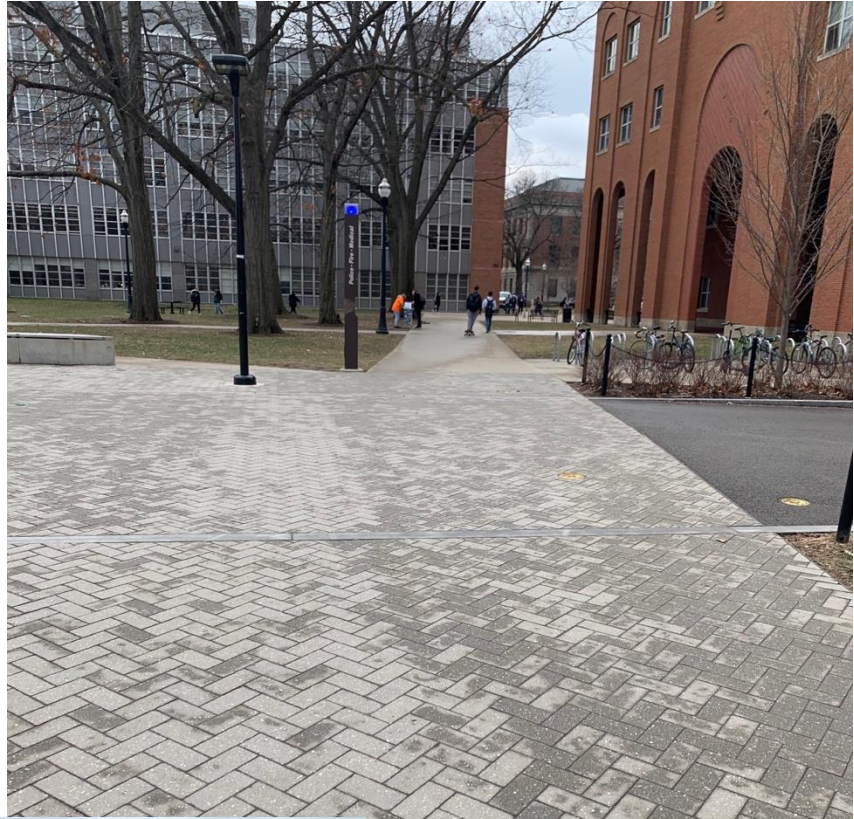
The image “18th Ave. Brick” shows one of the brick layouts in a pathway on 18<sup>th</sup> Ave. The bricks are a black color and are aligned in a crisscrossed pattern. The pathway is quite smooth. This should allow for wheelchair users to pass along this pathway with relative ease. The image “Brick-Pathway” shows the other brick layout used on campus.

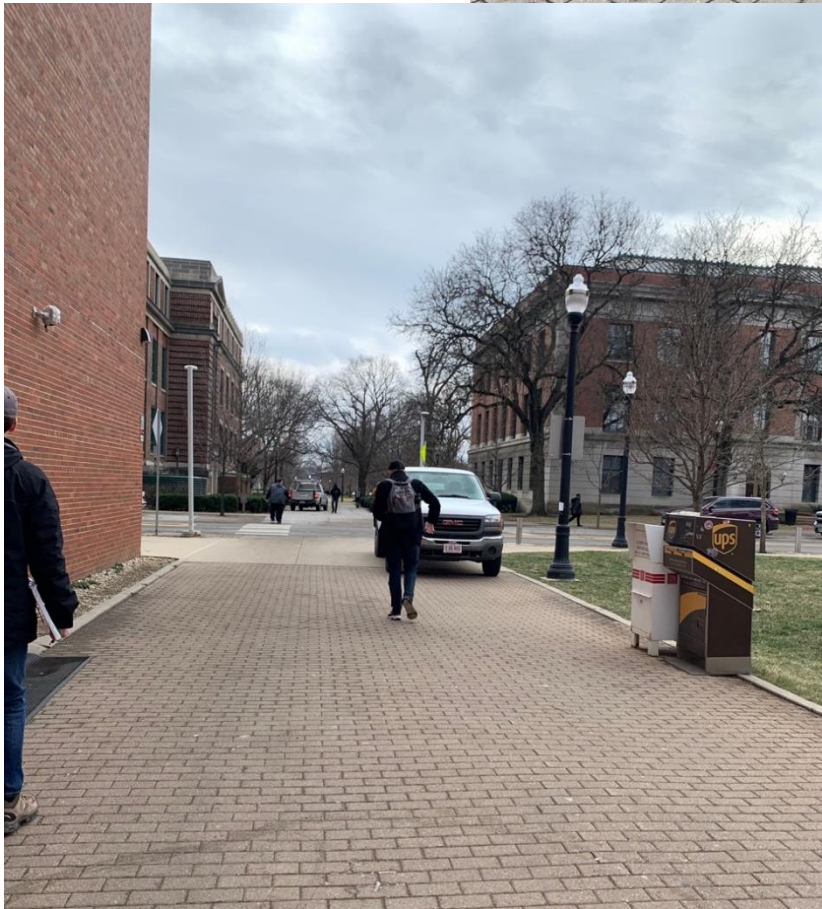
This image shows another pathway of bricks. These bricks are all aligned parallel to one another. While there are no missing bricks or significant bumps, this pathway could be quite bumpy to a wheelchair user. While it may be accessible, it has the potential to make a wheelchair user nauseous.

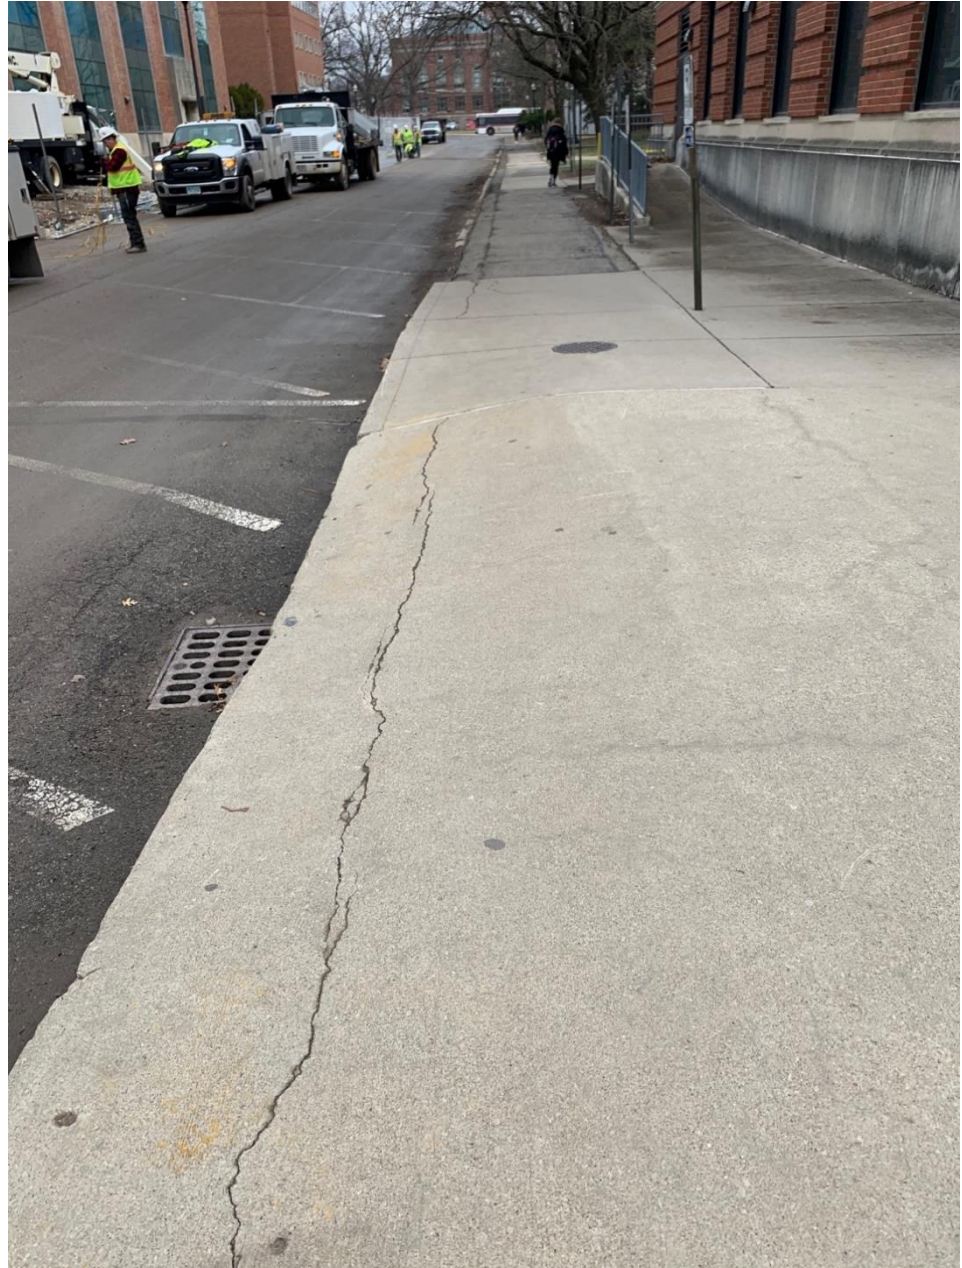
There is one major pathway obstacle along 19<sup>th</sup> avenue right: a collapsed sidewalk. This part of the sidewalk can be found in the image “Collapsed-Sidewalk.”

While the rest of the street has a relatively smooth sidewalk, right outside of McPherson Laboratory there is a storm drain where the sidewalk becomes angled at about 45 degrees. However, the pathway happens to be about twice the width of a normal sidewalk outside McPherson. This does give a person a greater chance at better accessibility around the design flaw, but during class changes when the pathways are congested with students, it will still be very difficult to get around.

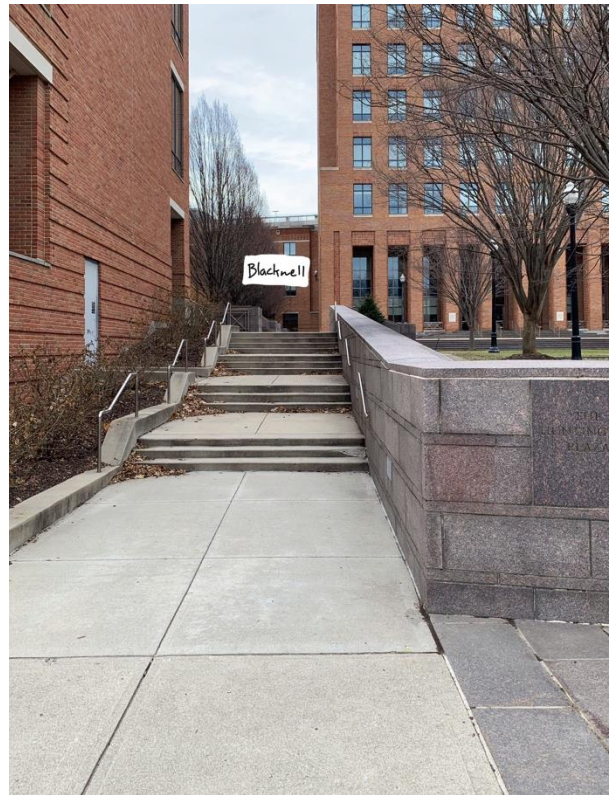
In the image, you can see the path leading from Woodruff up to the Blackwell Inn marked by an increase in elevation in the form of four sets of stairs, the last of which consists of four individual steps and is steep enough that it would be quite difficult for an individual with limited mobility to navigate. There *is* a ramp that can be used by wheelchair-bound individuals to circumvent these stairs, but it is all the way on the opposite side of the courtyard from the stairs and leads to the doors of the Blackwell Inn only in a distant and roundabout manner. We have submitted a picture of the layout of the courtyard and the ramp’s indirect path from Woodruff to Blackwell to the Carmen file and titled it “Blackwell-Ramp.”

Because of these several obstacles, we would recommend that a person with limited mobility not attempt to enter the Blackwell Inn from Woodruff. Instead, they would have an easier time continuing down Woodruff and taking a right onto Tuttle Park, then entering Blackwell from the front of the building where the doors are powered and can be automatically opened at the press of a button.

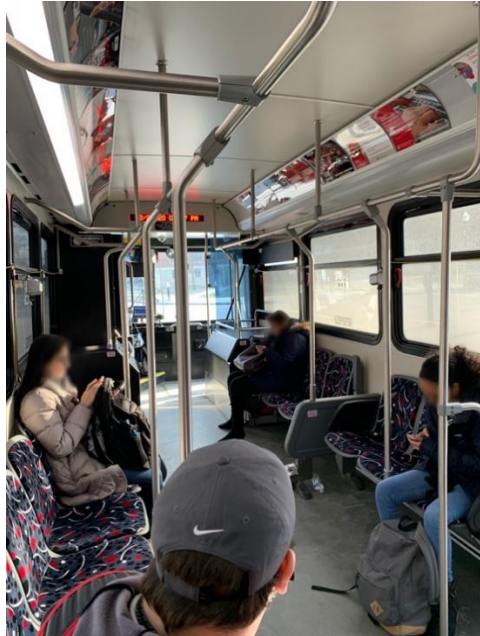
The buses are low-floor and low-entrance buses which makes them accessible to wheel-chair users. The front and back entrances do not have steps and can accommodate wheel-chair users with ramps that extend to align with the height of the sidewalk. For non-wheelchair users there are gaps between the floor of the bus and sidewalk. As a result, it forces passengers to carefully watch the gap when they board or alight, which may cause delays and

creates the possibility of injuries. In addition to that, there is no clear path to the bus from the sidewalk due to the lack of a ramp. The passenger must rely on the bus's ramp to extend onto the sidewalk to enter. Both entrances leading inside are narrow and do not leave enough space for a wheelchair user to comfortably maneuver to the disability priority seating. More importantly, this poses a serious issue for individuals with disorders such as Claustrophobia and

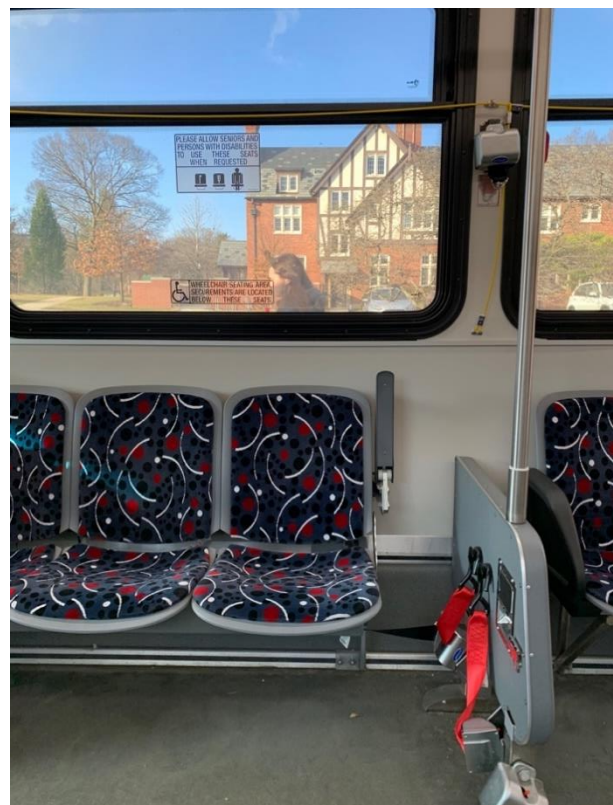
[This photo displays priority seating of the CABS bus. It shows red fastening devices for wheelchair users attached to mid-level height seat barrier from other seats. Above the seat barrier, a silver pole extends vertically to the top of the bus. Also, not accessible for those sitting in the middle section of the seating. A see-through window above this seating has a decal message stating "please allow seniors and persons with disabilities to use these seats when requested".]

The disability priority seating is in the front and can be accessed by lifting the seats up against the wall. The decal on the window is a visible signifier of this reserved seating. The wheelchair user is strapped with securements

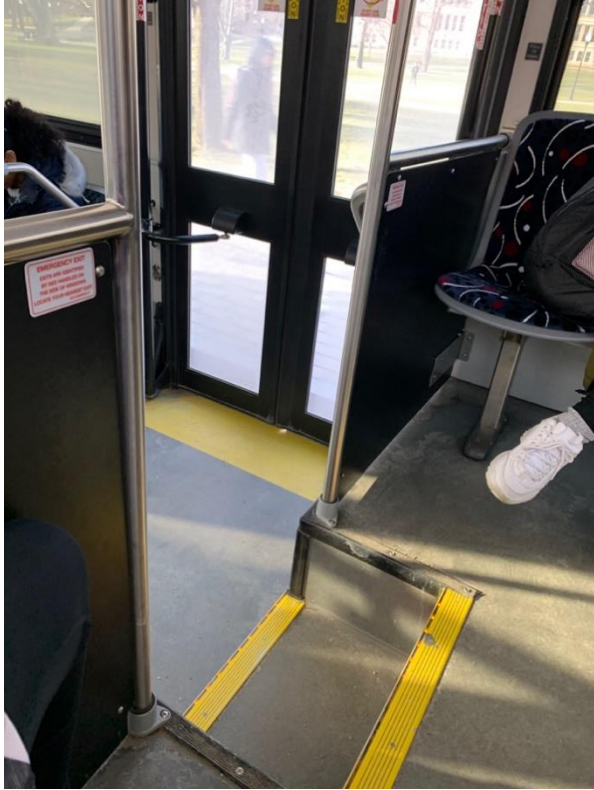
from below the seats and side barriers. There are only two poles on the sides of this seating area, which is dangerous considering if there are three users accessing the space, one would not have any access to stability. The only other pole is horizontally along the roof of the bus, impossible to any wheelchair user.

[Image of back entrance of a CABS bus and two steps highlighted by yellow leading to the back of the bus. There are two black barriers on either side of the step, separating the back from the front. The top and sides of the black barriers are silver poles that can be used as handrails for stability.]

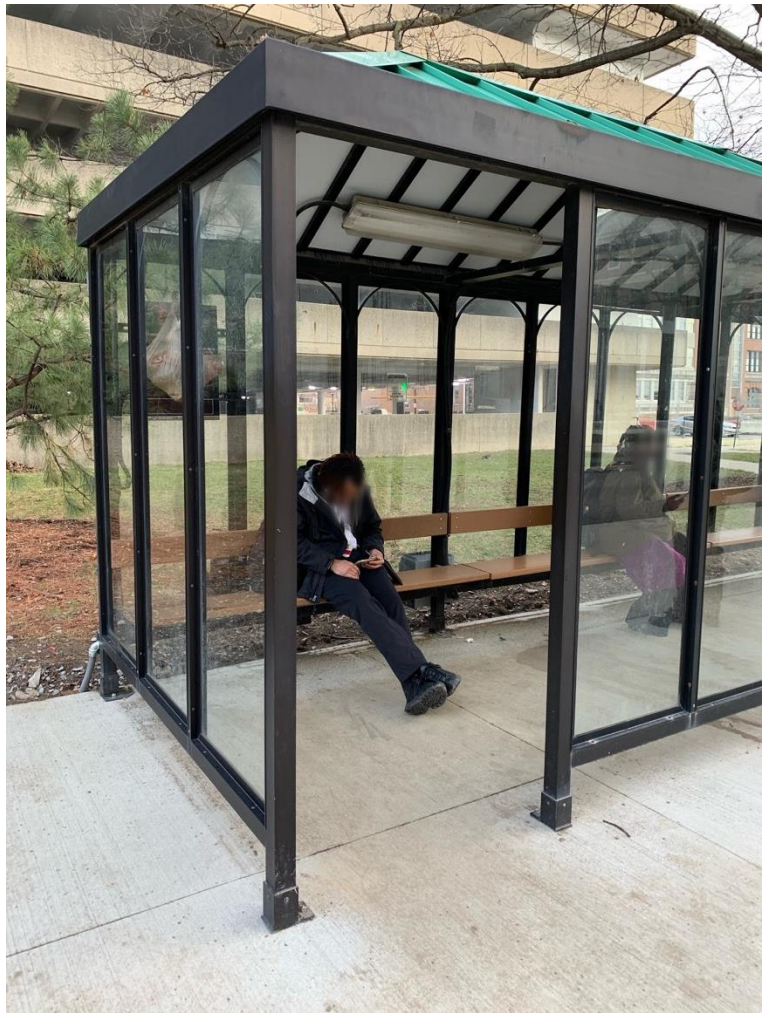
The sign for bus routes is about six to seven feet tall and not accessible for wheelchair users. Thus, I recommend accessing bus-tracking and other information on the Ohio State app or online at <https://ttm.osu.edu/cabs>. The names of bus routes are highlighted in different colors, which are not accessible to people with visual disabilities. The sign presents another access

barrier as it does not include any information concerning paratransit or other mobility services. Passengers with disabilities are required to exert additional effort to search for these services.

[Image shows a glass bus stop with black poles surrounding it. Inside are two passengers seated on a long bench. Attached to the roof is a long rectangular light box, which is currently turned off. The entrance to the bus stop appears to be narrow for wheelchair users. In the background, there is a multiple-floor parking garage and a tree.] There are two narrow entrances on the far right and left of the bus stop for wheelchair users to access. However, there is no disability priority seating inside the bus stop, which only has seating for able-bodied passengers. The interior width of the bus stop is limited and does not provide wheelchair users much room for movement with other able-bodied passengers inside.

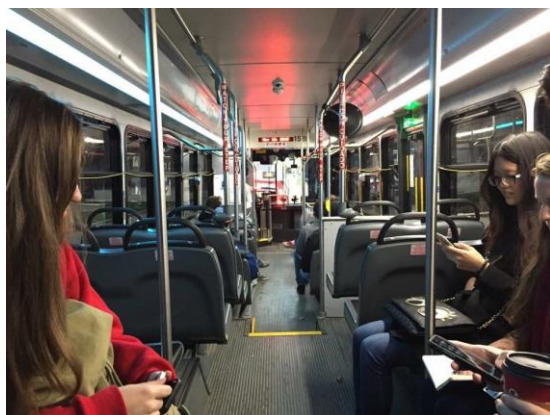
[Image Description: Passengers are seated in the back area. There are vertically aligned silver poles on either side of the bus and horizontally aligned silver poles along the top of the bus for stability. See-through windows are above the seats and attached to them are yellow ropes passengers must pull to signal their stop. There's a digital clock displaying the date and time in the color neon read.]

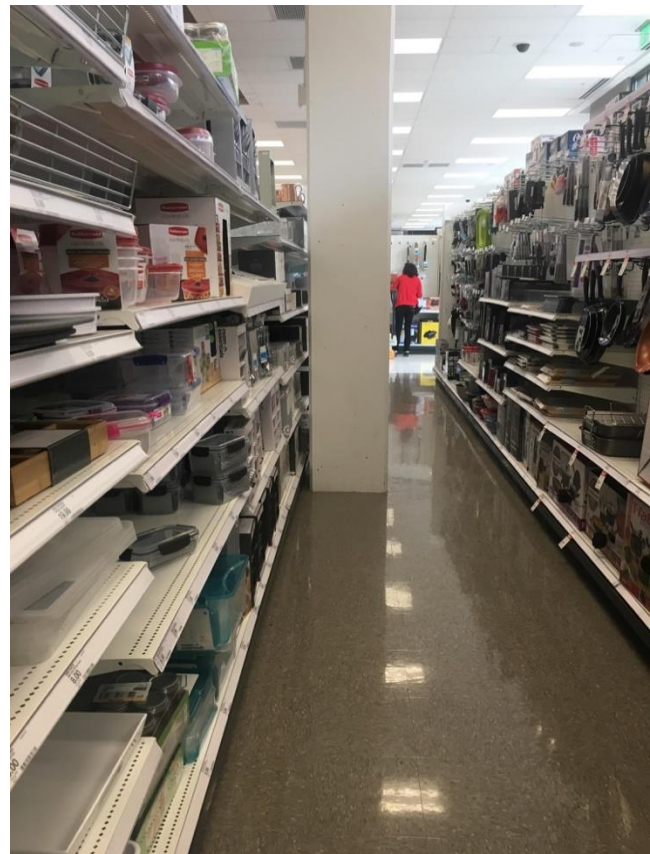
Target pillar in aisle - a large support pillar in an aisle of the Target on 16th and High. It takes up about half the width of the aisle, and there are four of these throughout the store.

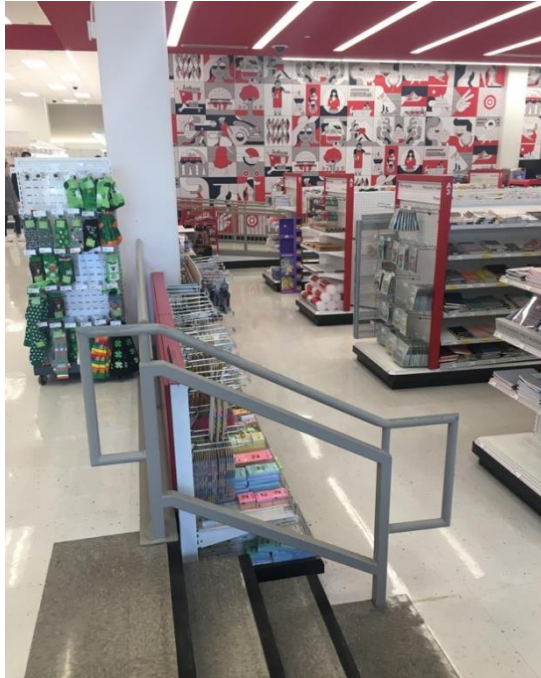
A staircase leading up to the store and across from it, a ramp leading down to the checkout lanes.

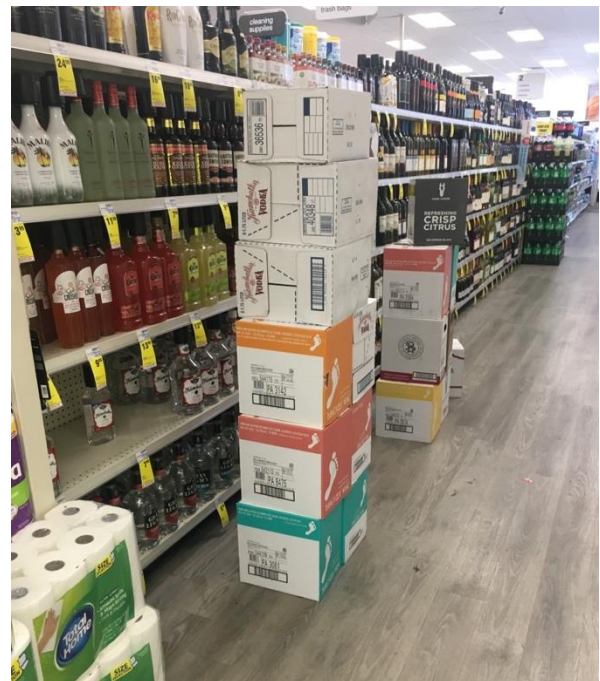
A stack of wine and liquor in the aisle blocking access to the shelves.

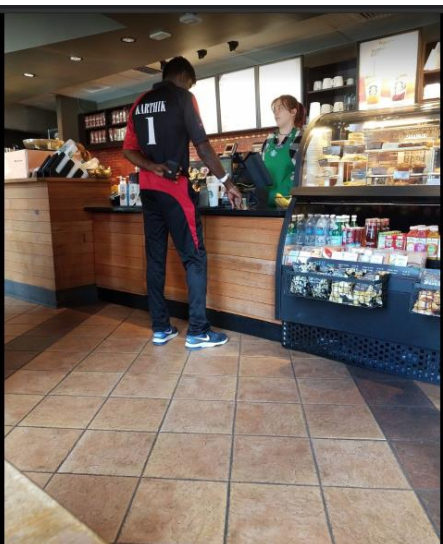
Starbucks offers many positive aspects that are beneficial to those who may need it. For instance, they have a lower counter that can help people who can't reach the higher countertop that can be seen in image "Starbucks Low Countertop."

All Starbucks offer the lower countertop, so no matter what Starbucks location you go there will be an easily accessible lower counter.

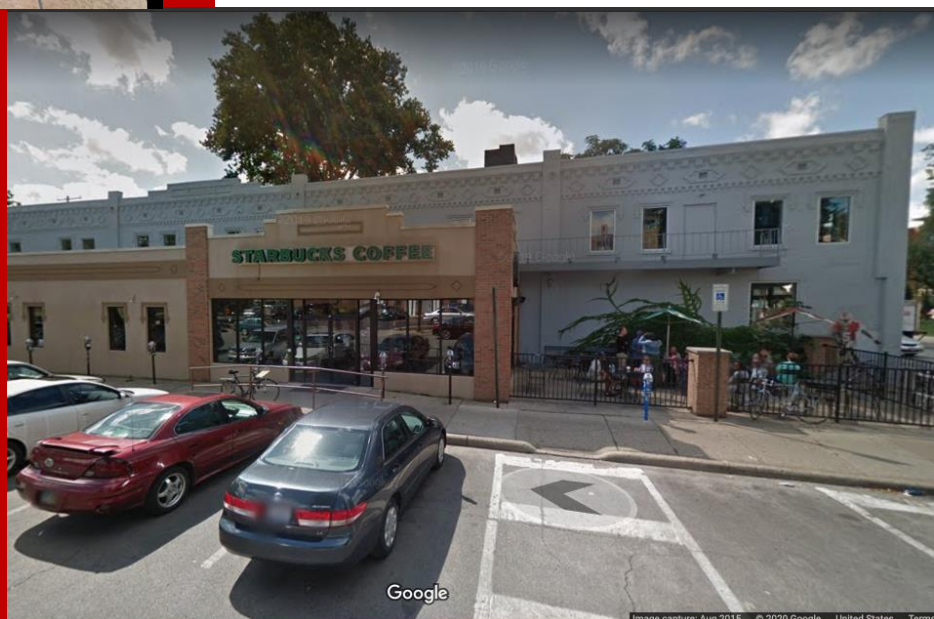
The first Starbucks from the image "Starbucks 1782 N High" located at 1782 N High Street had no stairs to the entrance, but rather an incline on both sides fit for wheelchair users. This Starbucks also has its own parking lot with handicapped spaces, so it may also be easier to access.

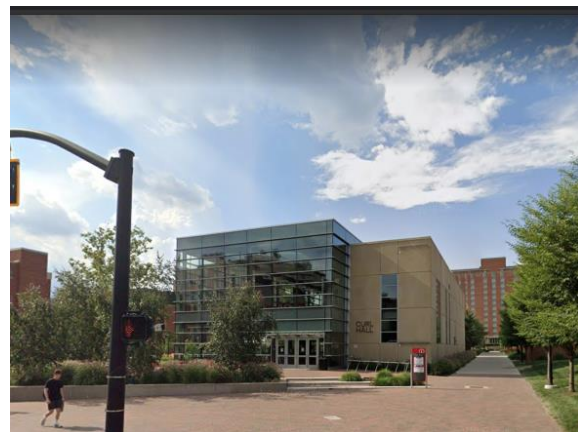
Upon entering the building, there are stairs to the sides that allow you to go upstairs to an eating area, but as you can see from image "Curl Market Hallway," there is also a hallway that leads to an elevator. The middle of the lower level of the Curl Market has all the food counters and racks in which to pick food from. The space is large enough to move around in as can be seen from image "Curl Market Lower Level."
