# Access Guide for The Ohio State University

**Authored by members of the Spring 2020 English 4591 (Rhetorics of Illness and Disability):**

Created for the 2020 Society for  
Disability Studies (SDS) Conference at  
The Ohio State University

First Edition, April 2020

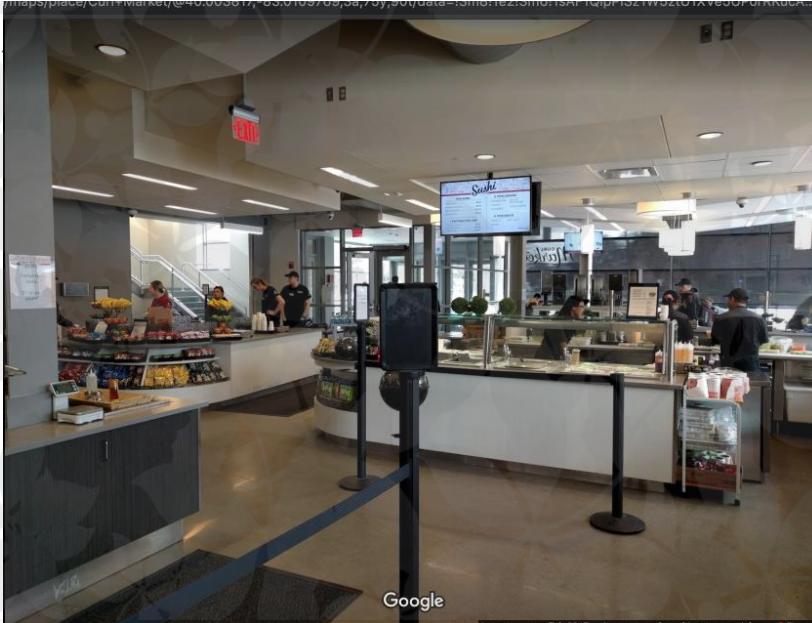
The bottom floor of Curl Market is a large space with counters and racks to pick food from.

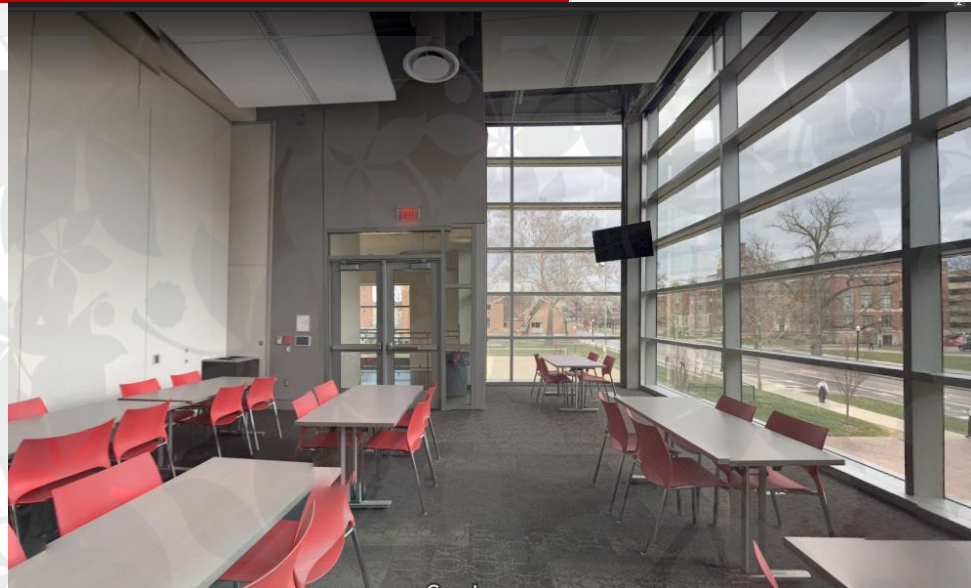
The dining area in Curl Market with lightweight, easily moveable chairs

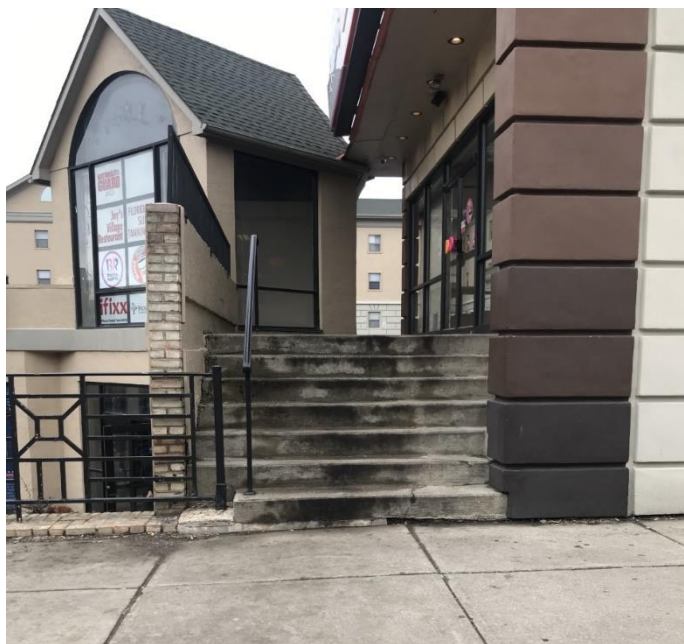
#### **Dunkin Donuts Main Entrance**

This image is a picture of the main entrance to Dunkin Donuts on High Street and East Woodruff Avenue. There are seven steep stairs with a handrail on one side leading to a set of double doors. There is no handicap push button to open the doors automatically. There is no signage shown to indicate an alternate accessible entrance (even though there is a separate entrance).

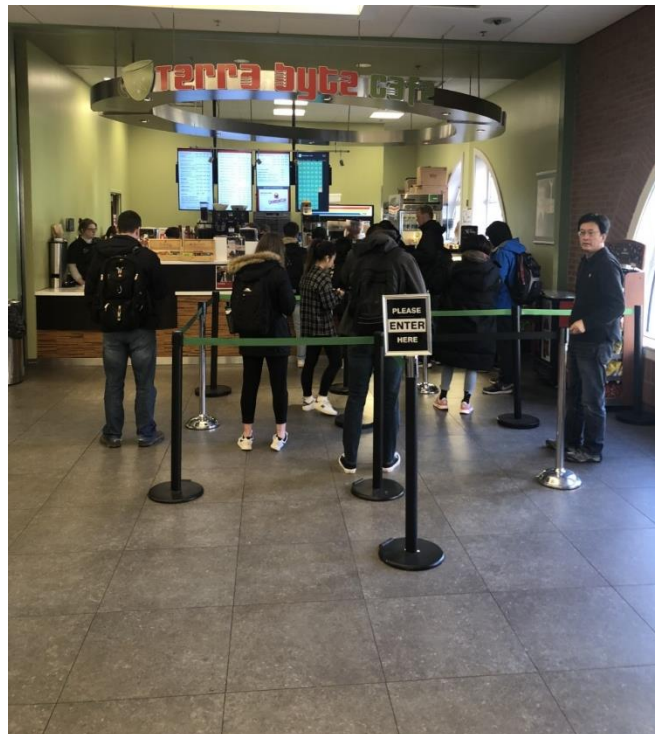
**Terra Byte Cafe**

This image shows the signage “Terra Byte Cafe” above the place where customers order. It shows the entrance into the zigzag ordering line created by a retractable belt barrier and noted with “Please Enter Here” at the start of the line. The low height of the counters can be seen in the background of the photo.

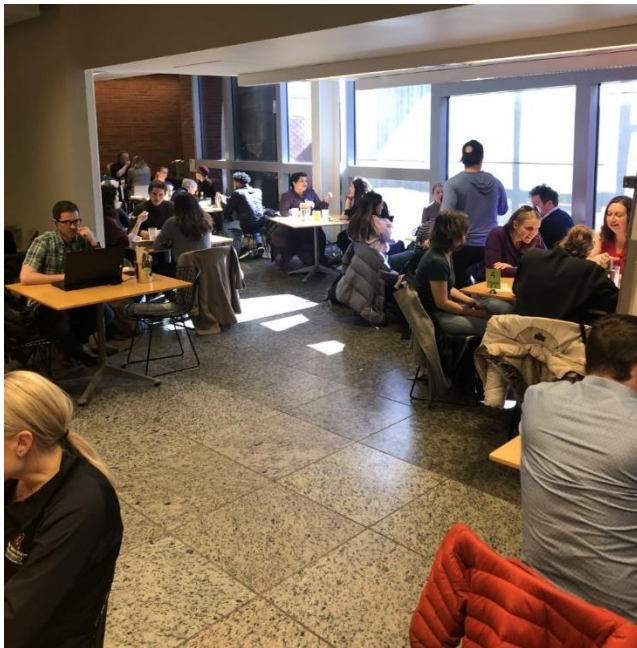
#### **Heirloom Cafe**

This photo shows that the tables and chairs in Heirloom Cafe are often close together and may be hard to navigate or access when other customers are seated or walking nearby. Similarly, the Heirloom Cafe is very crowded and it is sometimes hard to find a table. There are many windows in the space making it quite bright during the day.

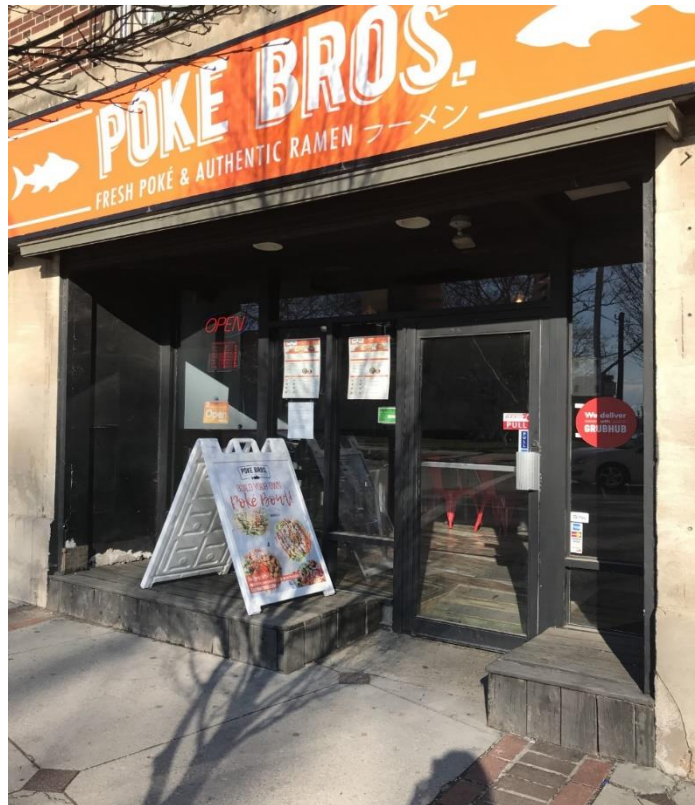
### **Poke Bros Entrance**

This photo shows the one entrance to this space off of North High St. There is one door with no handicap button, so the door must be pulled open from the right side when facing the door. There are wooden steps on either side of the door, making it somewhat constricting when trying to enter and open the door. Looking in from the outside you can vaguely see that as soon as the door is opened there is a small ramp up to the main level. The ramp is about 2 feet long and it goes up.
