Nantucket Accessibility Survey

An Interactive Qualifying Project
submitted to the Faculty of
WORCESTER POLYTECHNIC INSTITUTE
in partial fulfilment of the requirements for the
degree of Bachelor of Science

Date:
16 December 2015

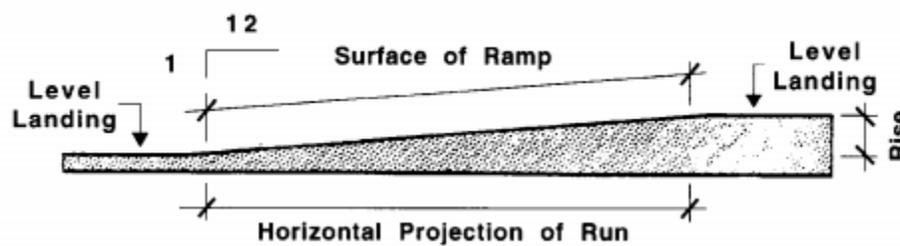
Figure 2.2 Example of a Curb Ramp Slope
(Architectural Access Board: 521CMR, 2006)

A picture of a slope on the curb ramp is shown in Figure 2.2

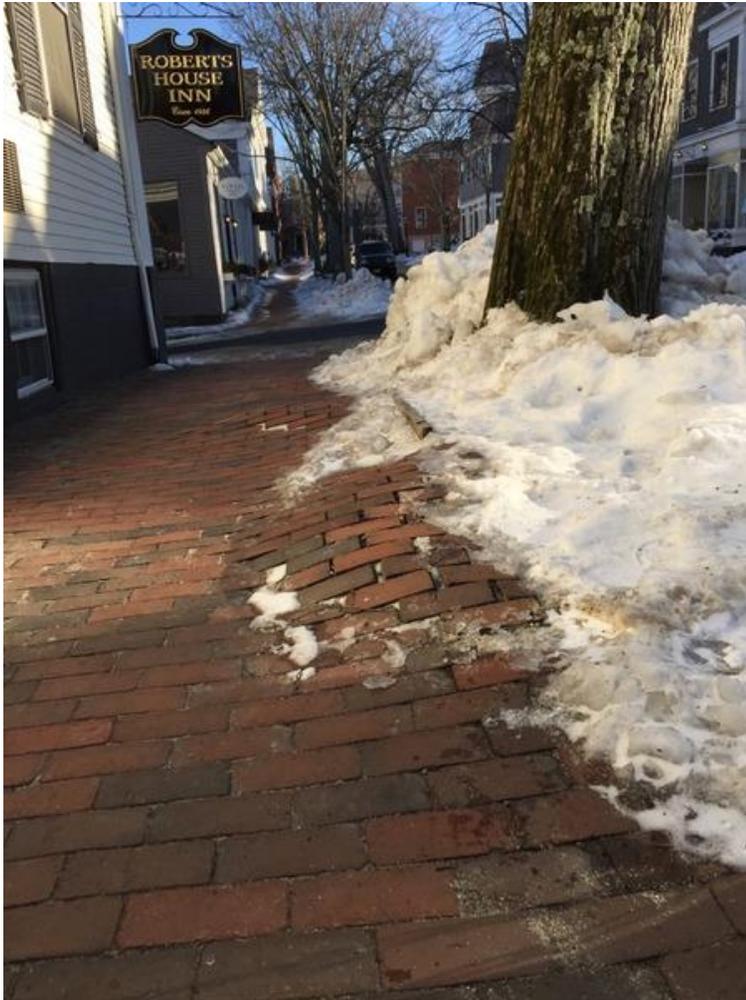
Figure 2.3 Example of Tree Roots Damaging the Brick Sidewalk
(SeeClickFix, 2015)

Figure 2.3 shows the kind of damage from tree roots that is common on many of Nantucket's sidewalks. Not only do the uneven bricks present a tripping hazard for all, but they present special difficulties for those with limited mobility and especially those in wheelchairs. As is evident in the photograph, the uneven surface prevents effective snow removal, which only exacerbates the problems of access. Figure 2.4 also illustrates the kinds of problems the disabled face in navigating Nantucket's sidewalks, including uneven surfaces and narrow clearances for the passage of wheelchairs or walkers.

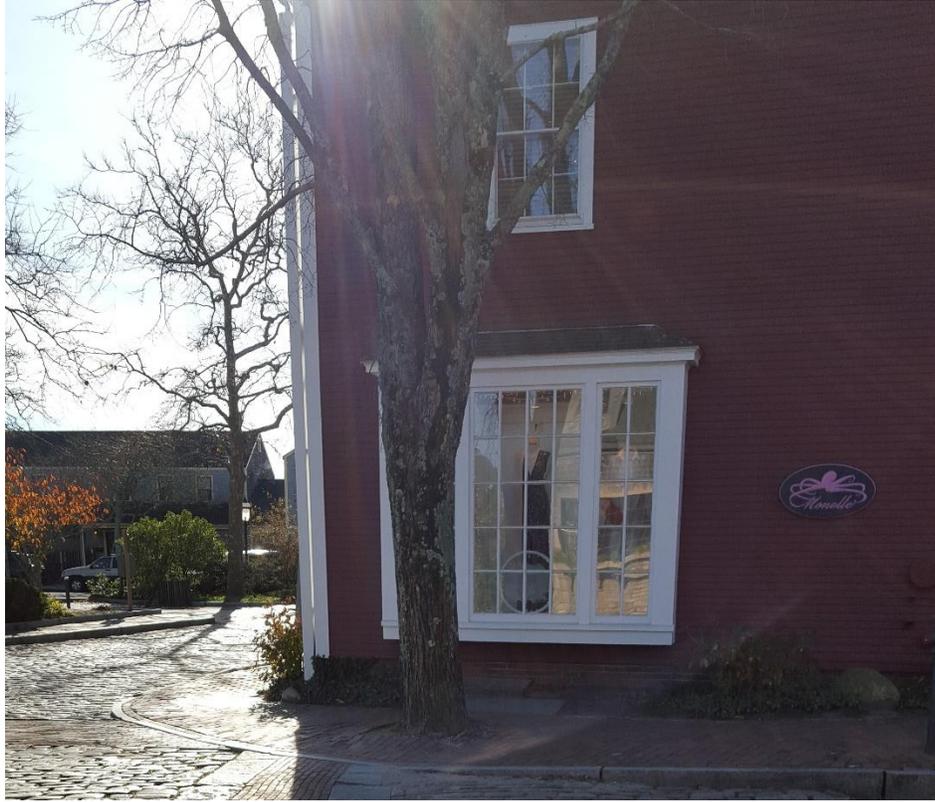
Figure 4.1 Example of a tree obstructing the sidewalk on Main St.

Figure 4.1 is an example of a tree presenting a sidewalk obstruction.

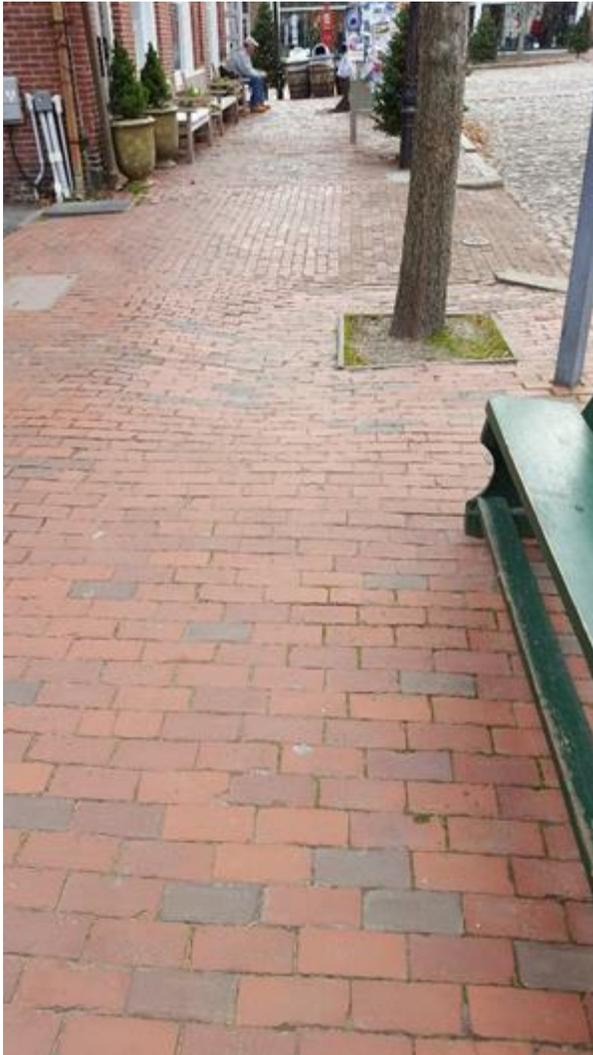
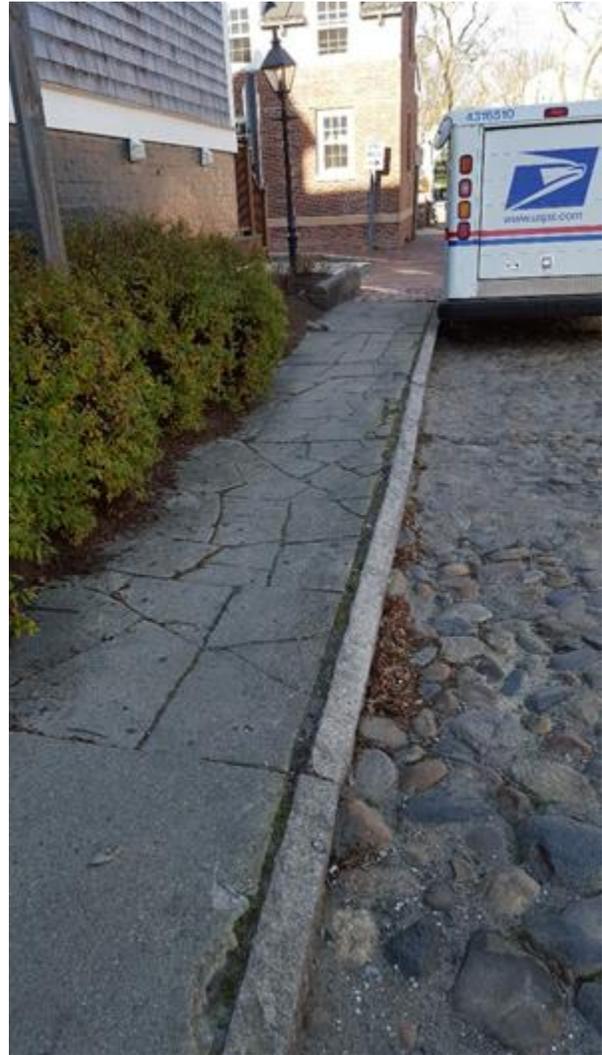
Figure 4.2 Example of a sidewalk given a) a rating of 1 versus a sidewalk given b) a rating of 4

An example of a sidewalk we rated a 1 versus a sidewalk we rated a 4 is shown in Figure 4.2.

a) Federal St.

b) North Union St.

The pictures in Figure 4.2 are examples of the best and worst sidewalks found in the Core Parking District. Figure 4.3 shows that 74 (73.4%) of sidewalk sections in the study area were in very good ('1') or good condition ('2') while 11 (10.9%) were in poor ('4') or very poor ('5') condition. The average rating of all sidewalk sections was 2.21.

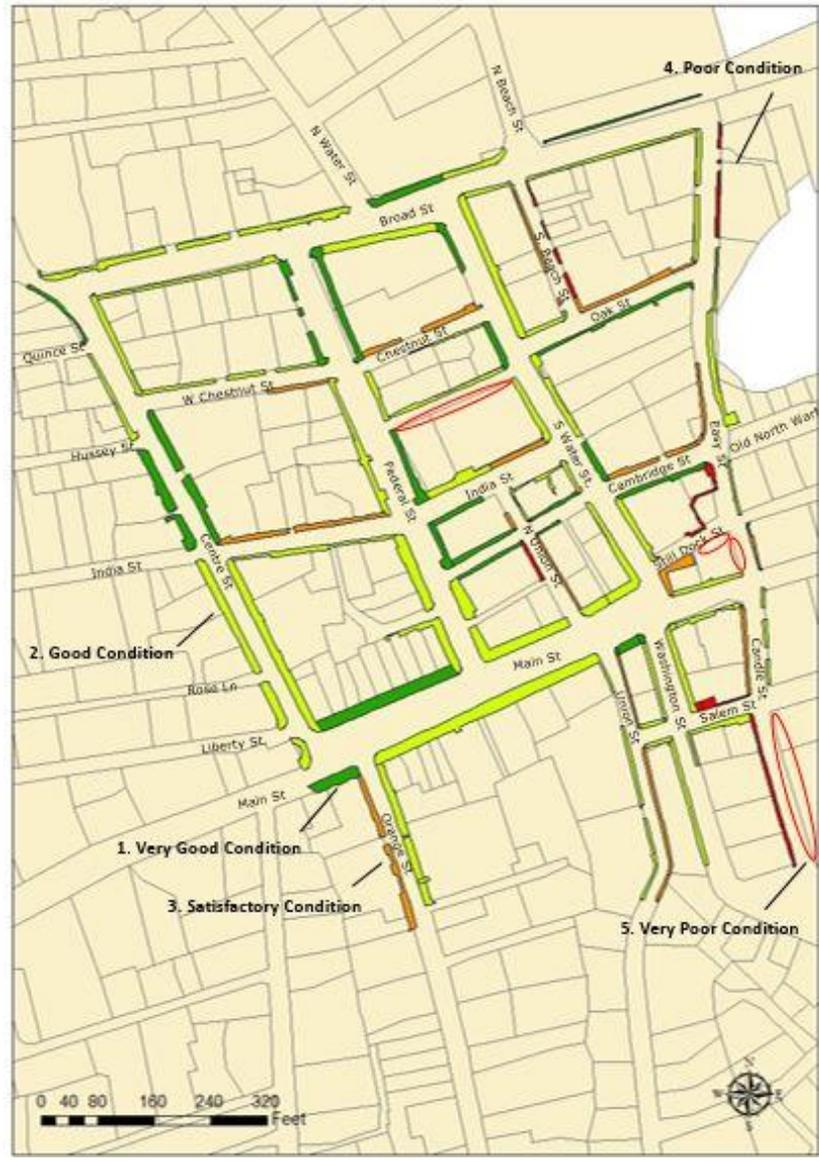
Figure 4.4 Nantucket Historic District Sidewalk Accessibility Map

Figure 4.4 shows the sidewalk ratings throughout the study area. The dark green displays a rating of 1, the yellow-green displays a rating of 2, the orange displays a rating of 3, and the red displays a rating of 4. A red circle displays a section that received a rating of 5, indicating the absence of a sidewalk.

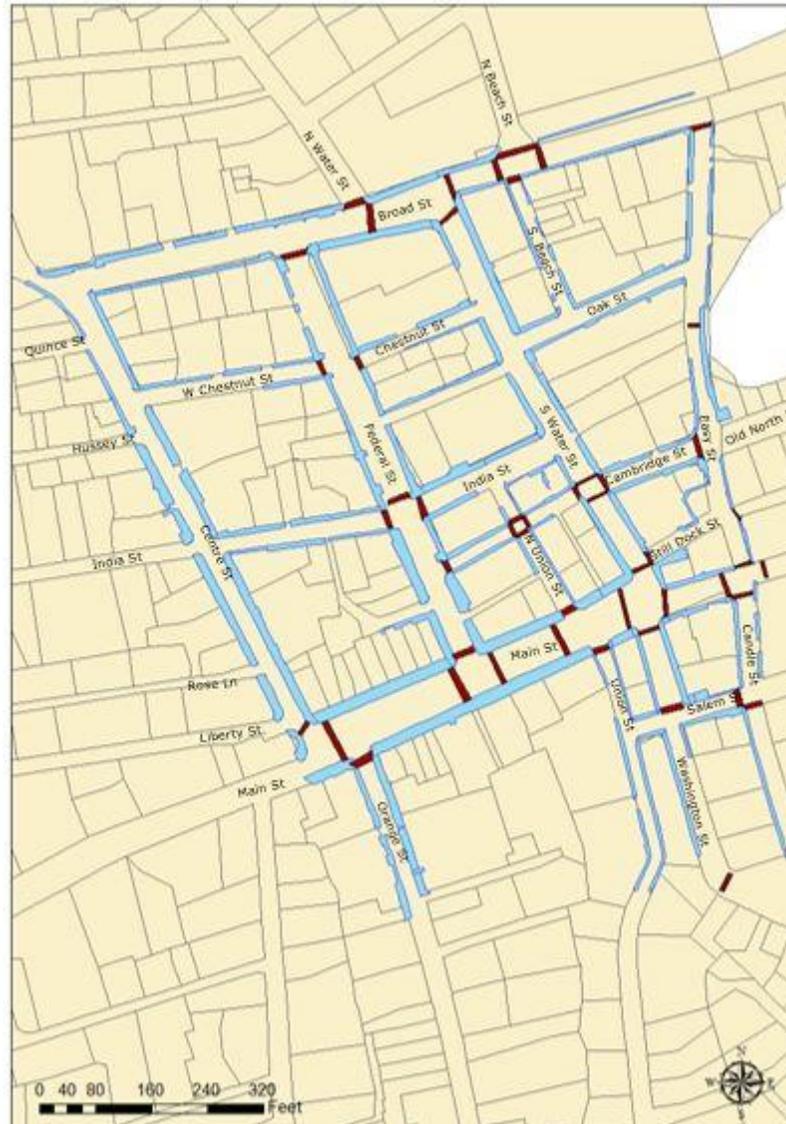
Figure 4.5 Nantucket Historic District Crosswalk Accessibility Map

We evaluated the crosswalks and curb ramps at 37 intersections in the study area, including 14 four-way intersections and 23 T-intersections. To comply with ADA standards a T-Intersection should have 3 crosswalks, and a 4-way intersection should have 4 crosswalks. Thus, our study area should include 125 crosswalks to meet ADA standards, but only 67 were present. Figure 4.5 shows the location of existing crosswalks (brown).

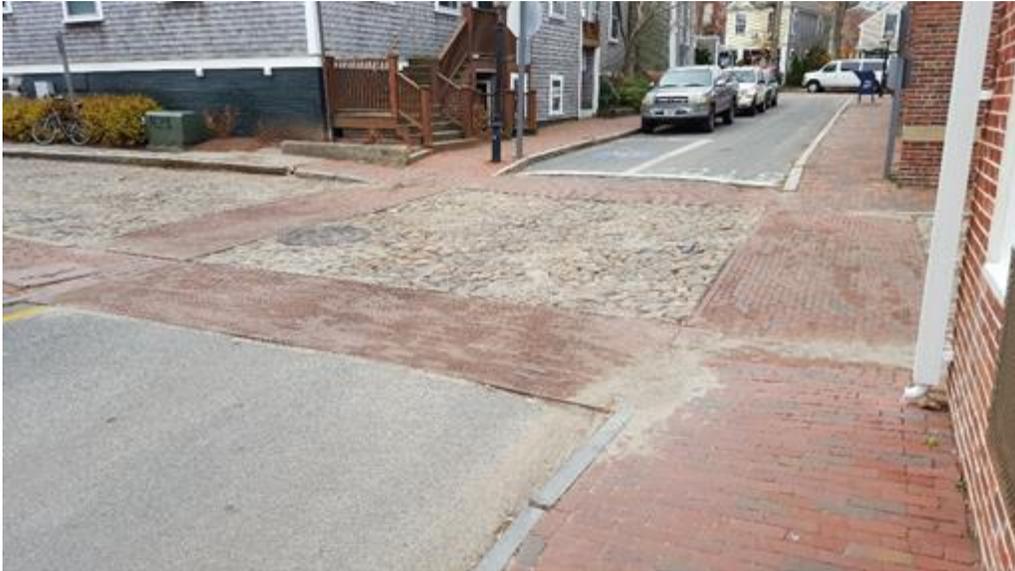
Figure 4.6 Example of a 4-way intersection that meets ADA standards (North Union St. and Cambridge St.)

Only 9 (24.3%) of the intersections contained all of the crosswalks needed to comply with ADA standards. An example of one of these intersections is shown in Figure 4.6.

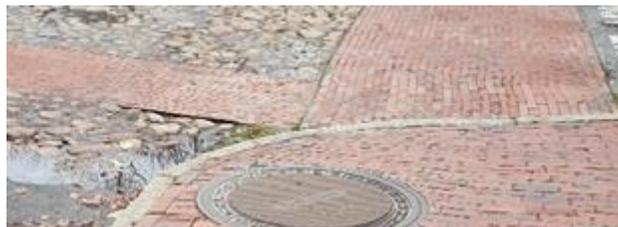
Figure 4.7 Example of a crosswalk ending in another crosswalk (South Water St. and Cambridge St.)

- 32 (or 47.8%) meet the ADA minimum width requirement of 72”.
- 12 (or 17.9%) were painted on concrete
- 55 (or 82.1%) were constructed of brick and granite
- 4 (or 6.0%) of the crosswalks contravene ADA standards by ending in another crosswalk (as shown by the example at the intersection of South Water St. and Cambridge St. in Figure 4.7).

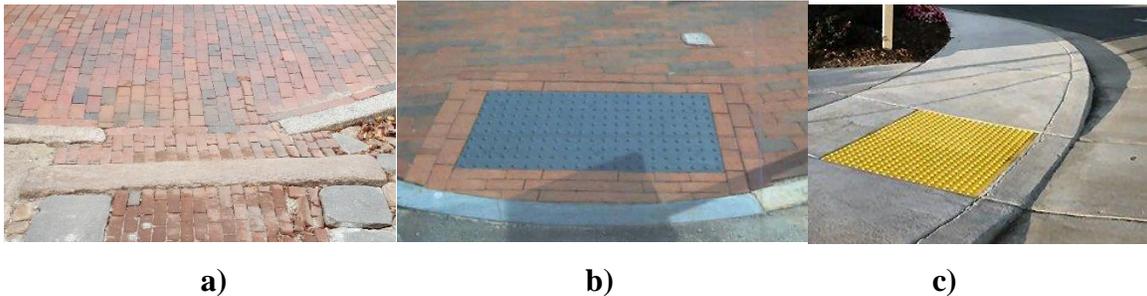
Figures 4.8 Examples of ramps
a) a ramp on Nantucket b) a Detectable Warning Panel in another historic community
c) an ADA approved Detectable Warning Panel
(McGuirk, 2015), (Portland Press Herald, 2011), (California ADA Compliance, 2013)

Given the number of four-way (14) and T-intersections (23) in the study area, the ADA guidelines would require 250 curb ramps. Presently, there are only 167 curb ramps or 66.8% of the required number. Figure 4.8 displays a typical curb ramp on a historic Nantucket sidewalk. After evaluating the 167 present curb ramps we found:

- 165 (or 98.8%) met the ADA minimum width requirement of 36.”
- 93 (or 55.7%) are below the maximum ramp slope requirement of 8.33%

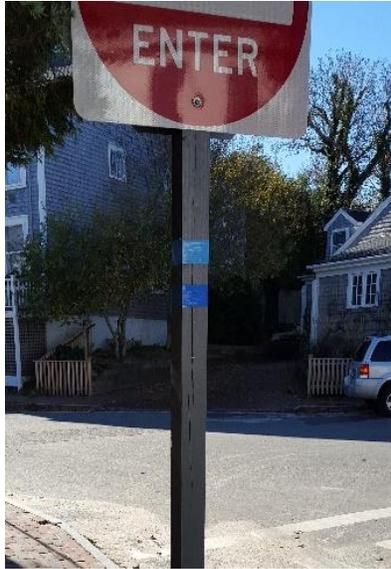
Figure 4.9 Blue tape markers used to mark the locations of bus stops

- 106 (or 73.6%) of the 144 bus stops had a boarding area.
- Of the 106 bus stops that have boarding areas:
 - 87 (or 82.1%) are the minimum required size of 60” X 96”.
 - 56 (or 64.6%) of these have the same slope as the adjacent street.
- Of the 144 bus stops surveyed:
 - 29 (or 20.1%) have space for the bus to pull over.
 - 47 (or 32.6%) are accessible by pedestrian path (bike or dirt path).
 - 36 (or 25%) are accessible by sidewalk.
 - 61 (or 42.4%) are accessible by the street.
 - 139 (or 96.5%) of the bus stop are marked by blue tape to designate a bus stop (Figure 4.9).

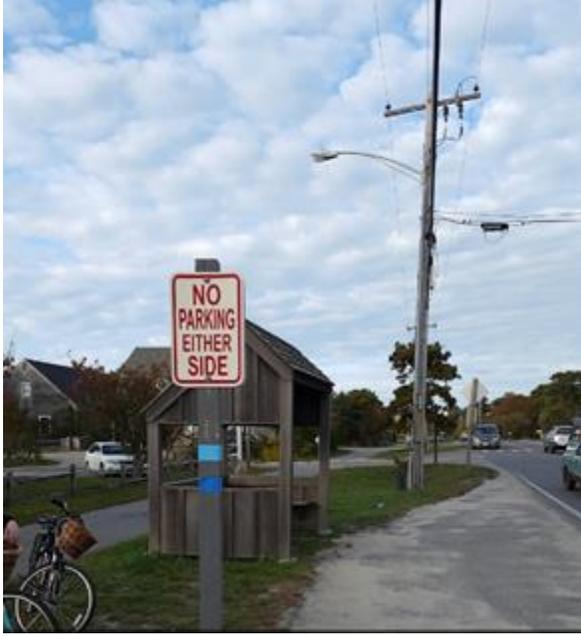
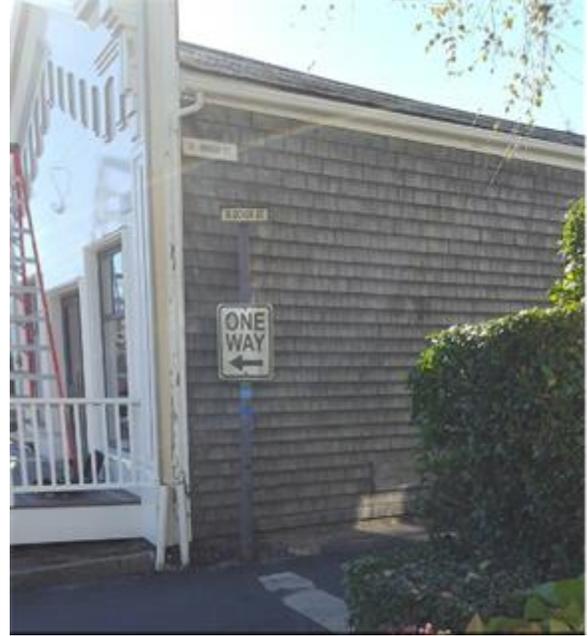
Figure 4.10 Bus stop given a) a rating of 1 versus a bus stop given b) a rating of 5

After assessing each bus stop, we rated each on a scale of 1 – 5 with 1 as the best and 5 as the worst. A bus stop with a rating of 1 would include an appropriate sized boarding area that has the same slope as the adjacent road and access from a sidewalk or pedestrian passageway. A rating of 5 would be an unmarked or potentially dangerous bus stop with no boarding area. Examples of a bus stop that we rated a 1 versus a bus stop that we rated a 5 are depicted in Figure 4.10.

a) Surfside Road

b) North Dover St.

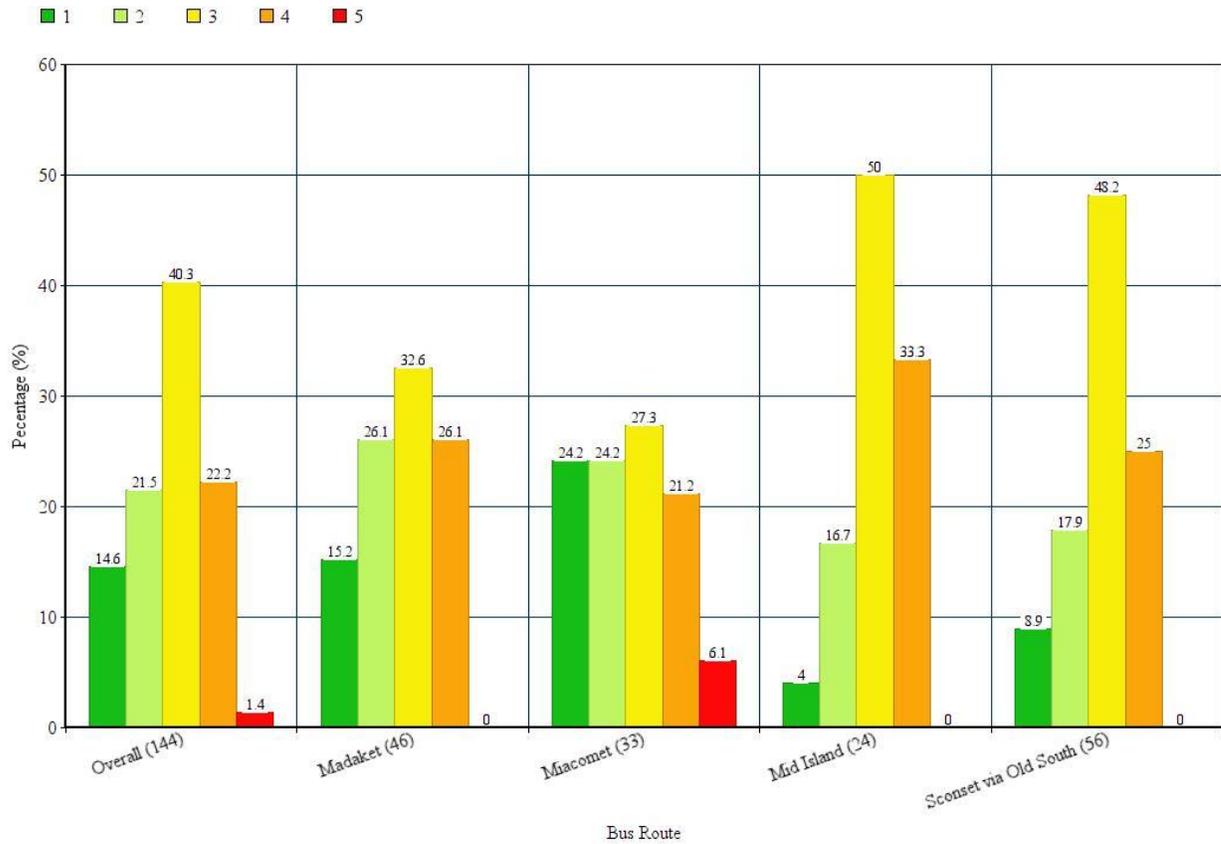
Figure 4.11 Bus Stop Conditions of Nantucket

Figures 4.11 shows the distribution of the bus stop ratings for all 144 bus stops taken together, as well as the ratings for each individual bus route. Clearly the majority of the bus stops overall and on any given route are rated at 3 or higher. Typically, this means that many of the bus stops are marked but do not have an adequate boarding area. The Miacomet route has the largest number of stops (48.4%) that are rated at 1 or 2, although it also has the largest on number (6.1%) rated at 5.

The average rating for all routes is a 2.67, and ranges from 2.57 for Miacomet to 3.0 for Mid-Island routes.

This collection of ratings indicates that Miacomet route has the best bus stops and the Mid-Island route has the worst. Although there were a few bus stops that complied with ADA standards, most did not. This indicates improvements are needed. The NRTA is currently concerned with improving the most popular bus stops. Figure 4.12 shows a map of the 51 most popular bus stops, and it indicates if the bus stop has an appropriately sized boarding area of 60” x 96”. The green color depicts a bus stop with an appropriate boarding area, and the red color depicts a bus stop where the boarding area is missing or inadequate.

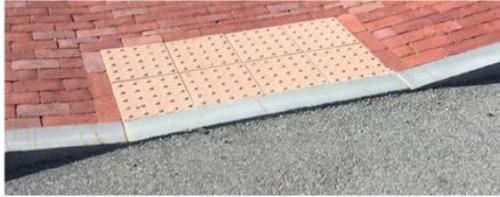
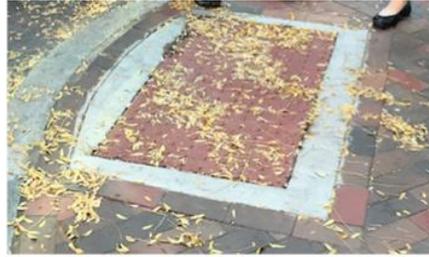
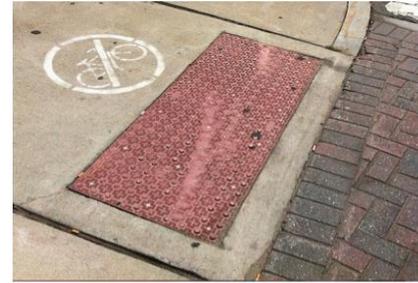
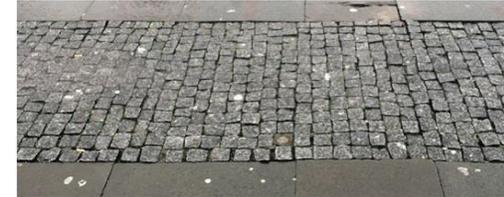
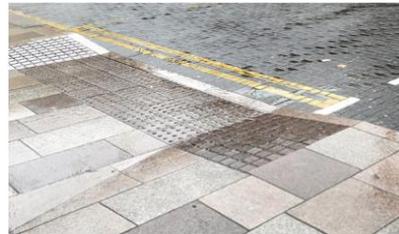
Figure 4.14 Results from our Detectable Warning Panel Survey

In our survey, we asked the following question for eight different examples of detectable warning panels: “Please rate the detectable warning panel in the picture below on a scale of 1 to 5, where 1 is ‘very appropriate’ and 5 is ‘not at all appropriate’ for Nantucket.” We also asked what committees (if any) the stakeholders belonged to.

Our results showed that none of the options presented were particularly popular among representatives of the committees, see Figure 4.14. Respondents commented that they wanted to make the sidewalks of downtown Nantucket more accessible for everyone, but would rather not change any of the current sidewalks. The granite cobbles (top right in Figure 4.14) was the option that appeared to be least objectionable to the respondents. Curiously this is not the option the HDC had chosen to test on Main and Federal Streets.

Rating	Percentage (30 Responses)
1	16.67%
2	16.67%
3	16.67%
4	10%
5	40%

Rating	Percentage (27 Responses)
1	14.81%
2	18.52%
3	25.93%
4	22.22%
5	18.52%

Rating	Percentage (29 Responses)
1	13.79%
2	10.34%
3	24.14%
4	17.24%
5	34.48%

Rating	Percentage (29 Responses)
1	27.59%
2	17.24%
3	13.79%
4	20.69%
5	20.69%

Rating	Percentage (30 Responses)
1	10%
2	16.67%
3	6.67%
4	26.67%
5	40%

During the second meeting, we shared the results of an online survey we sent out to various committees, which will be explained in more detail later. All members were present, and they were open to all of our suggestions. After looking through each of the eight detectable warning panels that were on the survey, members of the HDC asked a few questions concerning the material of each panel, as well as discussing the advantages and disadvantages of each option, the HDC decided to conduct a trial run with option #2, the detectable warning panel surrounded by granite, shown in Figure 4.14. This option will be placed in the curb ramp located at the intersection of Main and Federal, near The Hub. After placement, various stakeholders will be consulted to determine if the design is suitable for the Old Historic District of Nantucket.

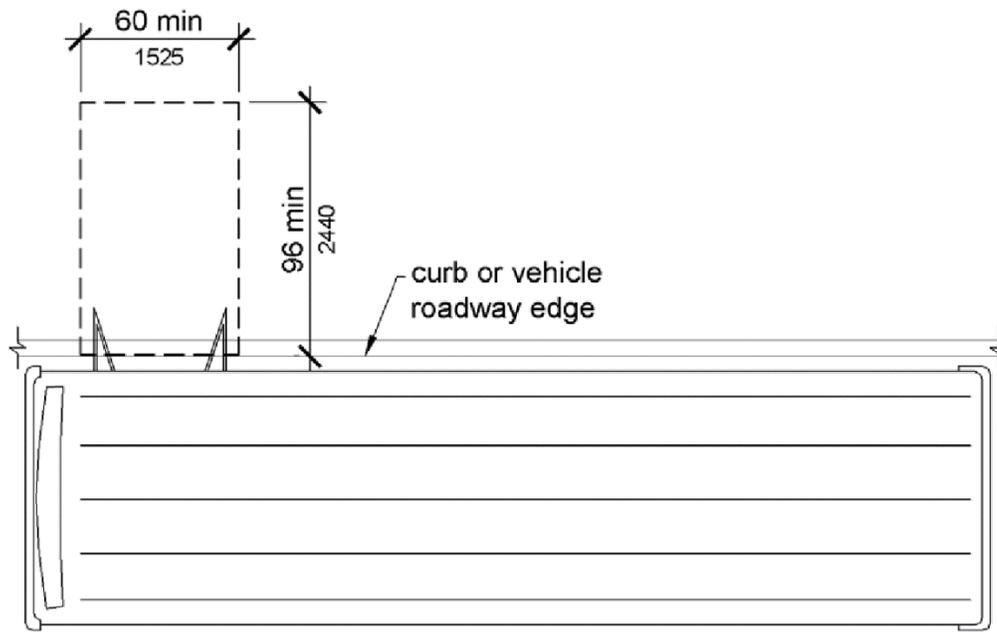
Example of a Bus Stop Boarding Area
(ADA, 2010)

- Bus stop boarding areas shall provide a length of a minimum of 96” inches from the curb or roadway edge.
- The width of the boarding area must have a width of a minimum of 60” parallel to the roadway.
- The bus route must be connected by accessible routes such as sidewalks, pedestrian paths, or streets.
- The slope of the bus stop boarding must be the same as the roadway.
- There must be identification signs for every bus stop (United States Access Board, 2010)

The figure on the next page shows an ADA schematic of how a bus stop boarding area should be constructed.
