Eel Point Road Restoration and Resilience

An interactive Qualifying Project submitted to the Faculty of
WORCESTER POLYTECHNIC INSTITUTE
in partial fulfillment of the requirements for the
Degree of Bachelor of Science

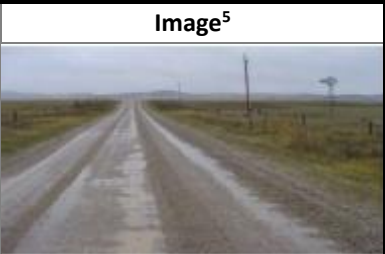
Distress Condition	Description	Source of Distress	Image ⁵
Improper cross section	<ul style="list-style-type: none"> Road not sufficiently sloped to carry water off road surface Water pools on road surface 	<ul style="list-style-type: none"> Improper road shape Lack of maintenance on road surface

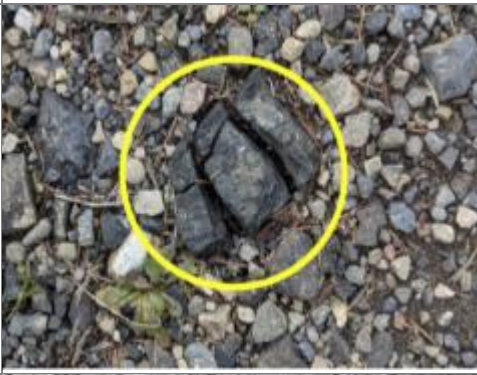
Structural Erosion Type	Description	Source of Erosion	Image ⁷
Crushing	<ul style="list-style-type: none"> • Breakdown of surface aggregates 	<ul style="list-style-type: none"> • Heavy loads/vehicles pushing downwards onto road surface

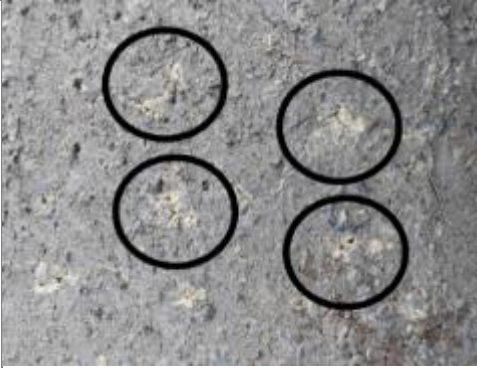
Pumping	<ul style="list-style-type: none"> • Fine sediments displaced to road surface • Displacement of subsurface road materials 	<ul style="list-style-type: none"> • Vehicle traffic

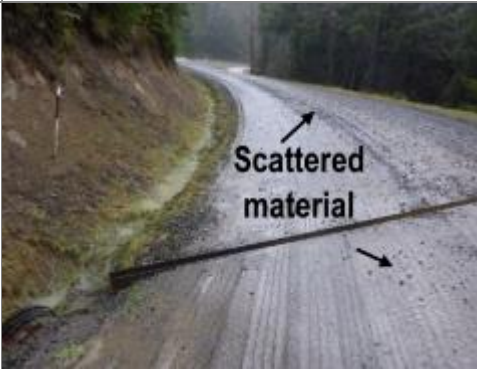
Scattering	<ul style="list-style-type: none"> • Displacement of large road sediments • Exposure of fine sediment layers 	<ul style="list-style-type: none"> • Vehicle traffic

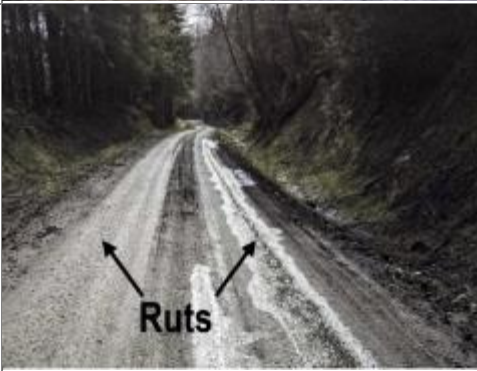
Flow rerouting	<ul style="list-style-type: none"> • Water flow paths diverted/altered by erosion 	<ul style="list-style-type: none"> • Vehicle traffic • Water flow across road surface

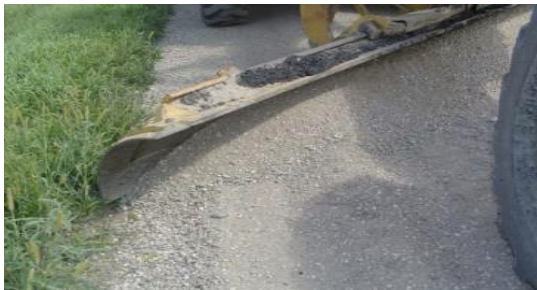
Figure 7. Blading being performed on an unpaved road. The moldboard is used to drag loose sediment across the road surface.

Techniques to directly address unpaved road surfaces are blading and reconstructive grading. As shown in Figure 7, blading is the practice of smoothing the road surface by pulling loose aggregates from the road across surface deformations (Kearley 3). As shown in Figure 8, reconstructive grading is the practice of cutting, redistributing, and compacting the road surface to reshape the road (Kearley 4). Reconstructive grading also involves the addition and distribution of new road surface material to address rutting, potholes, corrugations, and erosion caused by standing water (ibid). Table 5 (on following page) lists structures used to mitigate the effects of flooding and erosion on unpaved roads, their function, where on the road the structures are placed, and images of each structure.

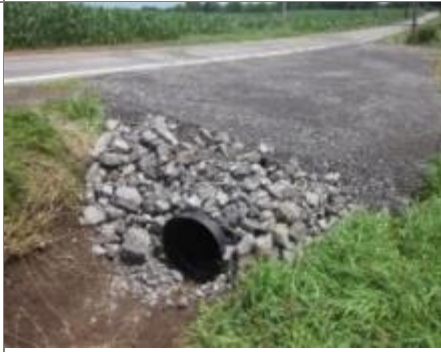
Structure Type	Function	Installation Location	Example Image ¹⁰
Ditch	<ul style="list-style-type: none"> • Transport water from road surface • Reduce speed & turbulence of flowing water 	<ul style="list-style-type: none"> • Roadside • Typically placed uphill to prevent water flowing onto road surface 	 
Culvert	<ul style="list-style-type: none"> • Transport water between locations • Drain water from other installations 	<ul style="list-style-type: none"> • Installed alongside other flooding and erosion installations • Underneath road surface

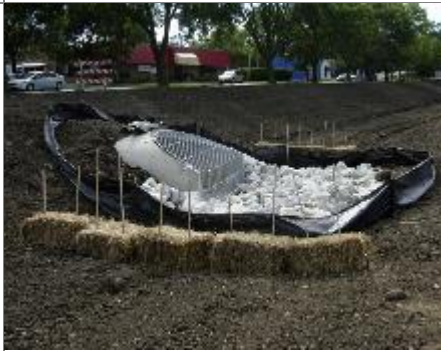
Outlet structure	<ul style="list-style-type: none"> • Reduce speed & turbulence of water • Remove sediment & pollutants from runoff 	<ul style="list-style-type: none"> • Areas of high velocity/turbulent water discharge • Ditch & culvert outlets

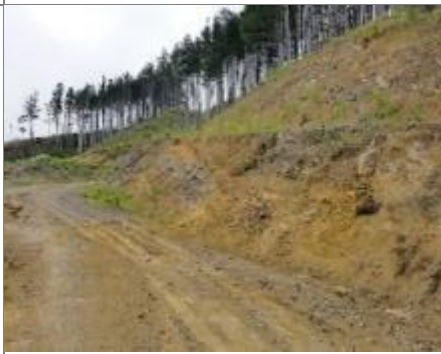
Bank stabilization	<ul style="list-style-type: none"> • Resist erosion of slopes & embankments • Improve slope stability 	<ul style="list-style-type: none"> • Road slopes & embankments

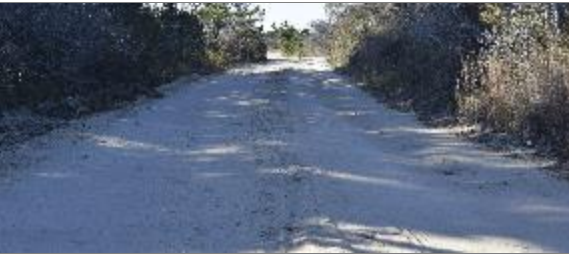
Distress Type ¹³	Description	Photograph
Improper cross section	The W-shape of the road prevents water from flowing off the road surface. The slope of the road surface is insufficient to carry water off the road.

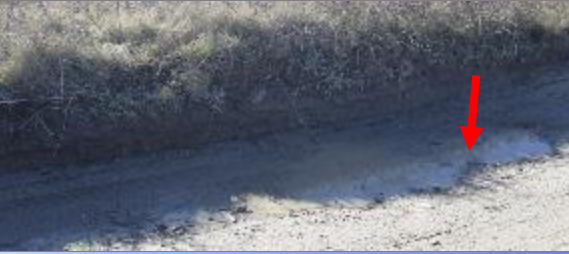
Inadequate roadside drainage	Water is prevented from moving off the road surface due to a lack of drainage and entrenching of the road into the surrounding land.

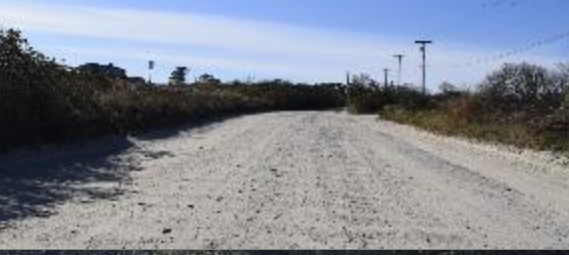
Corrugation	Ripples have formed in the road surface due to damage from heavy vehicles and high-speed vehicle traffic (S. Engelbourg, personal communication).

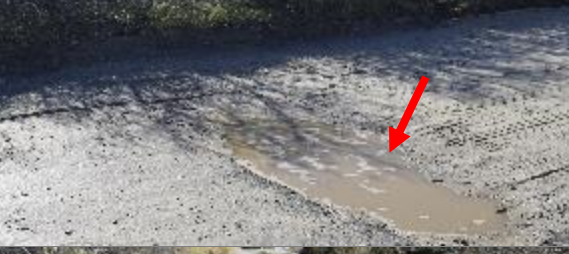
Potholes	Large, water-retaining potholes have formed in areas of soft surface material. Traffic and water inundation contribute to the growth of potholes along the road.

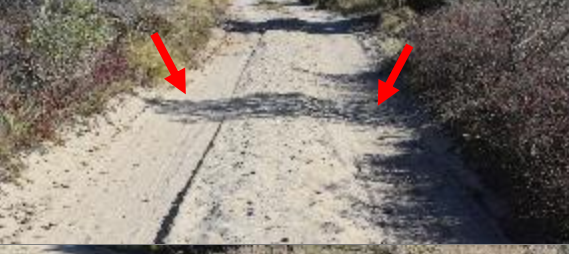
Rutting	Vehicle traffic has caused rutting in areas of the road surface where surface materials are soft and easily erodible.

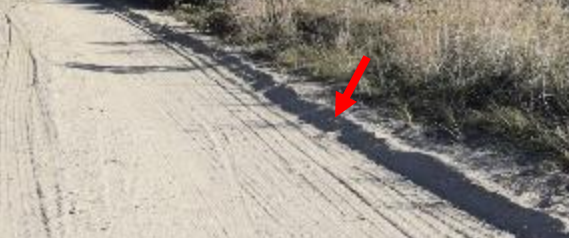
Loose aggregate	Loose road surface materials have been pushed onto the road shoulder from vehicle traffic and erosion.

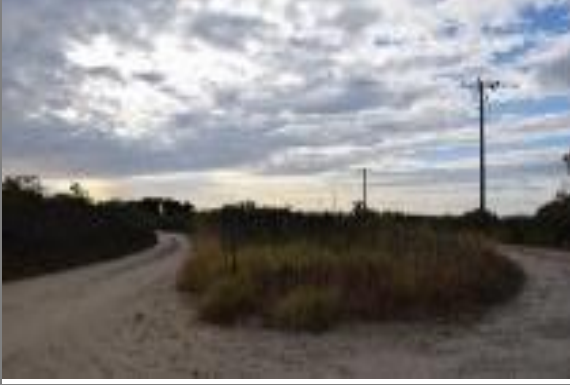
Condition	Description	Photograph
Desire paths	Traffic over time has produced additional paths along EPR. These paths fragment surrounding habitat and cause variations in road width.

The LLNF should establish a single road path on EPR by blocking off the additional road paths that have been created over time. By establishing a single road path for EPR, a set boundary of the road can be created for which regular maintenance can be performed. As shown in Figure 17, this can be done by installing snow stakes or wooden bollards at the sides of EPR to block vehicle traffic from moving off the established road. These installations should be monitored and replaced as needed.

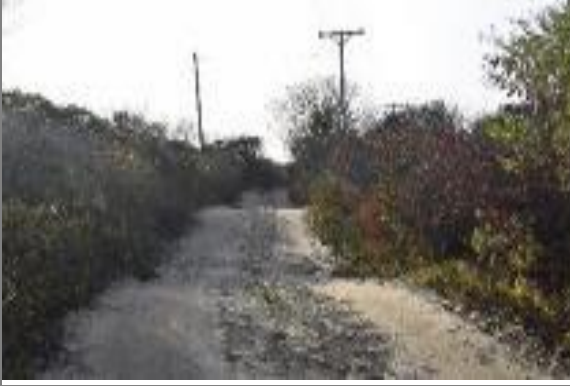
Road height	Large variations in the height of the road are inconsistent with surrounding terrain elevation.

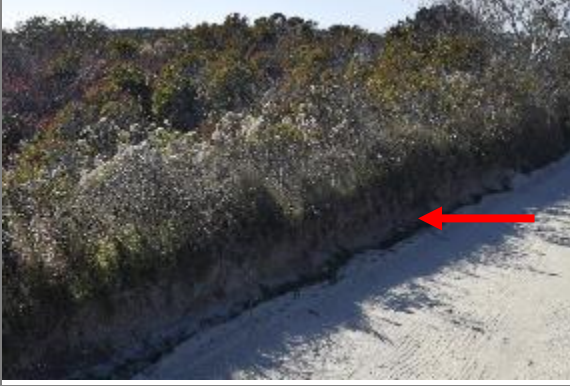
Entrenchment	Erosion of the road surface has depressed the elevation of the road below the surface of surrounding terrain.

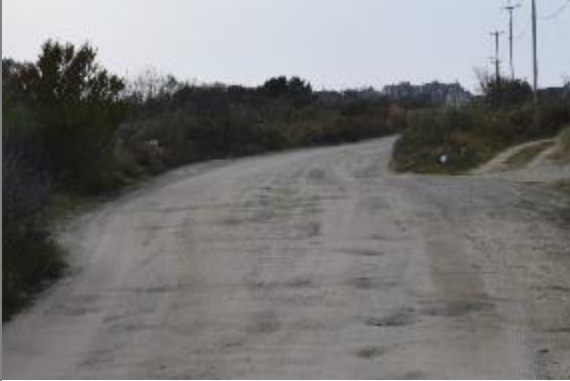
Width variation	Traffic has irregularly expanded the width of EPR. Expansion of the road surface encroaches into surrounding habitat and contributes to erosion.

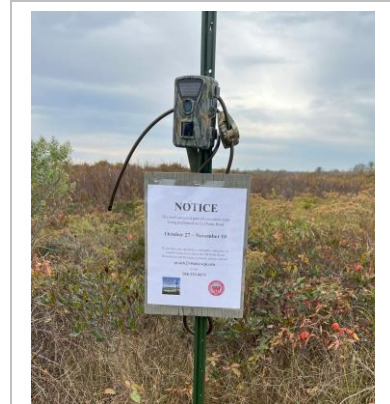
As shown in Figure 12, a trail camera facing EPR was installed on LLNF property¹⁴ to record the frequency of use and vehicle traffic composition of EPR between October 27, 2023 and November 10, 2023. Additionally, 1 question on the survey asked respondents to identify which forms of transportation they used to access EPR.

Figure 12. A photograph of the trail camera and notice posted on EPR.

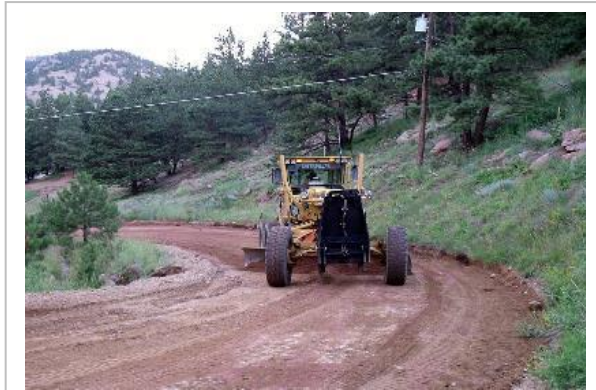
Regrade and Fill

- **Cost:** Based on contractor estimates, regrading EPR will cost approximately \$100,000 for labor, overhead, and materials costs (A. Dwyer, personal communication).
- **Environmental Impact:** Low impact ([EPA recommended](#))
- **Recommendation:** The LLNF should cut the road to the base so that additional fill material can be added and shaped to increase the overall road height, establish a proper road surface cross-section, and reduce the entrenchment of certain sections. This will also address structural issues with the road surface and subsurface such as soft spots, potholes, corrugations, rutting, and loose aggregate.

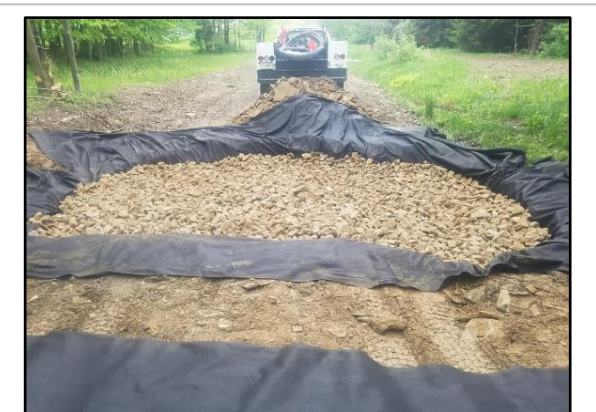
French Mattress

- **Cost:** A quote from an expert will be necessary. Can refer to this document for costs for installation and material: [French Mattress Cost](#).
- **Environmental Impact:** Low impact
- **Recommendation:** The LLNF should install French mattresses in areas of EPR where the soil becomes saturated with water. French mattresses consist of clean rock covered in geotextile fabric ("French Mattress"). Water can freely move across the mattress without saturating the road (ibid). French mattresses also help to disperse water flow through the road, mitigating rill and gully erosion (ibid).

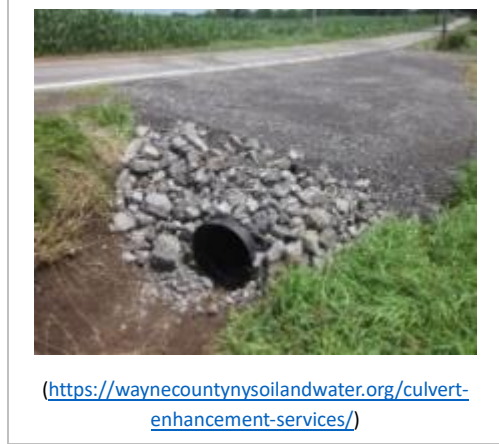
Culverts in Bank

- **Cost:** A quote from an expert will be necessary based on how complex the installation will be.
- **Environmental Impact:** Low impact
- **Recommendation:** The LLNF should install a culvert in the bank along EPR where water pools next to the roadside. Due to EPR’s bank existing multiple feet above the road’s surface, it is difficult for water to percolate through the compressed soil and is trapped by the banks. Installed pipes in the banks can redirect water before it accumulates to uncompressed soil that according to ArcGIS Pro layers already is effective at drainage.

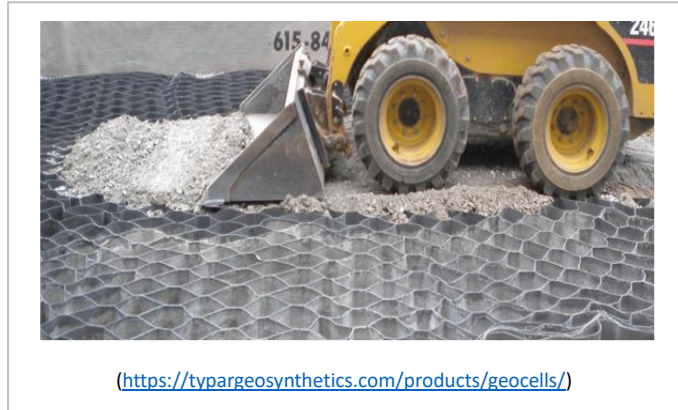
Geocell Installation

- **Cost:** The geocell grid from AgTec 8.4 feet by 27.4 feet are estimated around \$130 (“AgTec Geocell Ground Grid”). The total cost will depend on the amount needed.
- **Environmental Impact:** Low impact
- **Recommendation:** The LLNF should install geocells in areas prone to flooding and erosion. The geocells would limit the impact the road experiences from heavy equipment vehicles as the geocells will maintain the structure of the road (“BaseLok Geocell Cellular Confinement”). The geocells maintaining the structure of the road will limit the impact of erosion on EPR. In addition, geocells allow locations under the road in which the water can drain (Cellular Confinement BaseLok Geocell).

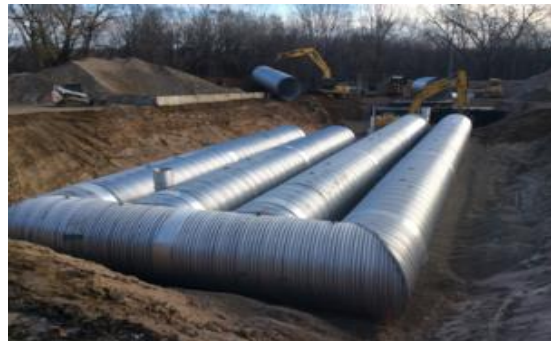
- **Recommendation:** The LLNF should install stormwater infiltration cells on EPR to direct and contain water from rainfall and stormwater flooding. These measures will help to reduce the volume of runoff water on EPR (“Overview of Stormwater Infiltration”). To install stormwater infiltration cells, the soil infiltration and evapotranspiration rates of EPR should be measured (ibid). These measurements will inform the LLNF of the rate at which water enters and leaves the soil on EPR due to infiltration and evaporation respectively (ibid). The stormwater infiltration cells would be able to be installed underneath the road surface and could include culverts or pipes to direct water into the cells (S. Engelbourg, personal communication).
