Stormwater Management in Monwabisi Park: C-Section

Existing Conditions, Interventions and Proposed Solutions

Compiled by the 2010 WPI Stormwater Management Team

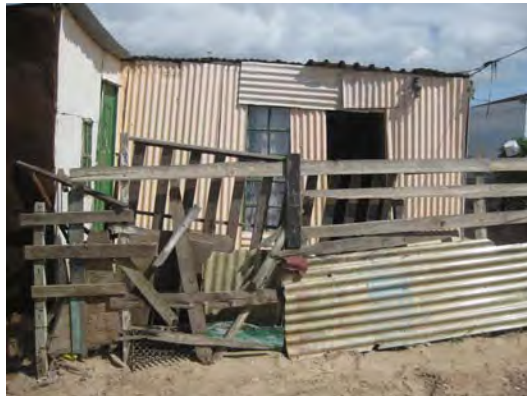
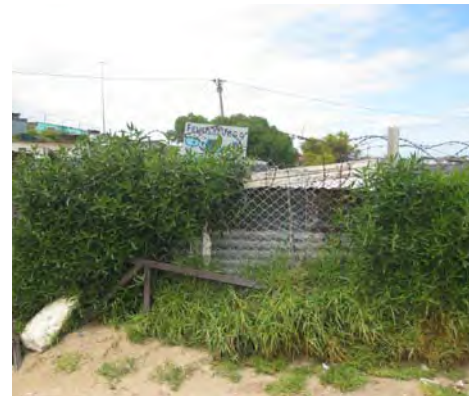
There are a variety of fences found along the C-section road. These fences serve as a barrier against both rainwater and communal tap water runoff and are designed to prevent household flooding. They are commonly built around the perimeter of individual yards and they are often incorporated with other interventions to reinforce their stability and functionality. Due to them being built directly into the sandy ground, over time they sink into the sand and become lowered.

Dimensions: Height: 1 meter – 1.5 meters
Width: Typically the same width as the house

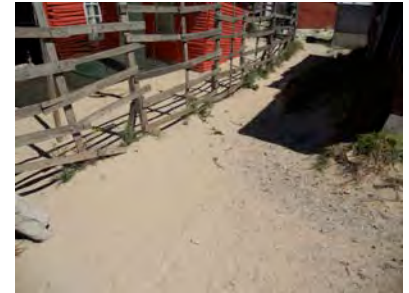
Varied Materials

Most fences found within the C-section road are made out of a variety of materials. Thin boards of wood are used commonly as poles to hold the fences up, while the materials that hold these poles together vary from house to house. Some people use strands of wire to hold the wood together, while others use scrap pieces of metal siding to keep the poles standing. In some rare cases, both metal wiring and metal siding was used. With regards to stormwater management, the fences that are the most successful in preventing water from entering yards and houses are the ones that are metal. They create a barrier against the water, and help to redirect it around the yard. However, it usually directs it into another near by, neighbouring yard.

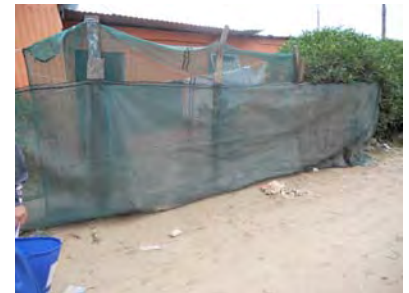
Another material that is commonly integrated into the design of a fence is a shade cloth. Shade cloths are large pieces of materials with a dark green tint that serve to help block the sun and provide privacy to the residents who reside in that area. Shade cloths are commonly not used as a method of stormwater management, but some people do consider this technique, and claim that it does help to create a small barrier against the water. In most cases it allows water to enter yards, but it helps to debilitate the overall flow of water.

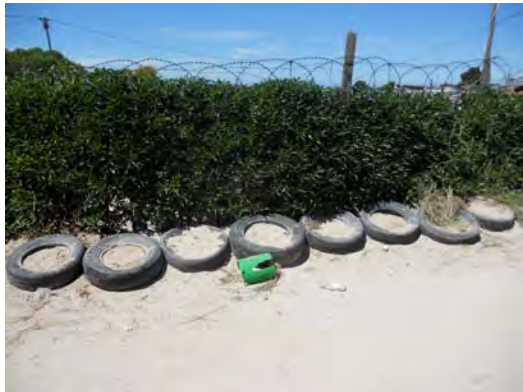
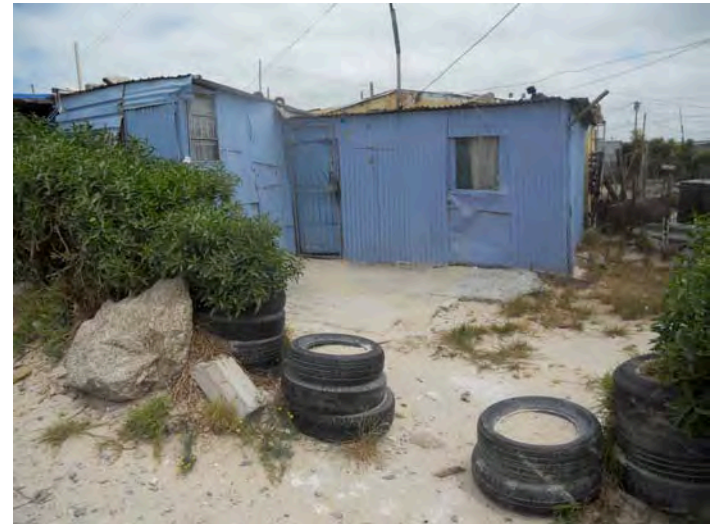
Old automobile tyres that are made out of a sturdy, rubber material and that are found along the main road (Mew Way) and throughout the settlement are used in various ways to help prevent household flooding. When incorporated with the sand found along the road, they can be very useful in producing a stable road surface that is able to withstand the pressures of water runoff. Tyres are used to stabilize the sand and prevent it from moving and shifting during a rain storm. They can also be used to form a barrier against water by being stacked on top of one another, ultimately forming a wall-like structure that is similar to a fence.

Dimension: Height: 1 – 3 tires

Width: usually the width of the house

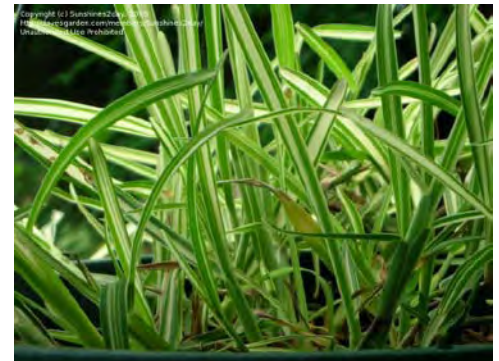
Many types of grass are found along the C-section road and in Monwabisi Park. The most common grass is referred to as Buffalo Grass (*S. secundatum*), which is indigenous to Cape Town. This grass is found sporadically alongside the road and throughout residents' yards. Unfortunately, the grass is not well maintained, so there are only a few prominent strips while the rest is found in small patches. This grass helps to soak up and catch the rainwater as well as excess water that runs the length of the road.

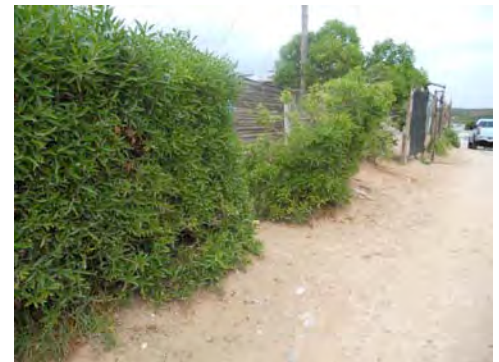
Shrubs

The shrubs found along the C-section road are most commonly used as fences and barriers against the water. They are placed along the bordering section of yards with the road, and they also serve to provide privacy and isolation to many residents.

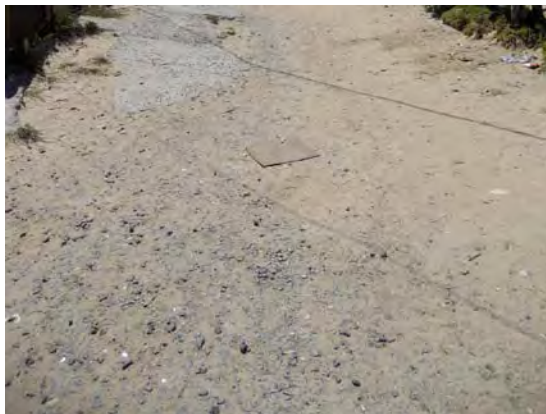
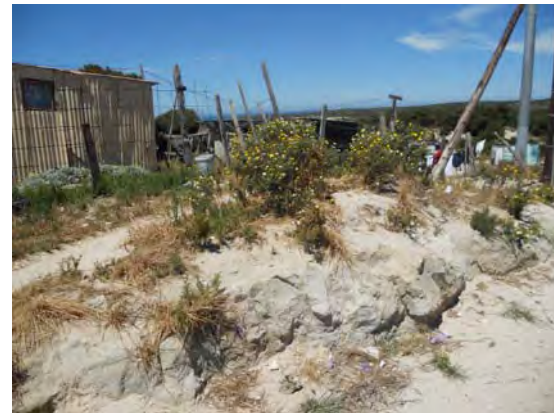
Rocks and stones are found throughout and along the entire length of the C-section road. They are buried both completely and partially in the sand. They serve to help stabilize the sand and help to prevent it from shifting and moving around. Unfortunately, the rocks that are only buried partially create an uneven surface and disrupt the natural flow path of water, resulting in spreading and flooding in unwanted areas (off of side roads, and into yards and houses). Residents have taken some of these rocks and incorporated them into their yards to prevent flooding. In some cases, large rocks have been used and lined up across the perimeter of the yard to create a barrier against the water. These rocks serve a similar purpose as fences, but they are often hard to acquire, so the barriers have open spaces and large gaps enabling the water to flow through into the yards.

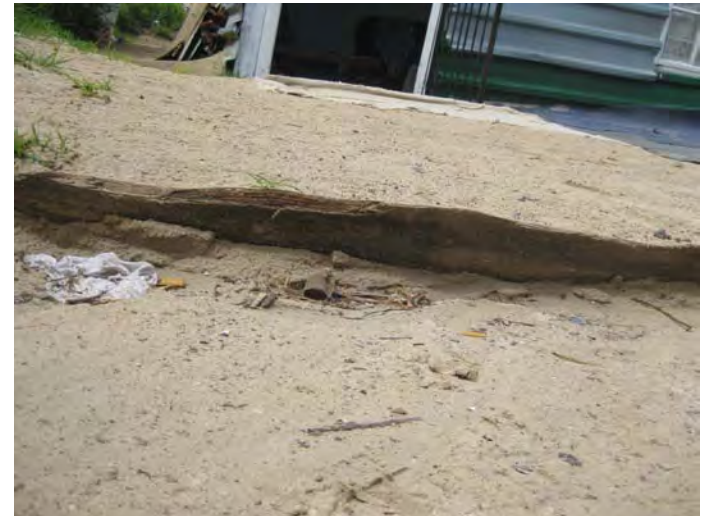
Many houses along the C-section road are located in valleys and low-lying areas. This predisposes these houses to a greater amount of flooding, and it has resulted in many residents building small interventions, such as wooden ledges in front of their doorways and around their yards to help block the water. These ledges are made from long, thin scraps of wood (mostly frequently found along Mew Way) and are positioned either along the perimeter of yards, or directly in front of doorways. They serve not only to block the water from entering the unwanted areas (yards and houses), but they also assist in redirecting the water into either neighbouring yards or central areas where water accumulates and pools.

Dimensions: Height: 10 centimeters – 20 centimeters from the ground
Width: Length of the door
*It is buried 10 centimeters – 15 centimeters into the ground

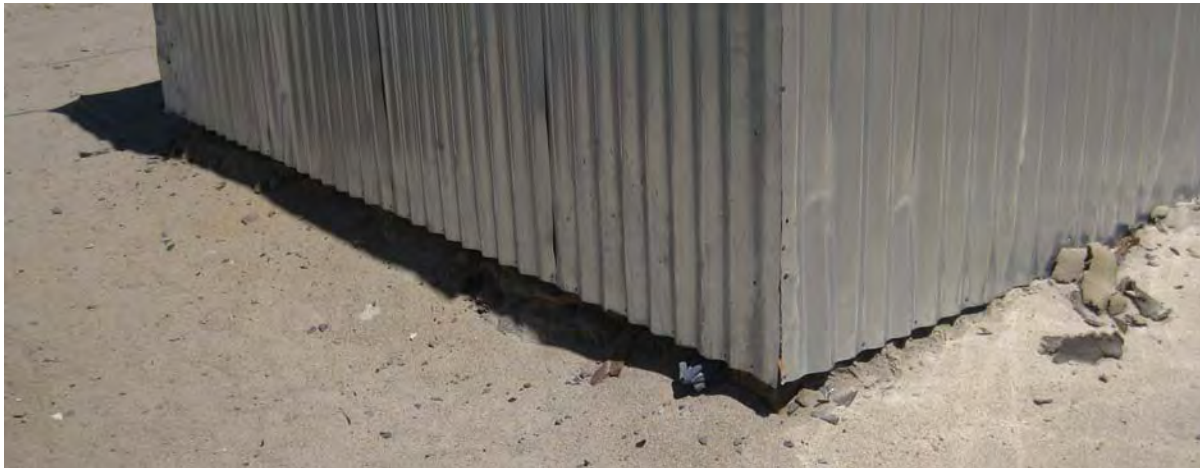
Raised Platforms

To prevent stormwater and communal tap water runoff from entering houses, some residents have designed raised platforms that enable their yards and houses to sit above the road level. These houses are often found at the bottom of hills and in low-lying areas, where flooding is the most prominent. The raised platforms incorporate scrap pieces of wood found throughout the settlement to create a border along the entirety of the yards, primarily composed of excess sand. The boards provide an outline for the sand and a barrier against the water. The risk of flooding is highly decreased since the whole house is raised above the ground.

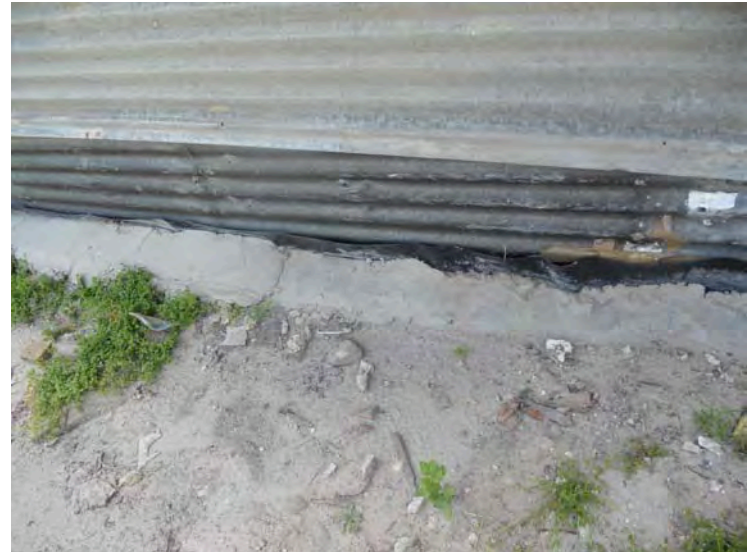
Plastic

Incorporated with sand and other select materials (metal siding, scrap wood), plastic is used to help stabilize the sand and protect houses from coming in direct contact with water. The plastic is intended to create a barrier between the sand and the walls of the houses, to eliminate the amount of damage caused by stormwater. The plastic can be located either between a layer of built up sand and the outside walls of houses, or it can be placed between the outside walls and inside walls, including the floors of houses. When placed between the sand and walls, the primary purpose of the plastic is to stabilize the sand and assist in preventing it from shifting around and breaking down around the houses. When located on the inner portion of the houses, the plastic serves to block the water from entering. When the water comes in contact with the walls, it often seeps through small cracks and holes, but with the extra layer of plastic in place, the water is unable to proceed any further, severely decreasing the amount of household flooding.

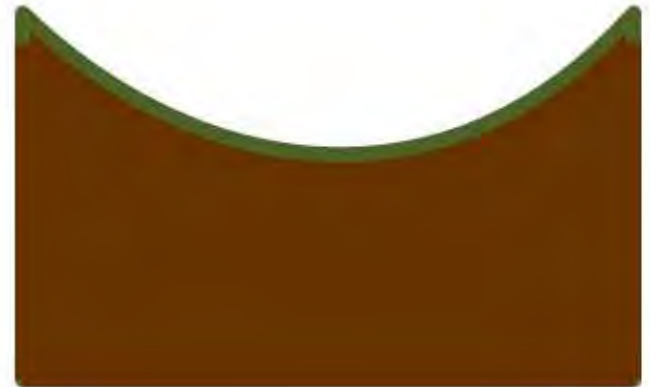
Ideal shape of ditch

The design of an artificial swale is crucial to its functionality and rate of success. Ideally, a swale should be created in such a way that the ditch forms a dish-like shape. This allows for a greater amount of water to be redirected in a shorter period of time and it provides a greater surface area in which water can be captured.

For an artificial swale to be successful in Monwabisi Park, it will need to be built on a small slope, no greater than 15° , and it must be designed to incorporate a shallow, wide, dish-shaped channel. By being built on a gentle slope, the water will naturally flow into the shallow trough and spread across the dish-shaped area, allowing it to be redirected toward the end of the swale.

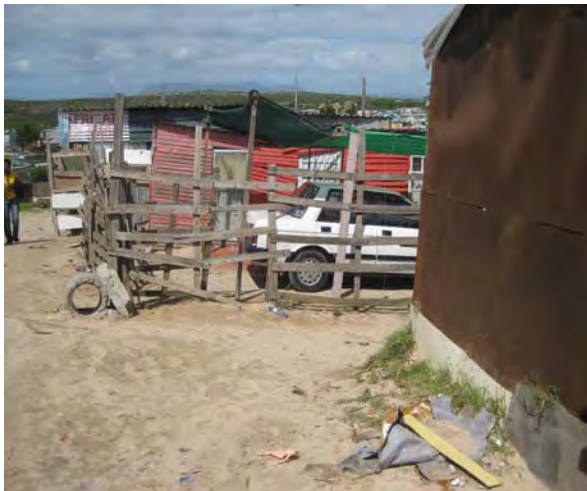
“We put a wooden board in the doorway to create a barrier, it didn't work as well as we had hoped.”

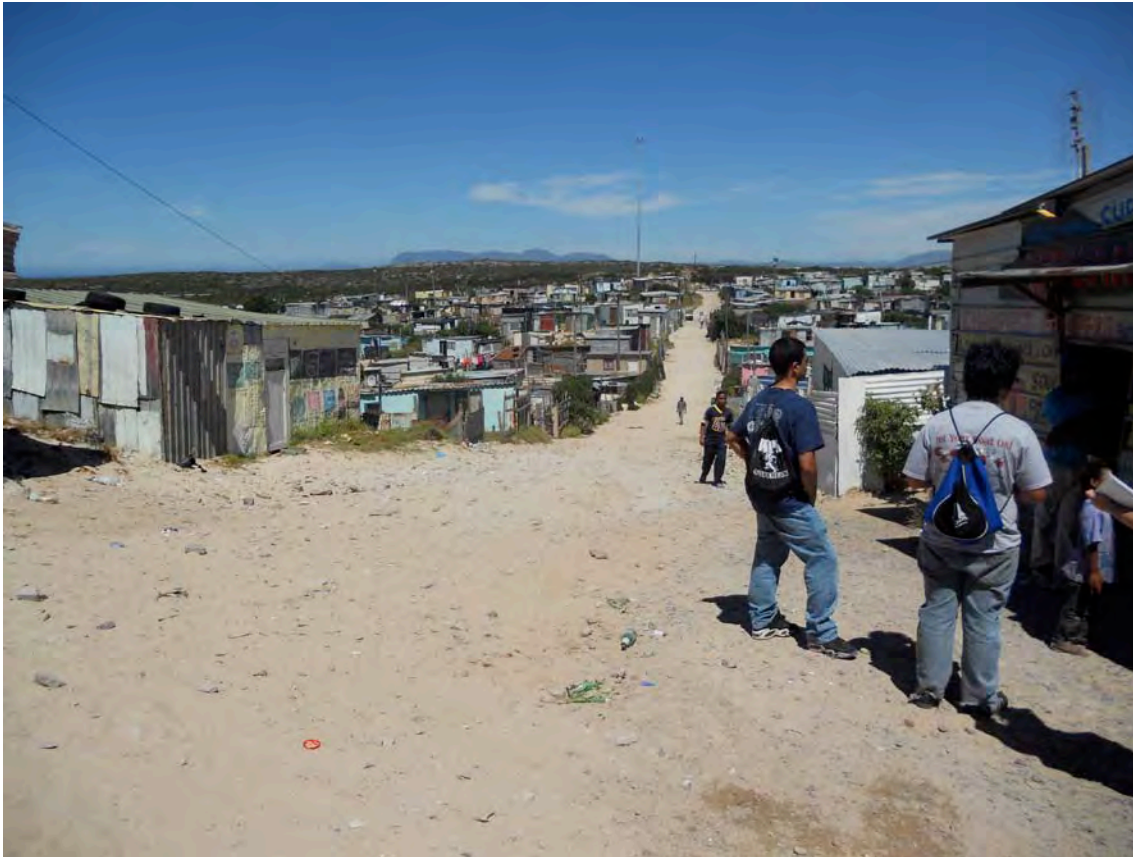
Downhill Slope

From the north to south end of this section, the road encounters a steep decline, forming approximately a 45° angle with the flat, ground level. Over a roughly 30 meter span, the road begins to level out, and it turns into a low-lying area. Due to this natural topography, water flows at a high rate along this slope. Gravity works to direct the water down this decline and enables it to accumulate at the bottom, forming a small pond that has the potential to spread to nearby yards and houses.

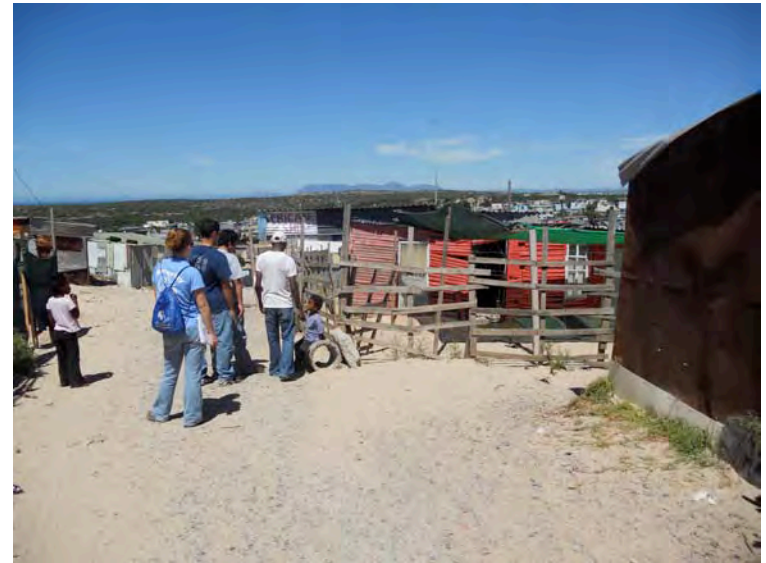
This portion of the C-section road is characterized by numerous holes, divots and protruding rocks. Holes are created by a relatively high flow of traffic, and the inability of the sand to stay in place, both when traveled on and when saturated during and after a rainstorm. These holes are scattered throughout the road and are characterized by a variety of shapes, including circles and long, rectangular shapes. Water is attracted to these areas, and over time it accumulates and eventually spreads to side roads and nearby yards and houses (increasing the risk of flooding). The small divots and bumps caused by rocks and other objects found within the road, such as rubbish and small household items, result in not only a dangerous path to walk along, but in a new path for the water to flow along, directing it to unwanted areas (yards and houses).

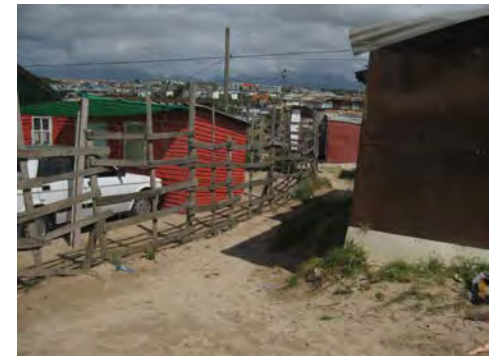
Culverts

Residents living in this area have built culverts along the perimeter of their houses to help redirect the water away. These ditches are very small, and are approximately twenty to thirty centimeters in depth, twenty to thirty centimeters in width and range from a meter and a half to three meters in length. These interventions serve to provide a channel for the water to run along, creating an alternative path directed away from houses. The culverts in this area are specifically designed to redirect the water along side roads, incorporating the downhill slope, so that the water will take on a partial natural flow. By directing the water along the side roads, the residents are able to keep the water from entering their yards, but they do not take into consideration the houses located on the side roads. As a result, these houses get bombarded with stormwater, and they witness an unfair amount of flooding.

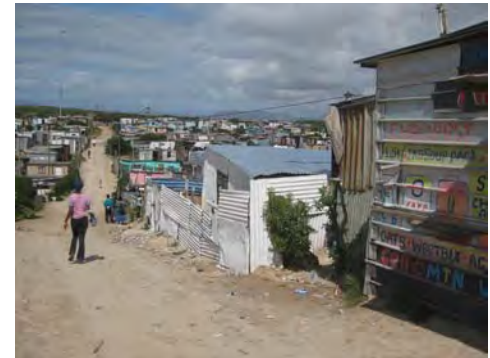
Accumulation of Sand

The use of sand to create a barrier against water has been implemented by a select number of residents in this area. Specifically, one resident whose house is located directly across from the spaza shop used large amounts of sand to create a ridge in front of his doorway to prevent water from flowing into his house. After speaking with this resident, it was determined that the build up of sand is not a reliable intervention. When the sand becomes wet and saturated, it becomes heavy and when built up, it begins to disperse and crumble. As the sand shifts around and moves away from the house, the barrier that it was intended to form becomes no longer effective.

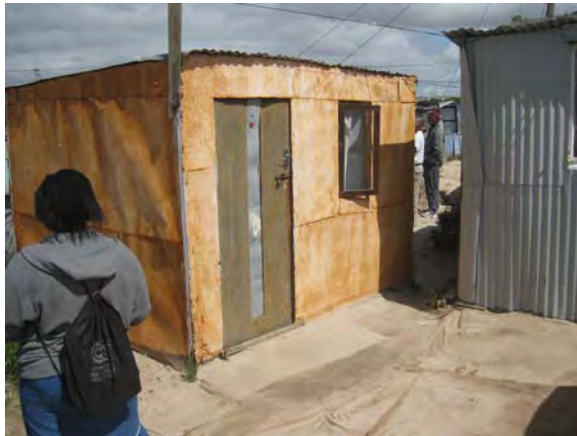
Wooden Ledges and Boards

Residents have taken small pieces of wood, approximately a meter in length and about twenty five centimeters in height and placed them into the ground, so that roughly ten centimeters protrudes. These pieces of wood are located in front of doorways to create an extra obstacle for the water to overcome when entering houses. The ledges in this area are not very useful, as they are often not built high enough off the ground, and they do not provide a tall enough barrier for the water to come in contact with. Due to the lack of a functional barrier, the water simply flows over the board and enters the house with great ease.

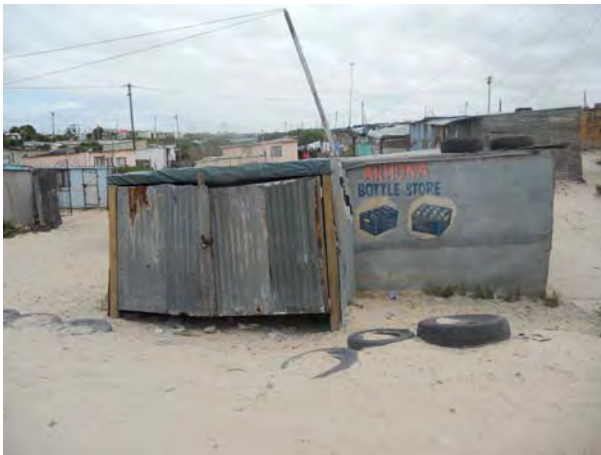
“We dug a ditch to help redirect the water, but every time it rains, we have to re-dig it.”

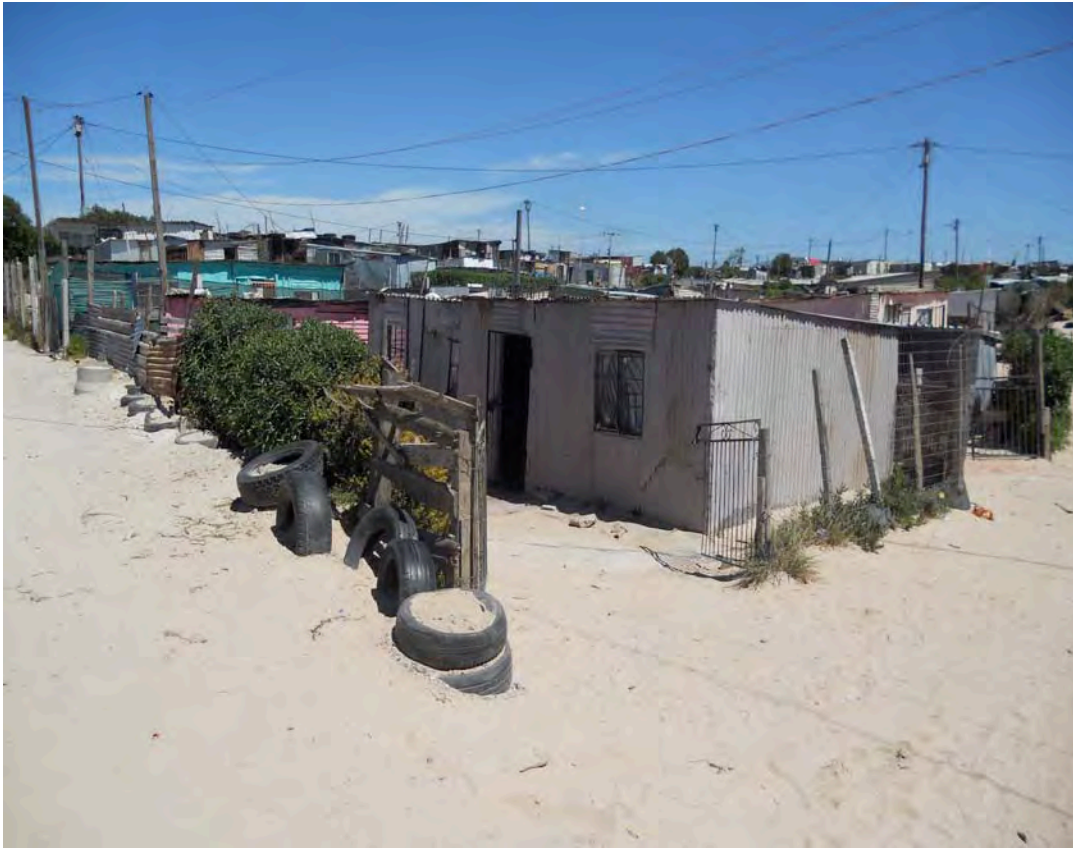
Low-Lying

This section of the road is located at the base of two hills, one downhill and one uphill. Due to the topography of this area, the road forms a slight valley, and fairly flat surface. This stretch of road, measuring roughly eighteen meters in length, is prone to a high amount of standing water. Water is naturally directed along the slopes of the hills into this area, and the houses located alongside the road witness large amounts of flooding and water damage.

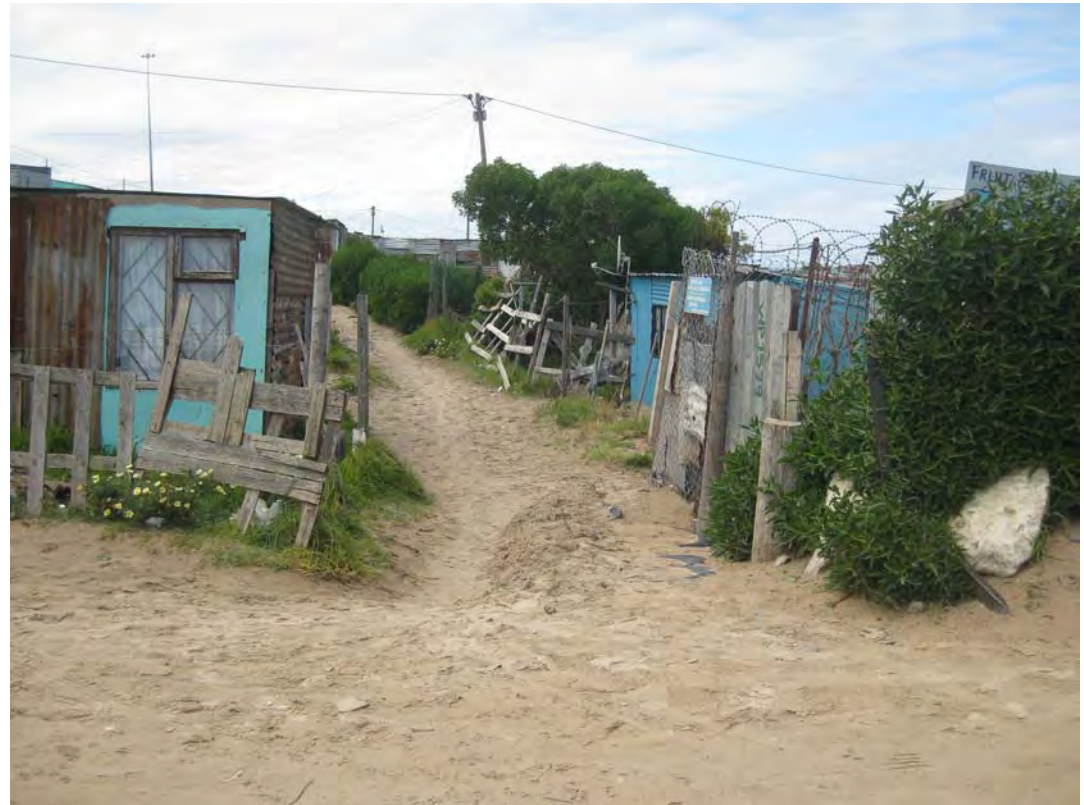
Located in a fairly flat section of the road, this area is characterized by numerous divots and bumps, caused by erosion (mainly from water), and small rocks scattered throughout the road. Due to the amount of excess water found in this section, the inconsistencies within the road disrupt the path of the water, and enable it to pool, and eventually spread into neighbouring yards and houses, resulting in high amounts of flooding.

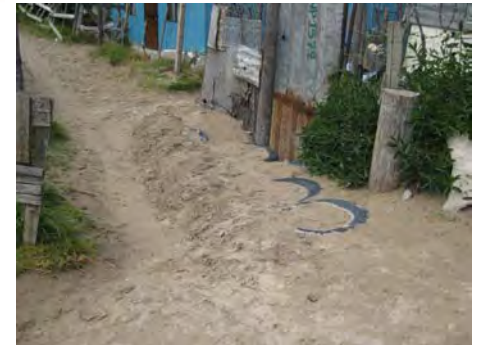
Culverts

Along the side roads branching from this area, specifically on the southeast side, residents have built a ditch to help channel the water that flows down the two adjacent hills. The high amount of water that travels along this path requires a deep ditch, approximately half a meter, as well as continual management. After each rain storm, residents, primarily the two who live directly next to this intervention, need to restore the ditch by re-digging it. Residents have begun to adapt to this challenge, and they have placed tires along one side of the ditch to help stabilize the stand and prevent it from filling in the conduit. Community members have mentioned that these tyres do provide assistance, but during the heavy rain storms, the sand from the main road gets pushed toward the low lying area and shifts into the ditch. Despite the extra labour and time that this intervention requires, it is very successful in redirecting the water from the main road into an area where it can be appropriately stored.

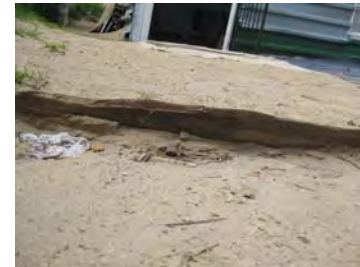
Raised Platforms

On the southeast side of the C-section road, off of a small side road, residents have used wood boards to create an elevated surface in which their houses are placed upon. These platforms, approximately twenty five centimeters above ground level, help to block water from entering houses and causing infrastructure damage. The wood boards are placed along the entire perimeter of the yards, and they form a discrete enclosure. One resident designed a raised platform on his property and incorporated a small ledge in front of his door as well to ensure that the amount of water entering his house would be minimal. These platforms are slightly time consuming to implement, but once in place they are functional for a significant amount of time. In this area, it was noted that the enclosure formed by the wooden boards also serve to redirect water into neighbouring yards. This has lead to a greater number of residents building ledges and platforms around their yards, and eventually redirecting the water into remote areas far from the main C-section road.

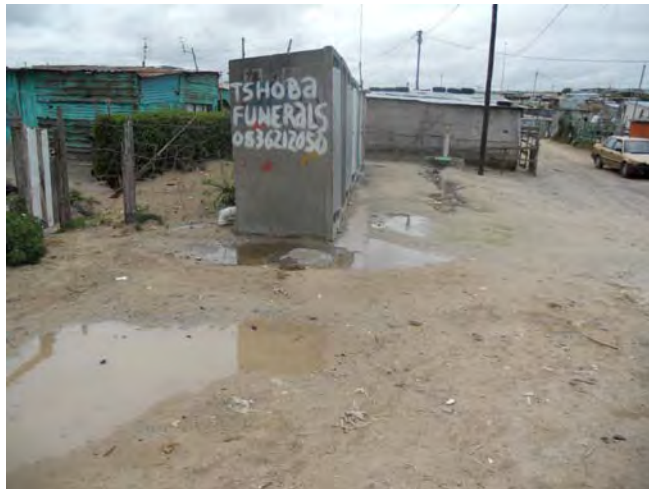
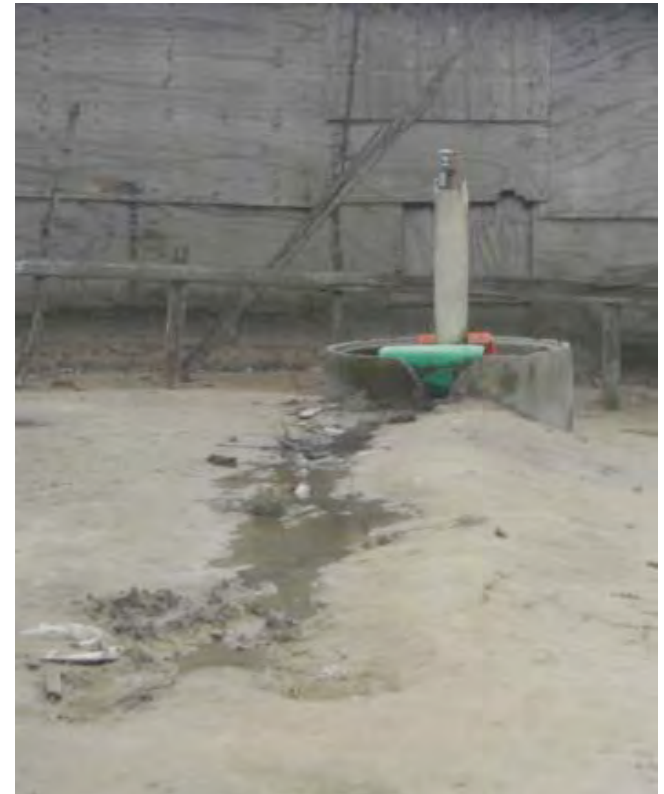
Broken Tap

On the northwest side of the road, there is a communal water tap which lacks proper management and is cracked along the base. This crack results in the excessive release of both clean tap and dirty grey water along the road and leads to the pooling of water in front of the toilets and in the path of neighbouring side roads.

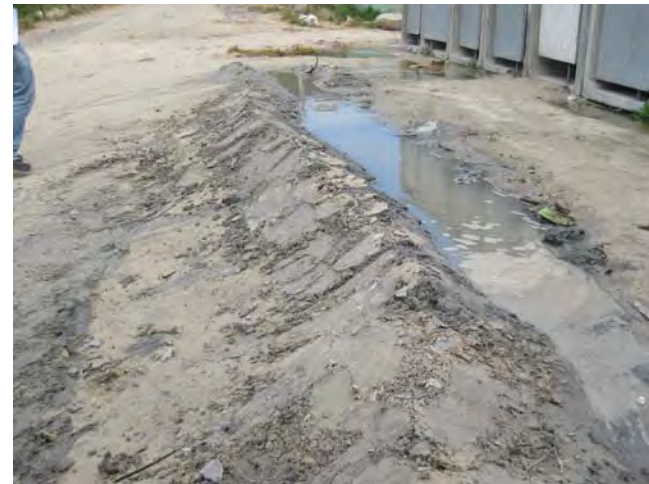
Potential Ponding

Due to the varying levels in the road in this area, water flows to specific spots and pools in the low-lying areas. As discussed in the “broken tap” section, water tends to build up along the side roads and it creates a risk for the people residing beside these areas. When the ground is fully saturated and unable to take in any more water, it begins to push water outwards, resulting in the water having no place to go. As the water builds up to an excessive amount, it begins to spread to nearby areas, most commonly yards and doorways of houses. This results in increased flooding and water damage within and around multiple houses.

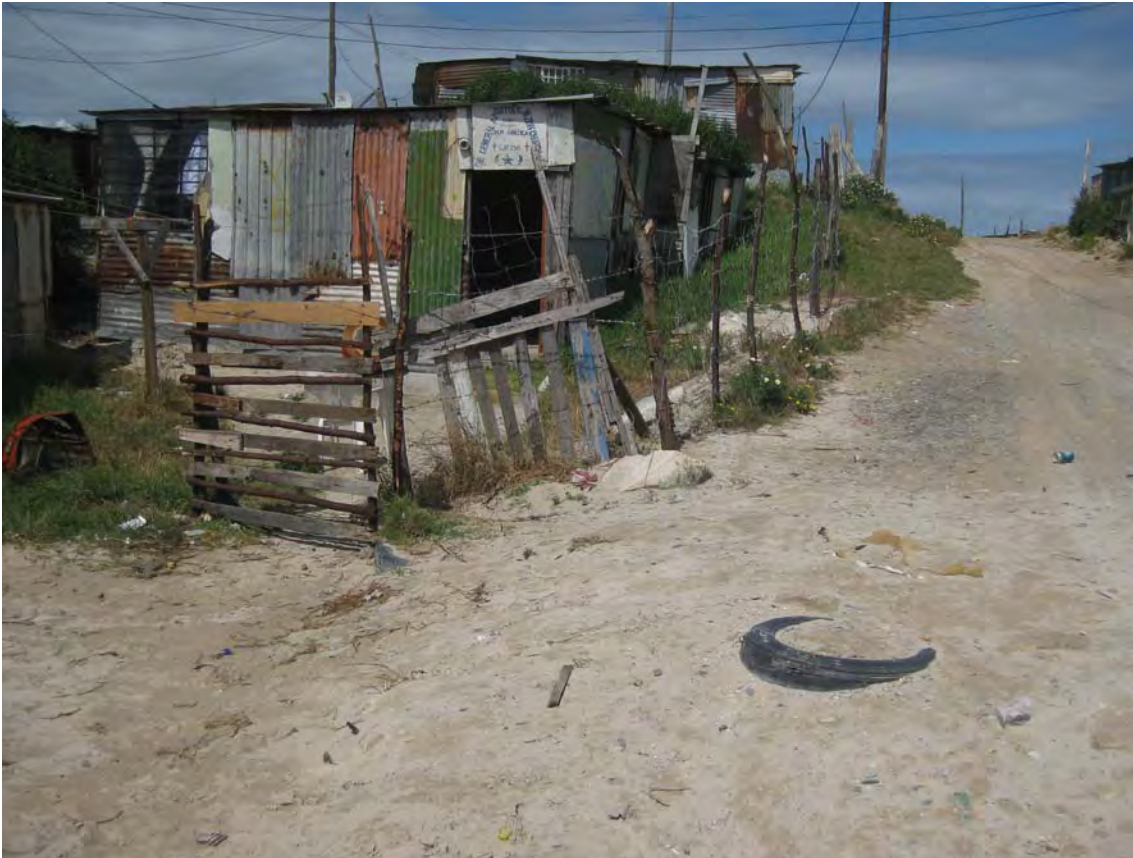
Elevated Road

Due to location of this area, the majority of houses along the road are located off of small side roads. These side roads are on a downhill slope from the main road resulting in the houses being set at a lower level than the road. With the high amount of ponding that occurs in this area, these houses are often inflicted with flooding from the runoff that spreads from the pooled water.

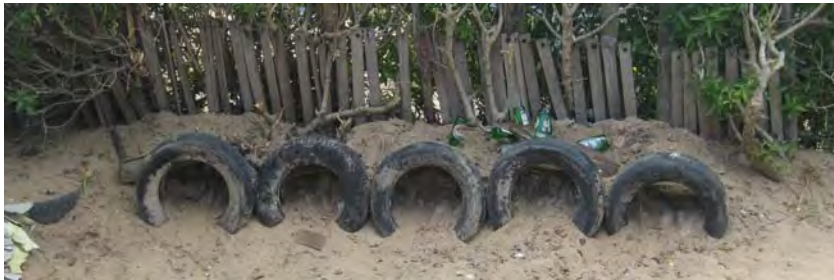
Tyres

Residents often use tires in this area to prevent water from entering their yards and houses. There are numerous ways in which interventions are designed using tyres. Some residents fill them with sand to create a strong, reliable barrier around their yards that help to stabilize the sand during a rainstorm (southeast side of the road). Other residents strategically stack the tyres on top of one another to form a wall that acts as a barricade against standing water and water that has begun to pool as a result of the uneven road surface (northwest side).

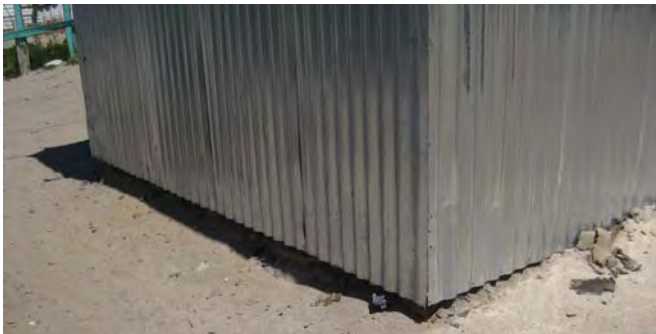
Raised Platforms

In this area, a few houses were built on a raised platform so that the base of their house is approximately 30 centimeters above ground level. This solution works very well because it allows the water to travel underneath the house in a natural pattern and prevents the house from receiving a large amount of flooding, specifically from standing and pooled water.

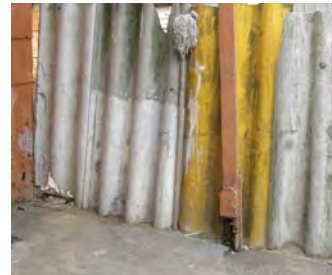
Metal Siding Fence

There are a variety of fences found within this area of the C-section road. The materials used for each fence are very different from the other fences found within this region, but the residents all have different reasons for why they built their fence the way they did. One resident used metal siding to create a wall around the perimeter of his yard, and he cut a hole in the corner of it to help redirect the water away from his house. Another resident used tyres to create a fence, which also served to stabilize the sand surrounding his house. No matter what material or design the fence is made from, they all work to serve the same purpose, create a blockade against the rainwater runoff and to prevent household flooding.

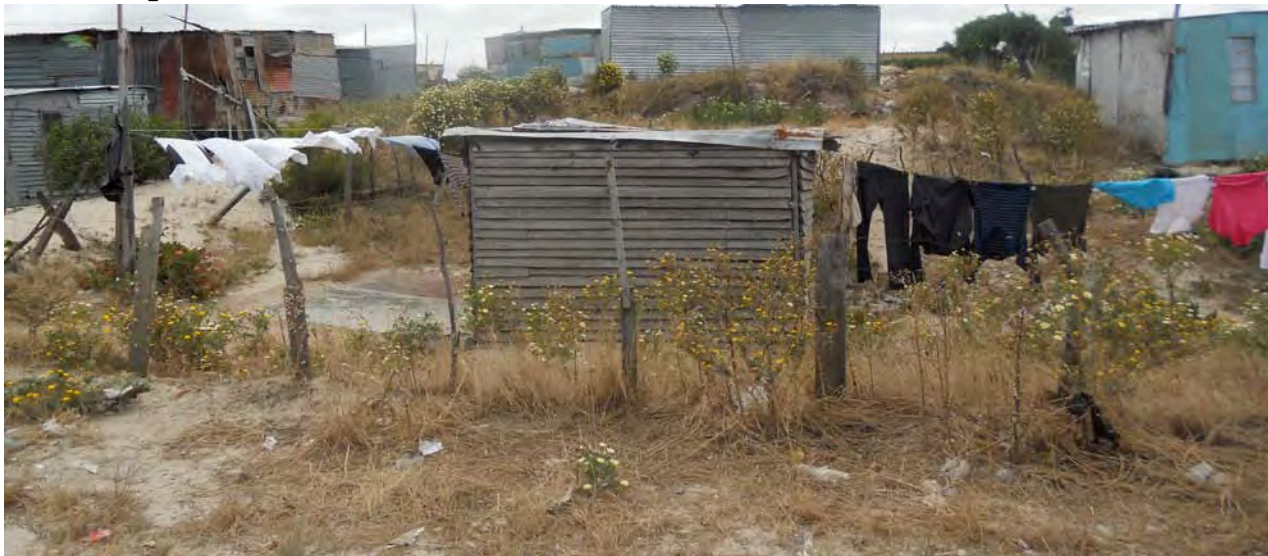
Perpendicular to the road, on the northwest side, the topography of this area is mildly varied. There is a steep slope, forming approximately a 30° angle with the ground that is aimed toward the main road. This natural landscape encourages water to flow from the hill onto the southeast side of the road, increasing the amount of flooding seen by the people who reside there. Due to the road being low-lying, gravity directs the water to this area where it spreads across the entire lower section with no barrier to control or stop it.

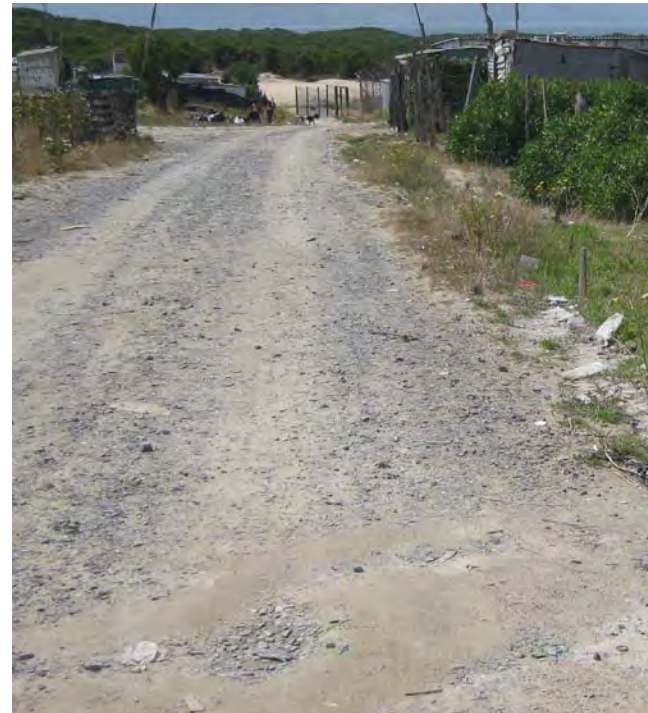
The composition of the road in this area is very uneven. Due to its make up of primarily sand and loose rocks, divots are very prevalent and some sections are raised up as a result of the sand moving around during rain and wind storms. When rainwater falls, it soaks into the ground and encourages the sand to shift in the direction of the water flow. Some residents have placed rocks in the road to prevent this, but this results in an even greater uneven surface, because the rocks are not distributed equally throughout the road, and some stick up while others are buried a few inches into the ground.

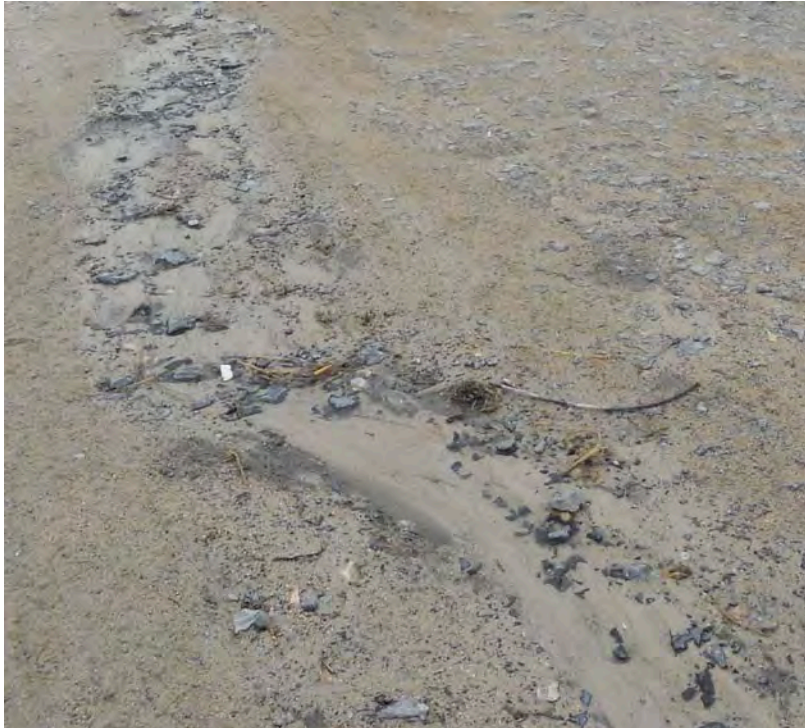
Potential Ponding

Due to the topography of this area, the risk for ponding in the road is very high. The natural flow of water from the hill on the northwest increases the amount of water found in the road, especially after a storm, and this excess of water does not have a place to disperse. Once the ground and the sand in the road are fully saturated, they will soak up any extra water which leads to standing water, known as ponding. The composition of the road also factors into the ponding of water, as the divots throughout the road provide space for the water to pool and collect.

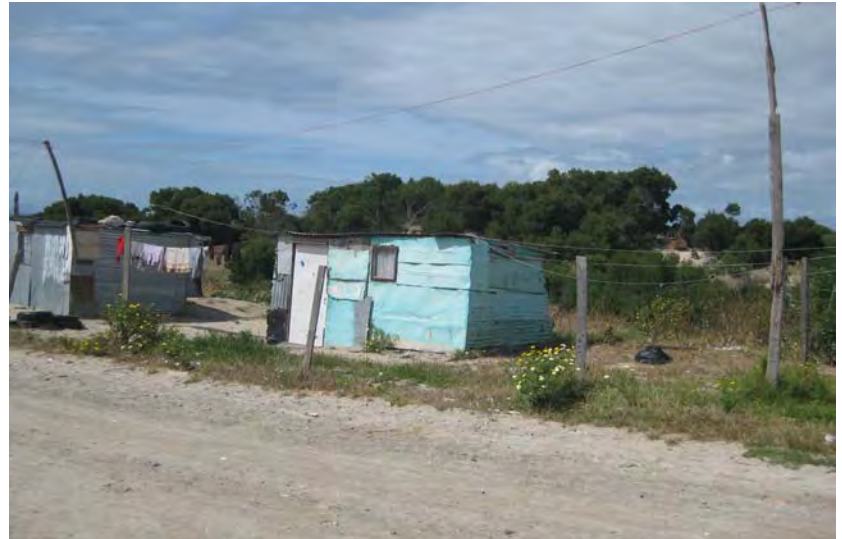
Vegetation

This area of Monwabisi Park is located very closely to the Wolfgat Nature Reserve. The houses in this section therefore have more vegetation in their yards than houses in other sections of the settlement. Alongside the southeast portion of the road, there is a small amount of vegetation which acts as a border between the road and the residents' yards. This layer of vegetation can be very helpful in capturing rainwater and preventing it from accumulating and pooling in the road.

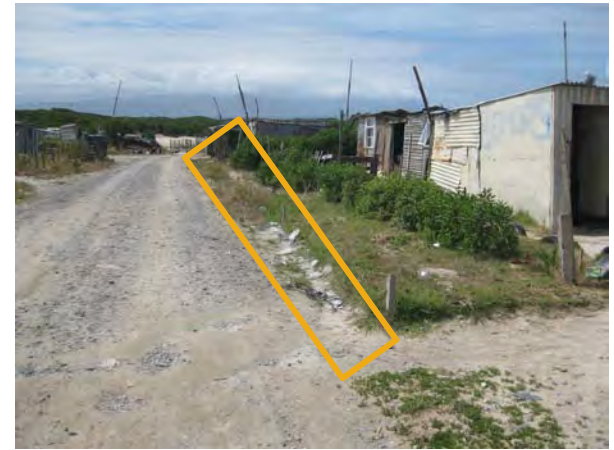
Vegetated ditch along SE side of the road

Numerous residents in this area take advantage of the vegetation that grows extensively around their houses. People have worked together to create a vegetated ditch along the southeast border of the road to help prevent water from spreading into their yards. They have also used hedges supported by fences to create barriers against the water in hopes of minimizing and eliminating the flooding that they acquire within their houses.

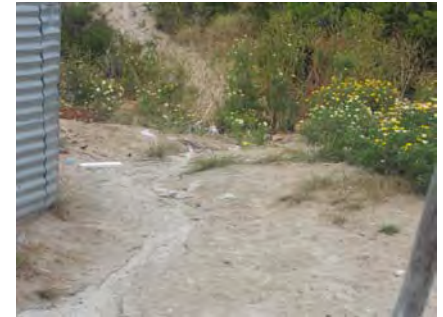
Culverts/Holes

Aside from creating a community-wide ditch to help redirect the water to the end of the road, many community members in this area have dug small ditches and channels in their yards, both in front of their doors and alongside their houses, to assist the flow of water away from their residence. Specifically, the people on the southeast side of the road have dug channels in between their yards to redirect the water to the grass covered valley behind their houses.

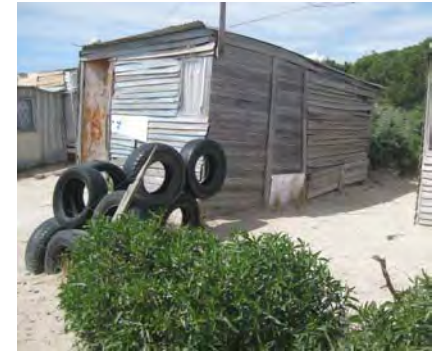
Tyres

In this area, some residents have used tyres stacked on top of one another to form a wall-like structure. After discussing this design with the residents who built it, it was determined that it served multiple purposes; it helped to block water from entering their yard and it acted like a fence to separate their yards from their neighbours' yards.

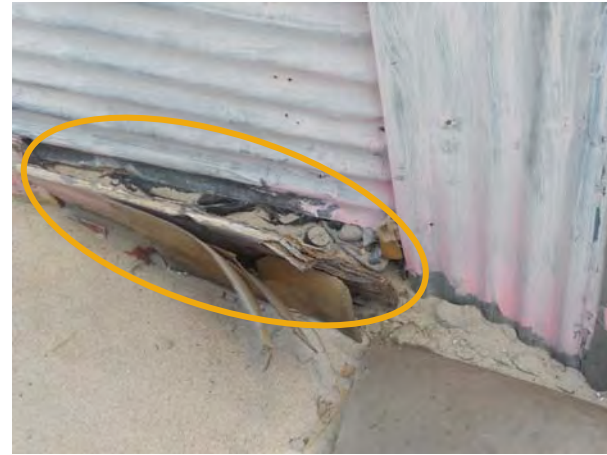
To assist in stabilizing the sand during rainstorms, one resident explained how she incorporated a piece of plastic between the foundation of her house and the sand surrounding it to help prevent the sand beneath the house from becoming saturated and moving around. When the ground underneath the houses soaks up a large amount of water, it becomes uneven, and the houses begin to slope to one side, making them unstable and unsafe to live in. Other residents have used plastic in similar ways, and after speaking with them, it was determined that the type of plastic used is crucial to the success of this preventative technique. The plastic used between the house and the sand was very thin, similar to the consistency of a plastic garbage bag, and over time, it began to break down and disintegrate.
