Evaluation of McWane Seismic Flex Coupling for Resistance to Earthquake-Induced Ground Deformation

Submitted to:
Stuart Liddell
National Manager - MASD
1201 Vanderbilt Road
Birmingham, Alabama 35234

C. Pariya-Ekkasut
B.A. Berger
H. E. Stewart
T.D. O'Rourke

April, 2018

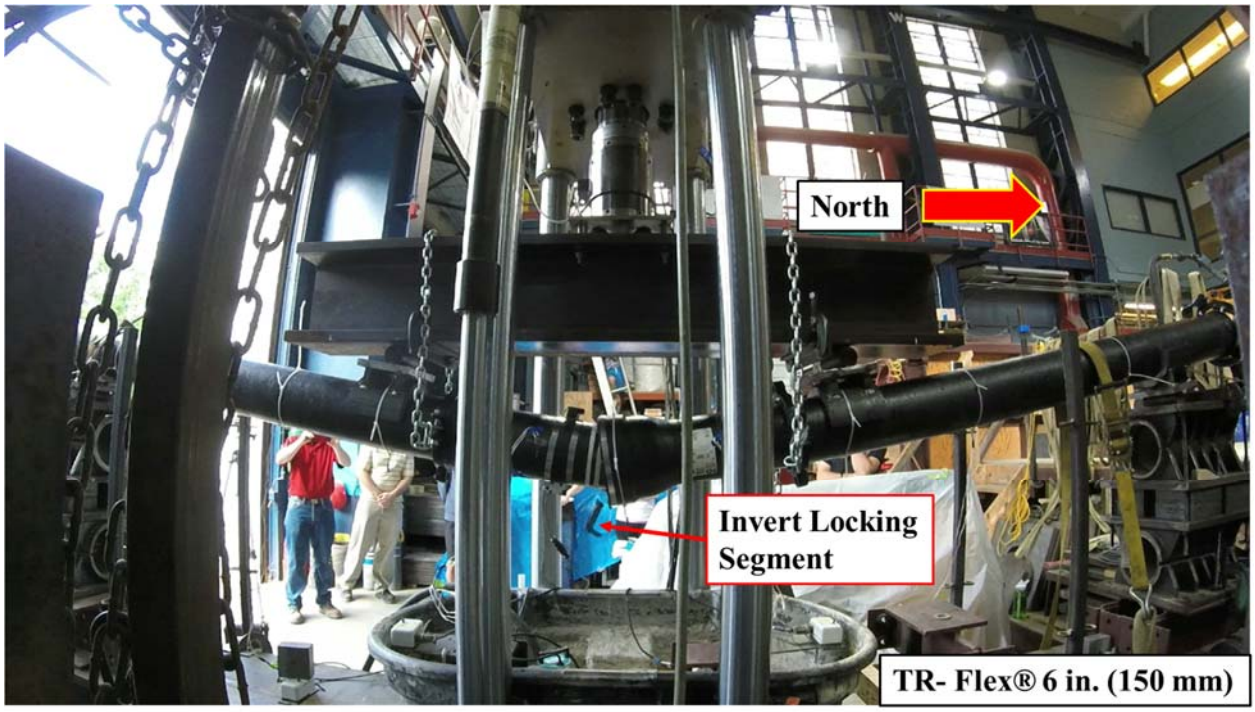
The moment vs. rotation relationship is shown in Figure 3.6. After the temporary supports had been removed, the self-weight of the pipe and water caused a rotation of 4.8 degrees. First leakage of approximately 10 drops/sec (25 ml/min) developed at a rotation of 11.9 degrees and an applied moment of 137 kip-in. (15.5 kN-m) as shown in Figure 3.7. The leakage was relatively constant during the test. The test was continued until the deflection reached 16.6 degrees of joint rotation when the actuator reached the limit of its stroke.

Figure 3.8. Invert Locking Segment Fell out of TR Flex® Joint

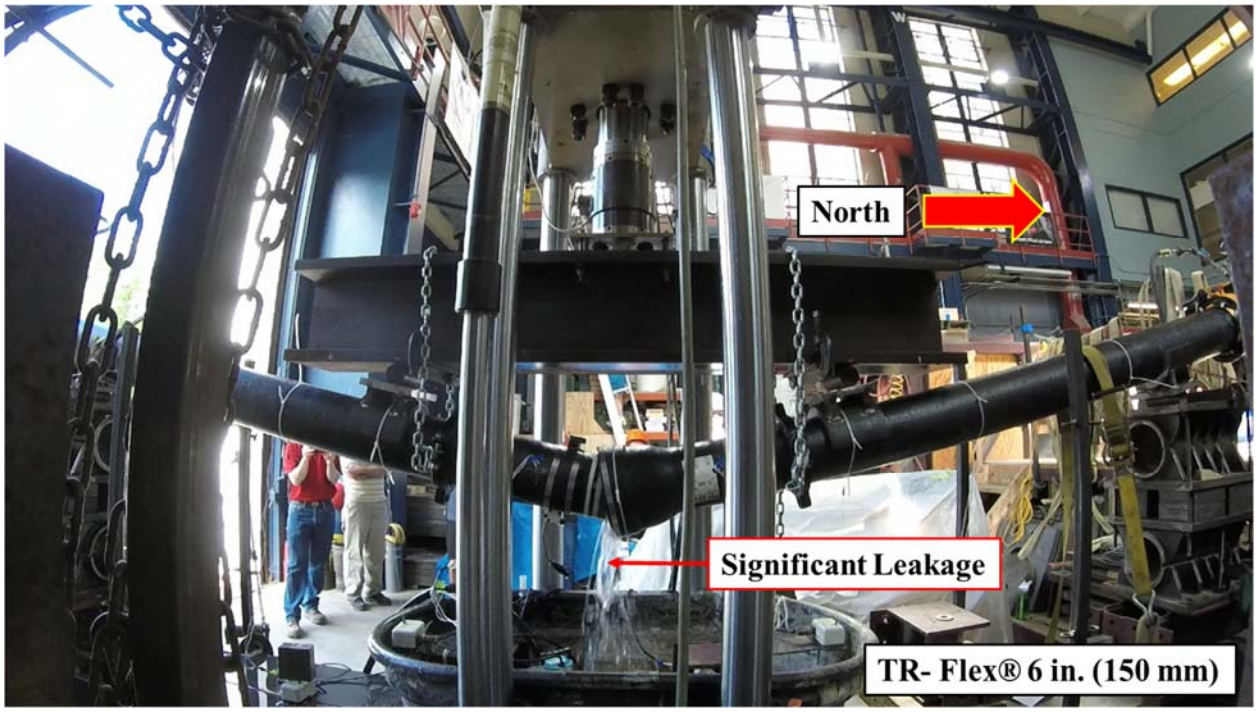
First leakage of approximately 10 drops/sec (25 ml/min) was observed at 11.9 degrees of pipe deflection. Due to safety concerns, direct measurements of leakage by collection of outflowing water at leakage locations around the joint were not performed. Estimates of leakage rates, however, were made by visual examination. Significant leakage is defined as flow exceeding 10 gals/min (38 l/min). The leakage observed was relatively constant during the test. The pipe reached 16.6 degrees of deflection at the end of actuator stroke. As the pipe was unloaded to reset the actuator, it rebounded to 15.1 degrees of rotation. During subsequent loading the pipe had significant leakage at 21.3 degrees of deflection. The pipe was then depressurized.

Figure 3.9. Significant Leakage of TR Flex® Bending Test Specimen

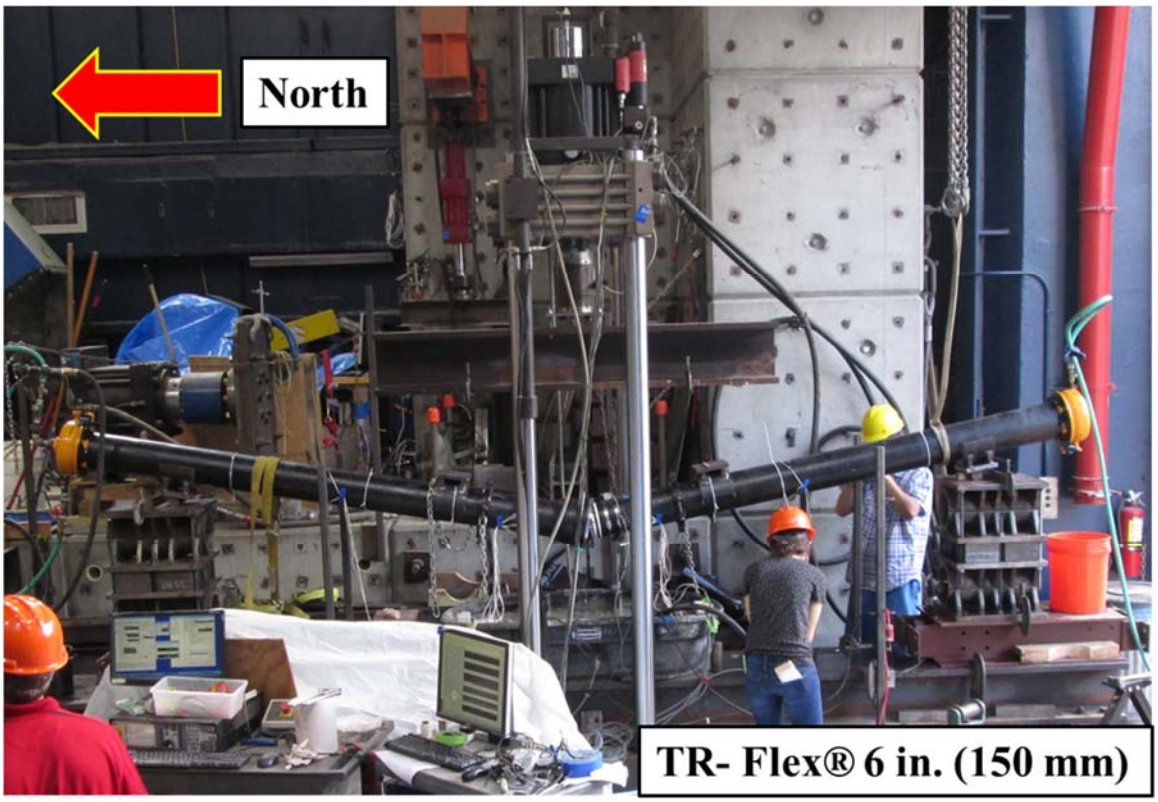
Figure 3.10. Photo of TR Flex® Bending Specimen after Testing

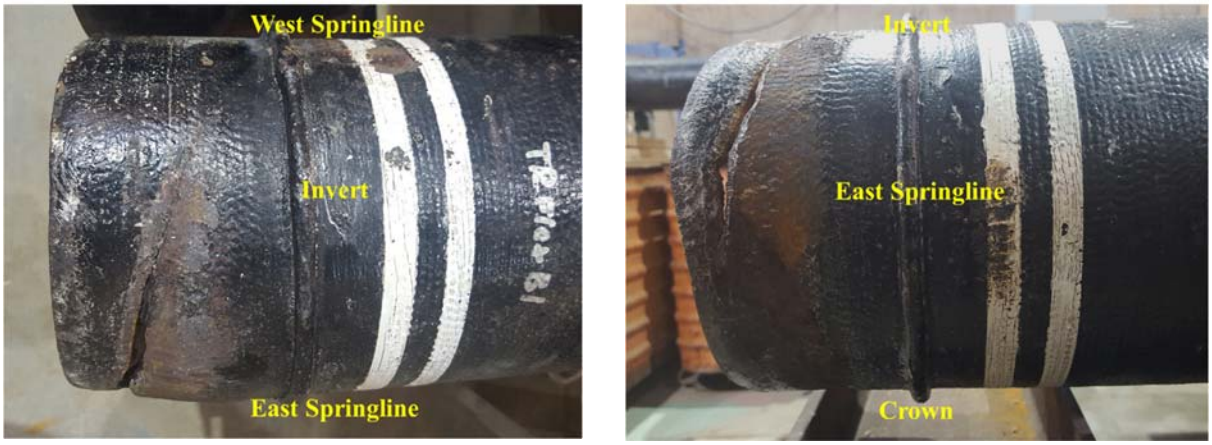
a) View from Invert b) View from East Springline

As the pipe was unloaded to reset the actuator, it rebounded to 15.1 degrees of joint rotation. The actuator and crosshead were readjusted. The pipe was then reloaded. At 17.5 degrees of joint deflection, the invert locking segment fell out of the joint as illustrated in Figure 3.8. The pipe achieved a maximum moment of 387 kip-in. (44.0 kN-m) at 19.4 degrees of joint rotation. The pipe leaked at a significant rate at 21.3 degrees of joint rotation as shown in Figure 3.9. The test was then stopped, and the pipe was unloaded. There was a residual joint rotation of 20.9 degrees after unloading. Figure 3.10 shows a photograph of the TR Flex® bending specimen after the test. Further investigation after taking the joint apart shows that the pipe broke at the invert of the TR Flex® plain end. Figure 3.11 shows the spigot damage after the test.

Figure 3.11. Damage at TR Flex® Plain End after TR Flex® Bending Test

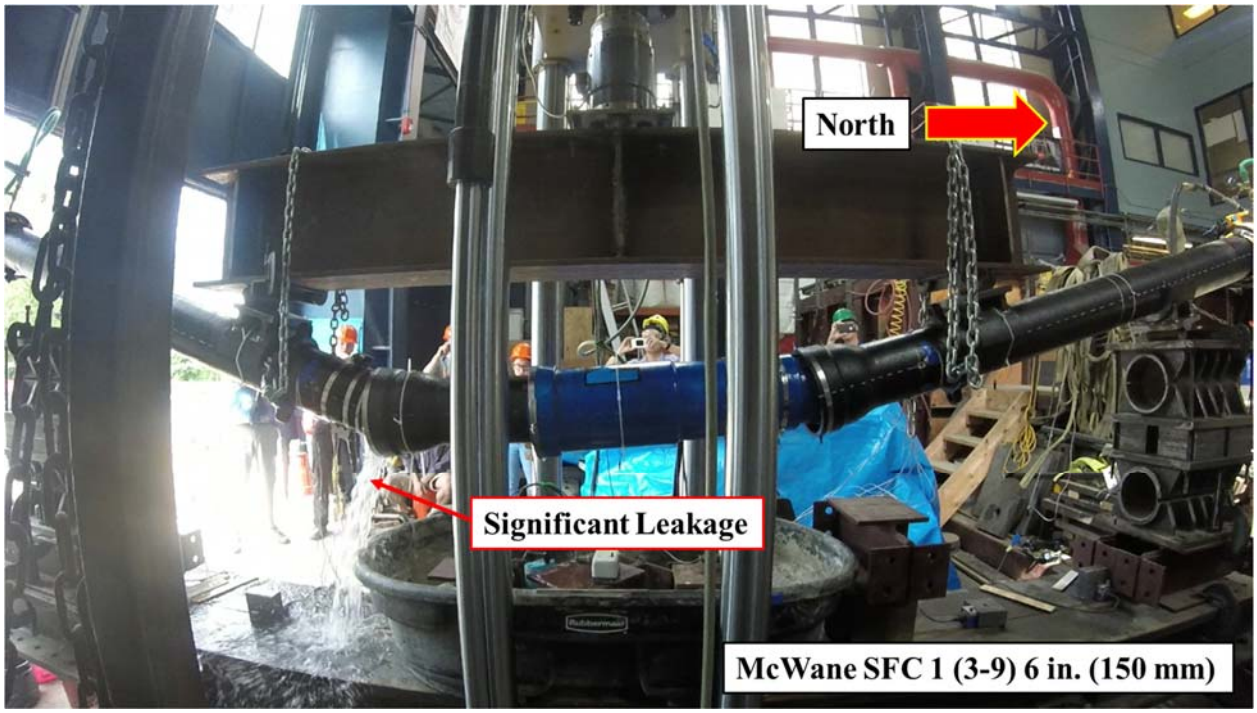
There was a slight drop of pressure to about 78 psi (540 kPa) at 17.7 degrees of overall deflection. The drop of pressure corresponds to first leakage on the order of 10 drops/sec (25 ml/min) at the X joint. This leakage at the X joint continued throughout the test. The pipe reached 28.8 degrees of deflection at the end of the first actuator stroke. As the pipe was unloaded to reset the actuator, there was a fluctuation in the internal pressure, and the pipe rebounded to 22.7 degrees of deflection. The pipe was then reloaded. At 32.5 degrees of overall deflection, the pipe had a significant leakage at a rate of about 10 gals/min (38 l/min), and the pipe was then depressurized.

Figure 3.18. Significant Leakage of McWane SFC Bending Test Specimen 1 (3-9)

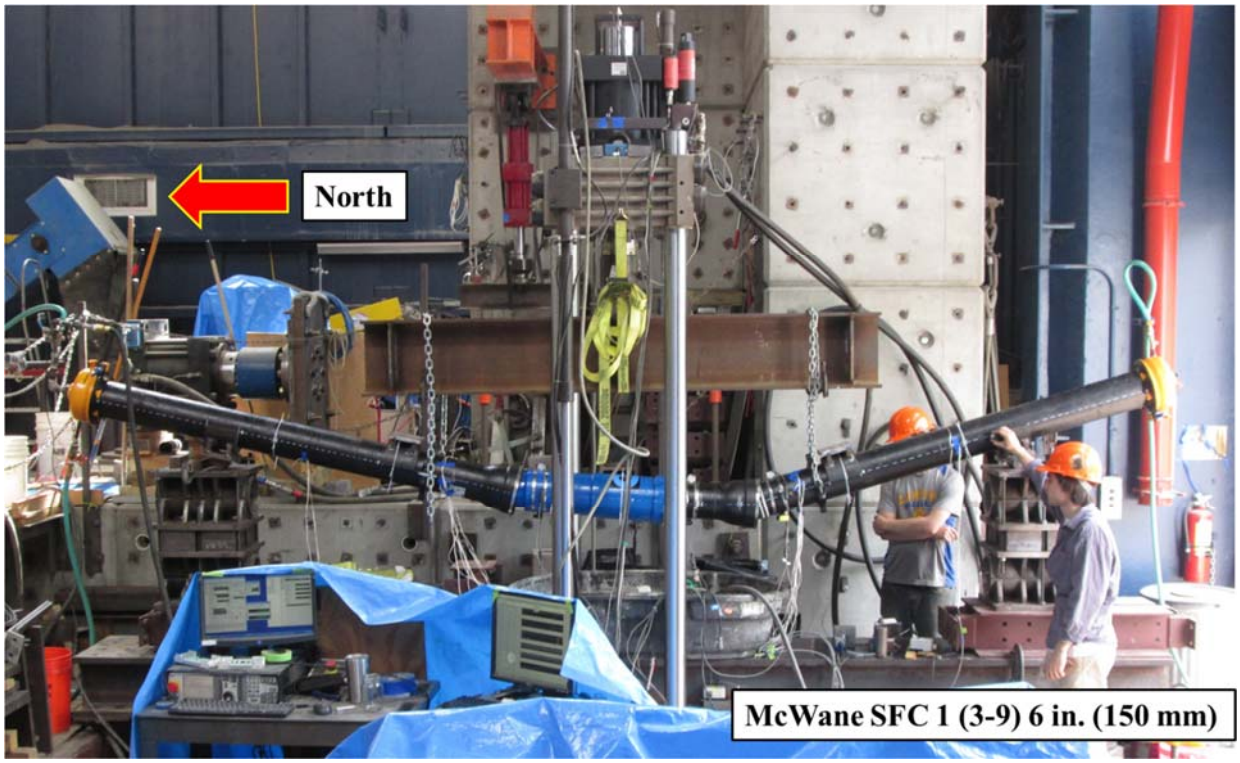
Figure 3.19. Photo of McWane SFC Bending Specimen 1 (3-9) after Testing

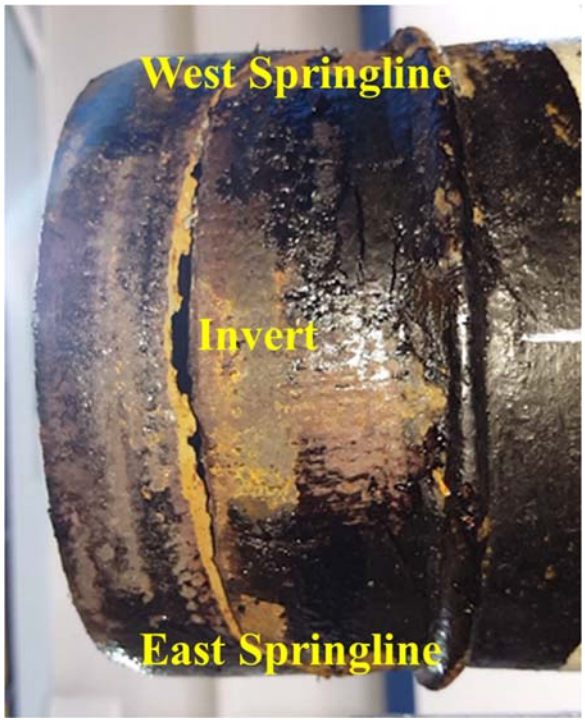
As the pipe was unloaded to reset the actuator, it rebounded to 22.7 degrees of overall deflection. The actuator and crosshead were readjusted. The pipe was then reloaded. The pipe achieved a maximum moment of 440 kip-in. (49.7 kN-m) at 30.6 degrees of deflection. The pipe leaked at the B joint with a significant rate at 19.4 and 32.5 degrees of B joint rotation and overall deflection, respectively. Figure 3.18 shows the significant leakage at the B joint. Shortly after the significant leakage, the test was stopped, and the pipe was unloaded. There was a residual deflection of 29.8 degrees after unloading. Figure 3.19 shows a photograph of the McWane SFC bending specimen 1 (3-9) after the test. Further investigation after taking the joints apart shows that the pipe has similar damage as the TR Flex® bending specimen such that the pipe broke at the invert of the TR Flex® plain end. Figure 3.20 shows the spigot damage after the test.

Figure 3.20. Damage at TR Flex® Plain End after McWane SFC Bending Test 1 (3-9)

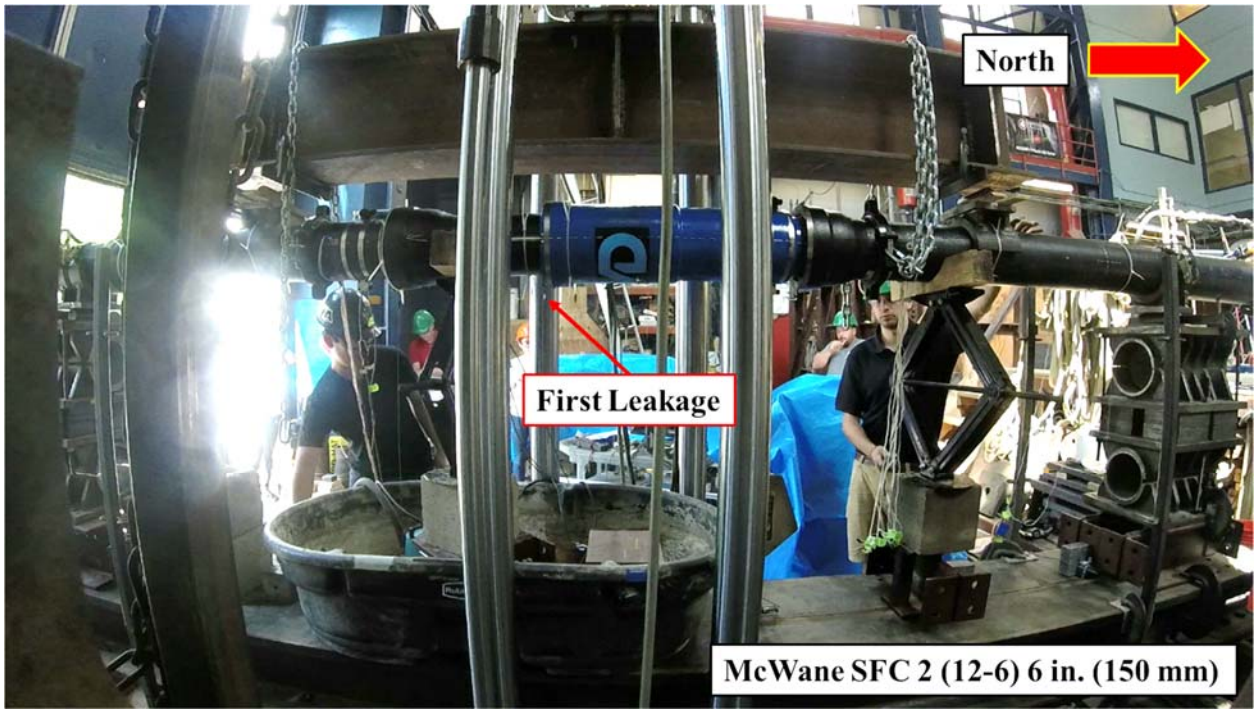
First leakage was observed at the X joint at the beginning of the test. The leakage stopped at a pipe deflection of 20.5 degrees. The pipe reached 26.1 degrees of deflection at the end of the first actuator stroke. As the pipe was unloaded to reset the actuator, it rebounded to 24.1 degrees of deflection. The pipe was then reloaded. At 34.9 degrees of overall deflection, there was another leak on the order of 2.4 fl. oz./min (75 ml/min) at the P joint. The pipe failed and had a significant leakage at a rate of greater than 10 gals/min (38 l/min) and lost internal pressure at 36.0 degrees of overall deflection.

Figure 3.24. First Leakage of McWane SFC Bending Test Specimen 2 (12-6)

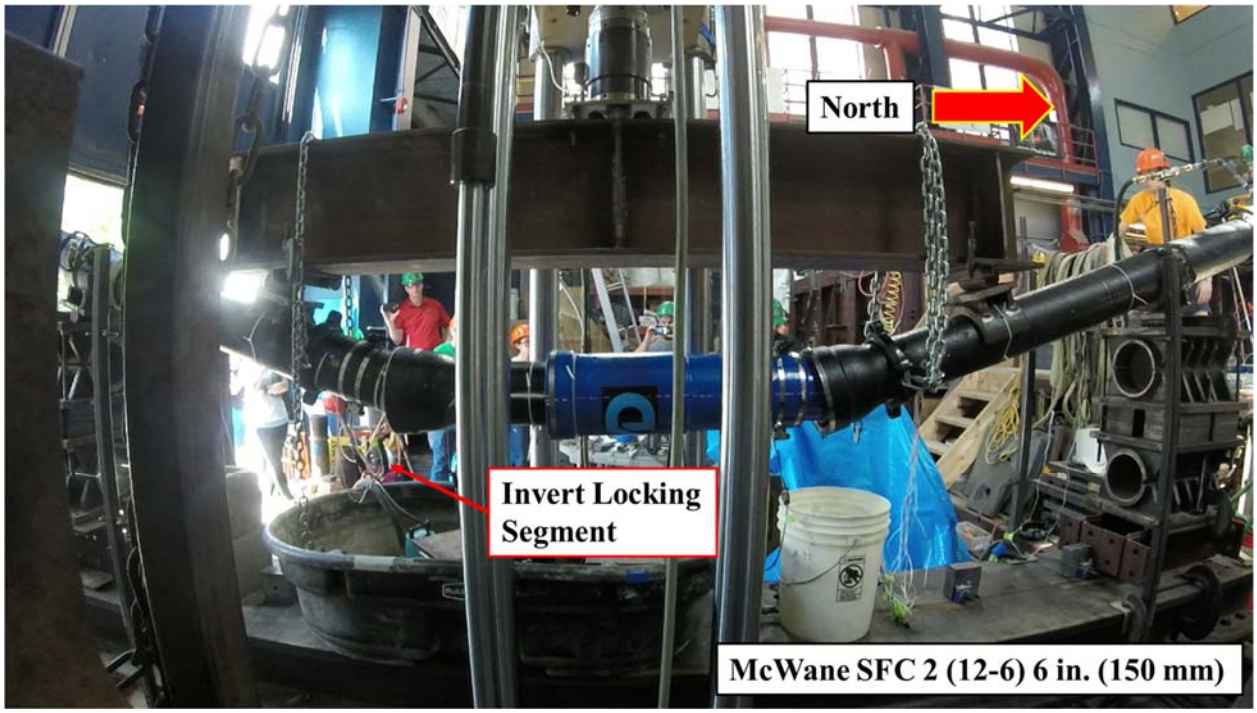
Figure 3.26. Invert Locking Segment Fell out of B Joint

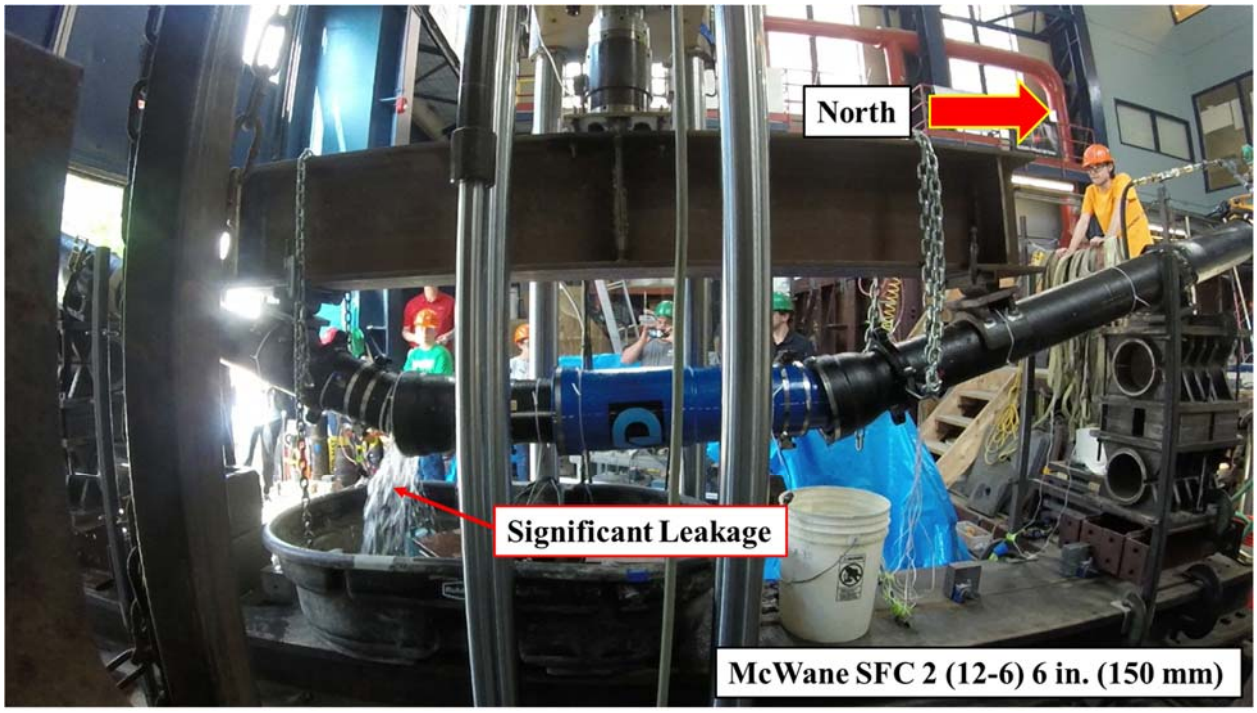
When the pipe achieved a maximum moment of 393 kip-in. (44.4 kN-m), leakage of approximately 2.4 fl. oz./min (75 ml/min) was detected at the P joint at 14.9 and 34.9 degrees of P joint rotation and overall deflection, respectively. The applied moment then rapidly decreased, and the pipe failed and leaked at the B joint with a significant rate at 21.7 and 36.0 degrees of B joint rotation and overall deflection, respectively. Figure 3.27 shows the significant leakage at the B joint. Figure 3.28 shows a photograph of the McWane SFC bending specimen 2 (12-6) after the test. Further investigation after taking the joints apart shows that the pipe has similar damage as the previous bending tests such that the pipe broke at the invert of the TR Flex® Plain End. Figure 3.29 shows the damage at the TR Flex® plain end after the test.

Figure 3.27. Significant Leakage of McWane SFC Bending Test Specimen 2 (12-6)

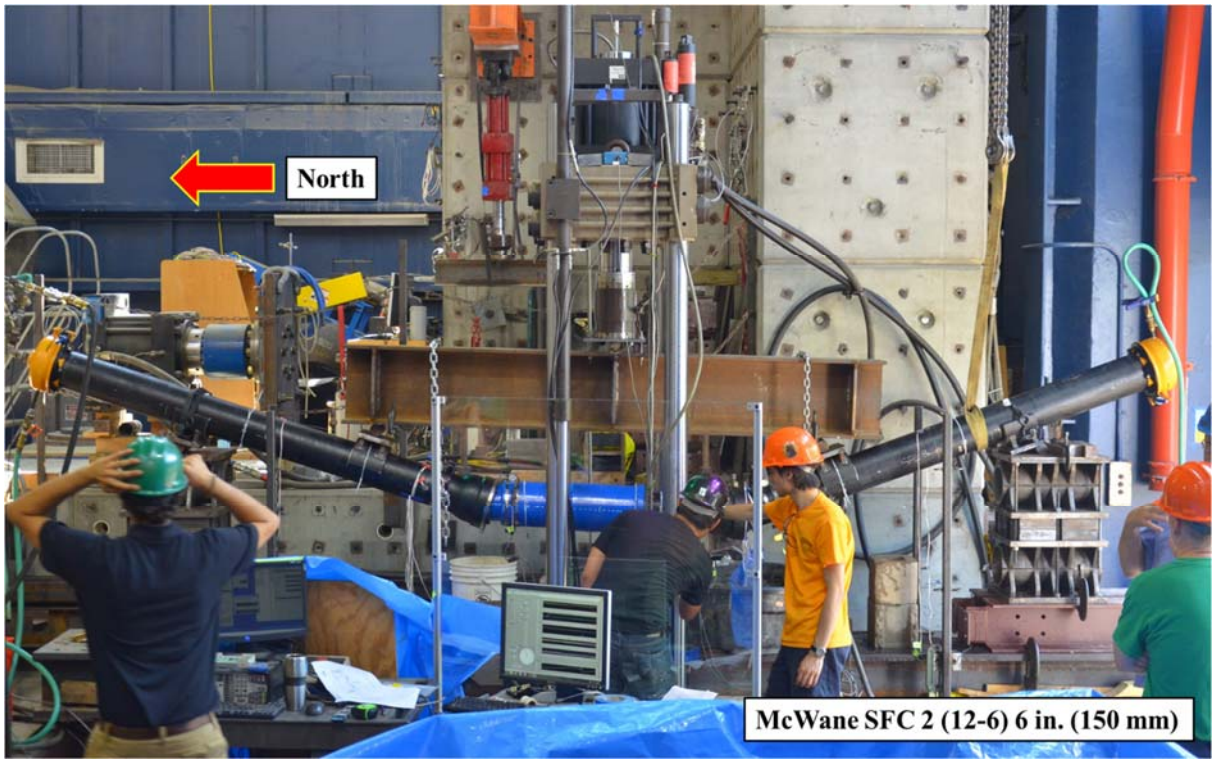
Figure 3.28. Photo of McWane SFC Bending Specimen 2 (12-6) after Testing

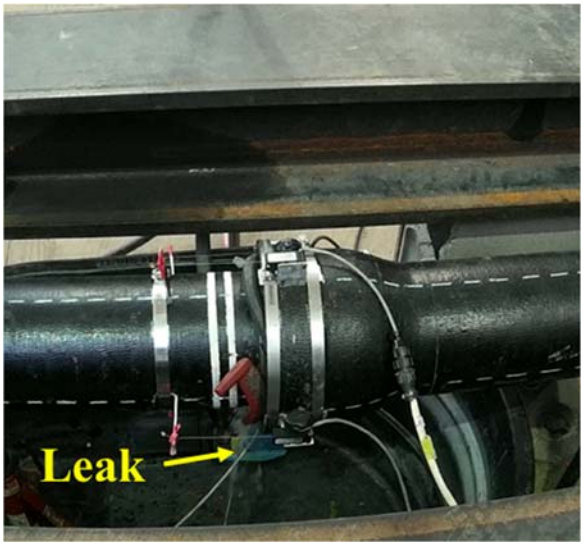
Loading began at a rate of 1 in. (25.4 mm) per minute. Figure 4.3 shows the relationships of tensile force vs. joint displacement for the TR Flex® joint. As tensile force was applied, the spigot was pulled from the bell and the spigot weld bead to bear against and transfer concentrated load onto the locking segments. The progressive movements of the joint and locking segments are provided in Figures 4.3 and 4.4. The peak load of 96.5 kips (429 kN) was achieved at 0.73 in. (18.5 mm) of joint opening. The tensile force subsequently declined, corresponding to cracking of the left-hand locking segment on the west springline. When the joint reached 1.57 in. (39.8 mm) of displacement at the load of 3.6 kips (16 kN), the left-hand locking segment broke, and the pipe began to leak.

d) Pipe Leaked

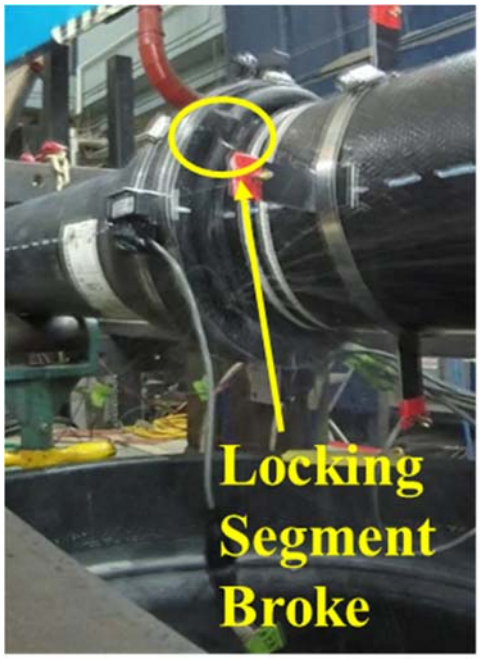
c) Left-Hand (Black) Locking Segment Broke

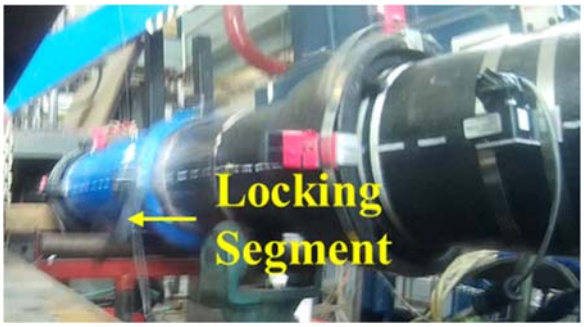
c) Locking Segments Poped Out

Figure 4.13. Successive Photos of McWane SFC Tension Test 1 Looking at Left-Hand Locking Segment

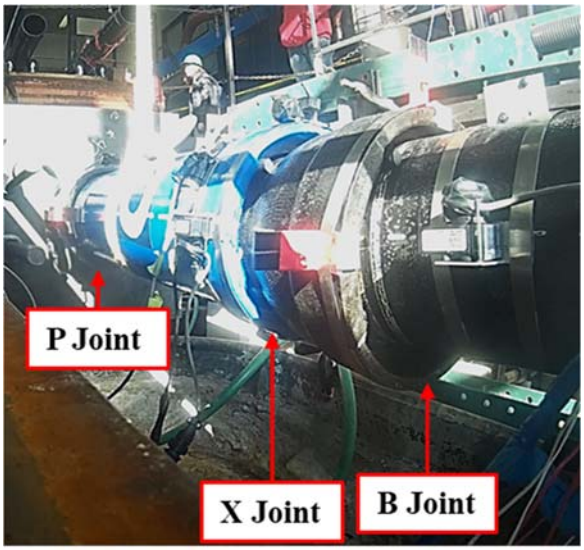
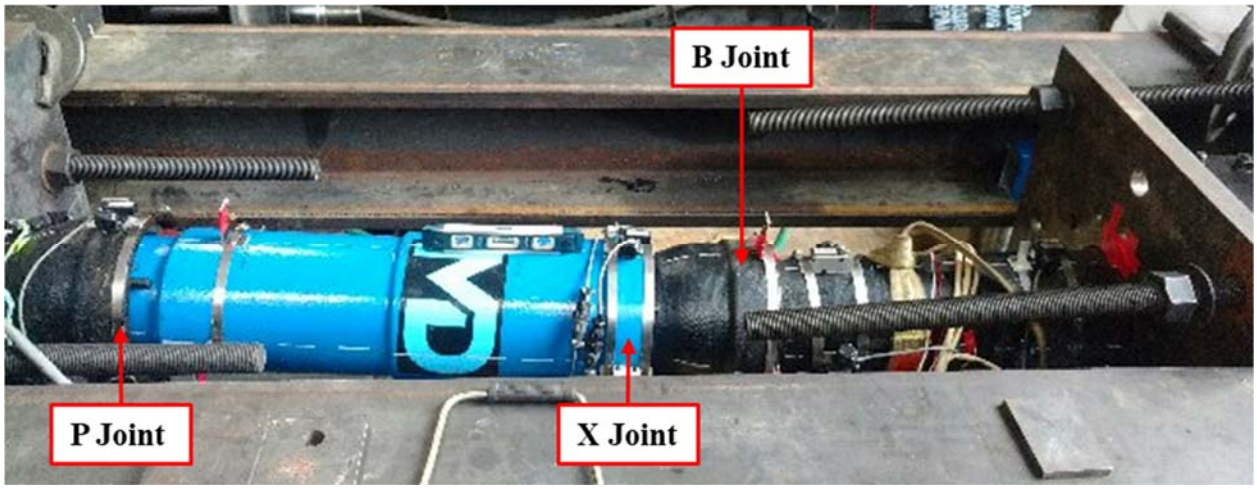
Figure 4.22. Irrecoverable Deformation at B Joint

Once the actuator began applying compressive movement to the pipe, each joint provided approximately 0.1 in. (2.5 mm) of displacement before becoming fully seated, and the compressive force then increased. At the total joint closure of 0.66 in. (16.7 mm), the pipe reached the maximum compressive force of 210 kips (934 kN), which is very close to the calculated proportional force of 204 kips (907 kN). After the maximum compressive force had been achieved, the load dropped rapidly, and the pipe was sagging at the B joint. The downward movement at the B joint caused the wheeled wooden dolly to break when the SFC reached a total displacement of 0.77 in. (19.6 mm) at a corresponding actuator force of 143 kips (636 kN). Attempts were made to straighten the pipe. However, the pipe already had significant irrecoverable deformation, and it could not return to the original position, as illustrated in Figure 4.22. No leakage was observed in this test.

a) Side View Before Test

b) Side View After Test

c) Overall View After Test

The compressive testing showed that the McWane SFC had a maximum compressive load capacity at about the DI proportional limit of 204 kips (907 kN). Once the proportional limit was achieved, the pipe started to behave plastically and have irrecoverable deformation such that a significant rotation was observed at the B joint. However, no leakage occurred during the compression test.

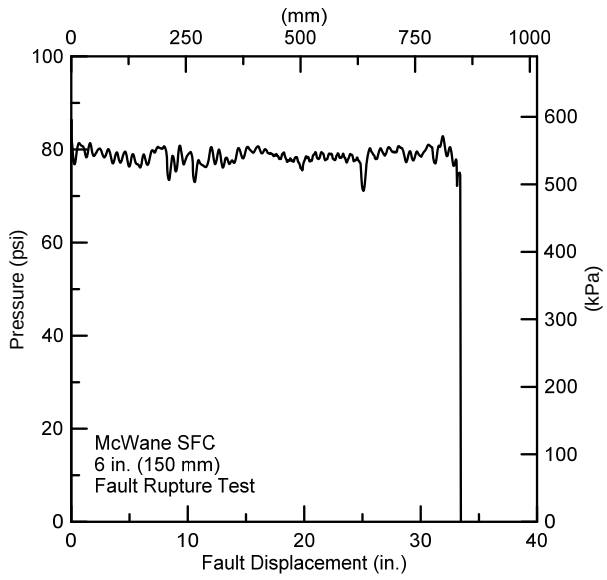
Figure 5.6. Internal Water Pressure vs. Fault Displacement

At a fault displacement of 33.4 in. (848 mm), the pipeline lost its the internal pressure, indicating leakage. After verification of total pressure lost, the test was then stopped at 33.7 in. (856 mm) of fault displacement. This fault displacement corresponds to an axial movement of 21.7 in. (550 mm)

The pipe was pressurized to 80 psi (550 kPa) before any basin movement, and remained constant pressure during the test. The basin movement caused the pipe to increase in overall length, causing fluctuations in pressure. Figure 5.6 shows the pipe internal pressure vs. fault displacement. At a fault displacement of 33.4 in. (848 mm), there was a large loss of pressure in the pipe. This fault displacement corresponds to 21.5 in. (546 mm) of axial pipeline displacement. After verification of total pressure loss, the test was then stopped at 33.7 in. (856 mm) of fault displacement. This fault displacement corresponds to a basin axial movement of 21.7 in. (550 mm).

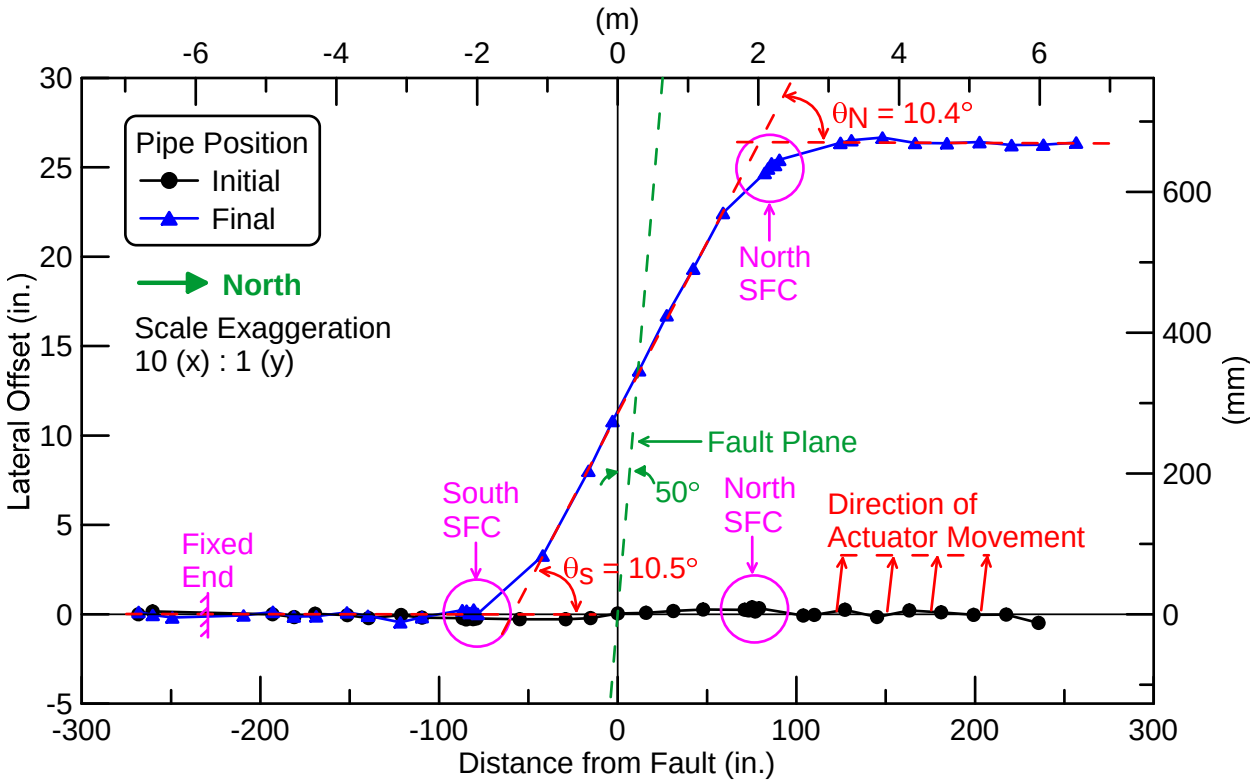
Figure 5.7. Initial and Final Pipeline Positions from Surveying Measurements

Figure 5.7 shows, on a greatly exaggerated scale, the Leica data for the initial and final pipe positions. The data shown in Figure 5.7 were used to estimate the overall SFC displacements and deflections. The survey data suggested the total axial movement and lateral offset of the pipeline are 21.1 in. (536 mm) and 26.9 in. (683 mm), respectively. The axial movement consists of 11.6

in. (295 mm) at the south SFC and 9.5 in. (241 mm) at the north SFC. The slope of each pipe section was found and used to calculate the south and north SFC overall deflection. In this report "deflection" is used to describe the angular deflection of the pipe, consistent with industry usage. The north and south SFC deflection obtained from the survey data are 10.5 and 10.4 degrees, respectively.

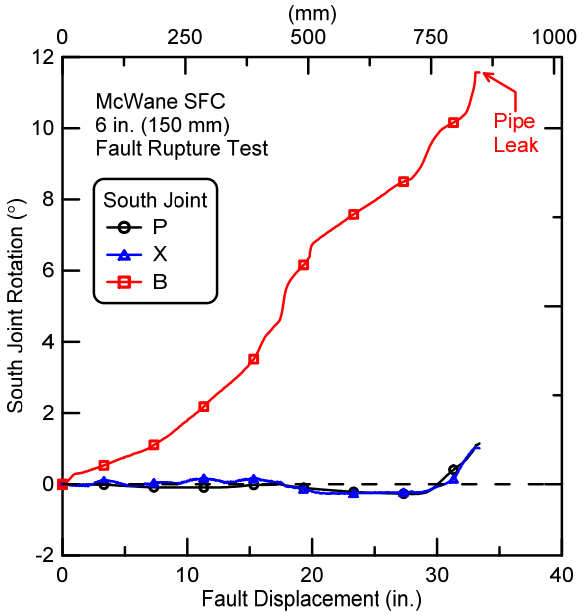
Figure 5.11. South SFC Joint Rotations vs. Fault Displacement

Joint rotations (deflections) were determined using the string pots at each joint and confirmed by survey measurements. It is critical to note that the observed failure during this test was due to the south B joint pullout. Joint rotation is calculated from the string pot measurements at each joint as:

As the test basin was displaced, the south SFC moved closer to the fault and accommodated most of the fault offset with a maximum deflection of 13.7° while the north deflection was 11.6° at the end of the test. The highest rotation of 11.6° was detected at the south B joint, which was the closest joint the fault and where the failure occurred. Table 5.5 presents a comparison between the joint deflections determined using the string pot measurements and the survey data.

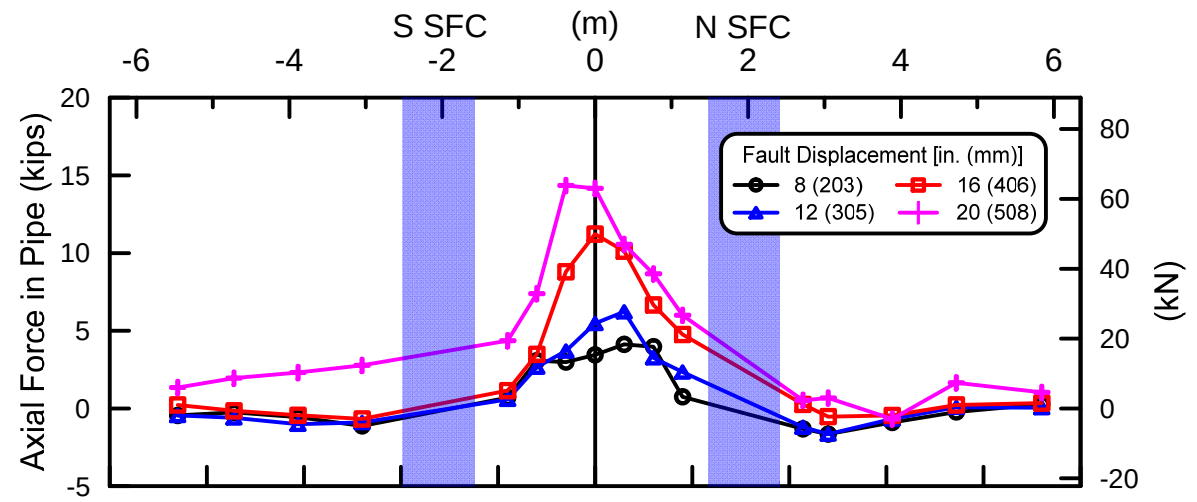
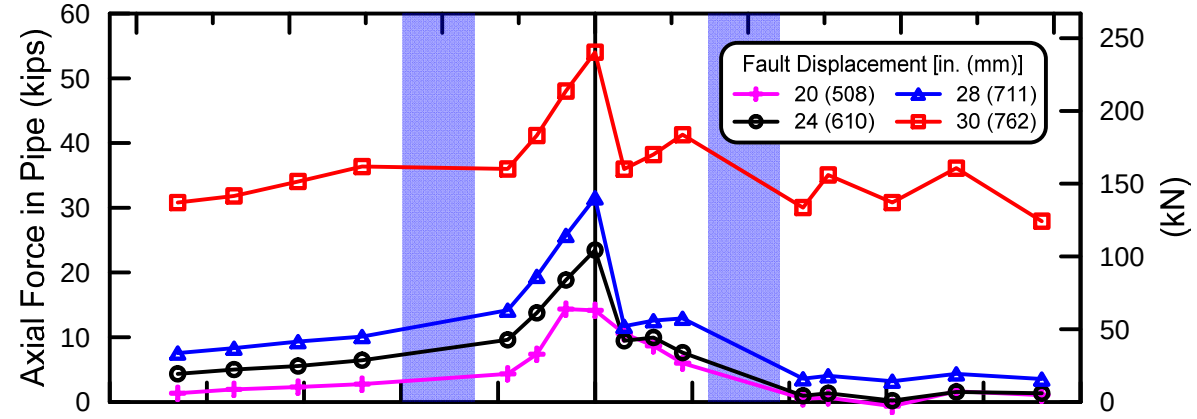
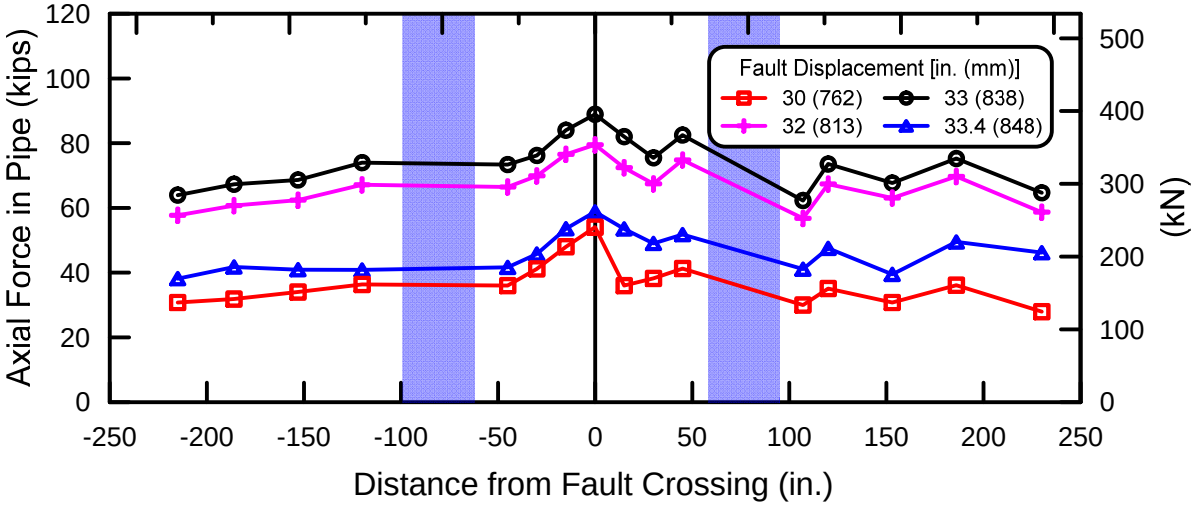
Figure 5.15. Axial Forces in Pipe vs. Distance from Fault

The calculated axial loads at each gage plane along the pipeline are presented in Figure 5.15 for various levels of fault displacement. The SFC locations are shown in blue shaded areas. Figure 5.15 a) shows the tensile forces up to 20 in. (508 mm) of fault movement. Relatively low tensile forces were measured along the pipeline during these initial increments of displacement. The highest axial force was detected in the vicinity of the fault, and the loads were lower at locations further away from the fault.

Figure 5.15 b) (note change in scale for load) shows that tensile forces were generally higher with increasing fault displacement. The highest axial force was detected at the fault location. The forces increased rapidly after 28 in. (711 mm) of fault displacement, indicating that all joint had been fully extended. Figure 5.15 c) shows the evolutions of the pipe axial loads from 30 in. (762 mm) to the end of test at 33.4 in. (848 mm) of fault displacement. At 33.0 in. (838 mm) of fault movement, the peak force of 88.9 kips (395 kN) was detected at the fault location. The axial forces then decreased, yielding similar behaviors as the joint axial tension tests. The highest force of 58.8 kips (262 kN) was also found at the fault before the pipe lost pressure at 33.4 in. (848 mm) of fault displacement.

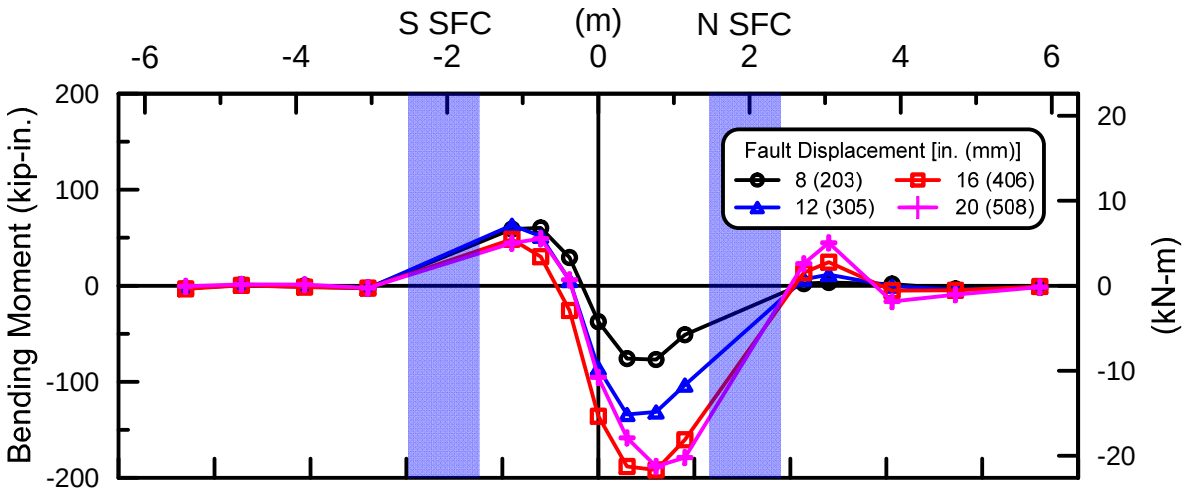
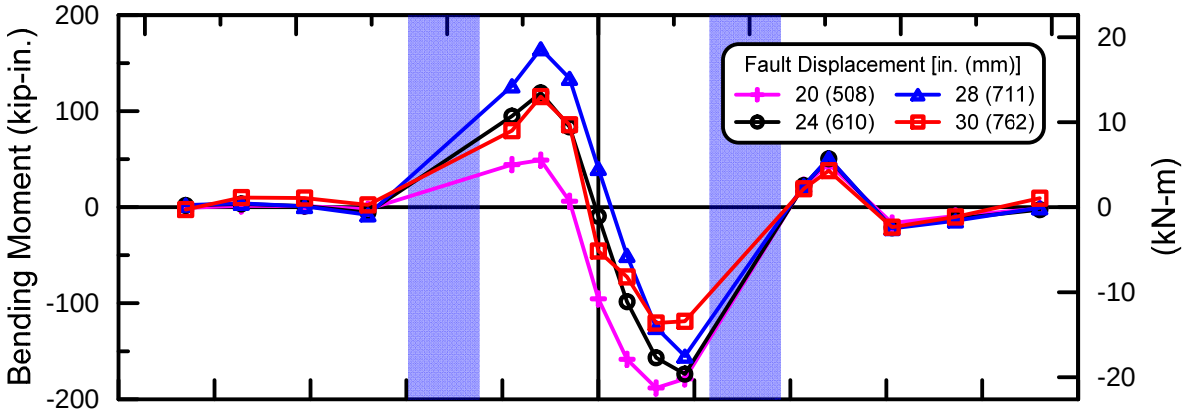
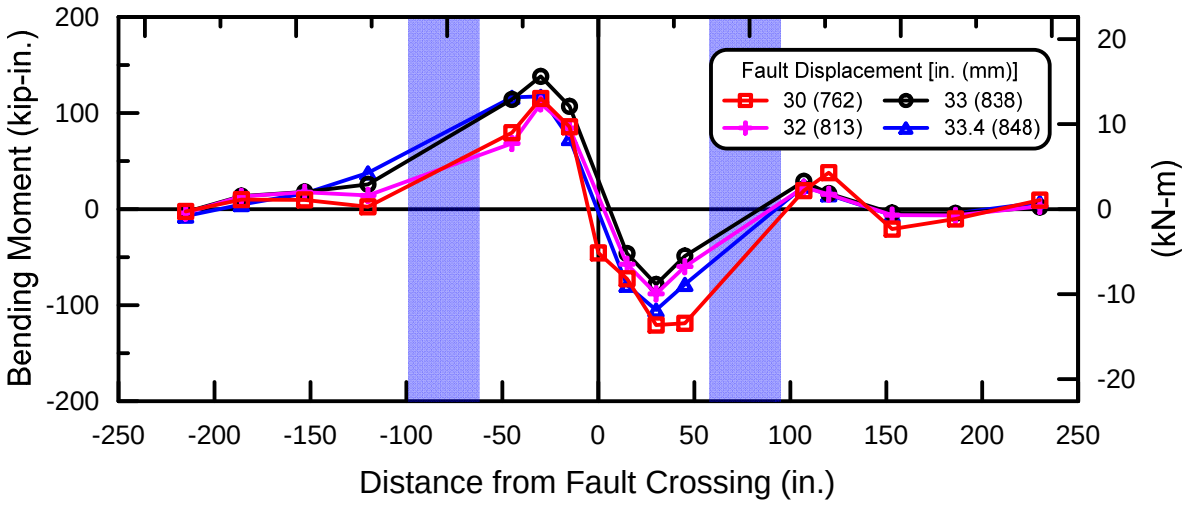
Figure 5.16. Bending Moments in Pipe vs. Distance from Fault

Figure 5.16 presents the bending moments measured along the pipeline corresponding to various levels of fault displacement. The SFC locations are shown in blue shaded areas. Figure 5.16 a) shows during the first 20 in. (508 mm) of fault displacement, bending moments along the pipeline were relatively low, except the area between the fault and the north SFC. Figure 5.16 b) shows that the moments were higher as the fault movement increased. The measurements disclose an anti-symmetric pattern of moment distribution centered on the fault. The peak moments were detected at 30 in. (762 mm) away on both sides of the fault. Figure 5.16 c) shows a consistent bending moment distribution for fault movements of 30 in. (762 mm) to 33.4 in. (848 mm). Noticeable bending moments occurred between the north and south SFCs with the highest moments on the order of 110 kip-in. (12.4 kN-m) detected at 30 in. (762 mm) away on both sides from the fault. Moments near the fault location were generally low, indicating that it is near the inflection point of the pipeline.

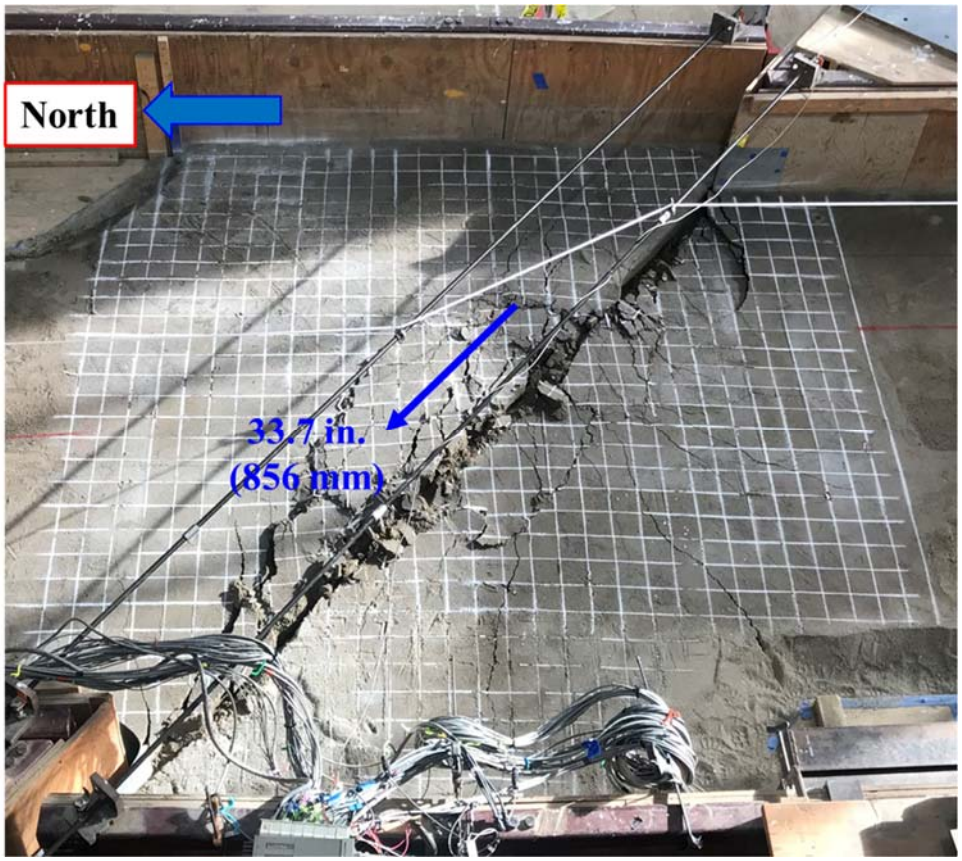
Figure 5.17. Fault Rupture at Test End

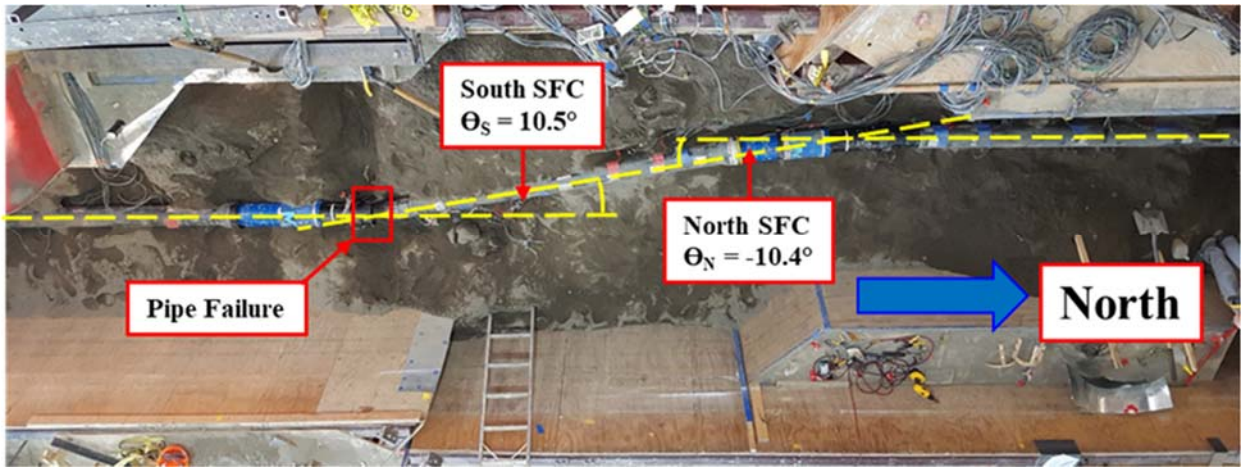
b) After Excavation

Figure 5.18. Overhead View of Pipeline (a) before burial and (b) after excavation (angles shown from total station surveying measurements)

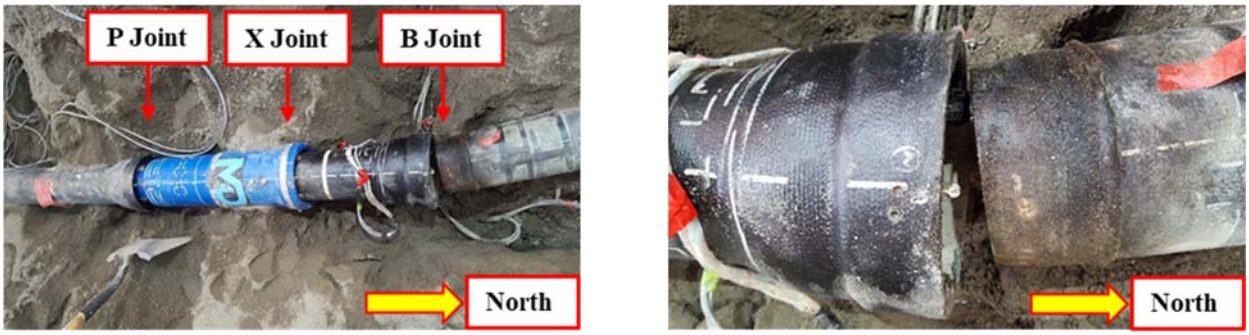
a) Plan View of South SFC b) Close-up View of South SFC B Joint

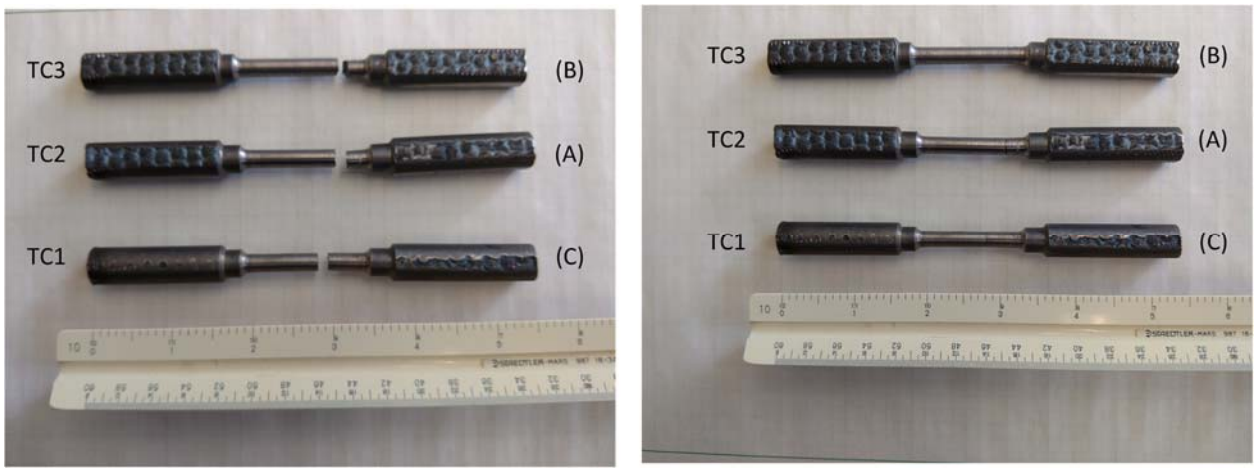
a) After Breaking b) Pieced Together
