Evidence of an emerging levee failure mechanism causing disastrous floods in Italy

Stefano Orlandini¹, Giovanni Moretti¹, and John D. Albertson²

Orlandini, S., G. Moretti, and J. D. Albertson (2015), Evidence of an emerging levee failure mechanism causing disastrous floods in Italy, *Water Resour. Res.*, 51, 7995–8011, doi:10.1002/2015WR017426.

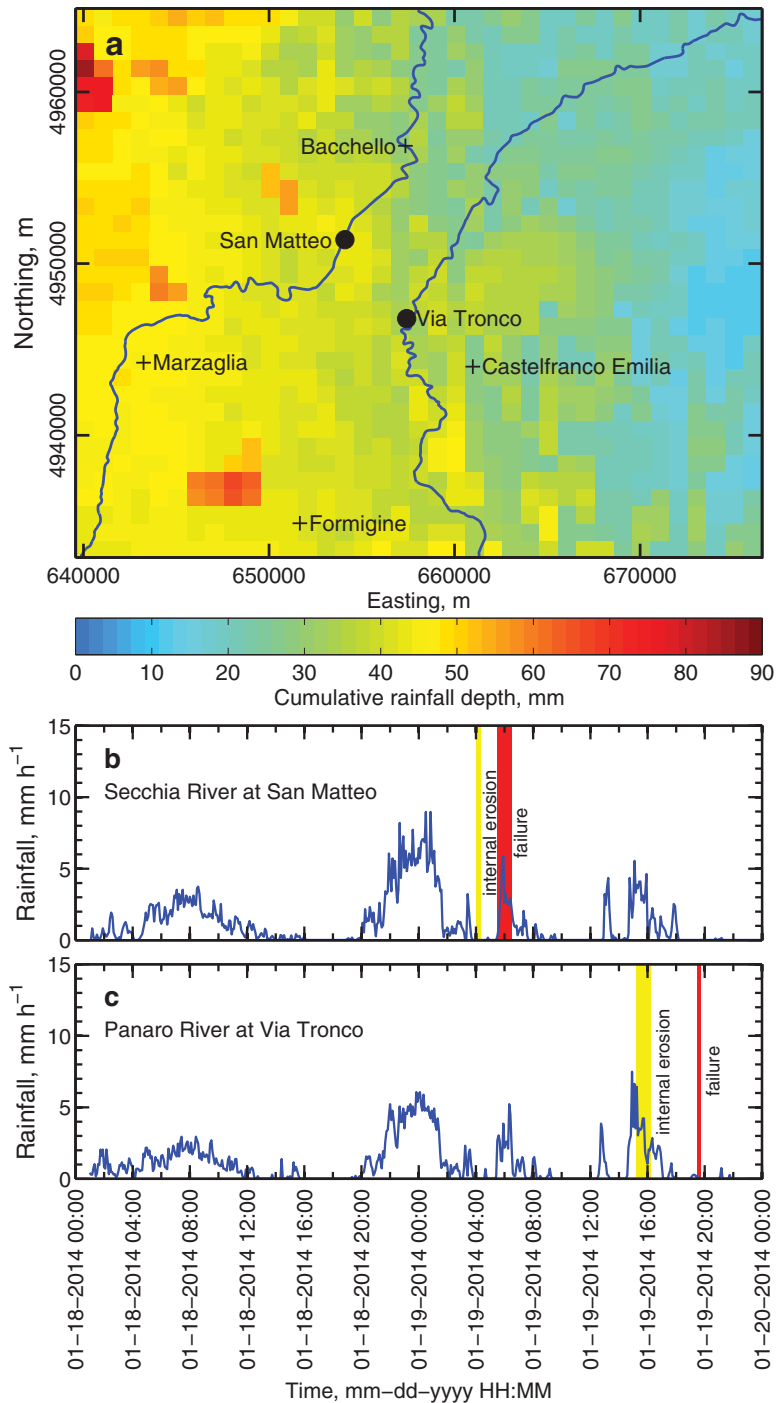
Figure 2. Rainfall occurred along the Secchia and Panaro Rivers in the period of time from 18 January 2014 at 2:00 to 19 January 2014 at 2:00. A radar image at 1 km × 1 km spatial resolution of the cumulative rainfall depth is shown in Figure 2a. The hyetographs extracted from radar images at 5 min temporal resolution, for the locations of the levee failures occurred along the Secchia River at San Matteo and the Panaro River at Via Tronco, are shown in Figures 2b and 2c, respectively. The estimated times at which the internal erosion was triggered and levee failure occurred are indicated in Figures 2b and 2c by the yellow and red bands, respectively.

First, the hydroclimatic conditions were very similar in the two cases, with both the failed levees directly wetted by vertical infiltration from local convective rainfall during the transit of the flood wave (Figure 2). Second, high river stages were reconstructed or observed to occur in both the river systems before the levee failures, but these stages were significantly below the top of the levees, so that overtopping of the original levee top can be excluded. Thirdly, in both the cases, dens of burrowing animals were found to exist in the locations in which the levees failed (Figures 5 and 7). In addition, other possible causes of levee failure were evaluated and found, in the cases of the considered levee structures and hydroclimatic events, to be significantly less plausible than a levee failure induced by burrowing animals [D’Alpaos *et al.*, 2014]. In any case, the event observed along the Panaro River and documented in Figure 7 provides clear evidence of this levee failure mechanism caused by burrowing animals. This is examined mechanistically below.

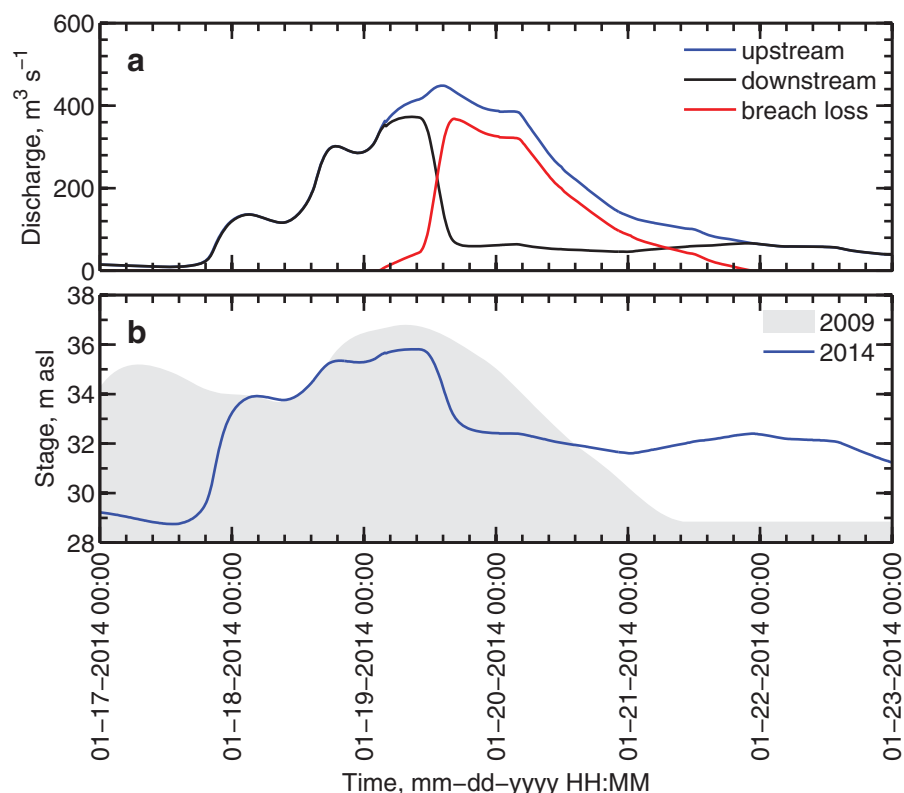
The flood hydrographs from December 2013 and January 2014 at the cross section of the failed levee were reconstructed by developing a level pool routing model and a dynamic wave model (section A1). Reconstructed flow discharge and river stage for the period 17–22 January 2014 are reported in Figures 3a and 3b, respectively. The breach flow loss was computed by incorporating into the dynamic wave model an explicit description of the breach evolution, obtained from photographs taken during the event (Figure 4). The combined use of observations and models yielded the results reported in Figure 3, revealing that (1) the maximum stage reached by the river flow in January 2014 was about 1.5 m below the top of the levee and (2) the magnitude of the peak river stage and the duration of high river stages along the Secchia River in January 2014 were smaller than the corresponding quantities observed in previous events such as, for instance, those observed in December 2009 (Figure 3b).

Figure 3. Reconstructed flow discharges (Figure 3a) and river stages (Figure 3b) at the cross section of the Secchia River at San Matteo where the levee failure occurred. A longer simulation period (from 22 December 2013 at 0:00 to 3 February 2014 at 24:00) than that reported in Figures 3a and 3b was considered to provide a sound analysis of the hydraulic response of the levee to the river stage forcing. The flood hydrograph occurred in December 2009 (from 23 December 2009 at 14:00 to 28 December 2009 at 14:00) is reported in the background of Figure 3b to enable a visual comparison.
