**Axial Pull Tests on Insituform IMain Liner**

**Prepared by  
Cornell University NEESR Group**

**September 7, 2011**

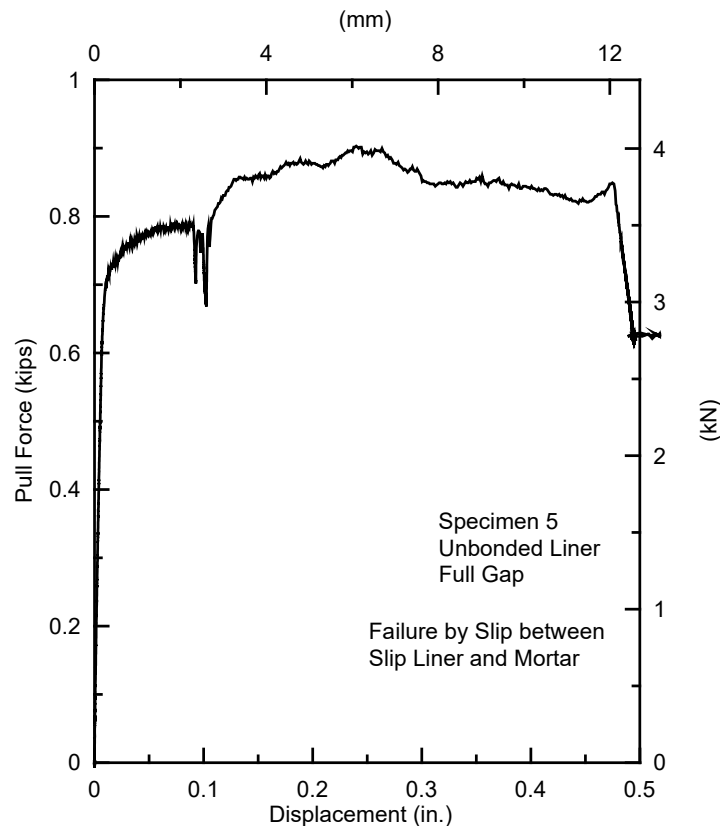
Figure 2. Force – Displacement Specimen No. 5, Unbonded Liner, Gap Pull Test

Specimen 5 was an unbonded specimen and loaded in a Gap Pull Test (tension only). As shown in Photo 2, the pipe is loaded on either side of a gap in the DI pipe. This test design allows the liner strength to be considered without the contribution of the existing pipe, similar to lining a cracked, in-situ pipe. As shown in Figure 2, at an approximate displacement of 2.62 mm (0.103 in.) and force of 3.51 kN (0.79 kips) an abrupt reduction of applied force was observed. The specimen continued to accept load reaching a peak of 3.87 kN (0.87 kips) at approximately 63.5 mm (2.5 in.) of displacement. As expected in an unbonded specimen, failure occurred between the liner and mortar interface. It should be noted that the gap was located 724 mm (28.5 in.) from one end of the 2160-mm(85-in.) -long specimen instead of at its center which suggests that this length was adequate to develop a full bond between mortar and ductile iron.

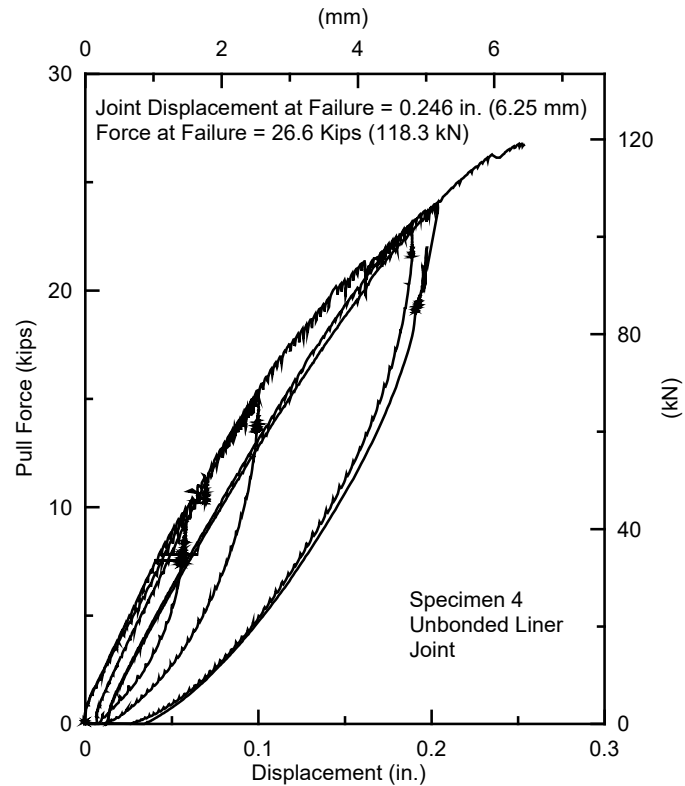
Figure 3. Force – Displacement for Specimen 4, Unbonded Liner. Joint Pull Test

Specimen 4 had an unbonded liner, a pipe joint at its approximate center, and was tested by means of the Joint Pull procedure. As shown in Figure 3, at a maximum displacement of 6.25 mm (0.246 in.) and force of 119 kN (26.7 kips) the specimen liner fractured. This failure mode does not comply with the other unbonded tests. As shown in Photo 3, the liner fracture occurred at the base of the bell. Unexpected mechanical behavior was likely present to produce a failure of the liner in an unbonded specimen.

One explanation is that the polyethylene liner used to preserve the unbonded interface between liner and mortar may have been damaged during installation allowing the epoxy to develop an unwanted bond.

Another possible explanation is that an increase in radial stress occurred because the outer diameter of the liner was larger than the interior diameter of the DI pipe resulting in greater frictional resistance along this interface. According to measurements that were performed on ring specimens, the average outside diameter of the liner is  $D = 152$  mm (6.00 in.), with standard deviation of 0.61 mm (0.024 in.) (Ring Compression Tests on Insituform IMain Liner, Cornell University NEESR Group 2011). It should be noted that the liner of Specimen 4 had consistently greater thickness when both undeformed and deformed than any other specimens tested. Specifically, Specimen 4 is about 5-10% thicker when undeformed and 6 - 38% thicker when deformed than bonded

Specimens 8, 9, and 11. However, the thickness ratio between the deformed and the undeformed liner is not significantly different than the thickness ratio of the other specimens. Measurements of liner thickness were performed assuming the thickness of the mortar and steel pipe remained constant.

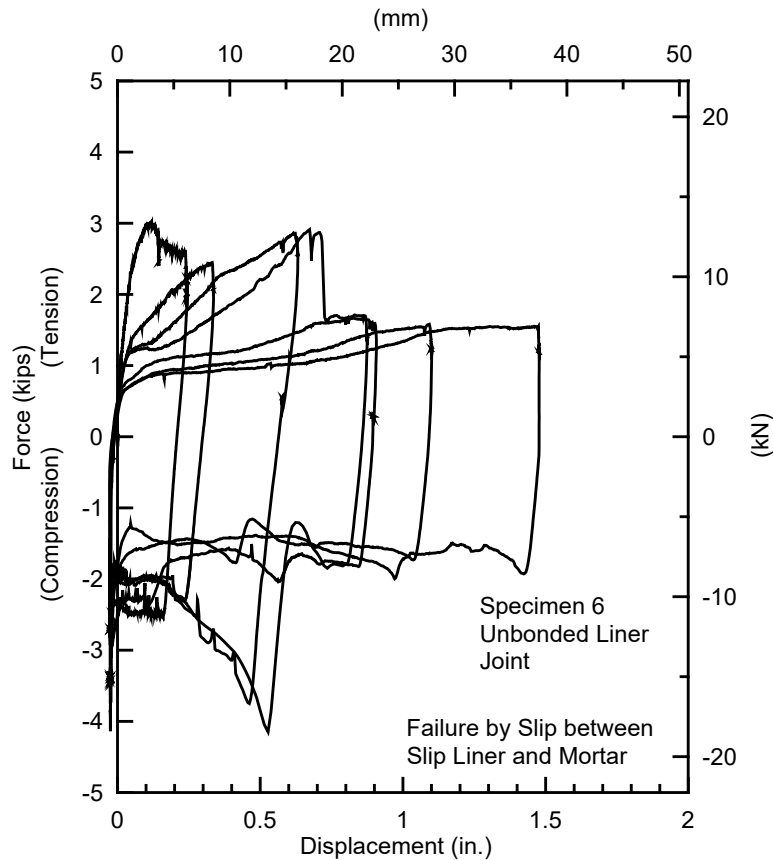
Figure 4. Force–Displacement for Specimen No. 6, Unbonded Liner, Joint Push/Pull Test

Similarly to Specimen 4, Specimen 6 had an unbonded liner with a joint at its center. It was the only specimen subjected to a Push-Pull procedure. At a displacement of 2.62 mm (0.103 in.) and force of 13.3 kN (3.0 kips) failure along the liner-mortar interface was initiated. As shown in Figure 4, Specimen 6 force-displacement curve, additional cycles of tension and compression were applied beyond initial debondment. The liner-mortar interface continued resisting greater than 80% of initial load until cycle 5 when, at 18 mm (0.71 in.) of displacement, the resisting load dropped abruptly to 7.12 kN (1.6 kips). Beyond this cycle it became obvious that the liner-mortar interface had been completely disbanded.

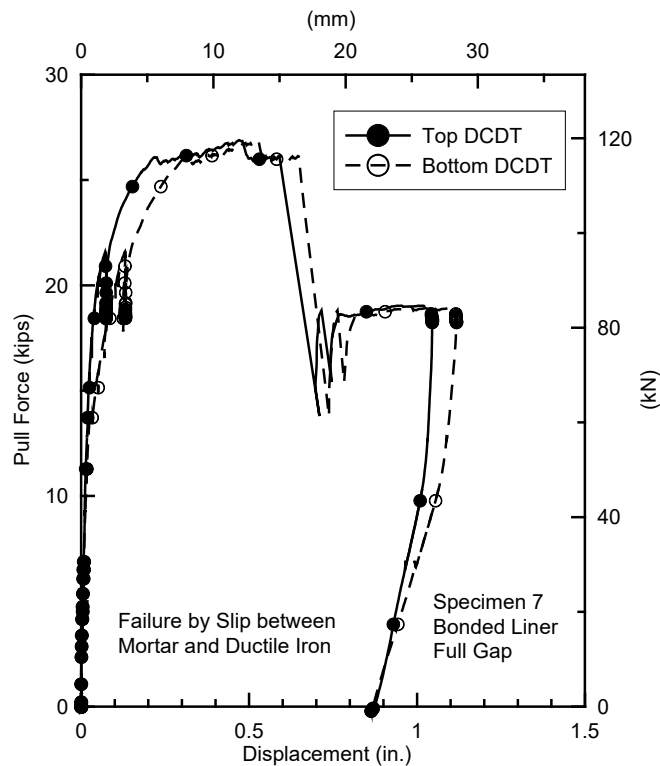
Figure 5. Force – Displacement for Specimen No. 7, Bonded Liner, Gap Pull Test

Specimen 7 had a bonded liner with full circumferential gap and was tested by means of an Axial Pull Test (Photo 4). As shown in Figure 5, the maximum load achieved before slippage along the DI-mortar interface was 117.9 kN (26.5 kips) at a displacement of 5.74 mm (0.226 in.). Upon continued loading the displacement increased with little change in load until a displacement of 16.5 mm (0.65 in.) when an abrupt decrease in load suggests further slippage along the DI-mortar interface. It should be noted that the gap was not located in the center of the 2160-mm (85-in.)-long specimen but rather 762 mm (30 in.) from one end. Further, slippage occurred in the shorter section which inherently had less available surface area to develop the bond between iron and mortar.

The failure between these surfaces suggests that the bond between liner and mortar is stronger than the manufactured bond between mortar and DI. It also provides evidence that to rupture the liner, the longitudinal development length between DI and mortar should be greater than 762 mm (30 in.).

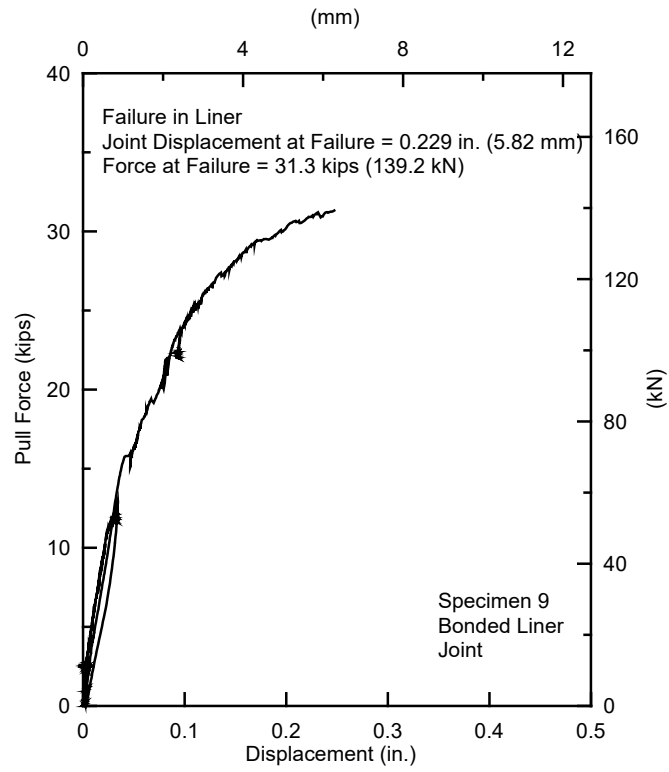
Figure 6. Force – Displacement for Specimen No. 9, Bonded Liner, Joint Pull Test

Specimen 9 was bonded and subject to a Joint Pull Test in which the joint was located at the approximate center of the specimen. As shown Figure 6, at a displacement of 5.82 mm (0.229 in.) the peak load of 139.2 kN (31.3 kips) was achieved. At this point the liner fractured approximately 180 mm (7 in.) into the bell end of the pipe from the base of the bell as shown in Photo 5. Once fractured, the specimen was no longer able to resist force and the test was discontinued.

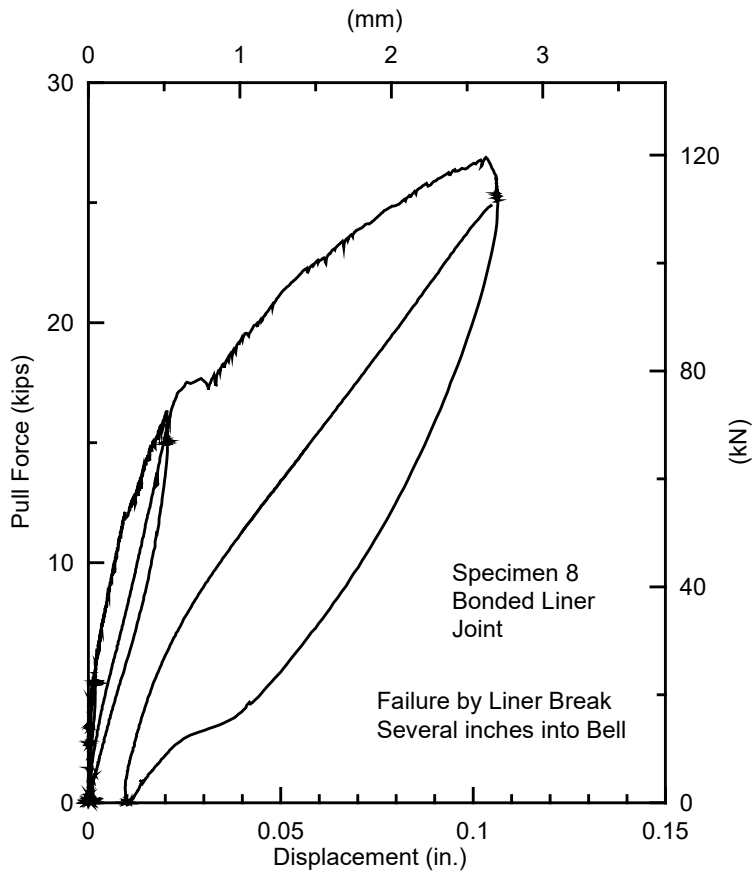
Figure 7. Force – Displacement for Specimen No. 8, Bonded Liner, Joint Pull Test

Similar to Specimen 9, Specimen 8 was bonded and subject to a Joint Pull Test. As shown in Figure 7, at a displacement of 2.64 mm (0.104 in.) the peak load of 119.2 kN (26.8 kips) was achieved. At this point the liner fractured several inches into the bell of the pipe as shown in Photo 6. After the specimen fractured it was no longer able to return to the peak force and testing was ended. Also noticeable in Photo 6, a portion of the mortar remained bonded to the liner. This further suggests that the mortar-liner bond has the potential to be stronger than the manufactured DI to mortar interface.

Despite Specimens 8, 9 and 11 being similarly bonded and joint centered, the liner of Specimen 8 failed at a displacement approximately 55% less than its counterparts. Assuming that the thickness of the mortar and DI pipe remain constant along the specimen, the thickness of the liner from the south to north end ranged between 8.23 mm (0.324 in.) and 10.4 mm (0.408 in.). Such variance in thickness was much more prominent in Specimen 8 than other pull test specimens. As a result, the thickness ratio between the deformed and undeformed liner ranged between 0.68 and 0.86 for the north or south ends respectively. The range in liner thickness ratio for Specimen 8 was greater than the range of any other tested specimen.

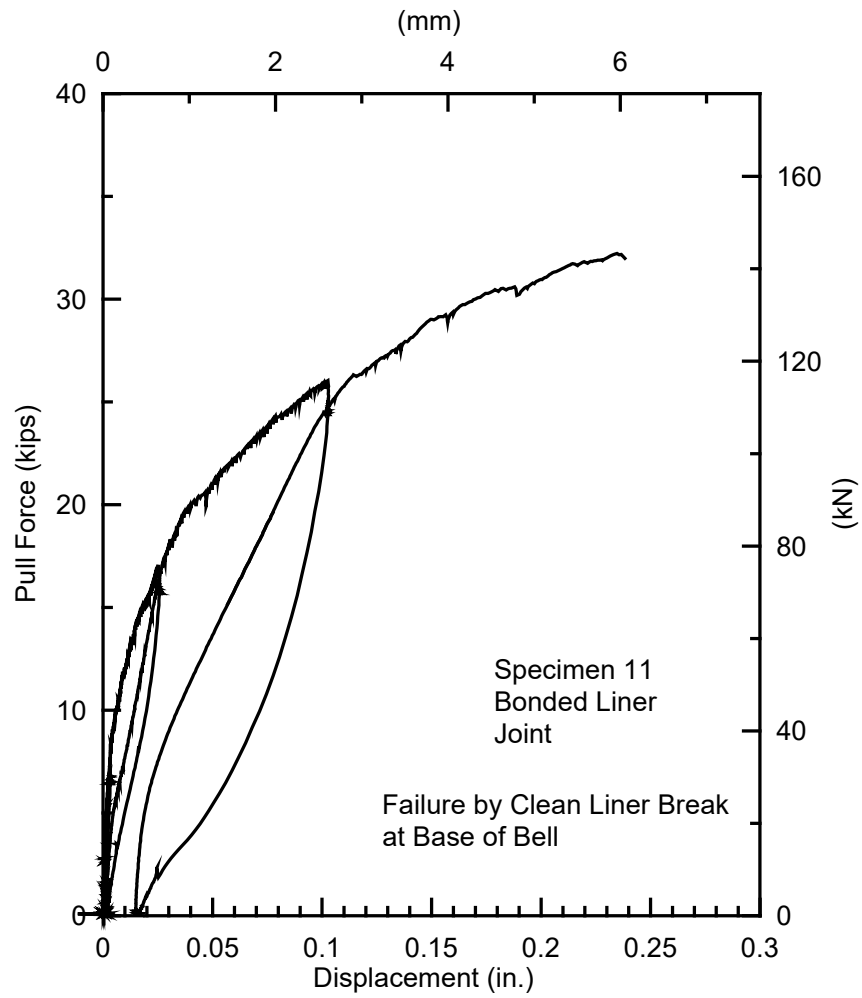
Figure 8. Force – Displacement for Specimen No. 11, Bonded Liner, Joint Pull Test

Similar to Specimens 8 and 9, Specimen 11 was also bonded and subject to a Joint Pull Test. At a displacement of 6.02 mm (0.237 in.) a peak load of 143.2 mm (32.2 kips) was achieved (Figure 8). As shown in Photo 7 and Photo 8, the liner fractured cleanly at the base of the bell. After the specimen fractured it was no longer able to accept load and testing was discontinued.
