Gilpin's Falls Covered Bridge

Cecil County, Maryland

2009 Rehabilitation

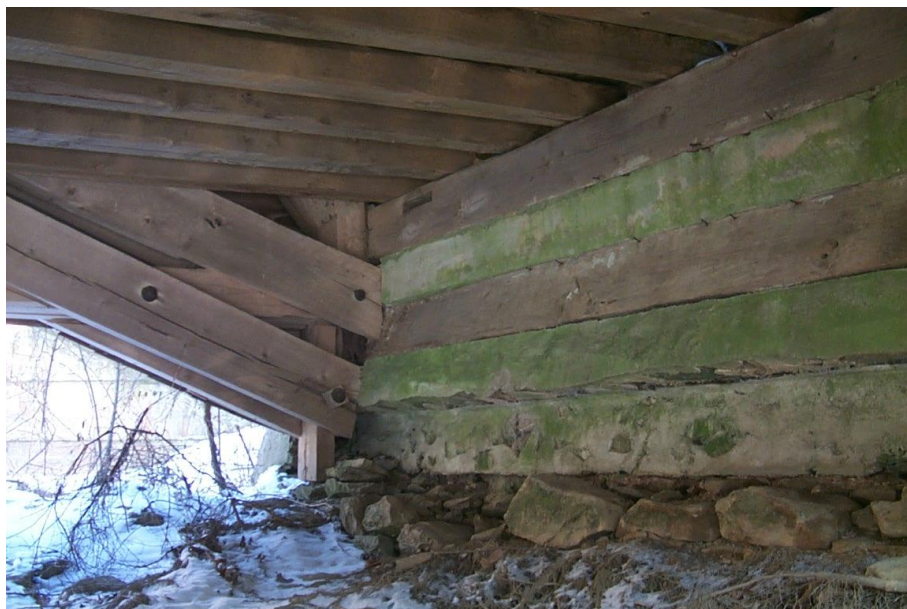
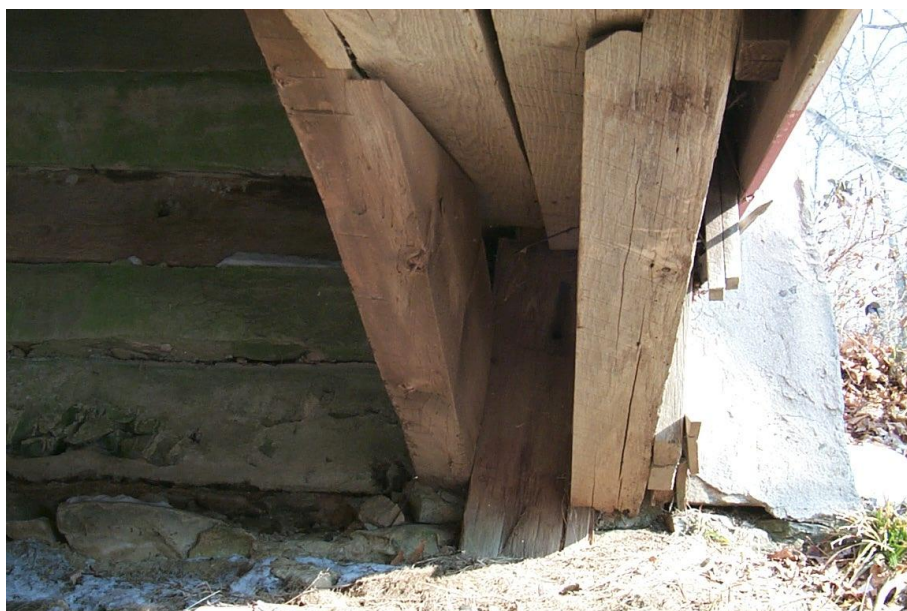
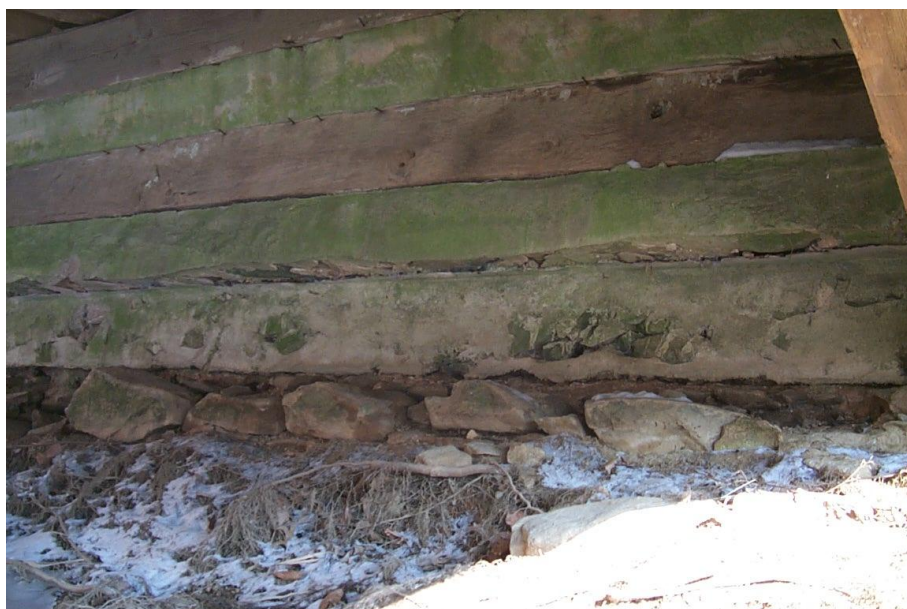
The preceding two pages show bridge details from 2001. The degraded condition of the siding, the internal structure of the Burr arch, and the 1959 addition of steel stabilizer rods can be seen. Notice the embedded timbers within the masonry abutment and how the arch has lost proper bearing (the arch should bear on the embedded timbers).

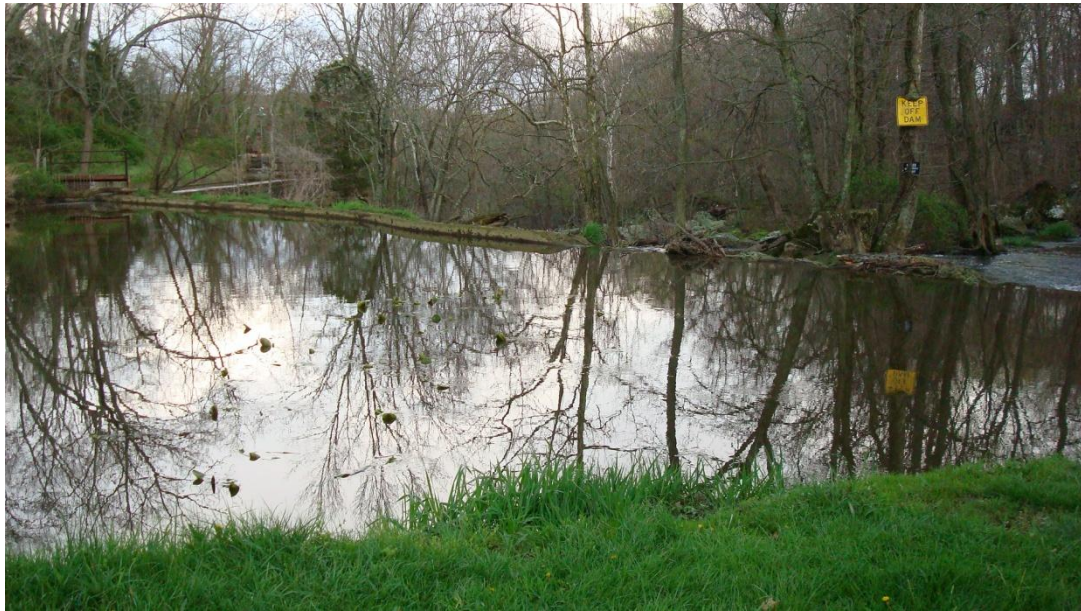
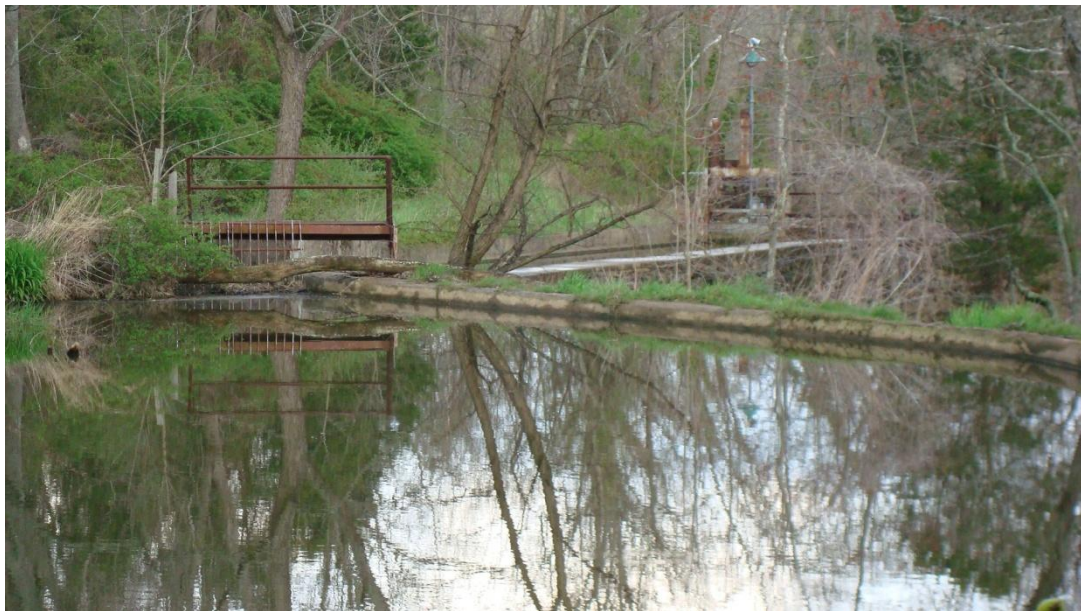
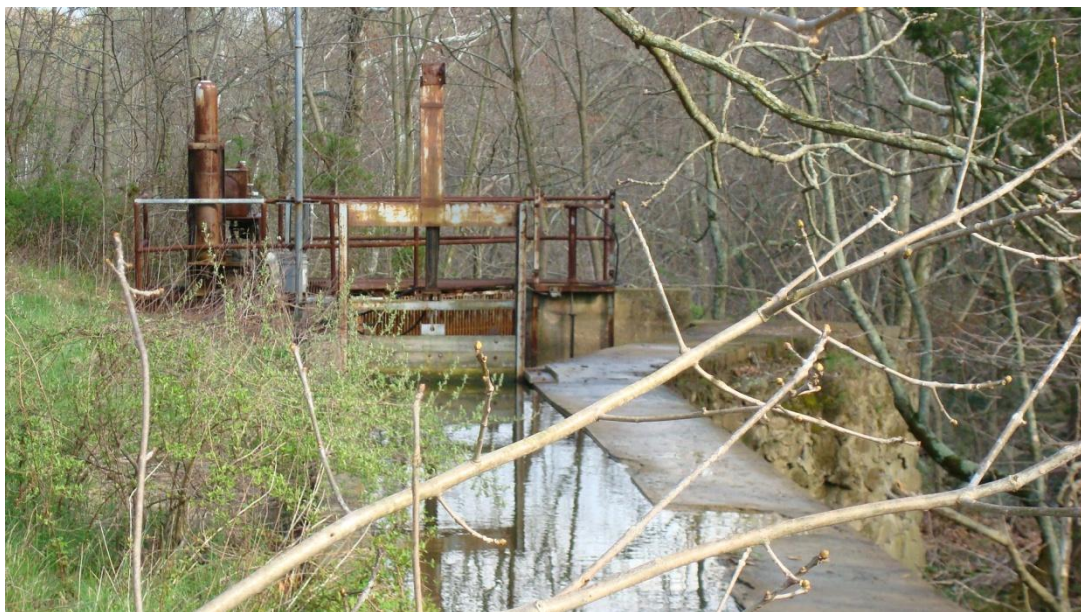
*These pictures
 begin to
 illustrate the
 (mostly) bucolic
 setting
 immediately
 east of the
 Gilpin's Falls
 Covered Bridge.
 The dam is still
 largely intact
 and remnants of
 the hydroelectric
 plant remain as
 well. On a clear
 day such as this,
 the dam creates
 something akin
 to a reflecting
 pool.*

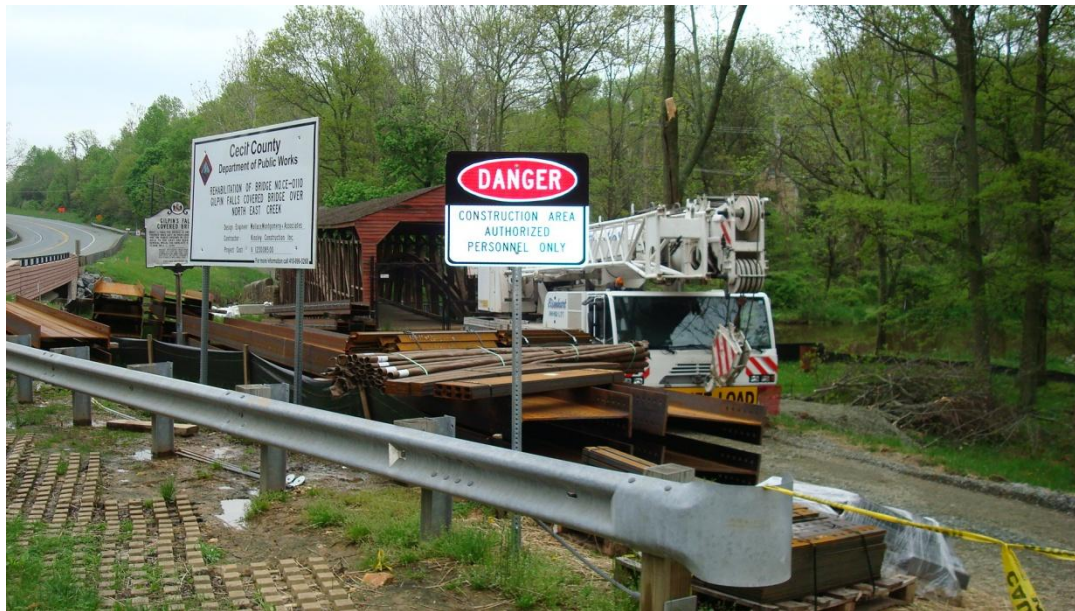
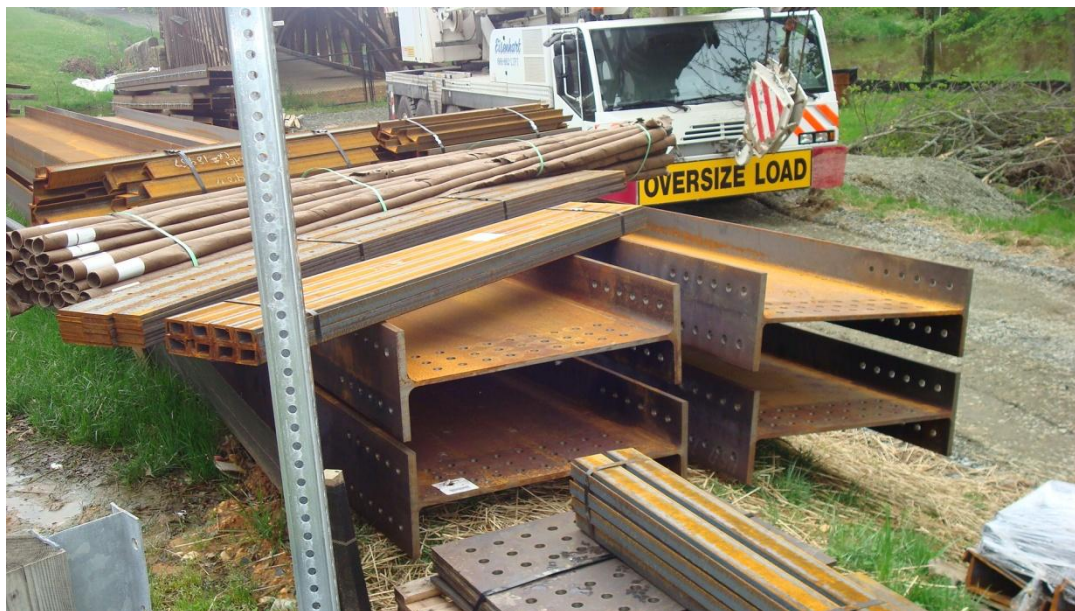
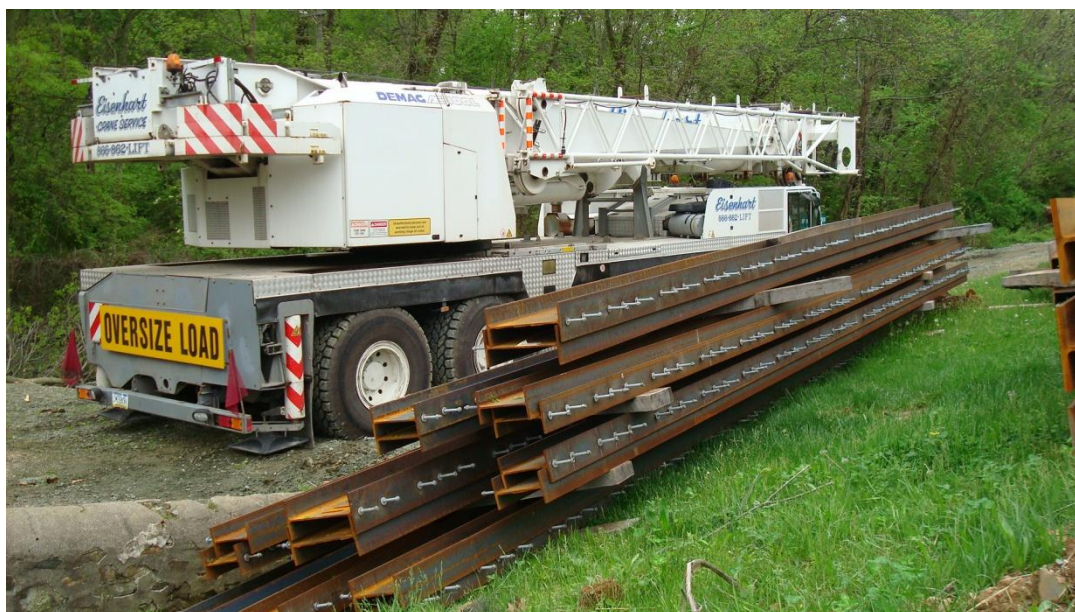
The steel for the temporary support frame, together with the crane, arrives on-site in early May 2009
