Durability Assessment of Externally Bonded Fiber-Reinforced Polymer (FRP) Composite Repairs in Bridges

AJAY BANIYA SANDRA MILEV RACHEL HENRY JOVAN TATAR

Department of Civil and Environmental Engineering University of Delaware

November 30, 2022

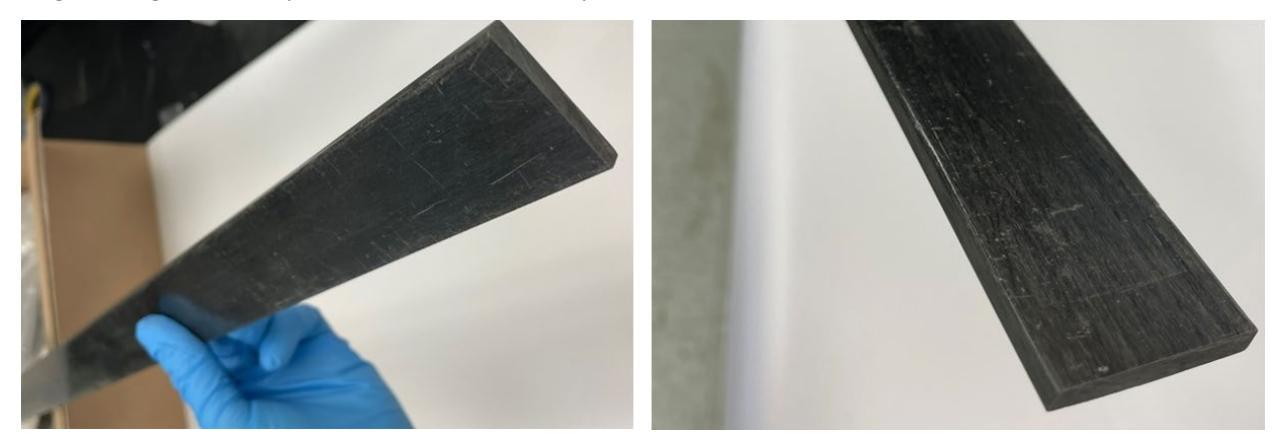
Figure 60. Control CFRP composite preserved for 22 years in the Structural Engineering laboratory located at University of Delaware.

Tensile tests were performed on field and control samples according to the procedures specified in ASTM D3039 (2014) to determine Young's Modulus (*E*) and Poisson's Ratio (v) of the samples. Tensile test samples measuring approximately 10 in. (length) × 0.5 in. (width) were cut from control samples (Figure 60) and field samples (Figure 66) and then sanded with a grit 100 sandpaper on all sides to make the surface even and remove paint or adhesive from the surface. The thickness of control CFRP coupons and field

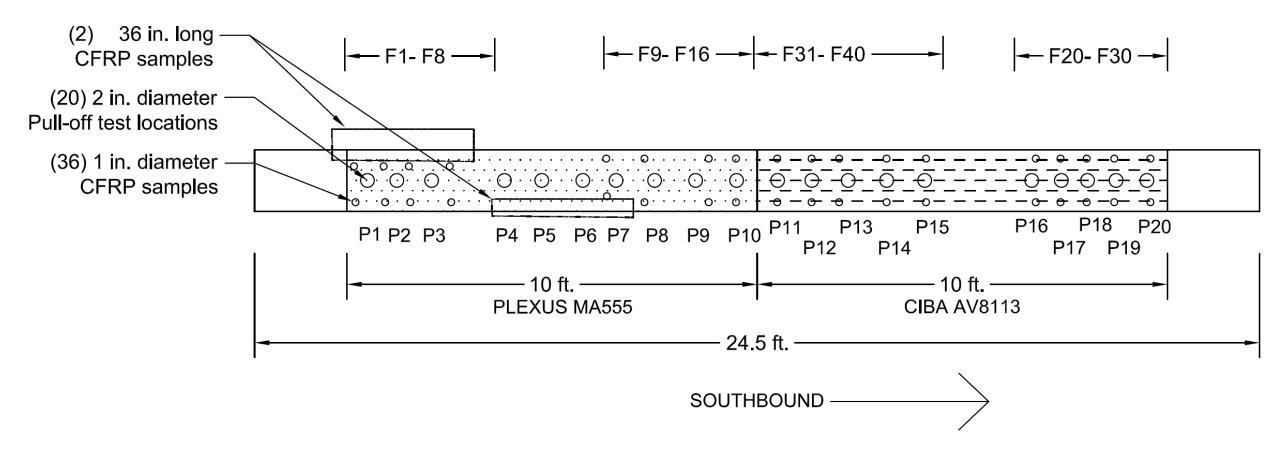
Figure 62. Bottom view of the girder G5 showing the tentative location of sample collected and pull-off tests.

The circular CFRP samples (F1 through F40) were spread out evenly along the length of the girder, not further than 2 in. from the edge of the girder, as shown in Figure 62 and Figure 65. The longer CFRP samples (36 in. long) were collected for tensile tests, three-point bending tests, and DMA tests, so it was necessary for the specimen to have at least 10 in. (length) \times 1.0 in. (width) \times 0.16 in. (thickness) to meet the requirements for all the tests (ASTM D3039, 2017; ASTM D7264, 2015). After multiple attempts at different locations of the girder, the samples meeting minimum requirements could only be collected from two locations shown in Figure 62.

Notes: 1) Tentative location of pull-off tests, P1 through P20 (Figure 64). A minimum clear spacing of 6 in. between each test location and a minimum clear distance of 3 in. from the edge is maintained at all test locations.

2) Tentative location of 1 in. diameter CFRP samples, F1 through F40 (Figure 63).

Figure 62. A minimum clear spacing of 6 in. between each test location and a minimum clear distance of 3 in. from the edge of the girder was maintained at all test locations.

Bond pull-off test results are presented in Table 6 and the photos of observed failure modes are shown in Figure 87. The nomenclature of the sample (e.g., P1) implies the Pull-off test at girder G5 and sample number 1. The approximate test locations are shown in Figure 62 and the exact locations are shown in Table

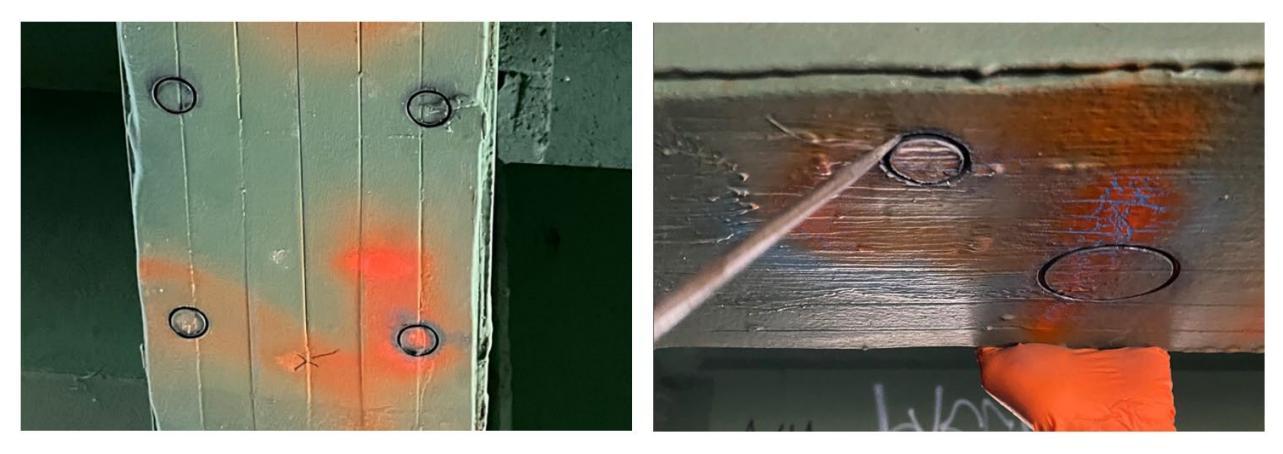
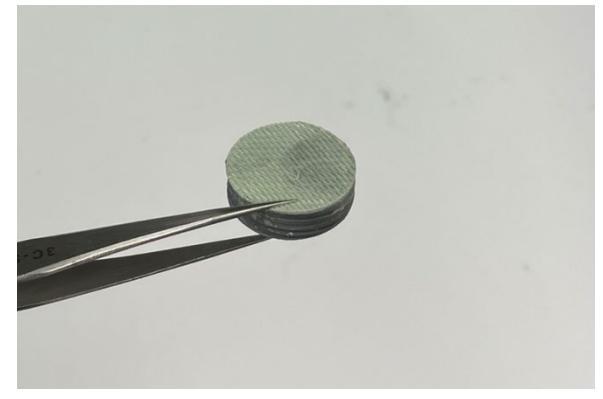
Figure 65. CFRP Sample collection at Br 1-704: (a) CFRP composite drilled using a 1-1/8 in. diamond-coated core saw , (b) Sample collection under progress using flat-head screwdriver, and (c) 1 in. diameter CFRP sample.

DSC was used to obtain the glass transition temperature (T_g) of structural adhesives. The powdered test samples were prepared by scrapping the structural adhesive from beneath the glass fabric from the 1 in. CFRP composite samples (Figure 65c).

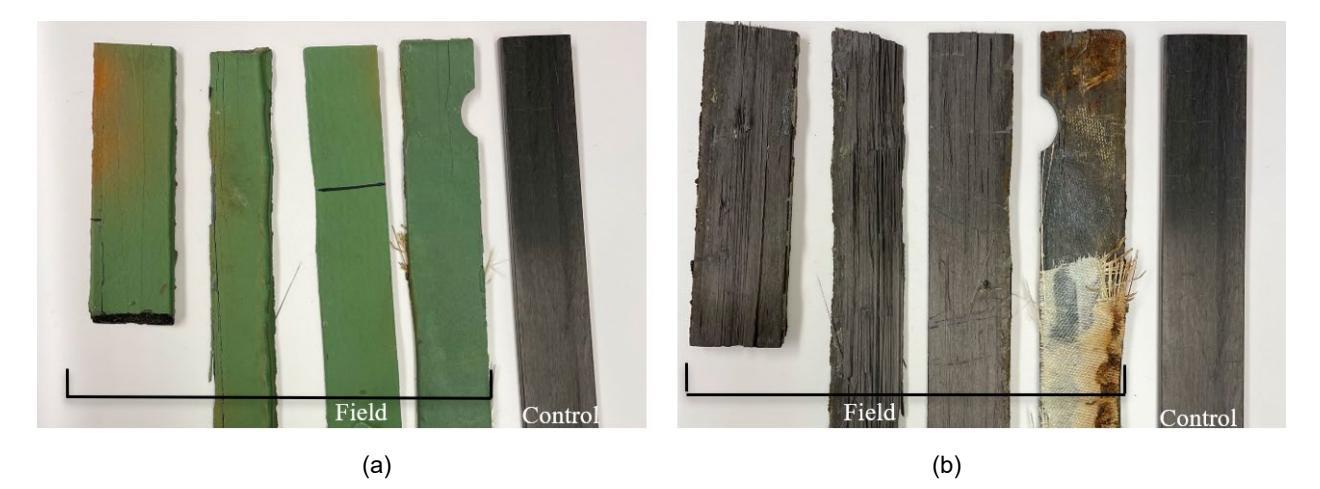
Figure 66. Field samples from Br 1-704 and Control sample : (a) Paint side of Composite samples shown, and (b) Other side of the samples.

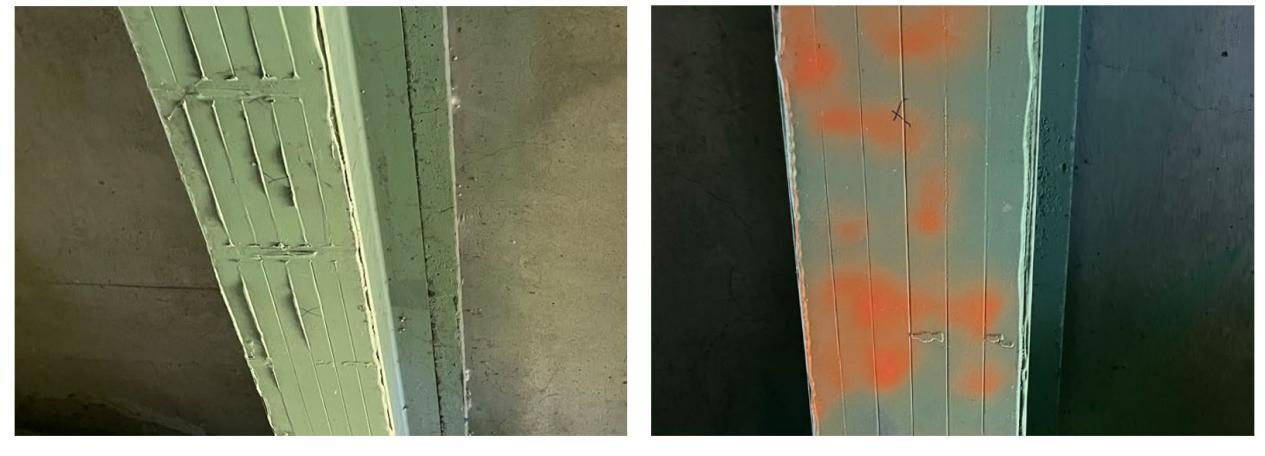
A preliminary visual investigation of the CFRP composite repairs did not indicate the presence of obvious degradation as shown in Figure 75. However, it was observed that approximately 6×6 in.² of CFRP composite was grit blasted as shown in Figure 76. According to DelDOT, it was grit blasted during the surface preparation work prior to the application of the paint on the soffit of the girder. The accessible part of the girder (Figure 75b,c) was found painted with graffiti paint. The abutments and concrete deck were inspected periodically throughout the year 2021, and it was observed that the moisture infiltrated the abutment during rainy days as shown in Figure 77. No signs of ingression of direct rainwater runoff from the roadway were observed on the CFRP composite during the inspection.

(c) Figure 75. Condition of CFRP composite girder repaired in 2000.

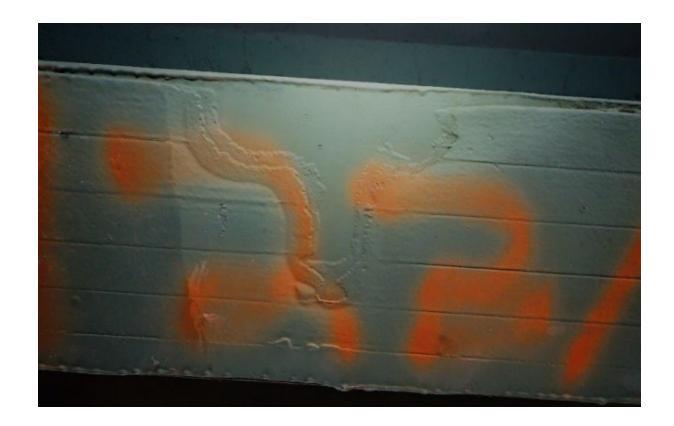
Figure 76. Damage to CFRP laminate from grit blasting.

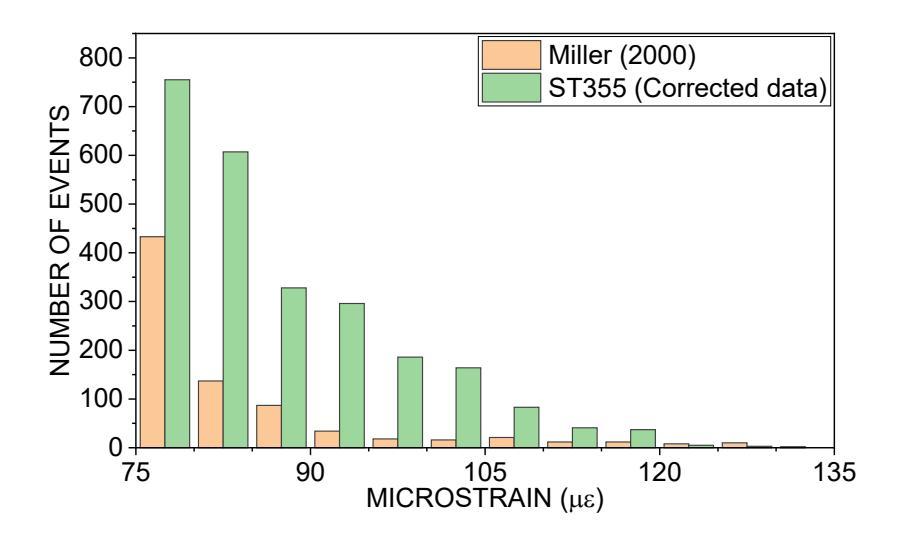
Given the existing state truck size and the weight limit laws were found consistent since 1991 in the country (FHWA, 2015), such a drastic increment in peak strain count (Figure 80) possibly indicates the reduction in global stiffness of the girder. The exact loss in global flexural stiffness of the girder could not be quantified because the diagnostic load tests (i.e., with controlled load magnitude and position) were not performed. The degradation of CFRP composite or the bond strength due to environmental conditioning could have potentially affected the stiffness but there could have been several other factors affecting the loss in stiffness of the girder. For instance, even though the girders were designed non-compositely, the contribution in stiffness due to the interaction of the steel girder-concrete deck was not evaluated at any stage of the service life of the bridge. In case there was composite action due to the concrete deck, the presence of cracks in concrete, loss of bond, etc. could result in stiffness degradation. Similarly, no studies were conducted to assess the cyclic strength degradation of girder due to dynamic loading, which could lead to a significant increase in peak displacement demands (Veletsos and Newmark, 1960). Overall, it was not possible to quantify the effect of environmental degradation in the reduction of global stiffness of the girder, thus, additional experimental tests need to be performed in the field and laboratory.

Figure 80. Number of peak Live load strain events above threshold at ST355 vs Miller (2000).

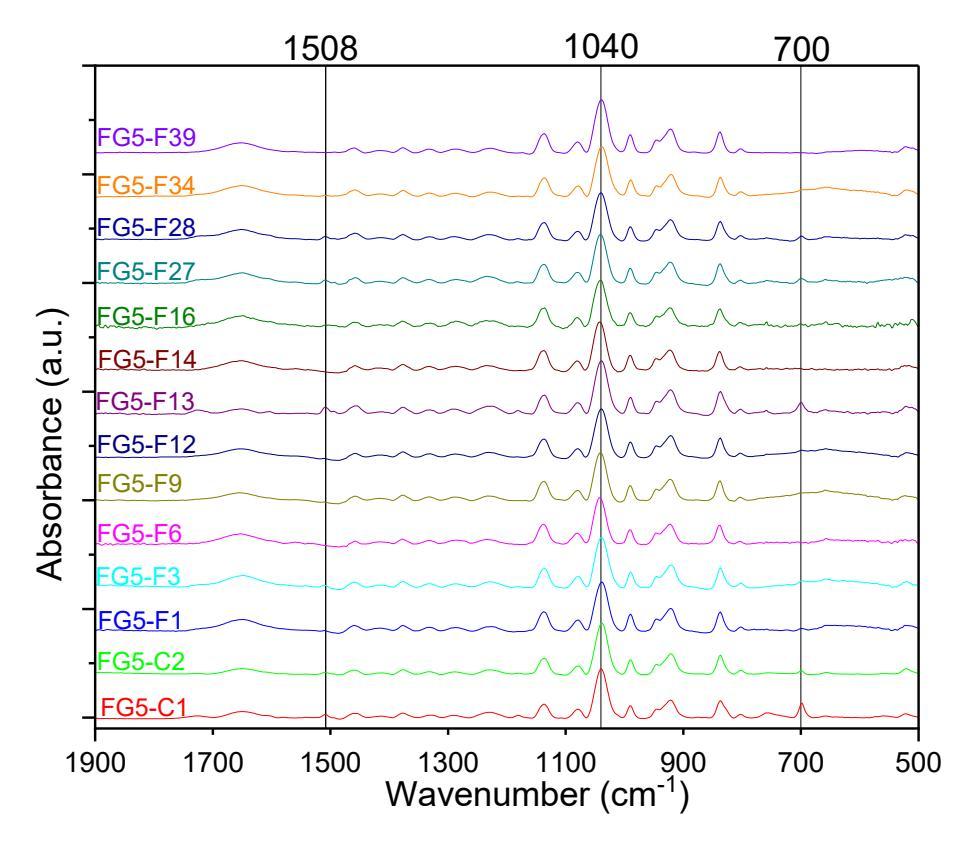
Spectra showed only minor spectral changes as a result of environmental exposure to the field conditions for 22 years. Some differences among spectra were observed: 1) intensity of peak absorbance at 700 cm⁻¹, was found present in both control samples FG5-C1, and FG5-C2, but the peak was partially or completely consumed on the field samples, and 2) intensity of peak absorbance at 1508 cm⁻¹ was also found present in both control samples, but the peak was partially or completely consumed on the field samples. The peak band 700 cm⁻¹ corresponds to the bending of the aromatic C-H bond in styrene (Jost et al., 2002, and Ziaee et al., 1999). Similarly, the peak band 1508 cm⁻¹ is attributed to the aromatic ring stretching of C=C, aromatic ring per (Auad et al., 1997). The intensities of both peaks at 700 cm⁻¹ and 1508 cm⁻¹ were found low and inconsistent in the field samples, which suggests that degradation did not occur or was insignificant.

Figure 82. ATR-FTIR spectra of CFRP control and field samples from Br 1-704.

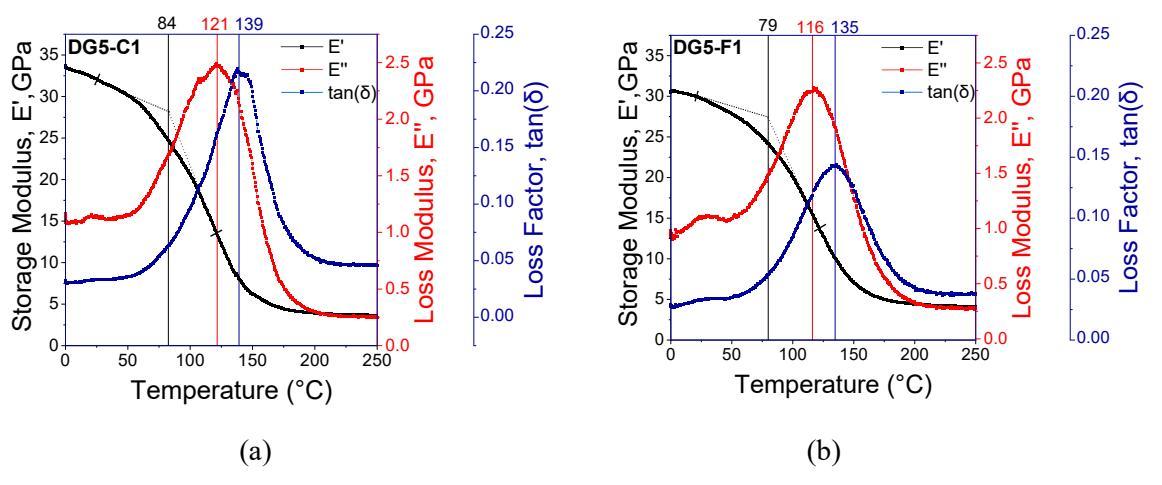
The nomenclature of the sample (e.g., DG5-C/F1) implies the DMA test of control (C) or field (F) samples from girder G5 and sample number 1. The glass transition temperatures of the control and field samples are shown in Table 4**Error! Reference source not found.** The T_g of field samples were found lower than the control samples by approximately 9% (Figure 84). Similarly, T_l and T_t of field samples were also found lower compared to control samples by 5% and 3%, respectively.

Figure 83. Representative DMA plots for: (a) control, and (b) field samples.

AASHTO (2012) recommends minimum T_g of the composite system be greater than the in-service temperature plus 40 °F. The maximum design temperature in Delaware for steel girder bridges with concrete deck per AASHTO (2017) is 43 °C, thus the AASHTO (2012) recommended minimum T_g is approximately equal to 66 °C, which is still lower than the T_g of the field as shown in Table 4 by approximately 20%. The reduction in T_g of field samples compared to controls can be attributed to the potential ingression of moisture at field conditions. The moisture uptake causes the plasticization and hydrolysis over short-term conditioning and long-term conditioning, respectively, through the breakage of ester linkage resulting in reduced T_g and softening of vinyl ester, which eventually causes a loss in stiffness and strength of CFRP composite (Chu et. al., 2005). In conclusion, some reduction in T_g was observed after 22 years of environmental exposure due to potential ingression of moisture; however, the reduction was not detrimental as the T_g of the field sample was still found greater than the AASHTO (2012) recommended minimum temperature.

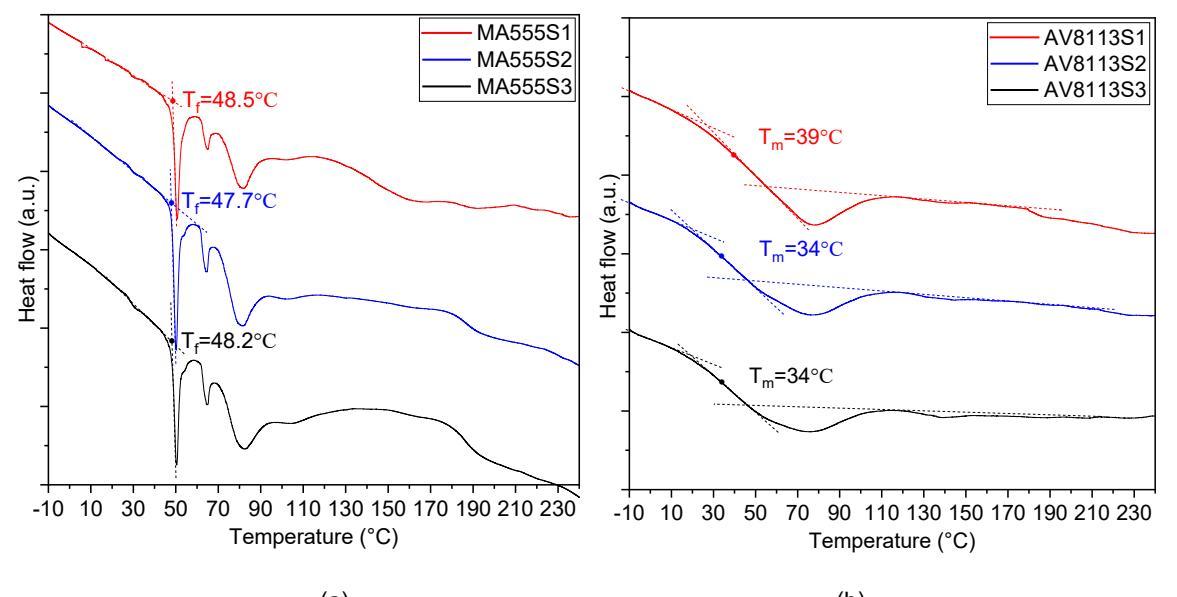
As shown in Figure 85Error! Reference source not found., the heat flow was plotted as a function of the temperature to determine the (T_g) of the structural adhesive samples collected from girder G5. The midpoint temperature (T_m) was selected as T_g for AV8113 structural adhesives since it is constructed closer to the middle of the temperature range over which the glass transition occurs. The first baseline was constructed to the heat flow curve before the transition temperature and the linear portion during the phase transition was extrapolated until it intersects the first baseline to determine the T_f per ASTM E1356-08 (2014). The second baseline was then established to the heat flow curve after the transition temperature. The linear portion during the phase transition was again extrapolated to meet the second baseline, the point of intersection is referred as Extrapolated End temperature (T_e) . An average midpoint temperature (T_m) for AV8113 was 35.7 ± 2.4 °C, which was found significantly lower than the glass transition temperature (i.e., 90 °C) reported by West (2001).

The extrapolated onset temperature (T_f) was selected as T_g for MA555 structural adhesives because of inability to establish the second baseline for determination of midpoint temperature. The first baseline was constructed to the heat flow curve before the transition temperature and the linear portion during the phase transition was extrapolated until it intersects the first baseline to determine the T_f per ASTM E1356-08. Several endothermic peaks were observed immediately after the phase transition as shown in Figure 85a. An average extrapolated onset temperature (T_f) for MA555 was 48.1 ± 0.3 °C, which was found lower than the glass transition temperature (i.e., 103 °C) reported by West (2001).

(a) (b) Figure 85. Glass transition temperature measured on samples from girder G5: (a) MA555 samples, and (b) AV813 samples.

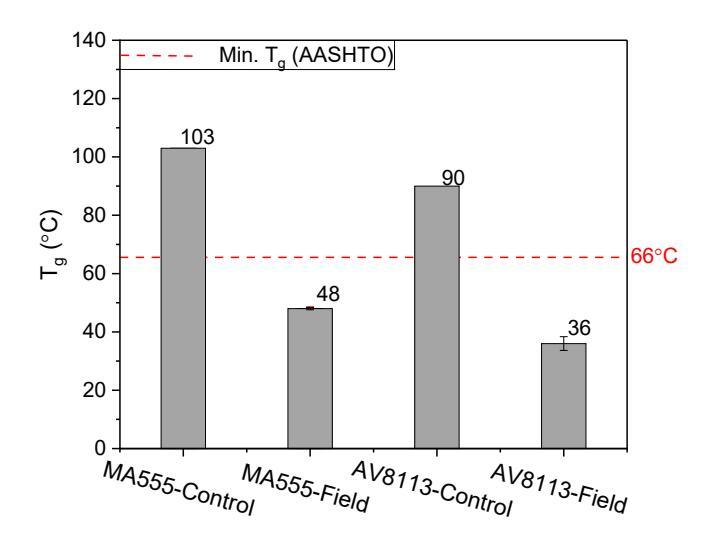
The T_g of both structural adhesives were found well below the minimum temperature of 66 °C as recommended by AASHTO (2012) and their respective control samples (Figure 86). Some reduction in T_g , similar to vinyl ester, maybe due to moisture ingression. The field samples were cured at the field conditions, but the curing information of the control samples was not known. The higher T_a of the control samples

could be due to the controlled curing at laboratory conditions. In conclusion, the observed T_g of both structural adhesives were found below the minimum requirement, which is concerning; T_g of the field sample may have been reduced due to moisture ingression, however, the cure phenomenon of the control samples was not known thus the quantification of reduction in T_g due to environmental conditioning was not possible.

Figure 86. Average Glass transition temperature of control and field structural adhesive samples.

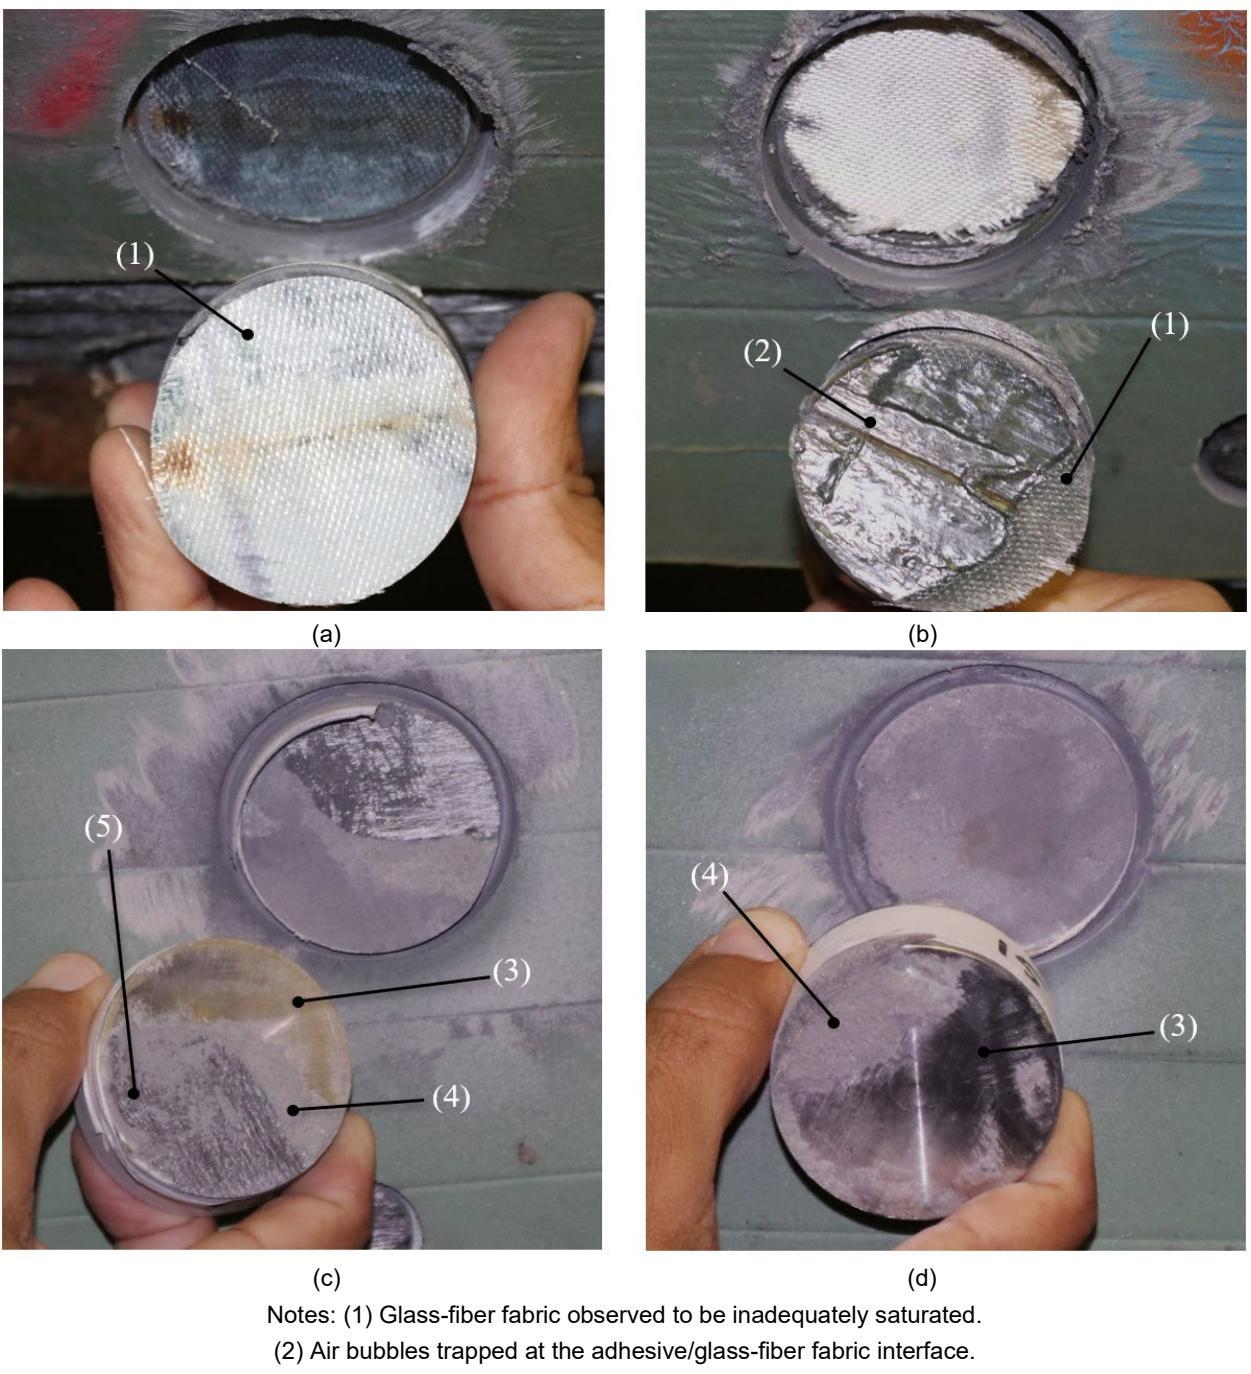
6 with respect to the centerline of the bearing at abutment 2 (Figure 55). A total of 20 tests were performed on the girder, out of which only two samples, P1 and P2, failed in the acceptable mode of failure (Mode C per ASTM D7522, 2021), where the adhesive failure in the adhesive/glass-fabric interface was observed. Additional two samples, P14 and P15 saw bonding adhesive failure at the loading fixture, which is not an acceptable failure mode per ASTM (2021). The remaining samples did not fail as the capacity of the pull-off tester (1145 psi) was reached.

Table 6 shows the bond strength for two samples, P1 and P2 was significantly below the minimum recommended bond strength value for various coating or paint system (Table 5). A careful observation at those test locations post-testing indicated inadequately saturated glass-fiber fabric and the presence of air bubbles trapped at the adhesive/glass-fiber fabric interface as shown in Figure 87a,b. Such failure at the adhesive/glass-fabric interface indicates issues with surface preparation, poor workmanship, or a combination thereof. The pull-off bond strengths at all the remaining 16 test samples, except P14 and P15 were found significant, as high as 1.6 to 4.6 times above the minimum bond strength values shown in Table 5.

(3) Clean surface of puck visible, no hint of "Sikadur-30" epoxy.

(4) Sikadur 30 epoxy residue.

(5) Cohesive failure of CFRP composite.

Figure 87. Failure modes observed at different location of G5: (a) Mode C at P1, (b) Mode C at P2, (c) Mode A at P14, and (d) Mode A at P15.

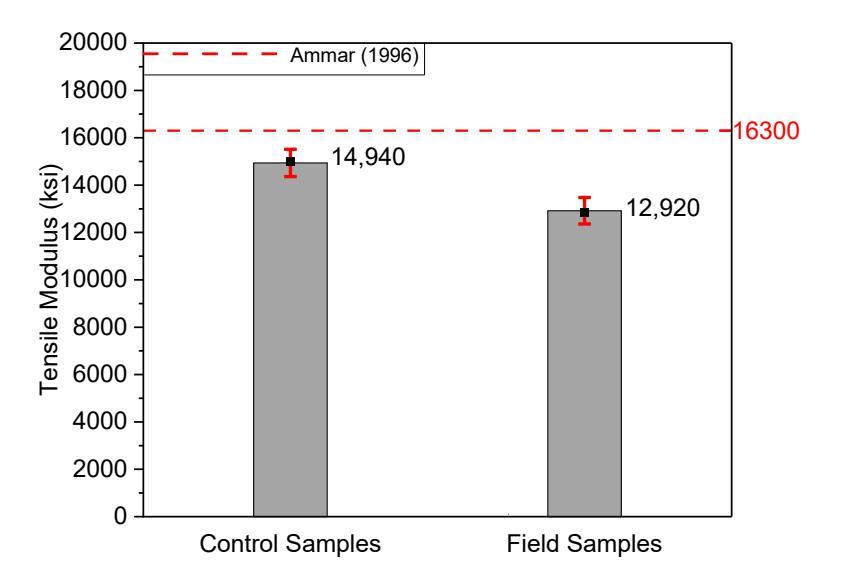
The tensile modulus for six CFRP coupons is shown in Table 7 and Figure 89. The nomenclature of the coupon (e.g., TG5-C/F1) implies the tensile test of control (C) or field (F) coupons from girder G5 and sample number 1. Tensile modulus, E_{11} , was calculated in the strain range of 0.005 to 0.025% instead of the 0.01 to 0.03% strain range recommended by ASTM D3039/D3039M-08 (2014). Tensile modulus was also calculated using the alternate numerical data method using ASTM E111-17 (2017), per chapter 13.3.2 of ASTMD3039, which was adopted for further analysis. The average tensile modulus of control and field coupons were 15,815±538 ksi and 13,408±820 ksi, respectively as shown in Table 7. Ammar (1996) performed tensile tests on several 8-in. long x 1.44-in. coupons using Intron 1120 at the University of Delaware to determine the tensile modulus, which yielded a mean value of 16,300±300 ksi. Upon comparison, the average tensile modulus for control and field coupons after 22 years was found to be 3% and 17% less than the tensile modulus determined by Ammar (1996), respectively. The average tensile modulus of control coupons was found to be 15% higher than that of field coupons.

Figure 89. Tensile modulus of field and control coupons after 22 years of service vs Ammar (1996).

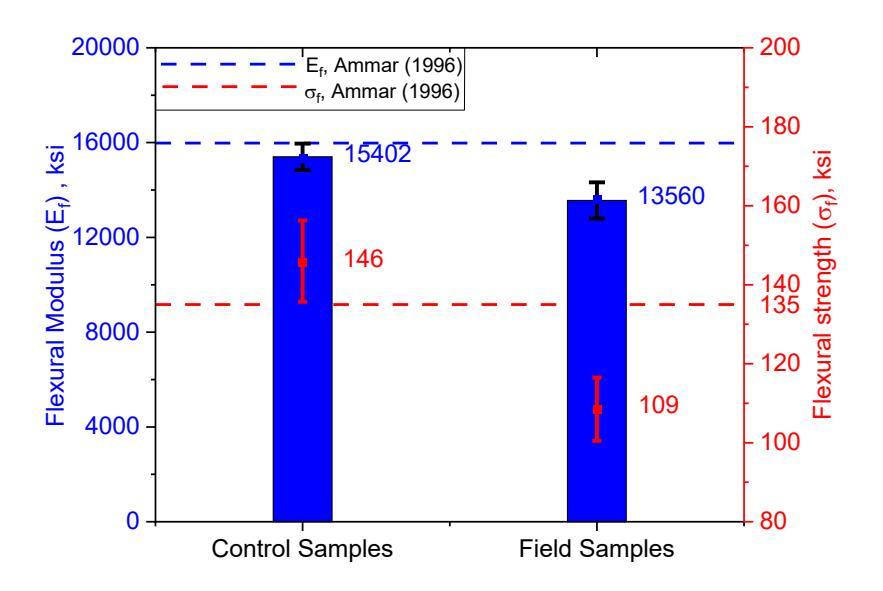
Similarly, the average flexural strength of control and field coupons were 146 ± 10 ksi and 108 ± 8 ksi, respectively, as shown in Table 8. Upon comparison, the average flexural strength of control coupons after 22 years was found to be 8% higher than the flexural strength obtained from Ammar (1996), while the average flexural strength of field samples was reduced by 25%. After 22 years of service, the flexural strength of field coupons was found to be lower than the design ultimate flexural strength computed using the C_E factor of 0.85 recommended by ACI440.2R (2017). Some reduction in strength, similar to tensile modulus, may be due to specimen extraction/manipulation procedures. However, considering the increment in number of peak strain events over the 22 years' service life and reduction in T_g of the field CFRP composite, it is likely that degradation also occurred. Considering the present data, a C_E factor of 0.75 may be more adequate within the considered service life (22 years) than the 0.85 value currently recommended by ACI 440.2R.

Figure 90. Flexural modulus and flexural strength of field and control coupons vs. Ammar (1996).

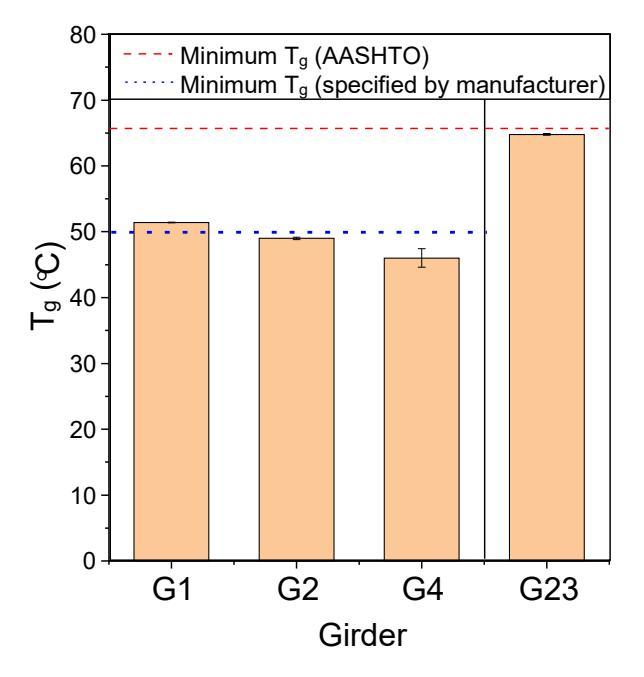
The primary objective of DSC experiments was to determine if environmental exposure during 26-year service life had an effect on the T_g of the CFRP bridge repairs. Figure 100 shows T_g of composite samples from girders G1, G2, G4, and G23. T_g of the CFRP installed in 1994 varied between 46 °C and 51 °C. These values were lower than T_g of the samples collected from G23 with the T_g of 65 °C. The lowest T_g was measured on G4. As shown in Figure 98, CFRP on G1 and G2 seemed more deteriorated compared to other girders. It was expected that the T_g of composite repairs on G1 and G2 is lower than on G4 since they seemed more degraded and had more exposure to water which is related to decreased cross-linking density through polymer chain scission/oxidation/hydrolysis (Lin et al., 2006). Surprisingly, the T_g values were 10% higher in G1 compared to G4. Lower T_g observed in G4 could be attributed to different thermal history. It is possible that exterior girders were more exposed to sunlight. Thermal history directly affects the cross-linking density, i.e., exposure to higher temperatures enhances the epoxy-amine reaction and results in stiffer network and higher T_g .

Assuming that 50 °C was the initial T_g value of the FR-E3P resin, it can be concluded that the reduction in T_g ranged from 0 to 10%. Decrease in T_g of 10% is lower compared to some results reported on artificially/naturally aged epoxy resin. A decrease in T_g in the range of 10% - 25% was measured during natural exposure in a tropical environment for no longer than 1 year (Lettieri and Frigione, 2011, Belec et al., 2015). Finally, measured T_g was compared to AASHTO recommendations. Given that maximum design temperature for Delaware is 45 °C, and taking into account AASHTO guidelines (minimum T_g of 45°C+21°C) low values like these are deemed inadequate.

Figure 100. Glass transition temperature measured on samples from girders G1, G2, G4 and G23.

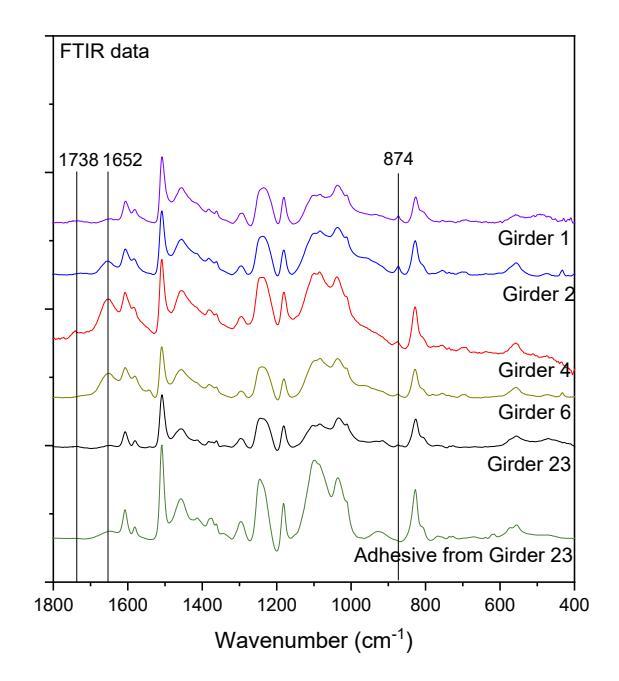
ATR-FTIR spectra are shown in Figure 102. Some differences among the spectra were observed: 1) peak at 1658 cm⁻¹ is prominent in some samples; 2) peak at 1738 cm⁻¹ and peak at 874 cm⁻¹ is present in the CFRP samples from G1 and G2, but not in the G6 and G23 samples; and 3) a relatively small peak at 1540 cm⁻¹ in the spectra of G2 and G6 samples.

Almost all FTIR spectra recorded on G1, G2, G4, G6 show the presence of the peak at 1656 cm⁻¹ which indicates amine cross-linker-related degradation. The appearance of a band around 1660 cm⁻¹-1670 cm⁻¹ is reported in amine-cured epoxies (Delor-Jestin et al., 2006; Meiser and Possart, 2011) after thermal aging, hygrothermal cycling (Lin et al., 2006), UV exposure and outdoor weathering (Belec et al., 2015; Gu et al., 2005) including thermooxidation under mild conditions (70 °C, 80% RH), Morsch et al., 2020). Researchers suggest that the formation of the 1657 cm⁻¹ band involves a reaction on the phenoxy group and corresponds to quinone methide (Mailhot et al., 2005). According to a different mechanism, 1658 cm⁻¹ is related to amine cross-linker oxidation. As proposed by Morsch et al., 2020, products of imine hydrolysis contribute to the absorbance at 1658 cm⁻¹ (primary amine N-H bend).

The peak at 1738 cm⁻¹ was present only in the spectra from G4. This peak was previously reported to correspond to the phenyl formate. The sample from G4 had the lowest T_g , too (Figure 100). It is difficult to what would be the underlying mechanism of the observed decrease in T_g , but the presence of 1738 cm⁻¹ suggests that the chemical degradation is causing it (possible chain scission reactions in hydroxypropyl ether groups in DGEBA are shown in Figure 101).

Figure 102. ATR-FTIR spectra of CFRP material samples collected from Foulk road bridge.

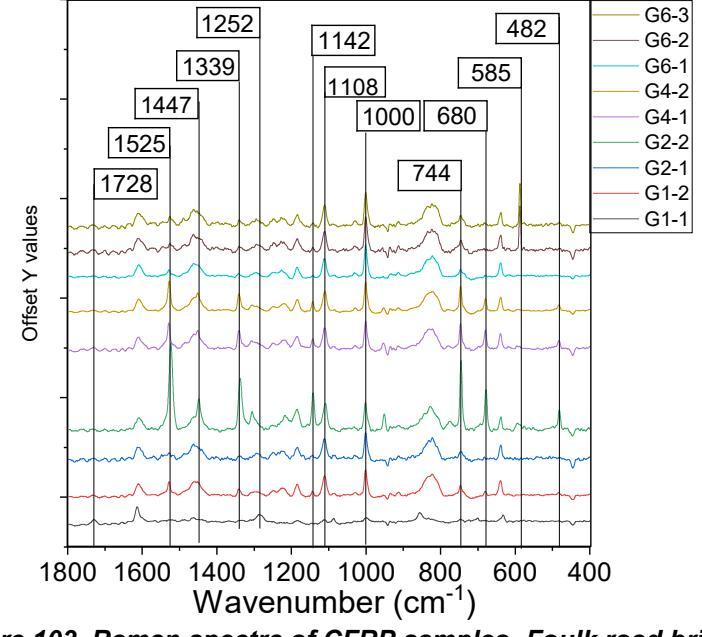
The spectra in the carbonyl range (1500-1700) have a poor resolution due to the noise and baseline correction procedures. To provide additional information regarding chemical degradation, Raman spectra were collected. A comparison of Raman spectra recorded on CFRP samples from four different girders are shown in Figure 103. Differences can be noticed at wavenumbers 1728, 1525, 1339, 1143, 1000, 744, 680, 585 and 482 cm⁻¹. Published literature on Raman analysis of epoxy were reviewed to serve as a reference for peak assignment (Daimay, 1991; Fu et al., 2020; Rocks et al., 2004; Vaskova and Kresálek, 2011; Younes et al., 1994; Zapata et al., 2013). Two peaks related to degradation are of particular interest: the peak corresponding to the carbonyl group and the peak corresponding to tertiary amides. Tertiary amides are observed in the Raman spectra in the 700-750 cm⁻¹ range (Daimay, 1991). The issue with using this peak to monitor the degradation of epoxy/amine is that epoxy ring deformation appears in the Raman spectra at 736 cm⁻¹. Another region of interest is 620-590 related to the skeletal deformation of tertiary amides with R-C(=O)NR2 type of structure. C=O bands are weak in Raman spectra (Daimay, 1991) and they appear at 1725 cm⁻¹ peak was observed only in the spectra on G1.

Monitoring variation in peak intensity at 1324 cm⁻¹, 1454 cm⁻¹, 1150 cm⁻¹ is another potentially useful way of monitoring chemical degradation as these peaks corresponding to C-C functional groups, indicate chain scission (Guo et al., 2019). Differences were observed in the Raman spectra from the Foulk road bridge at 1447 and 1142 cm⁻¹, which suggests that degradation occurred.

Figure 103. Raman spectra of CFRP samples- Foulk road bridge.

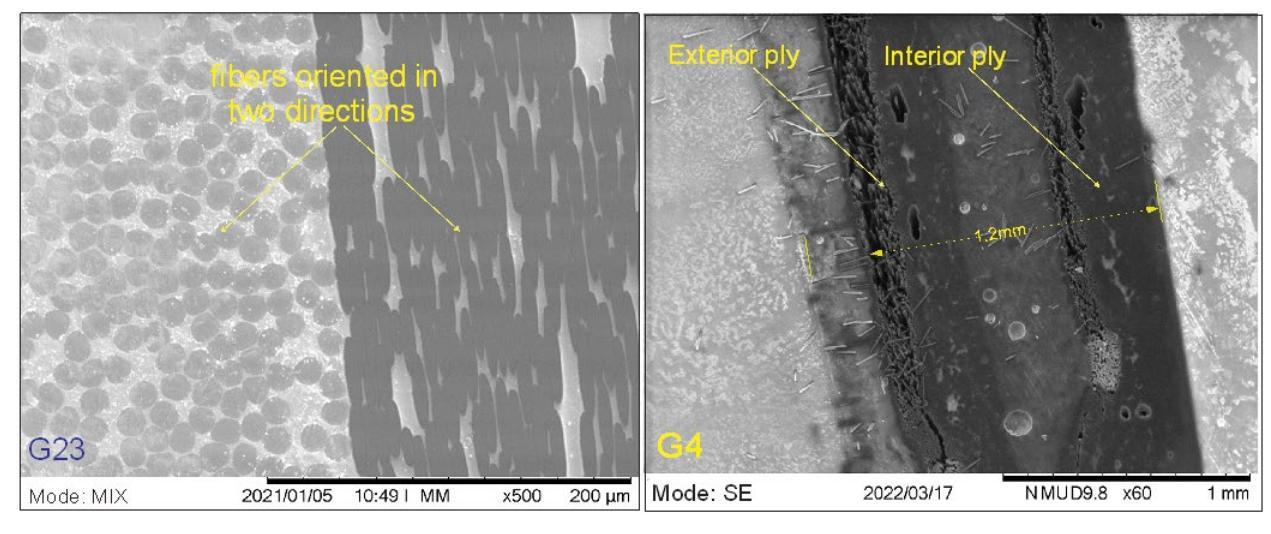
Figure 104 shows typical SEM images of cross-sections of samples collected from G1, G4 and G23. In the CFRP sample from girder G1 (Figure 104a), matrix cracking was noticed at the fiber/matrix interface. Low magnification images in Figure 104 show the non-uniform distribution of fibers that are about 7 μ m in diameter. Cracking along the fiber/matrix interface is one of the most common failure scenarios in composite subjected to static loading or fatigue. This damage mechanism is initiated by the formation of local fiber/matrix debonding, which proceeds until cracks coalesce into one large crack (Pupurs, 2012).

This leads to stiffness reduction and eventually results in composite failure (Pupurs, 2012). No evidence of damage was observed in the sample from girder G23 (Figure 104b).

Figure 104c presents a typical SEM image of the sample from girder G4. The image shows two plies of CFRP (~0.5 mm) with a layer of epoxy in between. SEM images show damage in both plies of CFRP but not in the epoxy layer between them. The surface of the exterior ply is the most deteriorated part. Composite damage includes loss of matrix and completely exposed fibers. Synergistic actions of mechanical stress, water diffusion, and temperature are the most likely causes of the composite degradation. The breakdown of resin molecular chains and leaching of broken chains likely increased sensitivity to water uptake which accelerated resin degradation and fiber-matrix interface.

Figure 104. SEM images of CFRP: (a) cracking at the fiber/matrix interface in G1, (b) cracking in the region of closely spaced fibers in G6, (c) bidirectional CFRP, (d,e) cracking and loss of matrix two-ply CFRP on G4, and (f) high magnification image showing exposed fibers in G4.

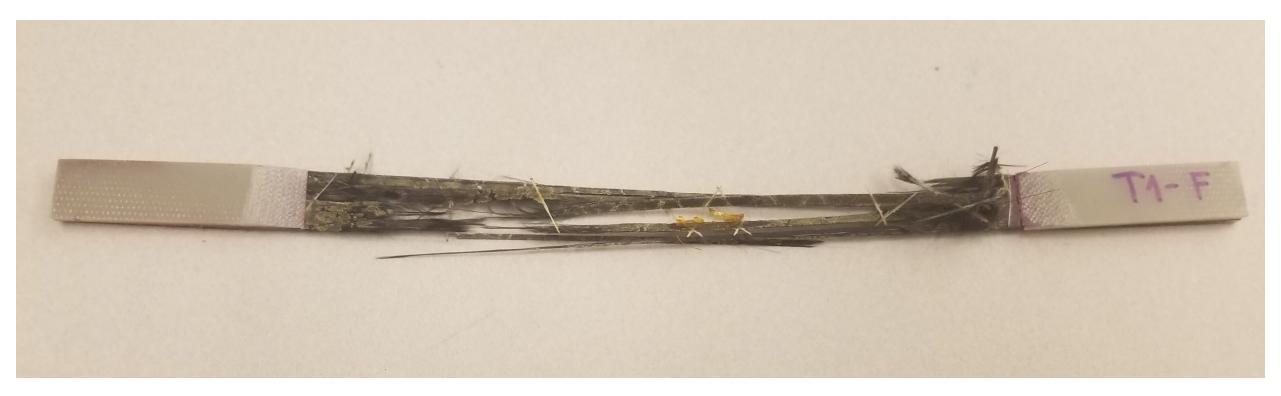
The average tensile strength was 318 ksi which is 37% less than the value specified in the materials data sheet—483 ksi. Failure mode can be best described as a staggered failure with fiber pullout and debonding along the fibers (Figure 105). The load vs time curve in Figure 106 shows the propagation of the failure where bundles of fiber progressively fail at different locations along the coupon length. As shown in the SEM images, there were many defects in the matrix – cracking and matrix erosion. These defects probably decreased composite strength since there was not enough resin to ensure uniform distribution of stress between the fibers. According to ACI 440.2R, the environmental reduction factors are applied to CFRP properties and vary between 0.85 and 0.95 depending on the environmental exposure. For CFRP installed on bridges, ACI 440.2R recommends an environmental reduction factor of 0.85. The calculated value of C_E based on strength data in Table 11 was 0.66, which is significantly lower than the value recommended in ACI 440.2R.

Figure 105. Typical failure mode of tensile test coupons.

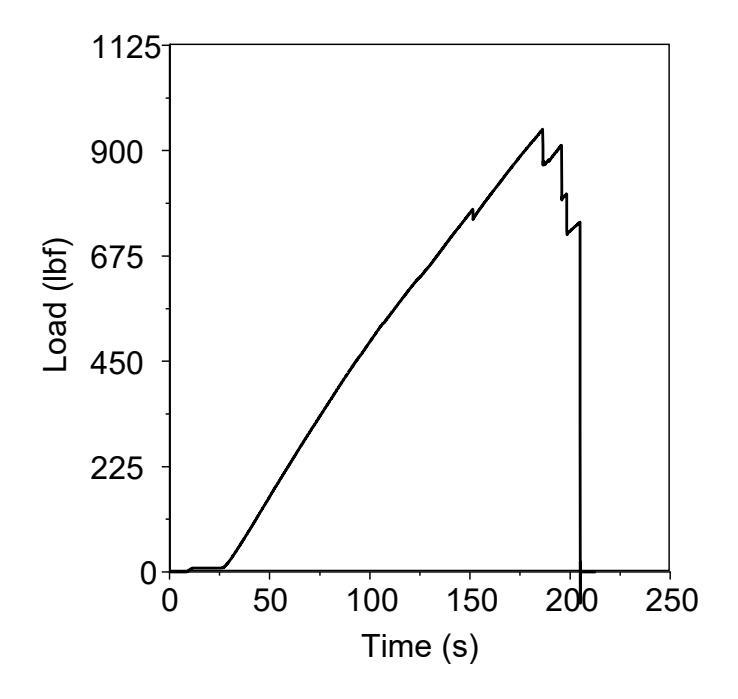
Figure 106. Load vs time curve (strain gage failed before the coupon failure, so part of the strain data is missing).

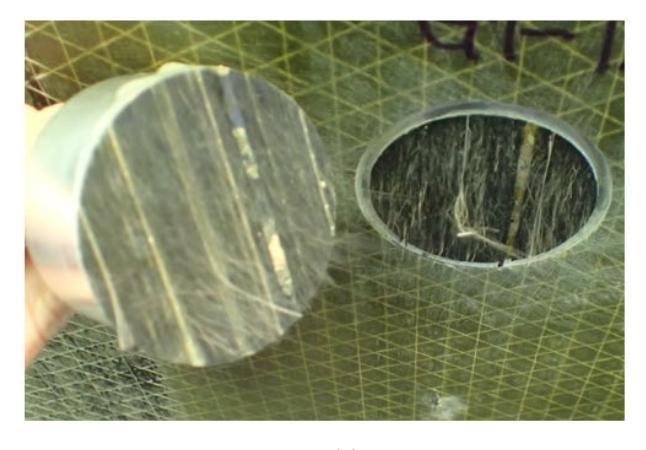
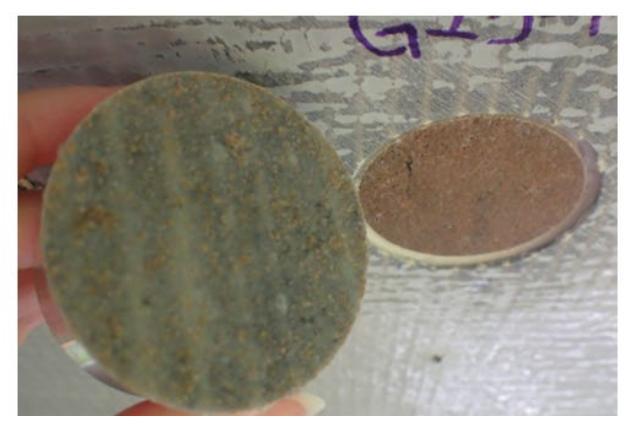
Pull-off test results and interpretation of observed failure modes are presented in Table 12 and the photos of typical failure modes are shown in Figure 107. The nomenclature of the sample (e.g., G1-U/UD/B1) implies the pull-off test at girder G1 with unidirectional CFRP with single ply (U), unidirectional CFRP with double plies (UD), or bidirectional CFRP with single ply (B) and sample number 1. Due to the unavailability of initial pull-off tests data during the time of repair, a quantitative assessment of bond strength degradation was not possible; therefore, the test results were compared to the minimum bond strength of 200 psi recommended by AASHTO-FRPS-1 (2012).

A total of five tests were performed on girders G1 and G4, repaired using unidirectional CFRP in 1994, where the cohesive failure of the CFRP laminate (Mode B per ASTM 2021) was observed on all the samples. It was not possible to determine the actual bond strength at G1 and G4 because the CFRP composite failed in a cohesive mode of failure before reaching the bond failure. The lower bound bond strength of G1-UX samples was found to be at least 80% greater than the minimum recommended by AASHTO-FRPS-1, however, the bond strength assessment at G4 could not be performed because G4-UDX samples failed prematurely at bond stress much lower than the minimum recommended bond strength (Table 12). The remaining three tests were performed on the girder G23, repaired with bidirectional CFRP, where adhesive failure at CFRP/concrete interface (Mode E) was observed on all three samples. The average bond strength of G23-BX samples was found to be approximately 62% greater than the minimum recommended value, but the strength of two out of three test samples was below the minimum recommended value by 31% and 3%.
