Tissue Strain Under the Sacrum & Coccyx

By Supine Posture and Skeletal Morphology

Stephen Sprigle ^{1,2}, PhD, PT & Sharon Sonenblum ¹, PhD ¹ The George W. Woodruff School of Mechanical Engineering ² College of Design

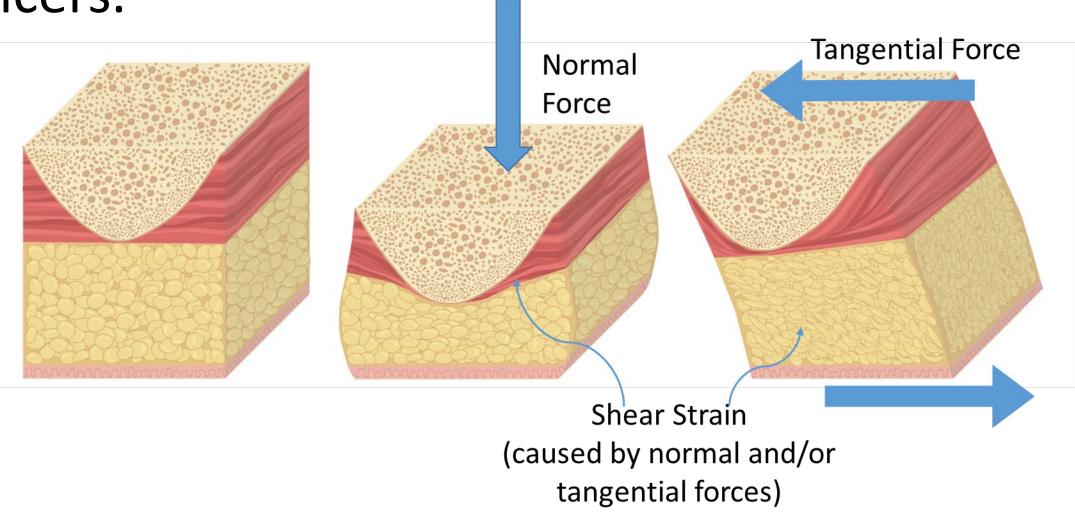
30° HOB is often not recommended for pressure ulcer prevention, but is for respiration, digestion, comfort and communication.

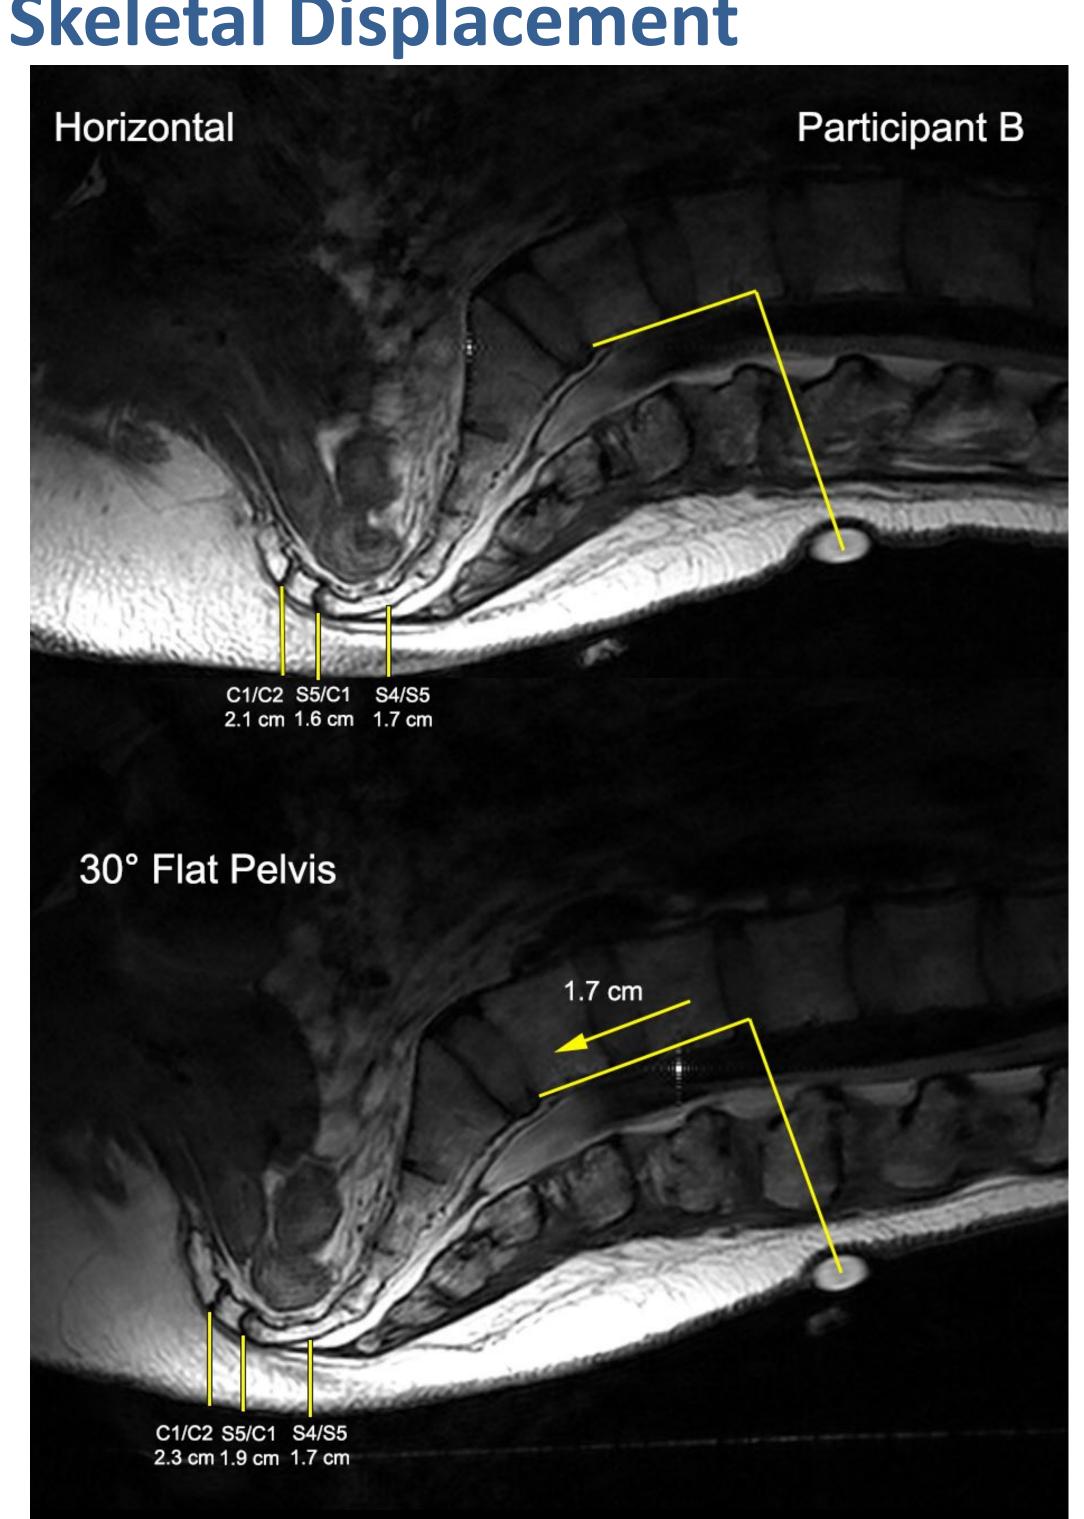
- Skin is held in place by friction, while the skeleton displaced
- Displacement of the skeleton towards the feet (relative to the skin) ranged from 0.8 to 2.3 cm when the HOB was raised to 30°
- The skeleton induced a force which deformed tissue through normal and shear stresses
- Shear strain must occur in the tissue layers in between the skin and bone

- Raising the HOB does not increase tissue compression, and instead may be more damaging due to increased tangential forces and shear strains
- Friction at the body interface induces stress in tissue that results in shear strain within internal soft tissue
- Further study into appropriate interventions according to the role of skeletal morphology in biomechanical risk is needed
