Lindsay McGovern
CRP 6798
April 22, 2016

Implementation of a Hoophouse in the Offinso North District, Ghana

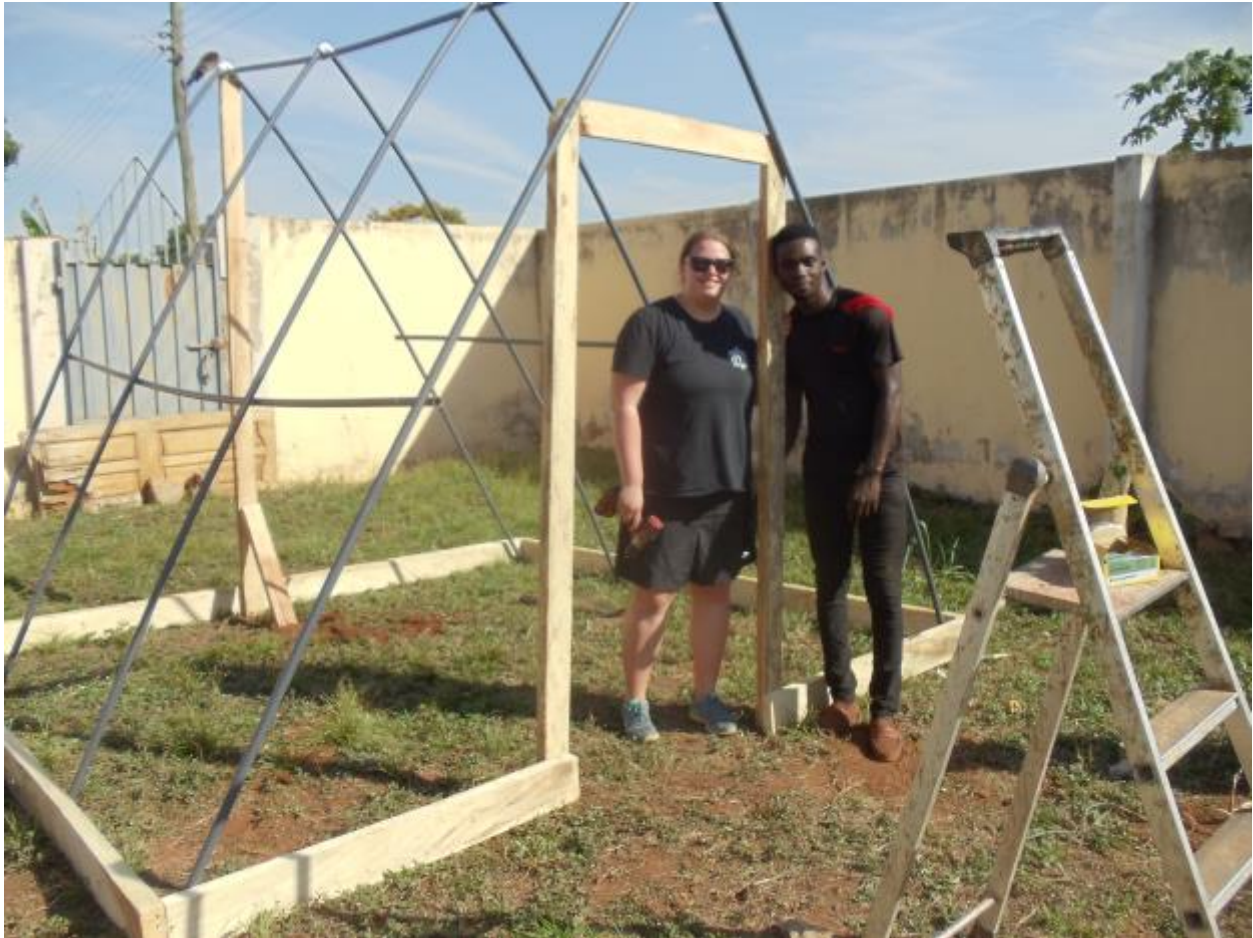
Figure 1: Construction completed after work day 2.

On the second day of work, I cut the 2x6" lumber to the appropriate sizes for a frame to create a 10 foot by 10 foot growing area. I screwed the lumber together in a square with a 3 foot gap in the middle of the front piece of lumber for the door. I primed and cemented the PVC piping and couplers into the peaks that would create the roof of the hoop house. At the point where each PVC pipe would be attached to the ground, I drove 6 inches of a 12 inch piece of rebar into the ground to stake the hoop house down. The PVC piping can then be attached to the wood frame for additional stability. PVC pipes should be placed about three to four feet apart for the entire length of the hoop house. I then attached the individual peaks of the hoop house by adding three more PVC cross pipes. Once the cross pipes were added, the PVC frame was placed over the rebar and planted into the ground. To stabilize the PVC frame, two 2x4" were cut into the shape of a door frame and attached to the PVC frame with screws. An additional 2x4" was cut and placed in the back of the hoop house and attached to the last peak using screws. An additional 2x4" was cut and placed at a diagonal from the 2x4" in the back and was planted into the ground for additional stability. A final 2x4" was cut and screwed into the 2x4" that created the door frame. This finished the door frame and added additional stability to the hoop house. The work completed on the second day can be seen in Figure 1.

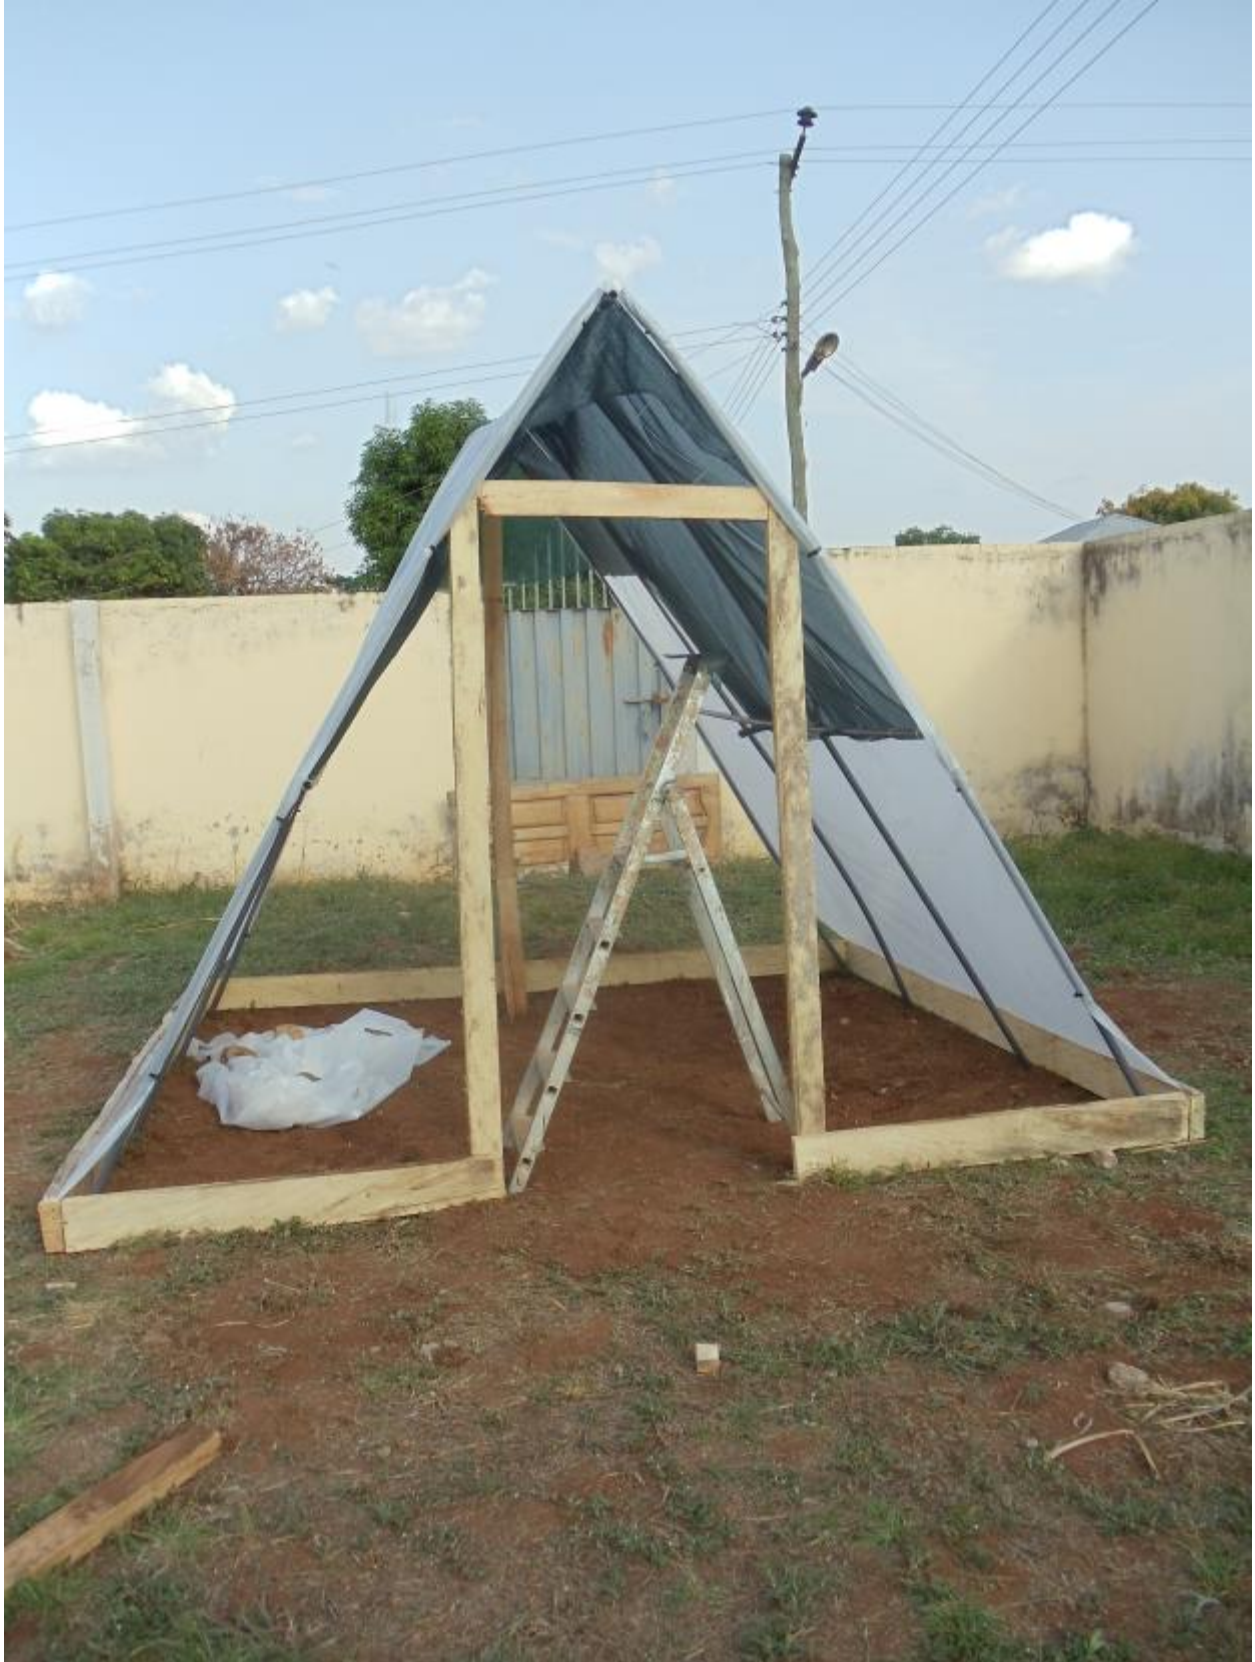
Figure 2: Construction completed after day 3.

On the third work day, I placed the shade cloth over the peak of the hoop house and attached it to the PVC piping using zip ties. I then placed the plastic tarping over the peak of the hoop house and attached to the top lip of the 2x6" using wood nails. To tighten the plastic over the roof of the hoop house, I attached PVC clips to the PVC piping over the plastic and turned the clip until the plastic became taught. Because of the stress to the plastic from wind, I then covered the top of the 2x6" with wood lathing and screwed it into the 2x6". This removed some of the stress at the site of the nail. At this point I realized I did not bring enough plastic tarping so I needed to brainstorm ideas to rectify this. Additionally, I removed the vegetation inside the hoop house and began tilling the ground for the garden. The completed work from day 3 can be seen in Figure 2.

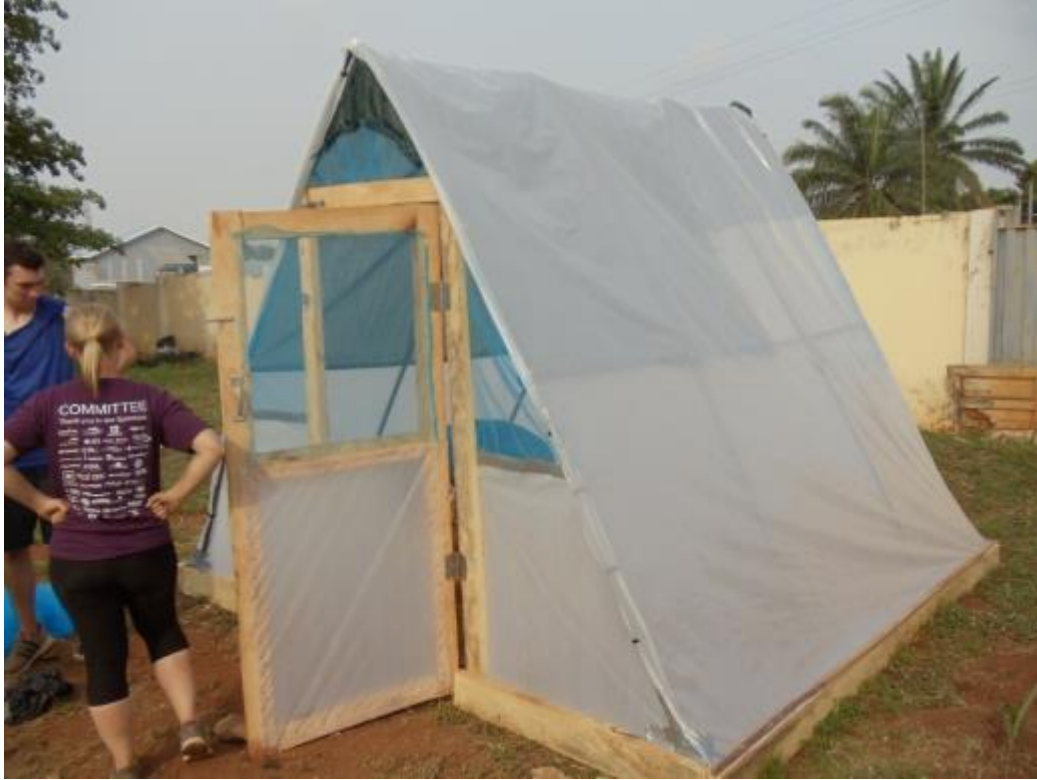
Figure 3: The completed hoophouse after day 4.

On the fourth work day, I attached the remaining plastic on the front and back of the hoop house towards the bottom to create the sides of the hoop house. The plastic was nailed into the 2x6" as done on the previous day. The new pieces of plastic that were attached to the PVC piping were incorporated into the clips already containing plastic from the roof and tightened. The solution to the lack of plastic was adding more mosquito netting. This would create a larger ventilation window than originally planned for. I then built and attached the door to the door frame using galvanized metal hinges. The lumber was very warped due to sitting outside of the wood mill so we needed to add shims to expand the door frame. We then added a metal bracket to stabilize the door frame at the point where the shims were added. The garden was then planted and watered. I

placed stakes in the ground labeling where each vegetable was planted. The completed work from day 4 can be seen in Figure 3 and Figure 4.

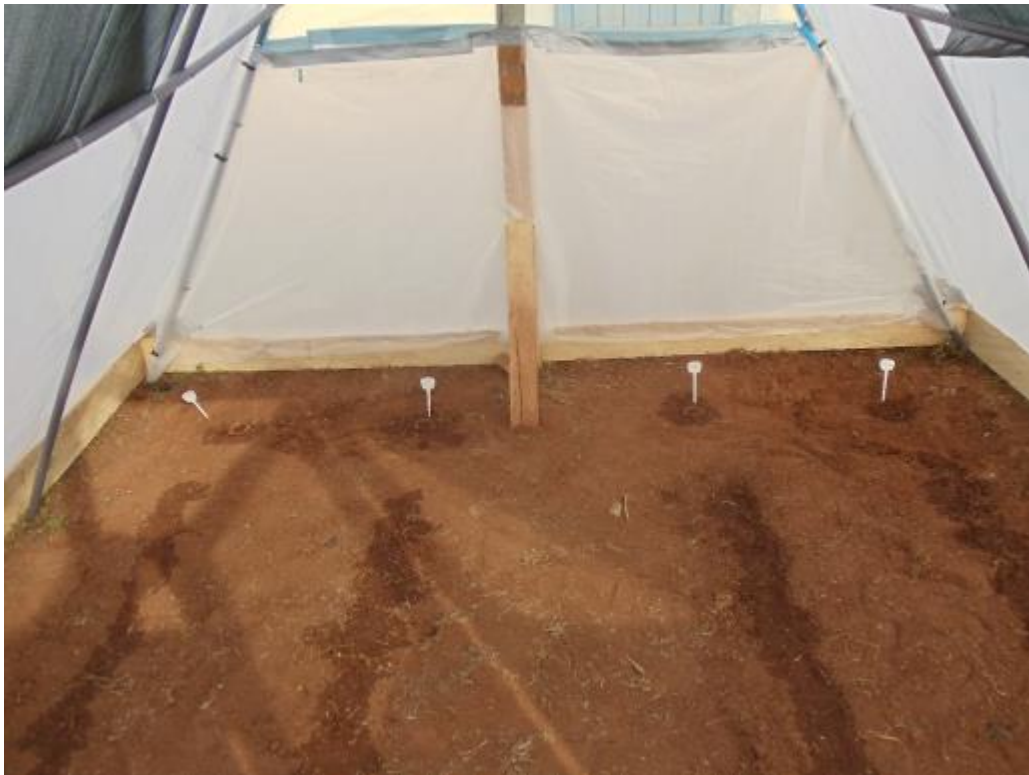
Figure 4: The inside of the hoophouse after it was planted and watered.

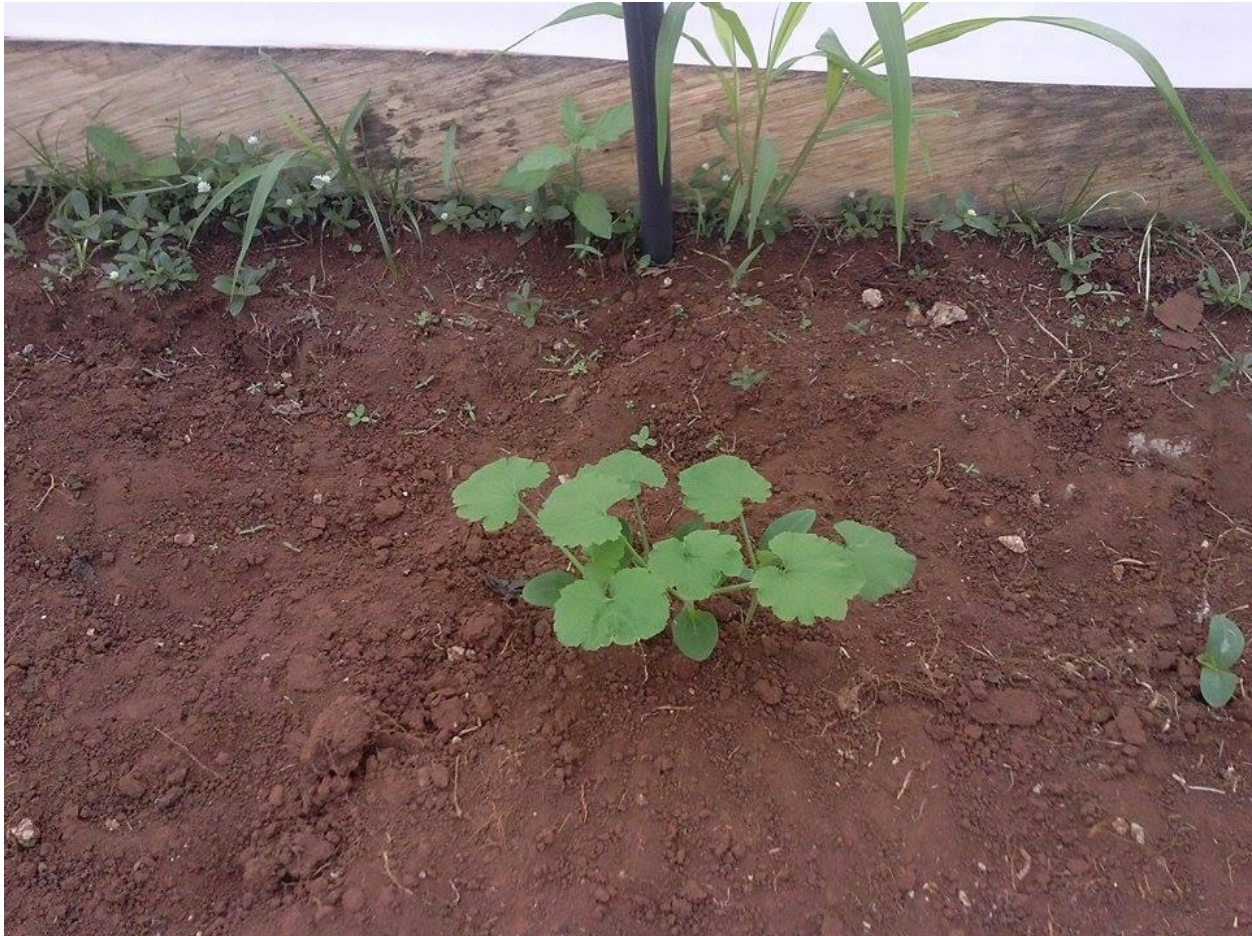
After returning back to the United States, I contacted someone from ONDA to check the progress of the hoophouse. He told me that the hoophouse was not being watered but that there was growth in the hoophouse. I asked him to find someone that could water and help maintain the hoophouse moving forward. The growth twenty days after planting can be seen in Figure 5.

Figure 5: Growth inside the hoophouse twenty days after planting.

The garden was not being watered after we left Ghana. I should have found a person that was willing to water and maintain it before leaving so as to avoid this problem. The hoophouse still had growth in it so I think it was collecting rain through the mosquito netting or the humidity

was condensing on the plastic and dripping onto the garden. It is important before you leave a project to properly train the people who will maintain it, this was a mistake I made.
